Sarah Watson
2718 Lazy Spring Dr.
Houston, TX 77080

May 25, 2022

PROPERTY INSPECTION REPORT FORM

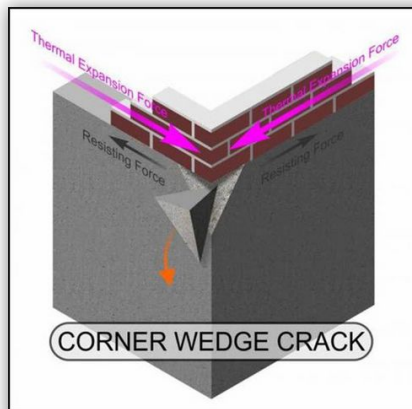
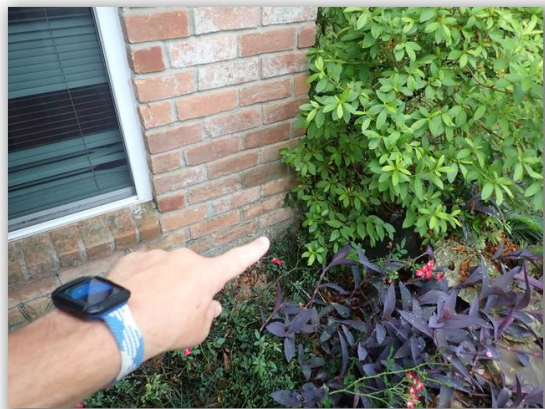
- One or more of the foundation perimeter beam corners were observed to be sheared off (corner pop). This is a common condition to observe and is due to thermal expansion and contraction of the different building materials. This condition does not adversely affect the foundation performance. However, in some cases, some cosmetic improvements may be necessary.

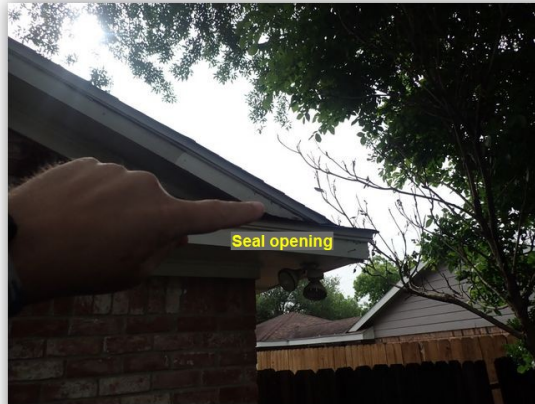
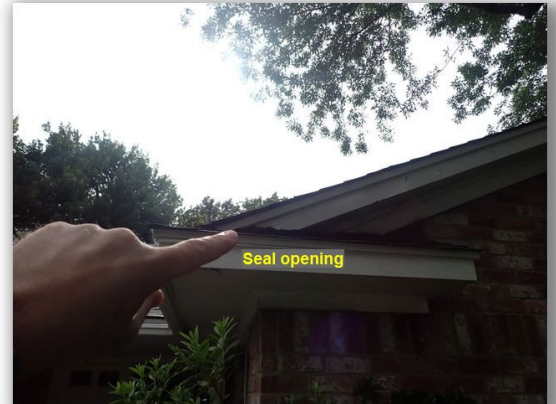
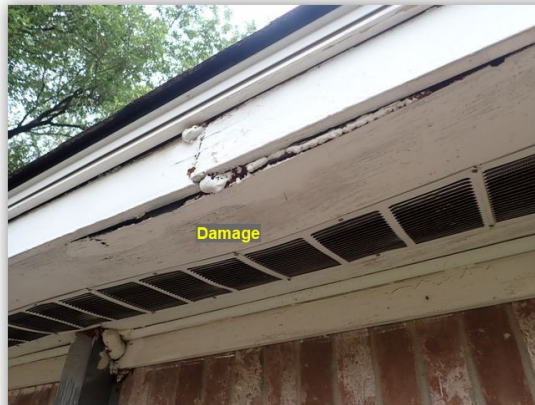
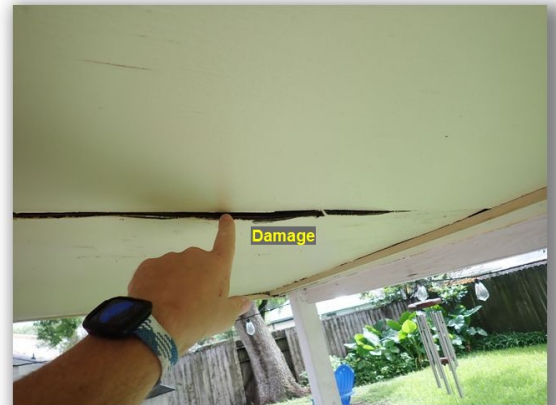
Roof Structure

- The fascia board material has some deterioration and/or damage on the west side of the roof structure.
- It is recommended to seal all openings between the soffit and roof covering to prevent pest/rodent intrusion at this point.
- The soffit material has some deterioration and/or damage on the south side of the roof structure.
- The soffit material is sagging and/or pulling loose on the south side, east side of the roof structure.

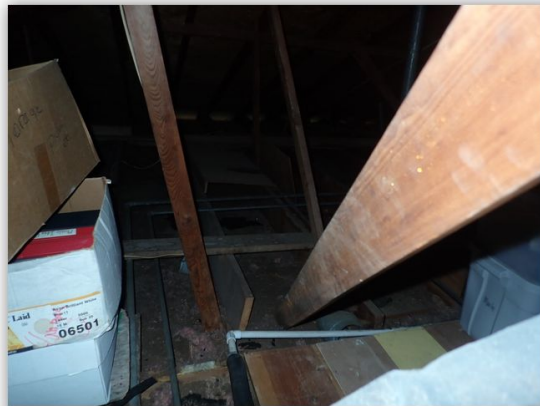
Attic Insulation

- The attic insulation is lower than typical and it is recommended to add additional insulation to achieve at least a R-30 rating.

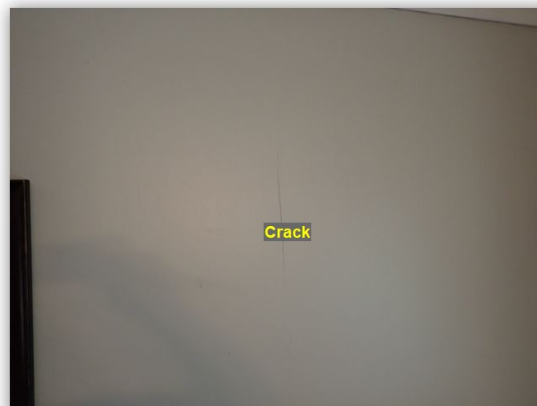
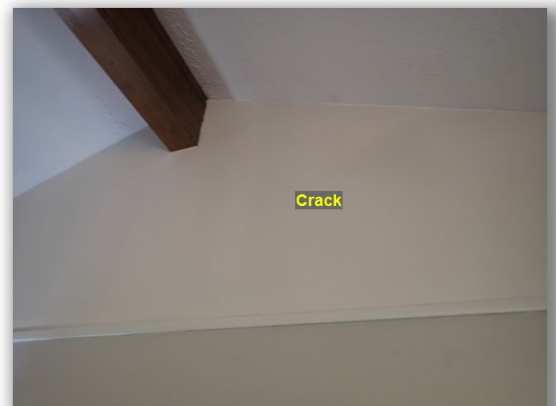
Note: There is evidence of painting and patching to the interior finish and prior interior finish repairs. This condition could limit the Inspectors visual observations and ability to render accurate opinions as to the performance of the structure.

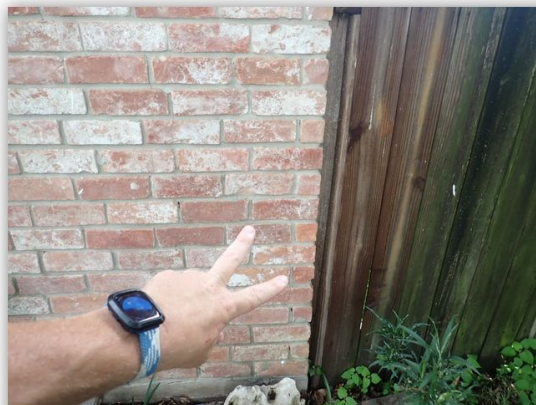
Exterior Walls & Surfaces

- All wood to ground contact at the base of the siding should be eliminated. Rotted or damaged siding that is uncovered should be repaired. The siding was observed to be in contact with the finish grade (ground) on the west side of the structure.
- All joints between two different types of siding should be properly sealed. It is recommended to use elastomeric sealant.
- The soldier bricks were observed to be loose on the north side of the structure. Some improvements are recommended.
- The area between the exterior cladding / veneer and all of the wall penetrations / openings need to be properly sealed. Areas such as utility connections, downspouts, hose bibbs, lighting fixtures, receptacles etc. It is recommended to use an elastomeric caulking / sealant.
- All of the exterior wood type surfaces need a fresh coat of paint.

Note: Previous repairs to the exterior masonry mortar / grout was observed on the north side, north, east, west and south sides of the structure.

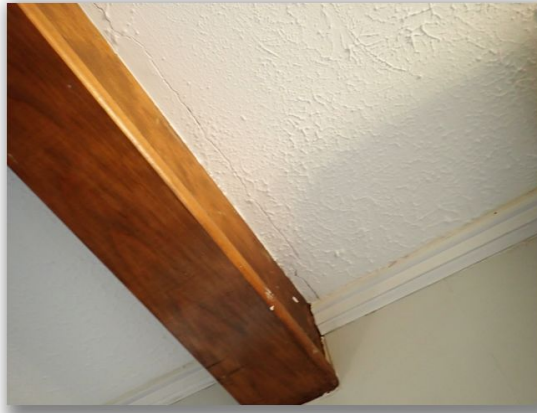
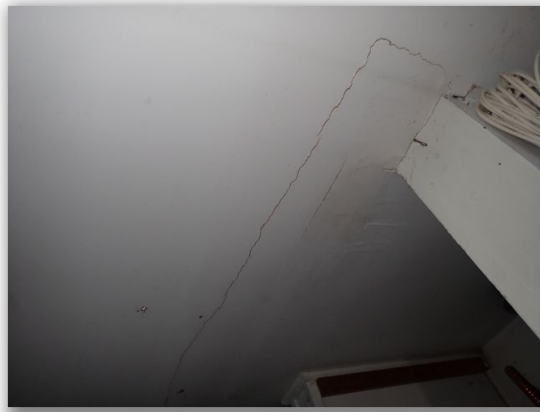
- Ceiling joint cracks were observed in the living room, garage.
- Water stains observed on the ceiling at and/or around the water heater flue area. The sealant at the flue roof level storm collar needs to be further investigated and corrected as necessary.

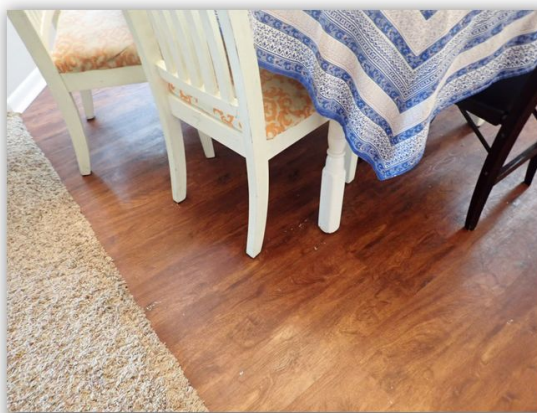
Floors

- The floor covering is worn and/or damaged in one or more locations of the home.

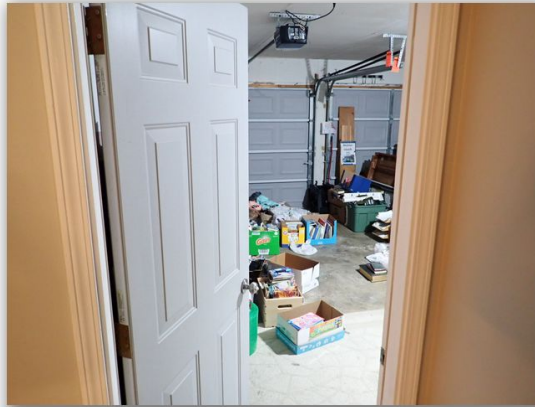
Exterior Doors

- The garage entry door is not equipped with a self-closing device.
- The exterior door frame has some deterioration and/or damage to the garage entry door(s).

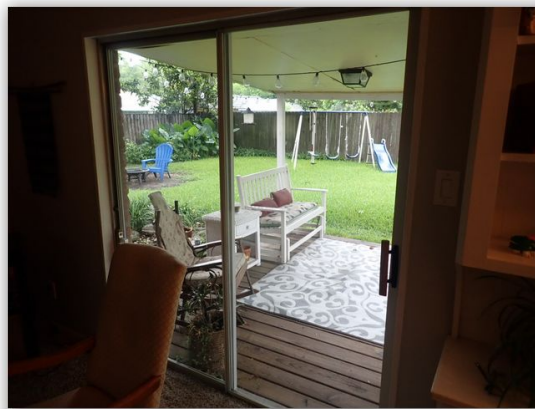
Sliding Glass Door

- The backyard entry sliding glass door lock is damaged and does not function properly.

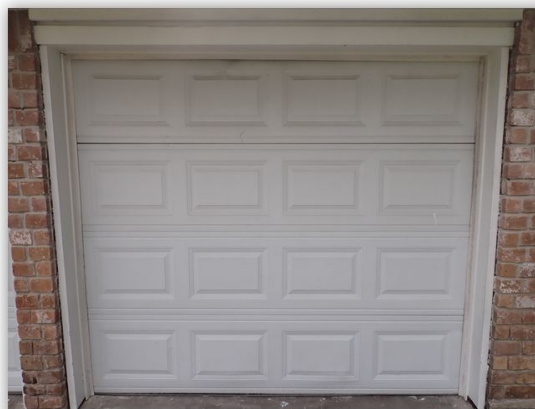
Overhead Garage Door

- Some damage to the overhead garage door was observed.

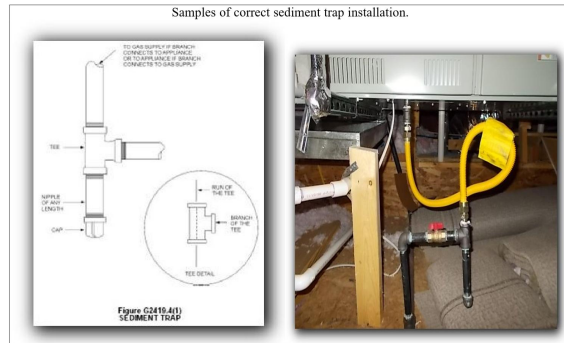
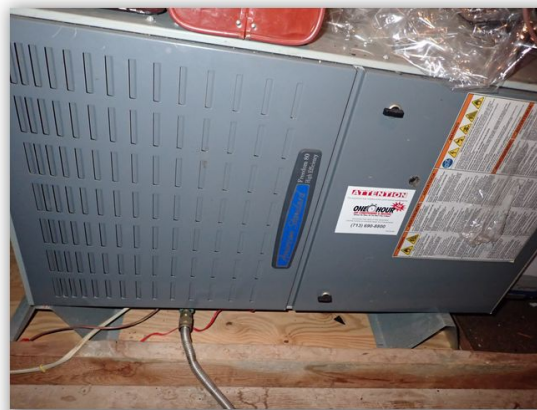
- The air return system currently has two filters in place (Double Filtered). The configuration will adversely affect the return air flow and performance of the HVAC system. This condition should be further evaluated and corrected as necessary.
- The heater gas supply line is not equipped with a sediment trap just before the gas appliance connector. This condition does not meet current installation requirements and should be corrected.

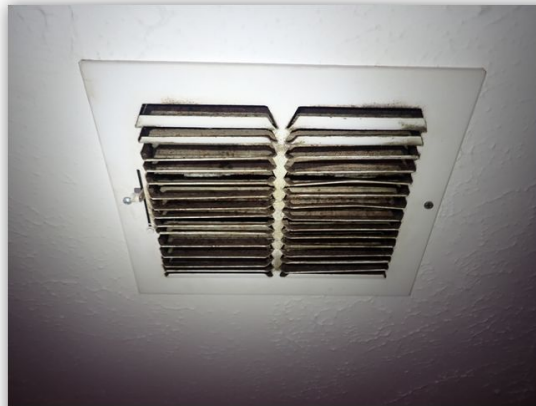
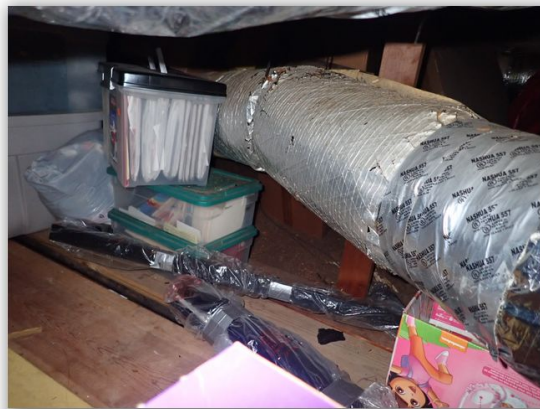
- The duct system was observed to be dirty and needs to be cleaned for air quality purposes.
- There is visible dust and/or mildew on the air registers in the front middle bedroom. The cause and remedy should be further evaluated. It is recommended to have the air registers and duct system cleaned for air quality purposes.
- There are electrical romex wires observed in the air return chase. Under current building standards, this is no longer an accepted practice.

Additional Notice from the Inspector: The ductwork was observed to be older and in poor condition. It is recommended to replace the ductwork for improved air quality and efficiency.

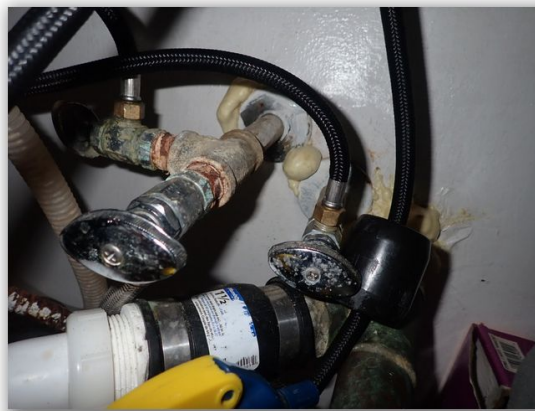
- There are galvanized water lines in use at the time of this inspection. This is an older obsolete water supply system that is prone to water leaks. Full evaluation of all of the galvanized water line components and the integrity of those components are beyond the scope of this inspection. You are strongly encouraged to have the integrity of all of the galvanized water line components further evaluated by a qualified plumber prior to the expiration of any time limitations such as option or warranty periods. All plumber recommended repairs should be made. It would be wise to budget for replacement of all the older galvanized water supply system and to make a conversion over to a newer type of water supply system as soon as it is financially feasible.

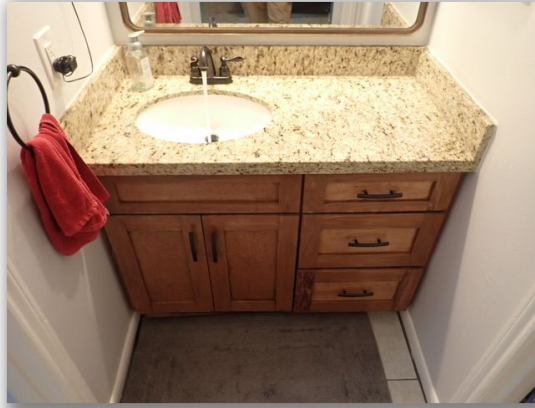
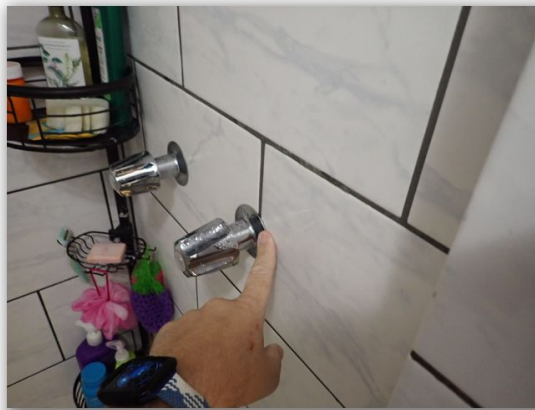
- The faucet assembly is not sealed at the wall. This condition has the potential to allow water to leak back into the wall cavity.

- The drain line is made of corrugated material. It is recommended to use smooth wall/PVC type material to prevent blockage.

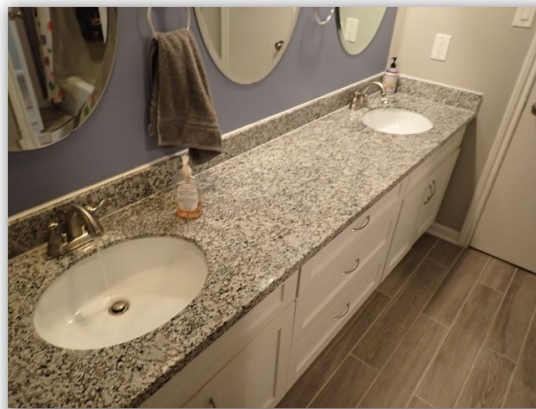
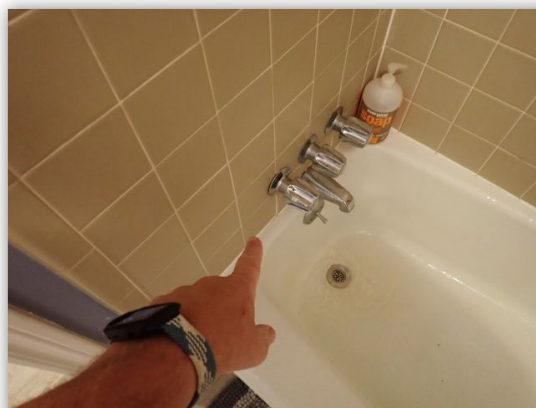
- Cracked, deteriorated and/or missing bathtub enclosure grout and/or caulking should be repaired or replaced as necessary.
- The tub spout is not sealed at the wall. This condition has the potential to allow water to leak back into the wall cavity.
- The faucet assembly is not sealed at the wall. This condition has the potential to allow water to leak back into the wall cavity.

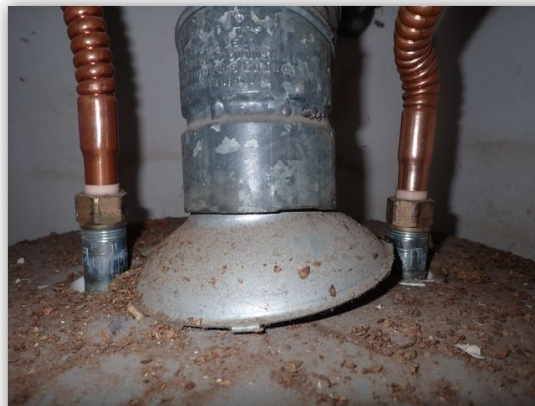
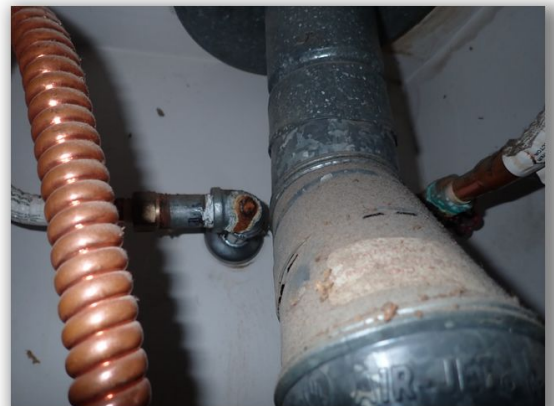
- The temperature and pressure relief (TPR) valve has two or more elbows. This can reduce the water heater efficiency of safely discharging the hot water.
- Some corrosion was observed at the water supply connections at the top of the water heater.
- The water heater flue connector should be mechanically attached to the draft hood with a minimum of three sheet metal screws.
- There is no pan installed under the water heater.

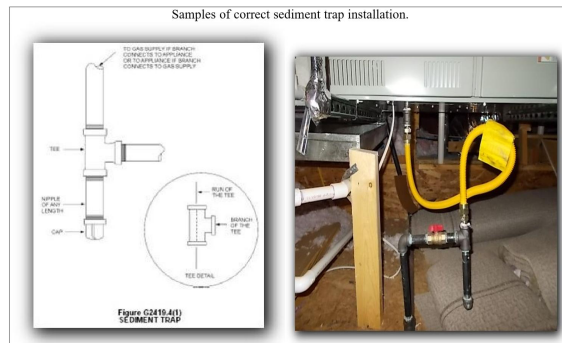
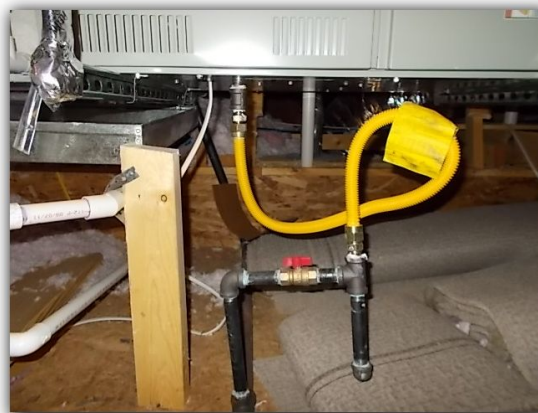
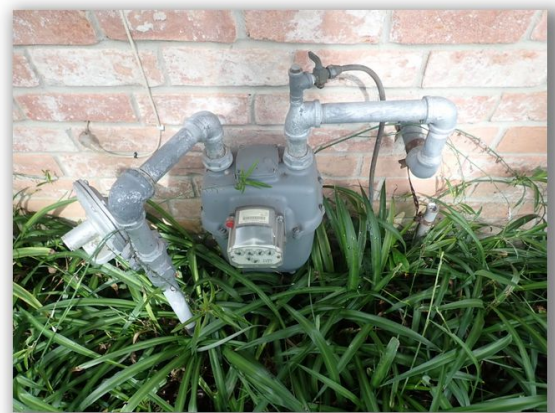
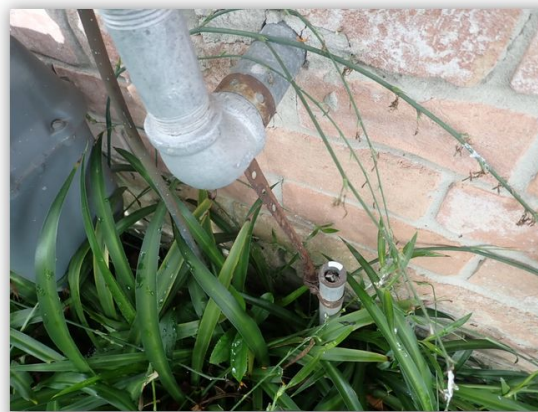
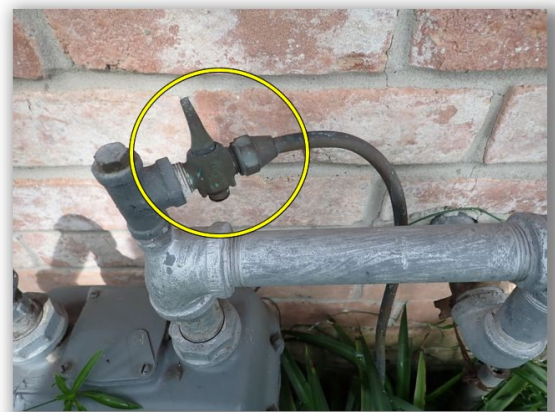
- There is an improper copper connection at the gas service meter.
- The heavy foliage needs to be trimmed back away from the gas meter. The foliage blocks service and inspection of the gas meter and related components.
- It is recommended that the older spring load gas valves be changed out to the new style ball valves.
- The Heater gas supply line is not equipped with a sediment trap just before the gas appliance connector. This condition does not meet current installation requirements and should be corrected.

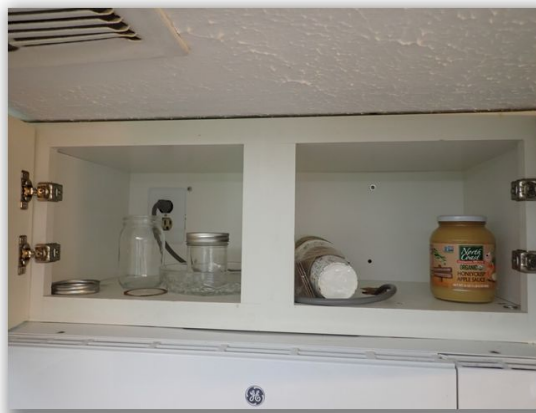
- The range hood in place is ductless. The range hood does not terminate outside and is dependent on the charcoal filter installed. It is recommended to regularly clean your filter system to prevent damage to the structure.

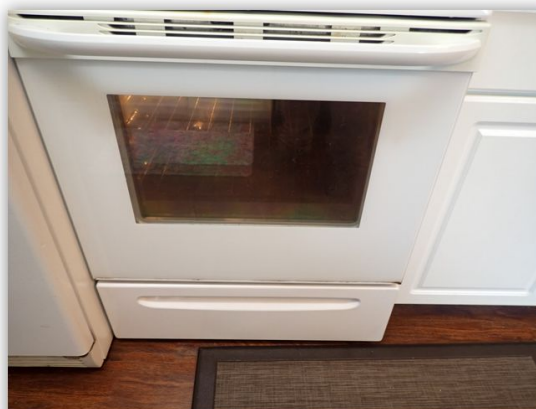
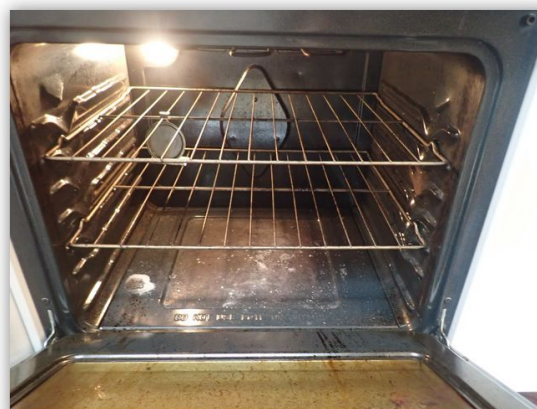
- Range must be secured by **Anti-Tip** bracket supplied.
- If the Anti-Tip device supplied with the range does not fit this application, use the universal Anti-Tip device WB2X7909.
- See instructions to install (supplied with bracket).
- Unless properly installed, the range could be tipped by stepping or sitting on the door. Injury may result from spilled hot liquids or from the range itself.

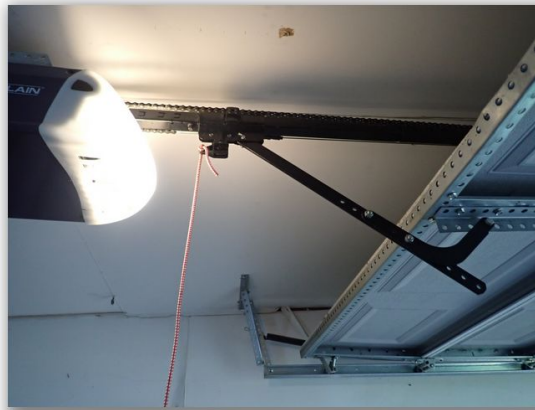
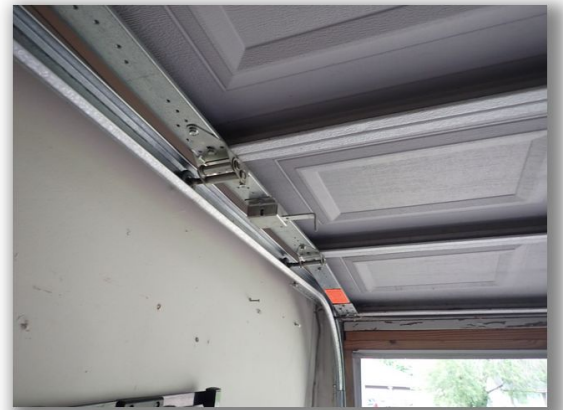
- When an automatic garage door opener is in use, the manual lock should be disabled or removed.

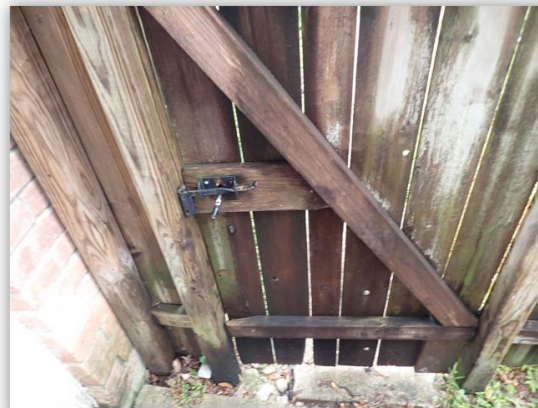
- The overall condition of the fence material, railing and posts are in poor condition and repair or replacement is necessary.
- One or more of the posts are damaged and the fence panels are leaning.
