NOBLE PROPERTY INSPECTION REPORT

12708 28th St
Santa Fe, TX 77510

PROPERTY INSPECTION REPORT FORM

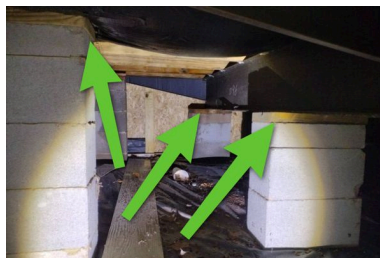
Termite blocks not present

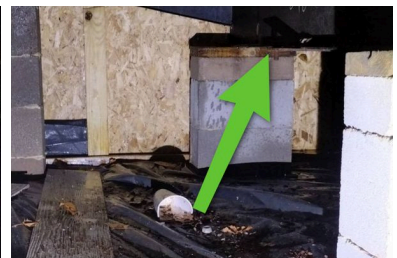
Termite blocks not present

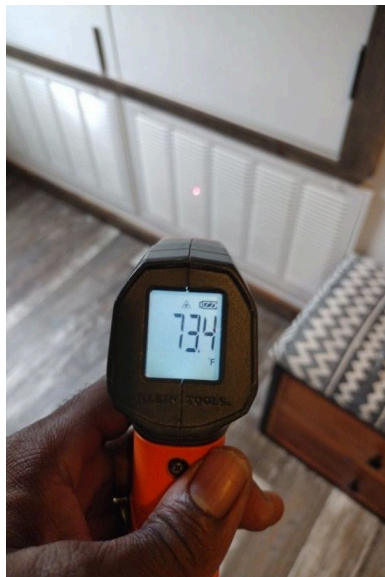
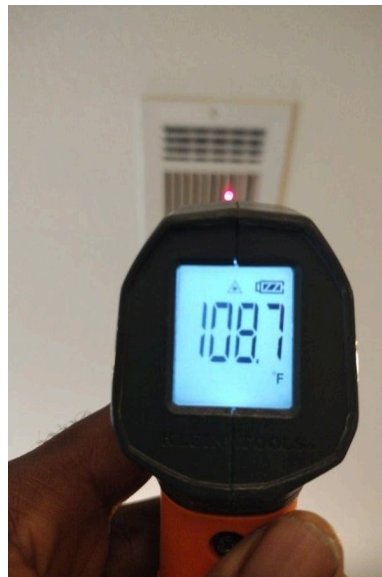
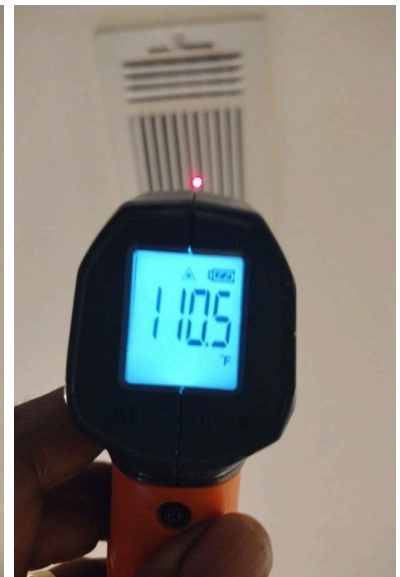
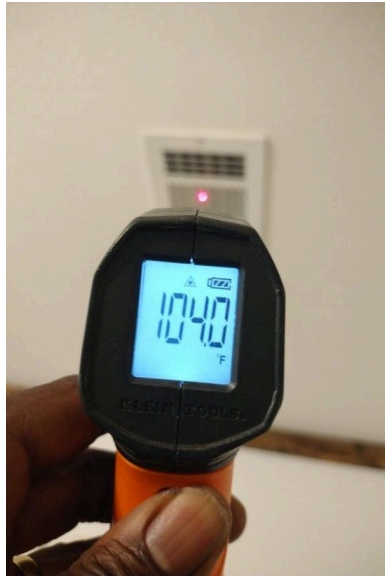
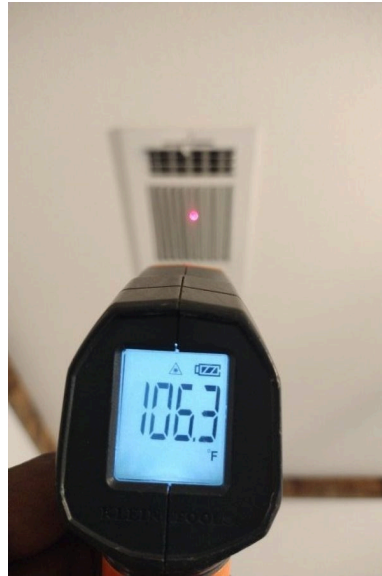
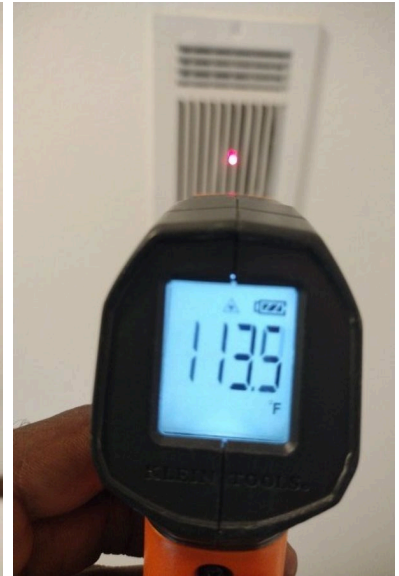
1st unit - measured temperature differential: Operable (20°F)

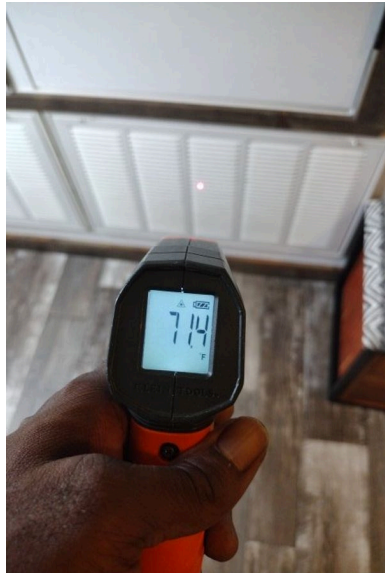
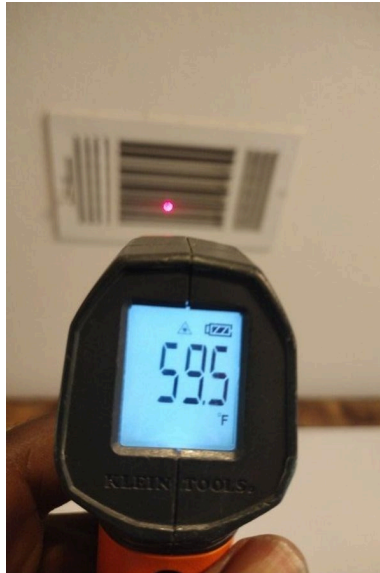
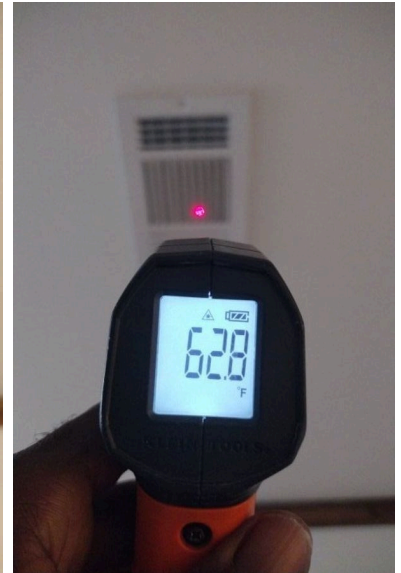
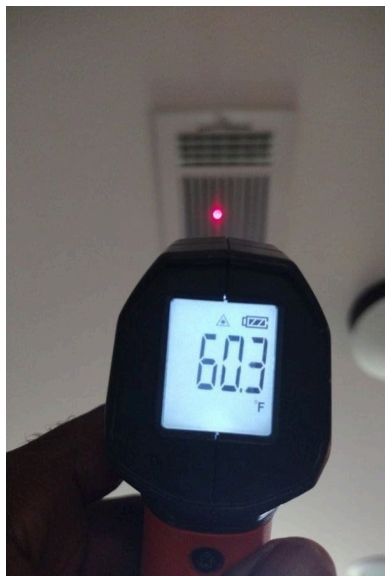
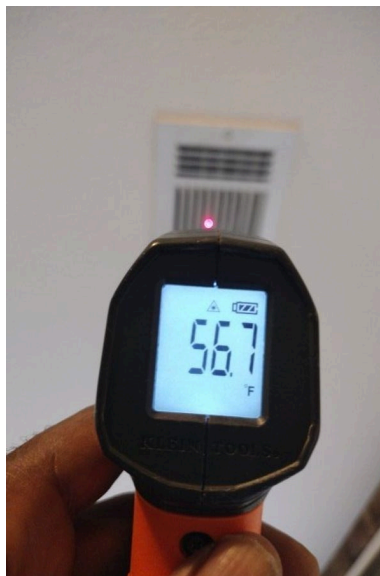
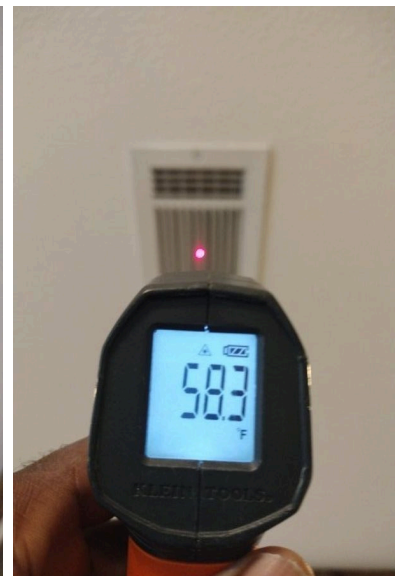
Interior - photo(s) of 2nd cooling system: None
1st unit - measured temperature differential: Operable (15°F to 20°F)

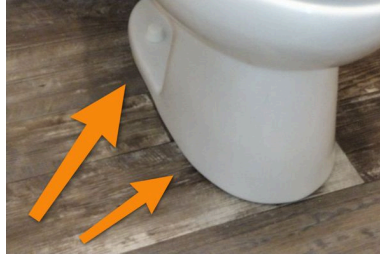
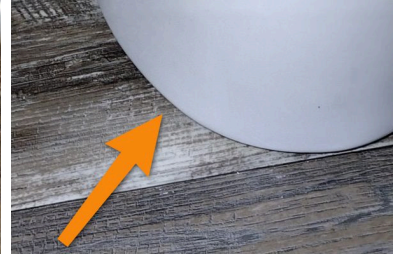
The toilet caulking is missing and/or the caulking has deteriorated and is considered damaged. Recommend a plumber re-caulk the toilet.

Recommendation: Contact a qualified plumbing contractor.

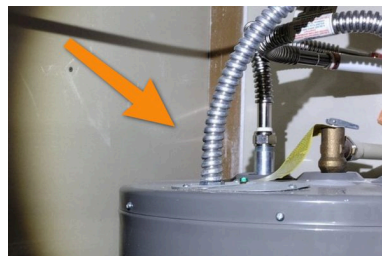
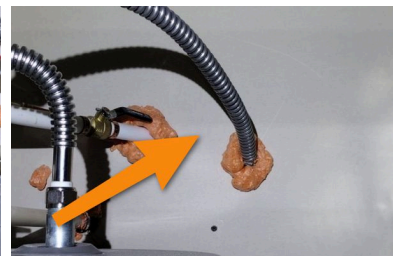
The water heater has no electrical disconnect. This is important because it would allow a person to directly disconnect the power to the water heater in the event of an emergency. Recommend hiring an electrical contractor to install a disconnect.

Recommendation: Contact a qualified electrical contractor.

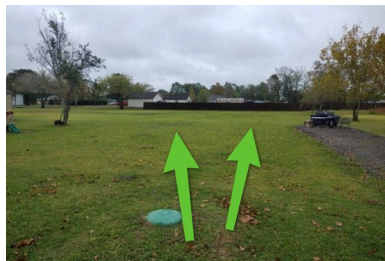
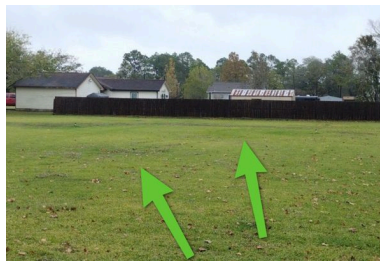
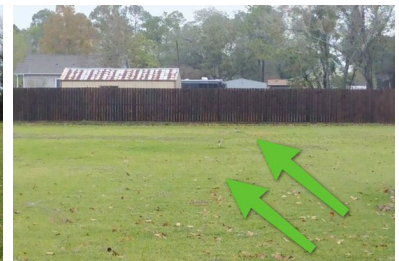
2: Septic system is generally deficient

Septic system is generally deficient and should be serviced. Indications include foul odors and tanks appear to contain heavy amounts of floatables and solids.

Recommendation: Contact a qualified septic system contractor.

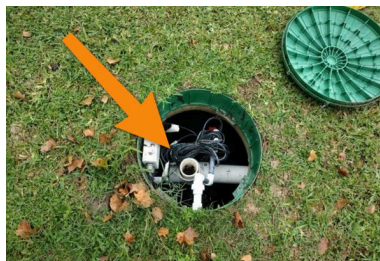
Back Right

1: Bleach tablet container empty

No 3-inch bleach tablets were found in the container. Bleach tablets slowly dissolve into the pump tank to provide treatment prior to pumping to the drip/spray field. Recommend adding tablets. Note: pool bleach tablets are not the same as septic bleach and should not be used as a substitute.

Recommendation: Contact a qualified contact a professional or do it yourself

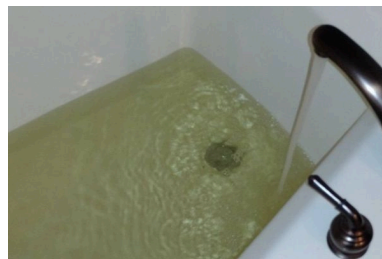
Primary Bathroom

Water color is unfavorable. Water well color and odor can be an indication that the water well source is contaminated, treatable and/or not treatable. In most cases however, water color and/or odor may be a characteristic of the aquifer. Some water wells produce water that is less clear than others. It is recommended that the water be treated, at a minimum, for high bacteria (BacT) levels to indicate a well contamination of chloroform or E. coli. Other tests to determine if the water is consumable may be chosen.

Recommendation: Contact a qualified professional.
