FRANCIS HOME INSPECTIONS, PLLC TREC #24926

PROPERTY INSPECTION REPORT FORM

Ali Hamade <i>Name of Client</i>	05/08/2026 1:00 pm <i>Date of Inspection</i>
3906 Beggs St, Houston, TX 77009 <i>Address of Inspected Property</i>	
David Francis <i>Name of Inspector</i>	24926 <i>TREC License #</i>
<i>Name of Sponsor (if applicable)</i>	<i>TREC License #</i>

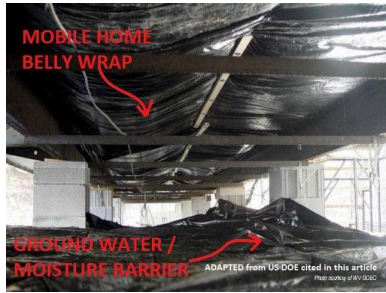
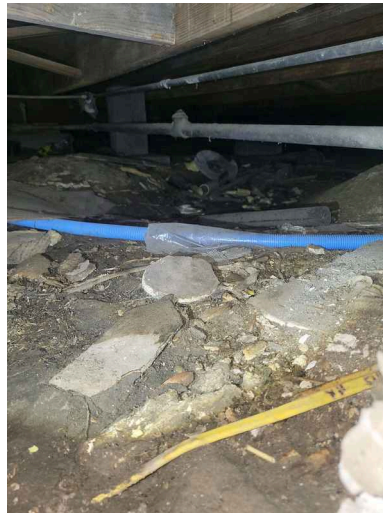
1: Missing Vapor Barrier (Moisture Retarder)

**The inspector is not a code enforcement official; however, current building standards and codes may be referenced as a guideline when describing observed conditions and recommending improvements*

Recommendation: Contact a qualified professional.

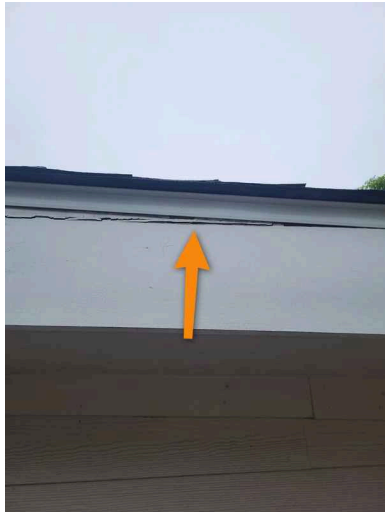
Back of home

1: MISSING/DETERIORATING CAULK

Observed missing or deteriorating caulk in one or more locations. With the exception of weep holes above windows, doors and at the bottom of exterior walls, all openings, penetrations, cracks, etc., in the exterior veneer or siding, or in any location on the exterior envelope of the building, should be caulked or otherwise sealed to prevent water or pest from entering the building.

Recommendation: Contact a qualified professional.

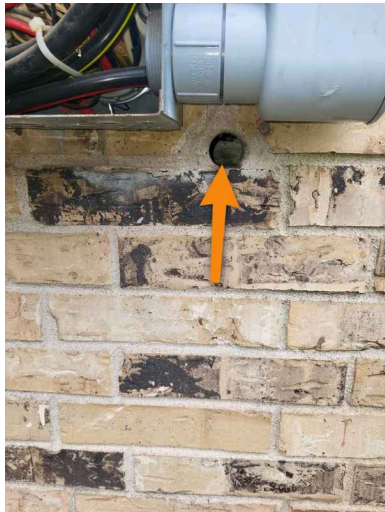
Left side of home

Observed unsealed penetration opening in one or more locations on exterior wall. The opening should be sealed to help prevent moisture and/or pest intrusion in that area.

Recommendation: Contact a qualified professional.

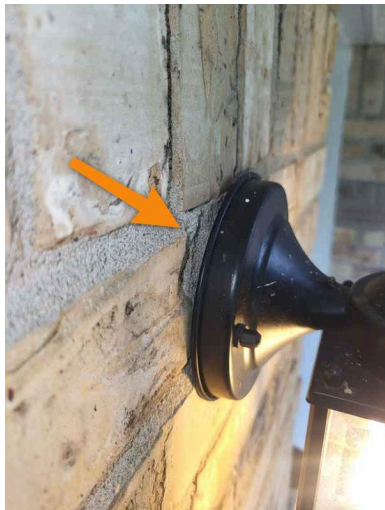
Exterior light fixture

4: Missing Caulking Around Exterior Light Fixtures

Caulking was found to be missing or deteriorated around one or more exterior light fixtures. Gaps at these locations can allow water intrusion, which may lead to moisture damage to the siding, wall cavity, or electrical components.

It is recommended that all exterior light fixtures be properly sealed with exterior-grade caulk to help prevent water intrusion and maintain weather resistance.

Recommendation: Contact a qualified professional.

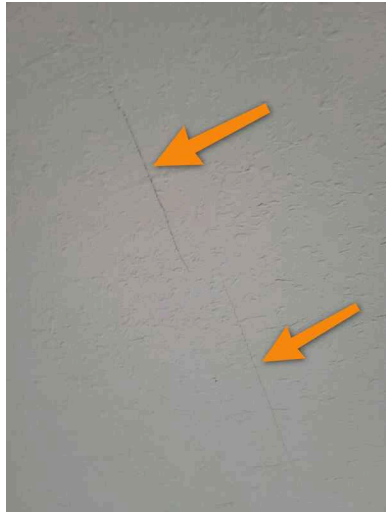
Living Room

1: TAPE LINE CRACKS-CEILING

At the time of inspection, tape line cracks were observed in various locations on the walls and ceiling. Cracks were noted along the tape lines where drywall sheets meet. These cracks are typically caused by settlement and thermal expansion.

The observed tape line cracks are considered to be cosmetic in nature and do not indicate a structural issue. They are common in homes due to thermal expansion and settlement. The cracks can be repaired by re-taping and applying joint compound, followed by sanding and repainting. This is a straightforward cosmetic repair.

Recommendation: Contact a qualified drywall contractor.

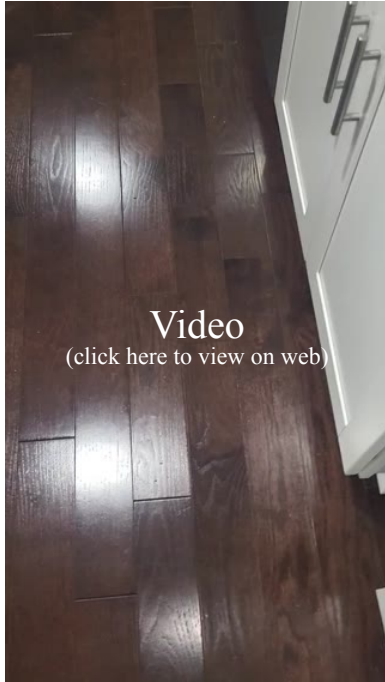
2: Soft spot in floor

When pressure was applied to the affected area, noticeable sinking or flexing of the floor was observed. Surrounding floor areas appeared to be structurally sound without any signs of similar issues.

It is recommended to consult with a qualified professional, or a licensed contractor experienced in flooring issues to further evaluate.

Recommendation: Contact a qualified flooring contractor

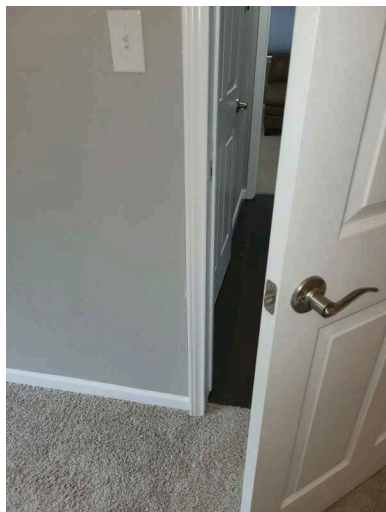
Bedroom 3

Improper latching could indicate minor alignment issues with the door frame, the door itself, or the hardware. This may be due to normal settling of the house, humidity changes causing the door to swell, or misalignment of the strike plate.

It is recommended to adjust the door hardware, such as the strike plate or hinges, to ensure proper latching.

Recommendation: Contact a qualified handyman.

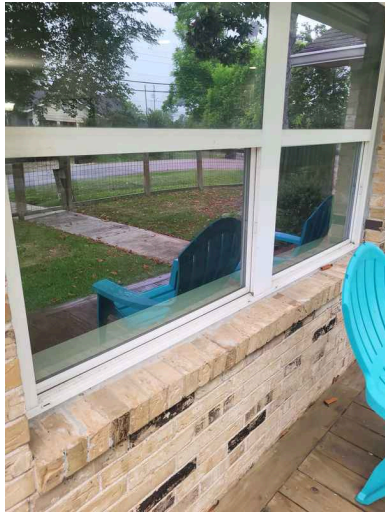
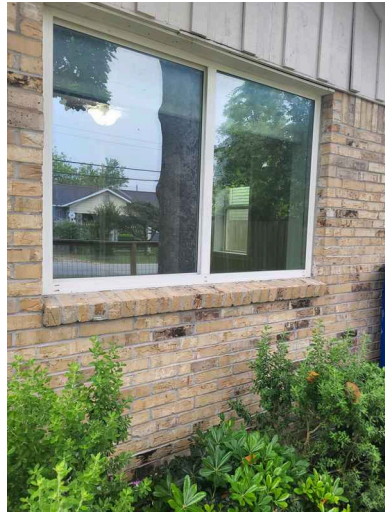
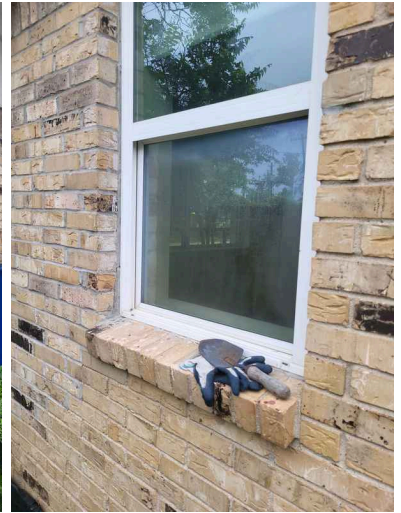
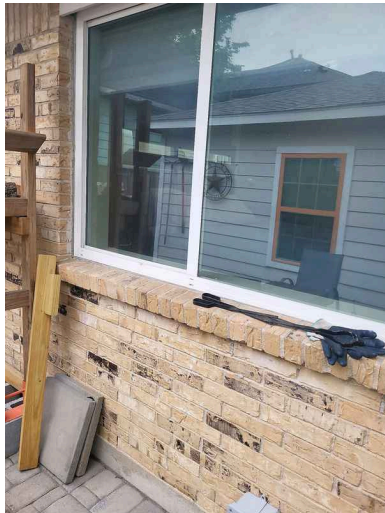
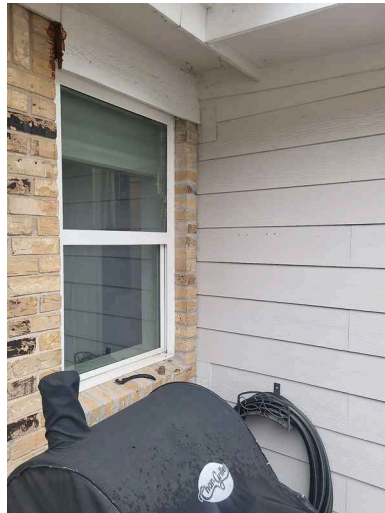
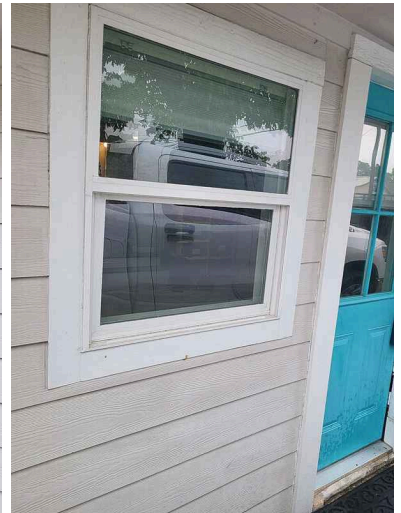
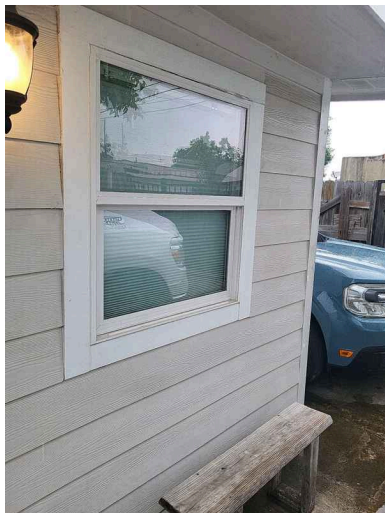
1: MISSING/DAMAGED SCREEN(S)

Screen(s) in one or more windows are missing or damaged. Recommend installing screens where missing or damaged.

Recommendation: Contact a qualified window repair/installation contractor.

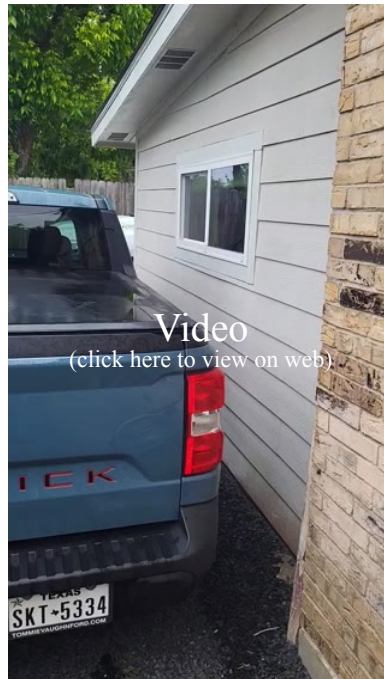
2: CAULKING AROUND INTERIOR/EXTERIOR WINDOWS

The caulking around one or more exterior/interior windows exhibited signs of deterioration, cracking, or shrinkage. Gaps or cracks in the caulking allow water infiltration, potentially leading to moisture intrusion and water damage.

Deteriorating caulk can also compromise the window's seal, reducing energy efficiency by allowing air leakage and affecting indoor climate control.

Recommendation: Contact a qualified professional.

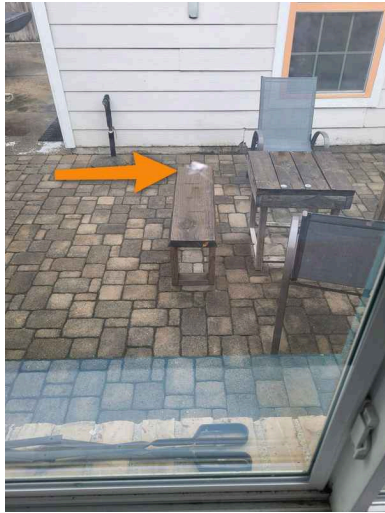
Primary Bedroom

3: Damaged

Recommendation: Contact a qualified window repair/installation contractor.

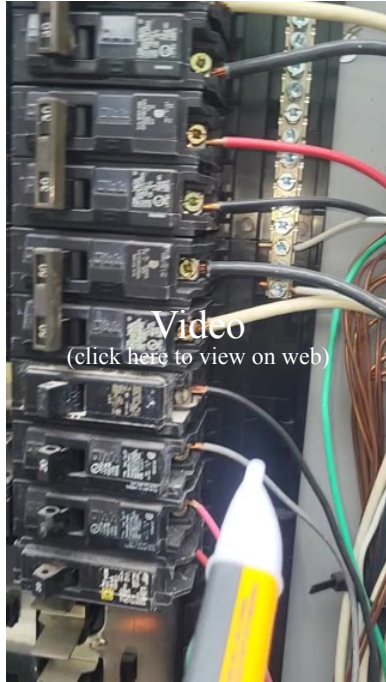
5: Emergency Disconnect Not Labeled

Per the 2023 NEC, the marking or labels shall be located on the outside front of the disconnect enclosure with red background and white text, the letters shall be at least 1/2 inches high. We recommend contacting a licensed electrician to properly label the main disconnect as required.

Recommendation: Contact a qualified professional.

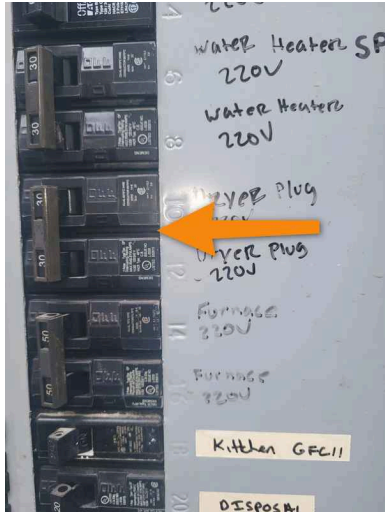
During the inspection, it was observed that the dryer is not protected by a Ground Fault Circuit Interrupter (GFCI) breaker. Current standards recommend GFCI protection for outlets serving laundry areas to enhance safety, particularly in wet or damp conditions.

We recommend consulting a licensed electrician to install a GFCI breaker or receptacle for the dryer circuit to meet current safety standards.

Recommendation: Contact a qualified electrical contractor.

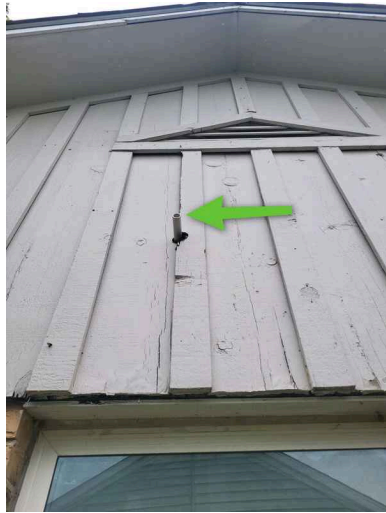
Right side of home

The secondary condensate drain line(s) for the air conditioning system were observed terminating on the right side of the home, positioned in front of a window. A secondary condensate drain serves as an emergency overflow outlet for the air conditioning system, designed to discharge condensate if the primary drain becomes clogged or blocked. Its placement in front of a window is intentional—it provides a visible alert to the homeowner if water begins to drain, indicating a potential issue with the primary condensate line.

If water is observed discharging from this secondary line, it is a sign that the system may need maintenance. Regular servicing of the HVAC system is recommended to prevent clogs and ensure proper drainage.

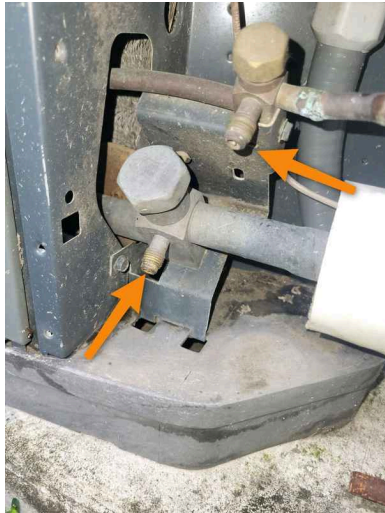
2: Schrader Valve Caps Missing

Have a licensed HVAC technician install proper replacement caps on all service ports and check for any signs of leakage or damage at the valves.

Recommendation: Contact a qualified HVAC professional.

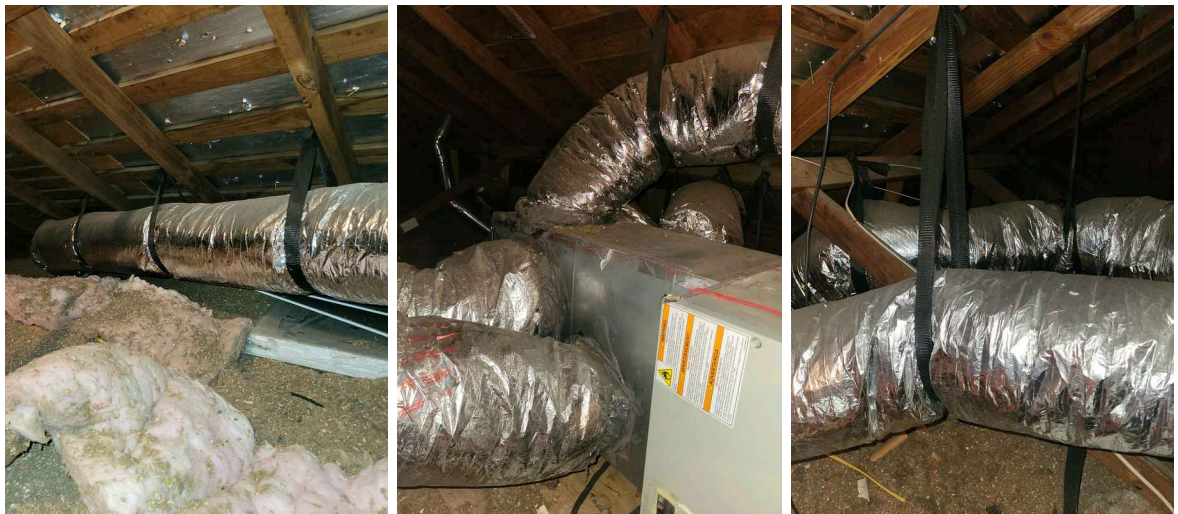
1: Air Filters, Ducts, Supply and Return Register Maintenance.

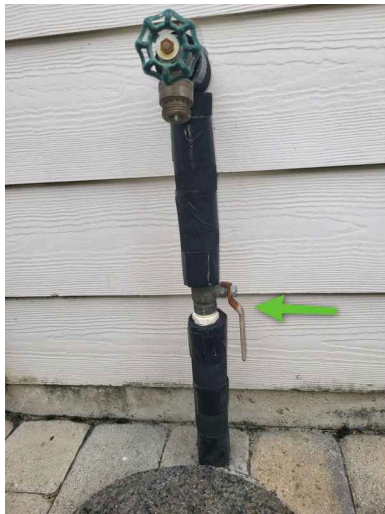
Static Water Pressure Reading: 50 PSI

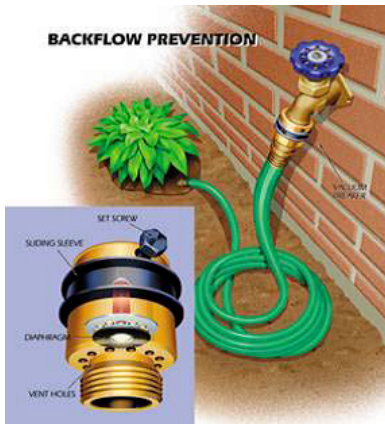
Exterior Hosebib

1: Missing backflow preventor

Backflow is the reversal of the normal and intended direction of water flow in a water system. Devices and assemblies known as backflow preventers are installed to prevent backflow, which can contaminate potable water supplies.

Recommendation: Contact a qualified professional.

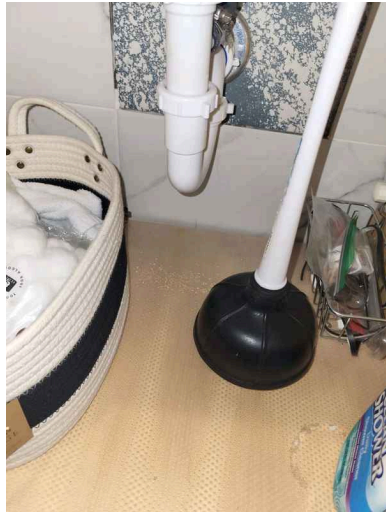
Garage apartment

2: Sink leaking

A leak was observed at one or more of the sinks during the inspection. The source of the leak may be from the faucet, drain assembly, or plumbing connections beneath the sink. This condition can lead to water damage to cabinets, flooring, or adjacent materials if not addressed promptly. It is recommended that a qualified plumber evaluate and repair the leak to prevent further damage.

Recommendation: Contact a qualified plumbing contractor.

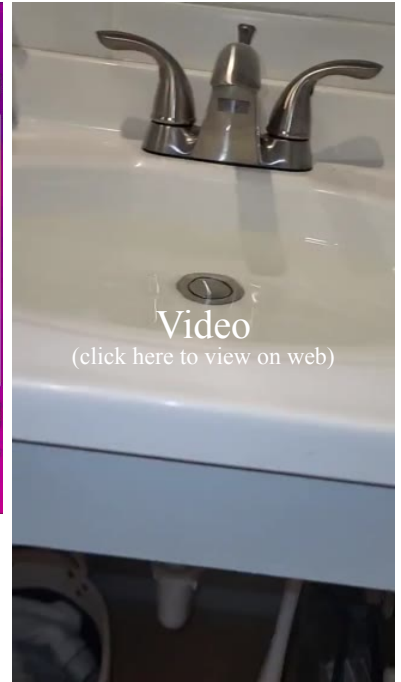
3: Low water pressure at fixture

Low water pressure and/or flow was observed at one or more plumbing fixtures during the inspection. This condition could be related to mineral buildup, partially closed valves, or issues with the supply lines. Further evaluation by a licensed plumber is recommended to determine the cause and make any necessary repairs.

Recommendation: Contact a qualified plumbing contractor.

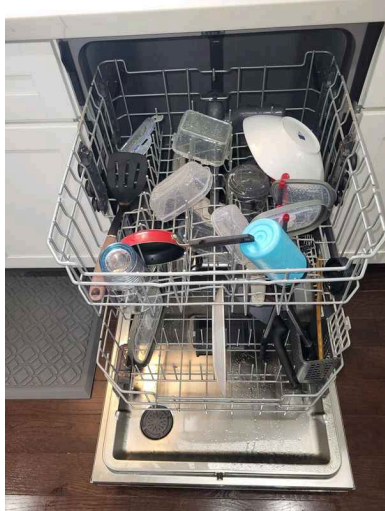
Dishwasher was operated in normal mode, run through a complete, normal cycle. Function and operation appear to be normal. Lower access panel not removed. At the time of the inspection the dishwasher did not leak.
