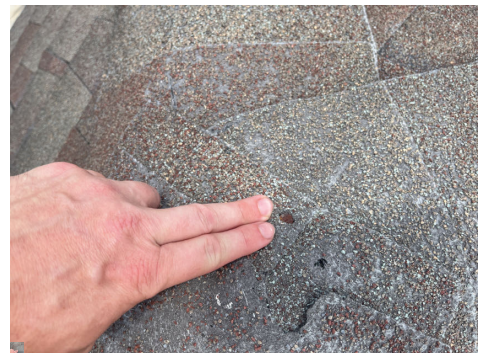
Exposed nail heads

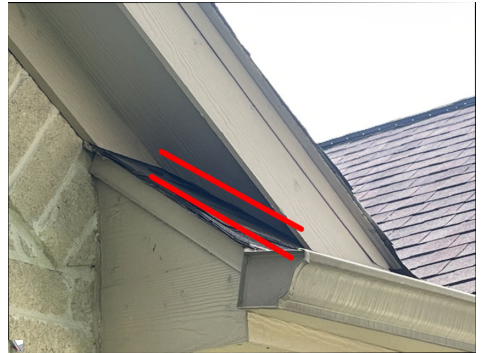
Front: Gaps at soffit/shingles

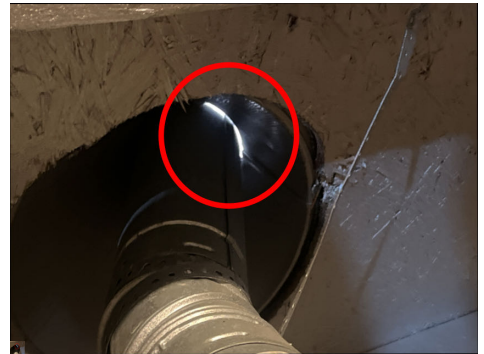
Daylight at roof protrusions

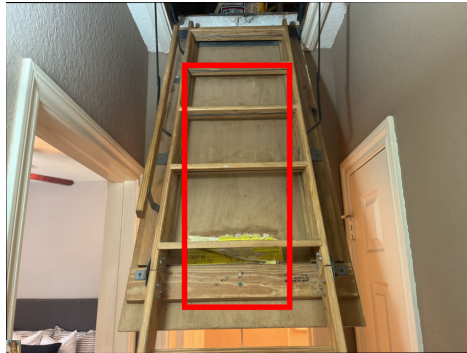
The pull-down stair to the attic was not insulated. We recommend adding insulation for improved energy efficiency.

Pull-down stairs lacked insulation

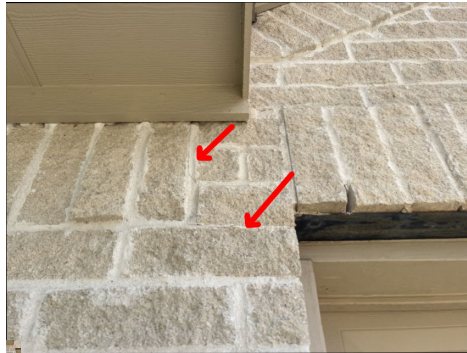
Front: Hairline cracks

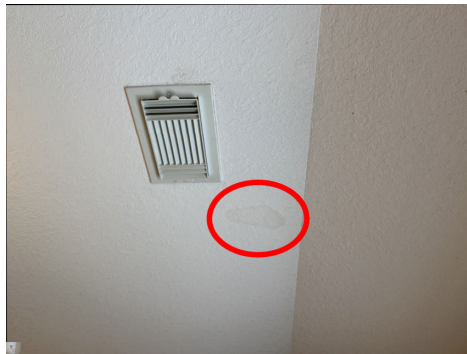
Dining room: Moisture stain

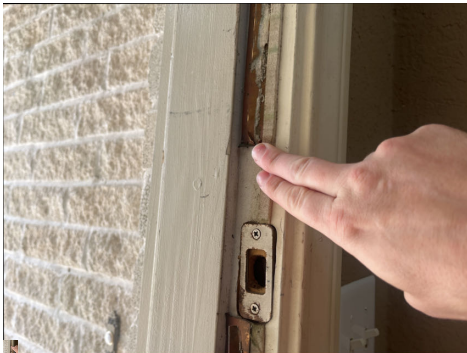
Front door: Damaged weatherstripping

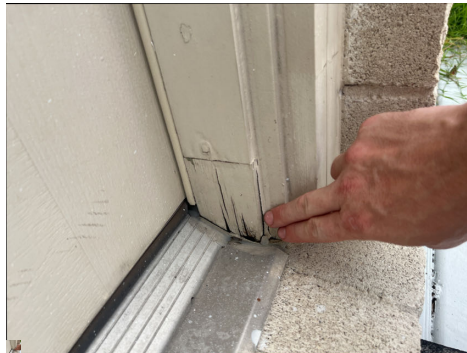
Back door: Wood decay at trim

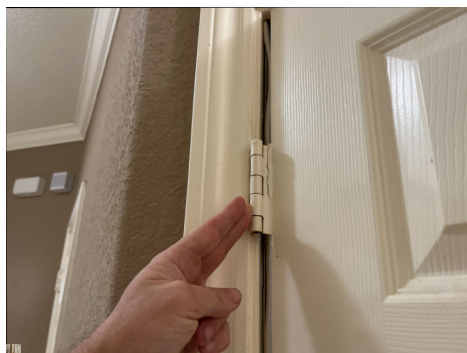
Garage man door: Auto-close device recommended

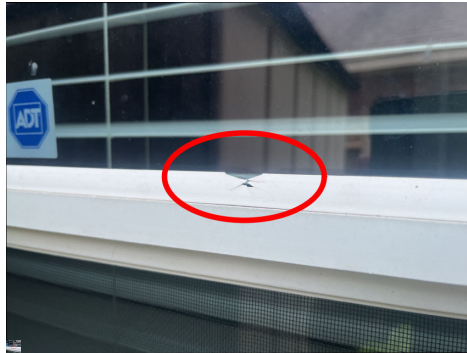
Left: Damaged weatherstripping

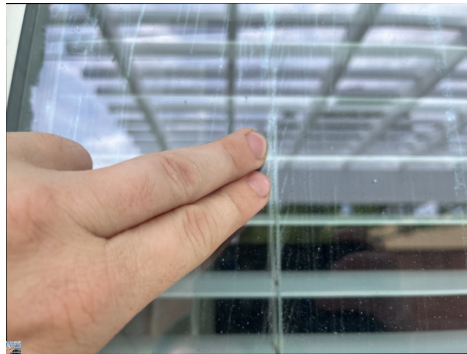
Living room: Evidence of lost seal

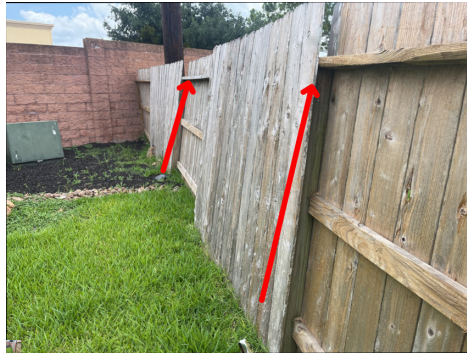
Fence: Tilted posts

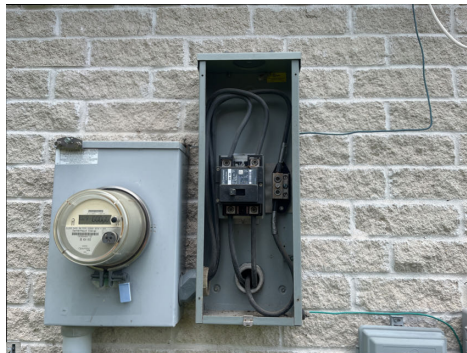
An ungrounded conductor (hot) was improperly identified. We recommend having this permanently re-identified.

Scorching visible on the dead front cover of the subpanel indicated overheating of electrical components located within the panel. This condition was a potential fire hazard. We recommend evaluation and any necessary repairs be performed.

Right: Service panel with deadfront removed

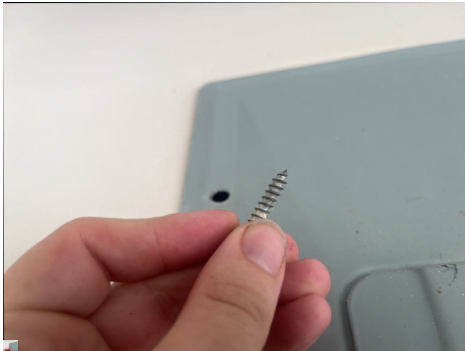
Sub panel: Improper deadfront screws

NOTE: We recommend all repairs on the electrical system and in the electrical panel be performed by a licensed, professional, competent and qualified electrician.

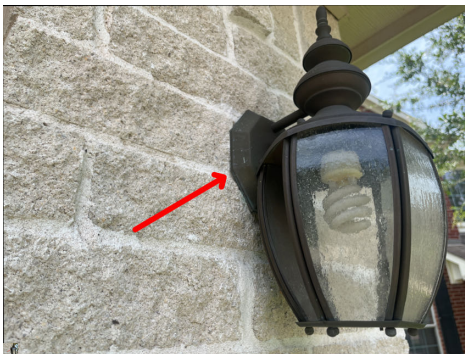
Around House: Caulk missing at fixture to wall connection

All exterior fixtures exposed to the elements should be caulked at the wall connection to prevent water and insect intrusion. We recommend caulking.

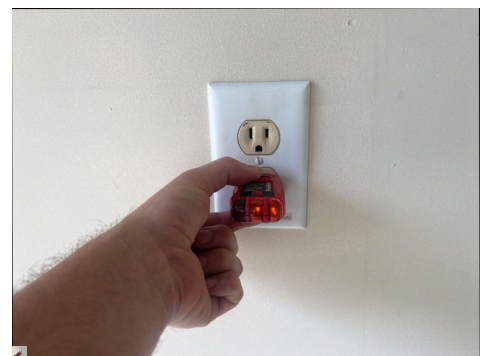
A receptacle outlet was found to not be protected by a Ground Fault Circuit Interrupter (GFCI) receptacle. Today's standards require GFCI protected outlets be installed at all 120 and 240 volt circuits at the kitchen counters/islands, laundry rooms, in basements, crawlspaces, garages, the home exterior as well as any interior receptacles located within 6 feet of a plumbing fixture as measured by flexible cord, to avoid potential electric shock or electrocution hazards. We recommend having this repaired per today's standards. This condition was observed at the in the garage, laundry room, the dryer outlet. and at the exterior outlets.

Garage: Outlet not GFCI protected

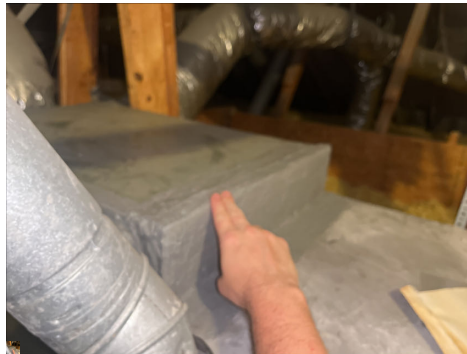
The evaporating coils had been sealed. Cutting the seal goes beyond the scope of the home inspection. We were unable to view the condition of the coils. We recommend having the HVAC system serviced on at least a biannual basis.

Attic: Evaporating coils sealed/unable to view coils

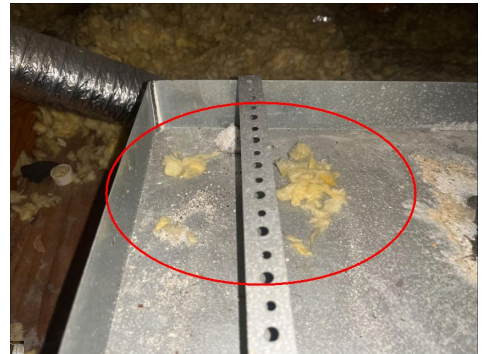
Debris was noted in the evaporating coils safety pan. We recommend all debris be removed to prevent drain lines from clogging.

Debris in safety pan

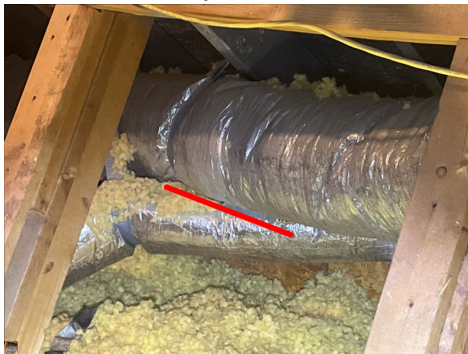
Multiple air ducts were found to be in contact with one another. Today's standards do not allow this practice anymore as thermal bridging could create condensation inside or between the ductwork. We recommend having the ducts strapped and separated.

Ducts in contact

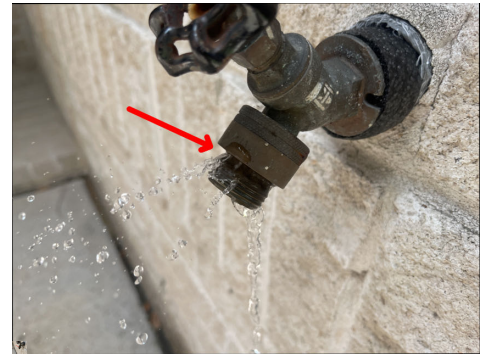
A faulty backflow preventer was noted. We recommend having this replaced. This was observed on the front.

Front: Faulty backflow preventer

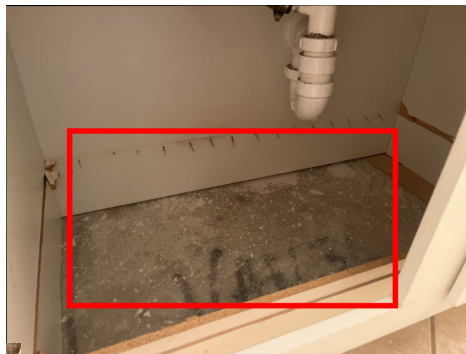
Bathroom 1: Missing/damaged cabinet floor

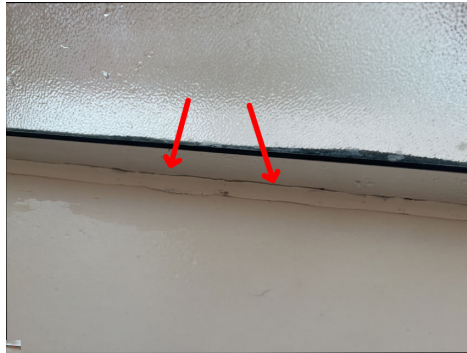
Deteriorated caulking/grout was noted, which may allow damage from moisture intrusion of the wall assembly at a bathroom. We recommend having this recaulked. We observed this in bathroom 1, and 2.

Bathroom 2: Deteriorated caulk

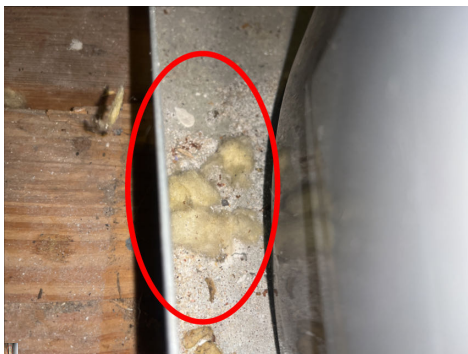
Debris in safety pan

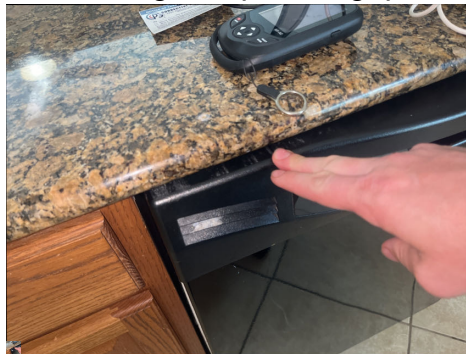
The door of the dishwasher rubbed against the adjacent cabinet. We recommend adjusting the footings/height of the appliance to allow better clearance.

Insufficient clearance at counter/door

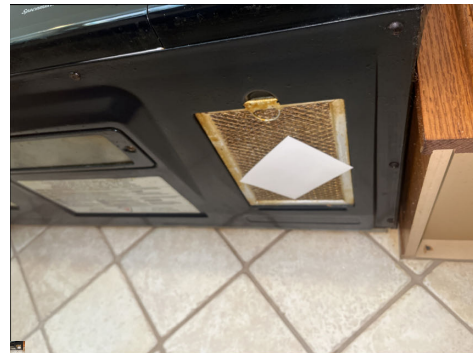
Range hood on, dirty filter

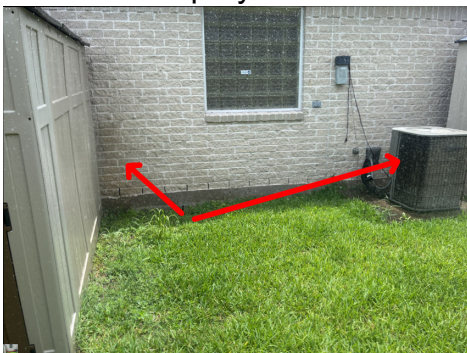
A sprinkler head was spraying the structure. We recommend adjusting the head so as to not add excessive water on the structure. This was observed in zone 1, 2, 3, 4.

Zone 2: Sprayed structure, condenser
