Inspection Report

Property Address:
11803 Old Spanish Trail
Santa Fe TX 77510

American Dream Inspections TX, llc

PROPERTY INSPECTION REPORT FORM

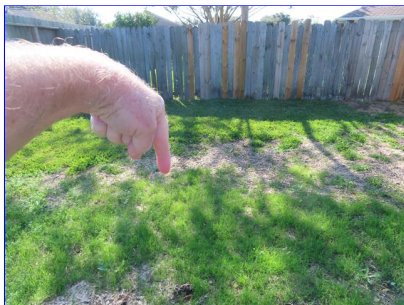
B. Item 4(Picture)

(4) Yards have low spots in several areas at time of inspection. This is conducive to ponding. Should have a professional correct for proper drainage.

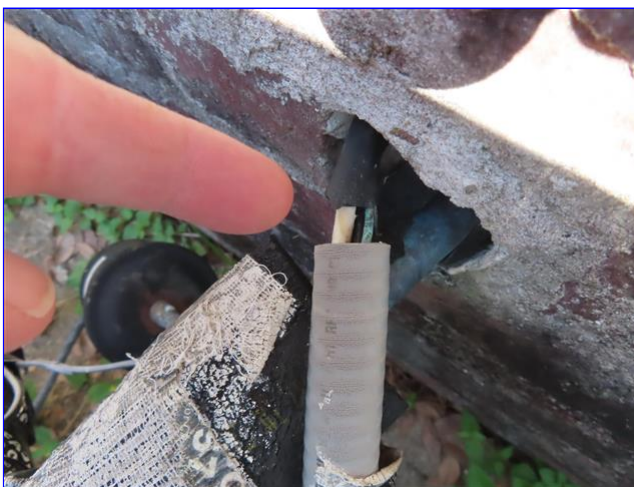
A. Item 2(Picture)

2013 Lennox 3 ton AC unit was operating properly at time of inspection. Recommend having a professional AC Tech inspect and service unit for proper efficiency. Electrical from unit was not protruding into the brick wall properly and exposing electrical at time of inspection. Should have a professional correct properly.

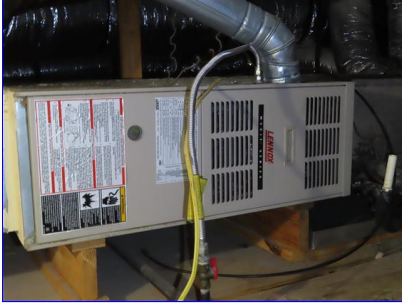
B. Item 1(Picture)

Lennox gas furnace in the attic was working properly in Cool Mode at time of inspection. Did not test in Heat Mode since the outside temperature was over 60 degrees at time of inspection. Should have a professional AC Tech evaluate unit for proper operation. Gas plumbing to unit was missing drip leg and electrical bonding, outside of unit has possible WDO (Wood Destroying Organisms) growth at time of inspection. Should have a professional correct properly.

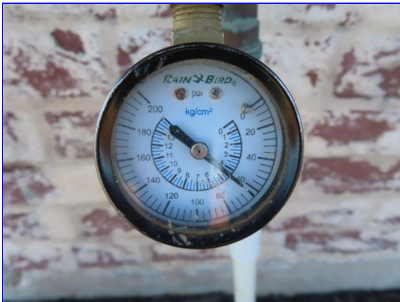
A. Item 2(Picture)

(2) Static water pressure was 62 psi at time of inspection. (This is for informational purposes only)

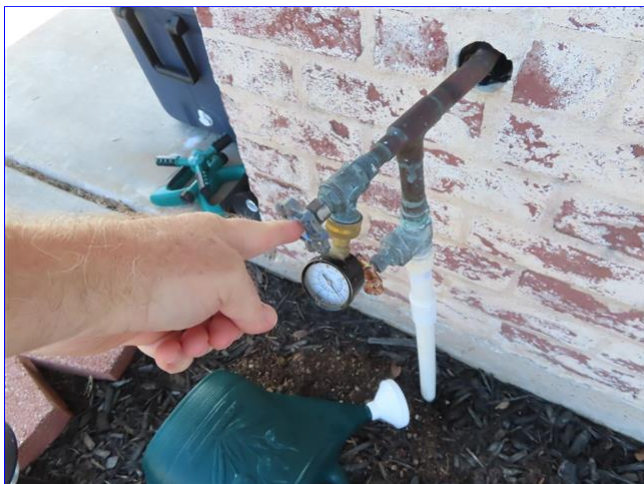
A. Item 3(Picture)

(3) Exterior faucet valve was leaking at time of inspection. Should have a professional plumber correct properly.

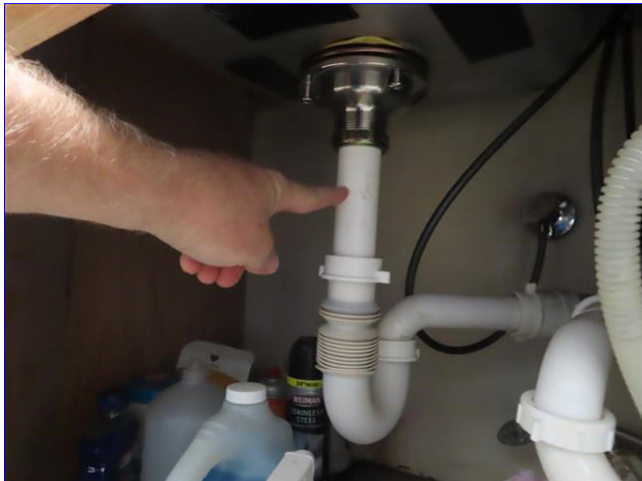
B. Item 1(Picture)

(1) Kitchen sink drain plumbing was loose and installed with improper flex piping at time of inspection. Conducive to leaking and causing possible damage. Should have a professional plumber correct.

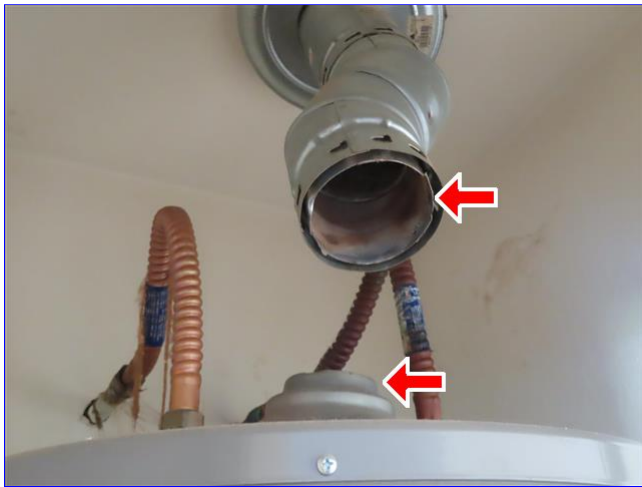
C. Item 4(Picture)

2017 Rheem gas 40 gallon hot water heater in the garage was operating properly at time of inspection. Unit was missing drip pan and drain to exterior, top plumbing connection is rusting and has signs of possibly leaking, exhaust duct is disconnected from flue and leaking possible Carbon Monoxide into the garage and possible living space, exhaust duct in the attic is disconnecting at joint, gas plumbing to unit was missing electrical bonding at time of inspection. Should have a professional plumber inspect and correct properly.

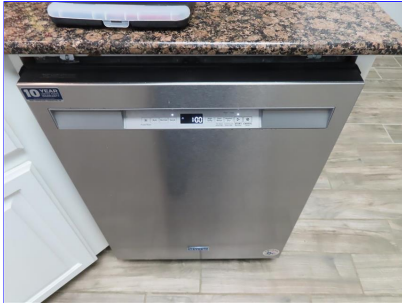
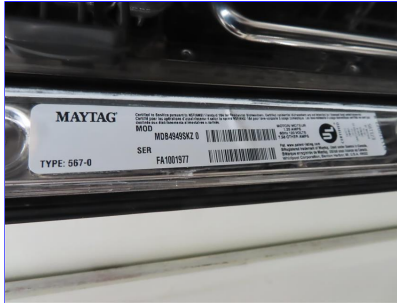
A. Item 1(Picture)

Maytag dishwasher was working properly at time of inspection.

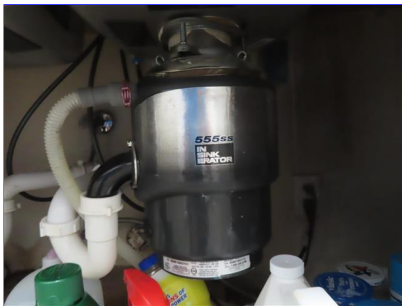
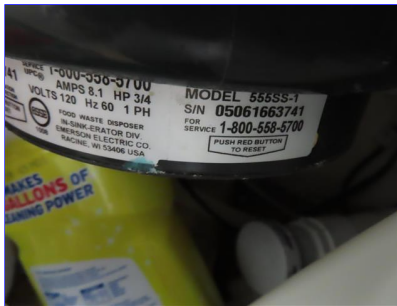
B. Item 1(Picture)

InSinkErator disposal was working properly at time of inspection.

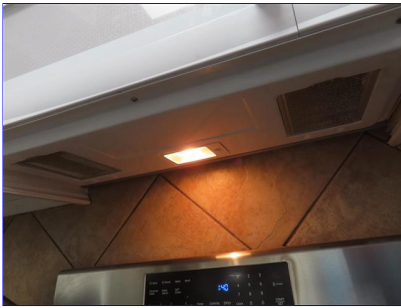
C. Item 2(Picture)

(2) GE built in microwave exhaust fan and light was working properly at time of inspection.

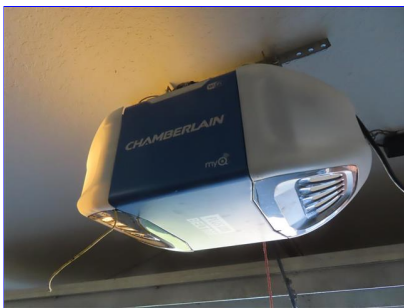
G. Item 1(Picture)

(1) Chamberlain garage door opener was working properly at time of inspection.
