## SUMMARY

17819 Serene Shore Dr, Cypress, TX  
77429  
Gwedolyn Burwell  
February 10, 2023

Jeff Ashley  
TREC #23924  
J. Ashe Home Inspection, LLC  
8326415338  
jashe832@gmail.com

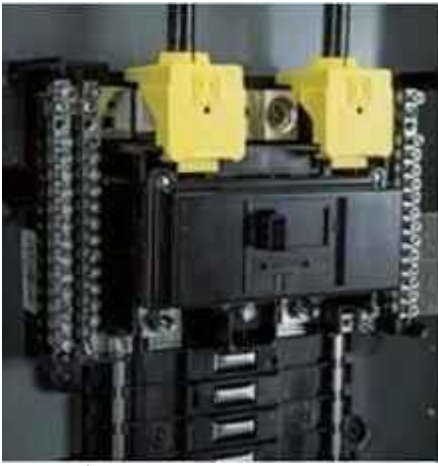
Example

**ELECTRICAL LUG COVERS MISSING ON SERVICE ENTRANCE WIRES**

Service entrance lug covers were not installed over the main entrance connector lugs. This is a requirement per NEC 17.

Recommendation  
Contact a qualified electrical contractor.

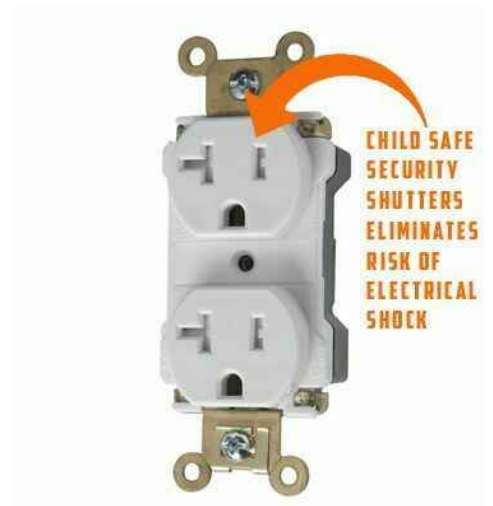
Tamper Resistant

### TAMPER RESISTANT RECEPTACLES/OUTLETS MISSING

The new tamper-resistant outlets look just like regular outlets but have an interior cover that will open only when the two prongs of a plug are inserted simultaneously. This prevents children from sticking something into one of the slots and getting burned or electrocuted.

Recommendation  
Contact a qualified professional.
