Property Data Report

Property Type	Property Street Address	Property Street Address (unit #)
Single Family	2630 Skyview Ridge Ct	
Property City	Property State	Property Zip Code
Houston	Texas	77047
Property County

4. Repair and Inspection

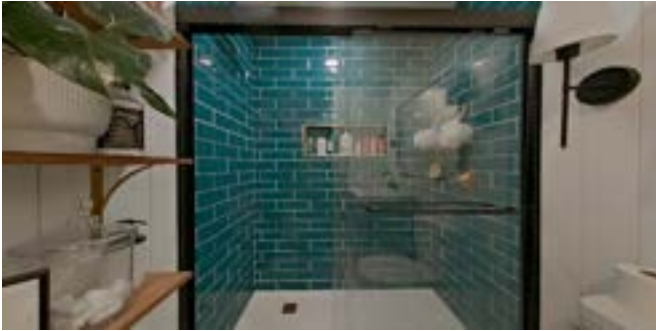
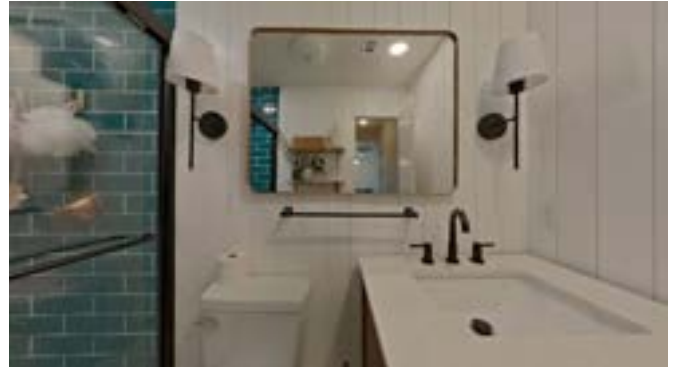
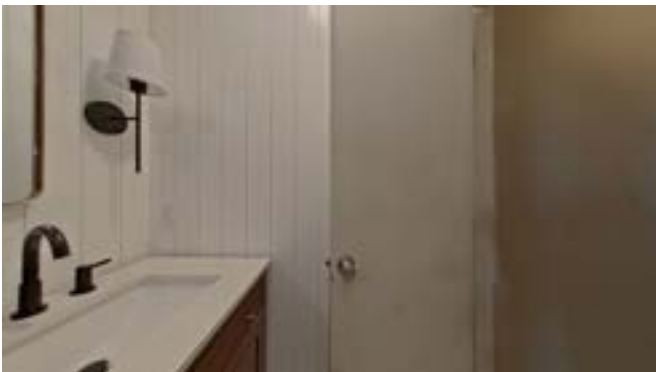
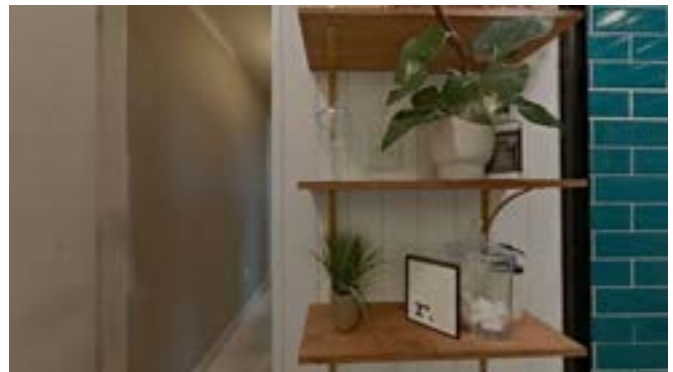
Bathroom 2 Photo

None

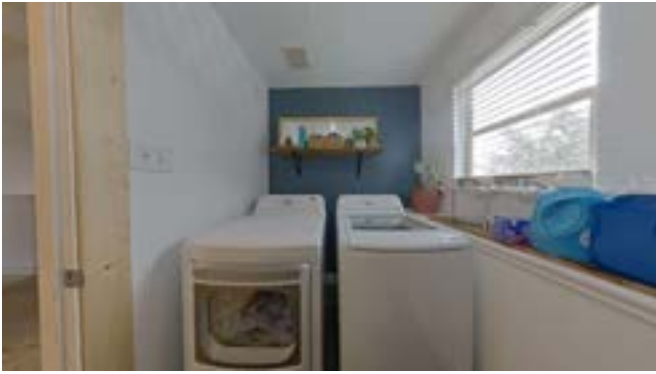
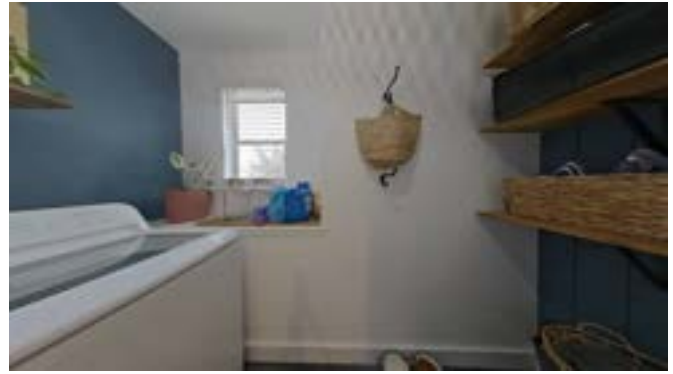
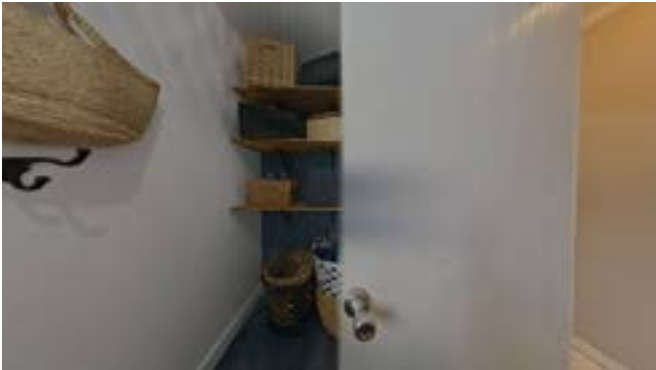
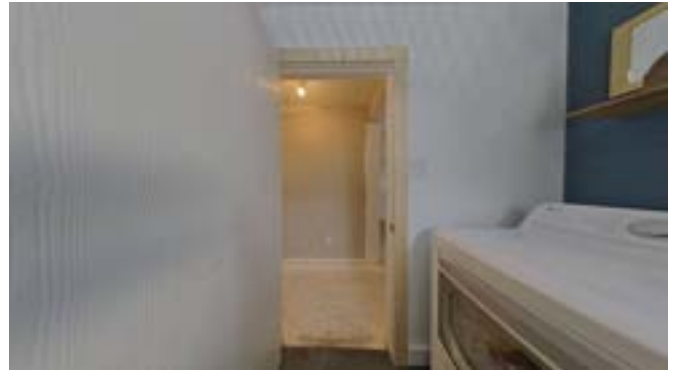
Laundry Room Photo

None

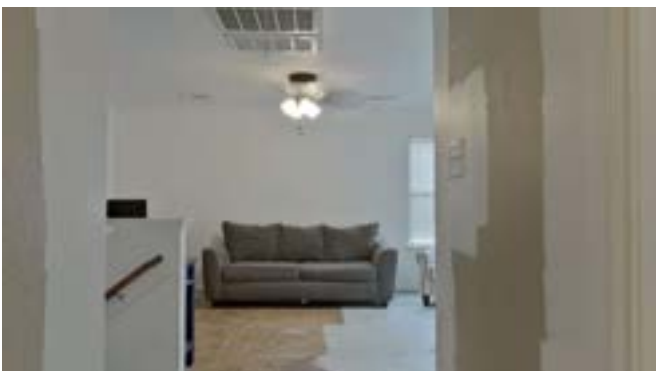
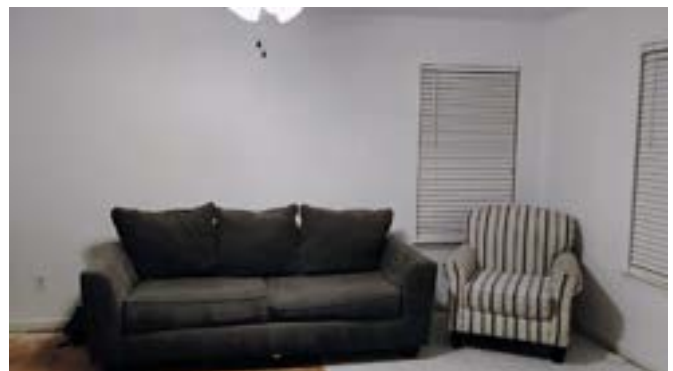
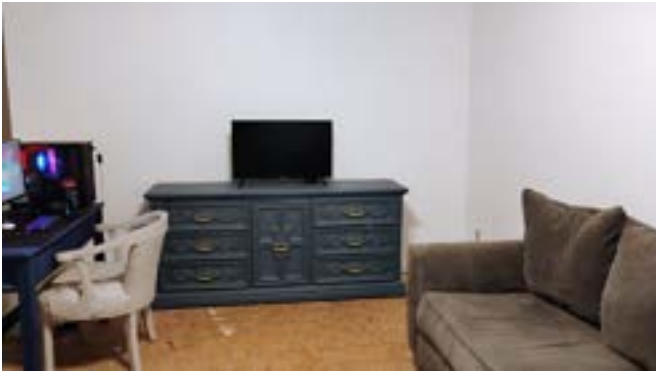
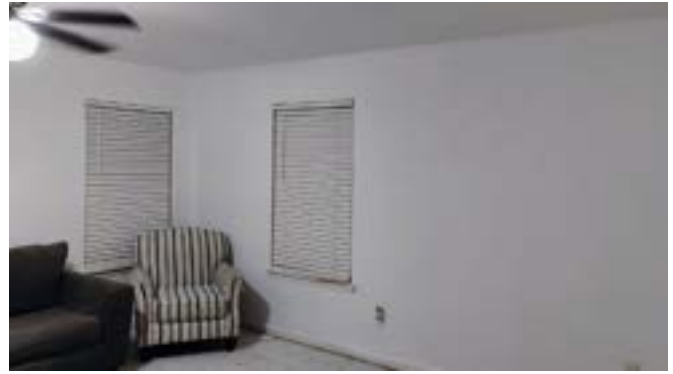
Loft Photo

None

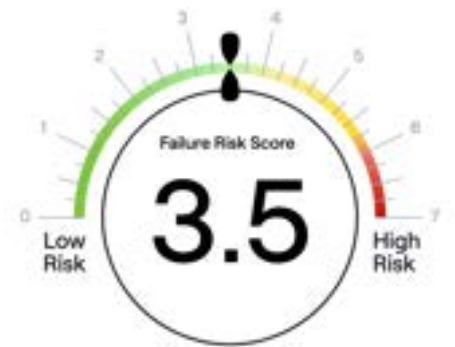
Manufacturer's Label

Date Manufactured June 2020
Product Age 5.58 years
Typical Expected Life 14.00 years

Estimated Remaining Life 8.42 years
Is Product Recalled No

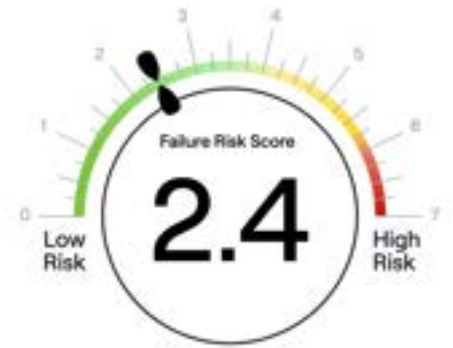
Manufacturer's Label

Product Type	Brand	Model #	Serial #
Air Conditioner	Goodman	GSX140481KE	2203158788

Date Manufactured	Product Age	Typical Expected Life
March 2022	3.83 years	20.90 years

Estimated Remaining Life	Is Product Recalled
17.07 years	No
