HOME INSPECTION 7-6

12818 Ribbon Meadow Ct  
Humble, TX 77346

# PROPERTY INSPECTION REPORT FORM

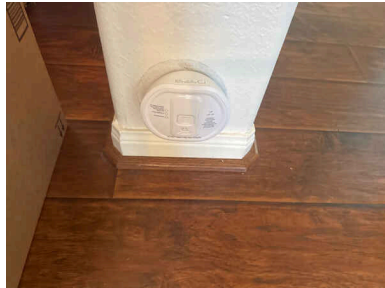
The smoke/CO alarms appeared to be in satisfactory condition. According to the U.S. Fire Administration, smoke detectors should be tested at least once a month, and batteries should be replaced at least once or twice a year.

(CO) alarm outside master bedroom

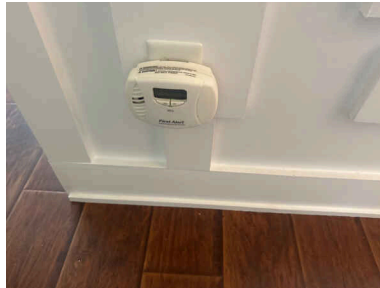
(CO) alarm outside secondary bedrooms
