# Weston Inspection

## Inspection Report

**Property Address:**  
1311 Coppercrest Dr  
Spring Texas 77386

Greg Brainerd	9/2/2025
<i>Name of Client</i>	<i>Date of Inspection</i>
1311 Coppercrest Dr, Spring, Texas 77386	
<i>Address of Inspected Property</i>	
Stephen Weston	TREC #21249
<i>Name of Inspector</i>	<i>TREC License #</i>
<i>Name of Sponsor (if applicable)</i>	<i>TREC License #</i>

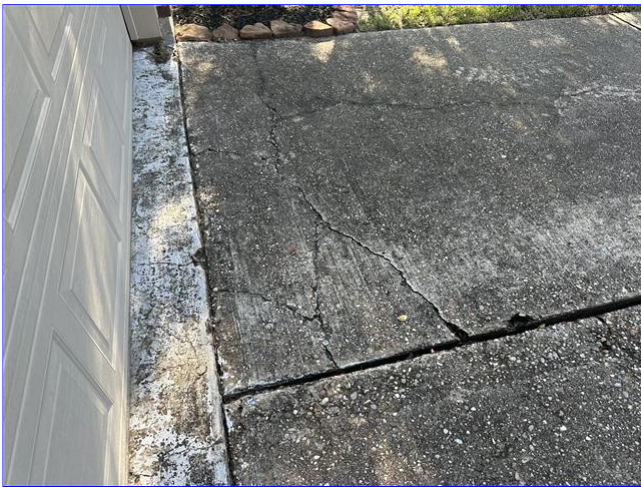
K. Item 2(Picture)

(2) Driveway expansion joints should be sealed.

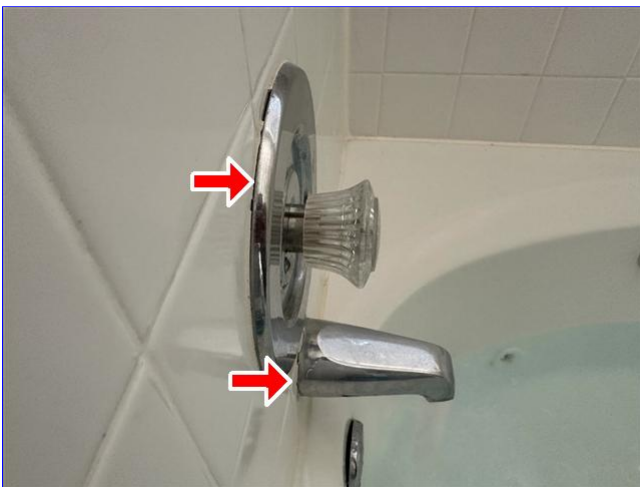
A. Item 4(Picture)

- (7) Hot and cold water supply is reversed at the master bathtub. Hot water should be on the left hand side.
