REDSTAR PROFESSIONAL HOME INSPECTION, INC

REDSTAR RESIDENTIAL INSPECTION REI 7-6

8 Cambridge Rd  
Conroe, TX 77304

# PROPERTY INSPECTION REPORT FORM

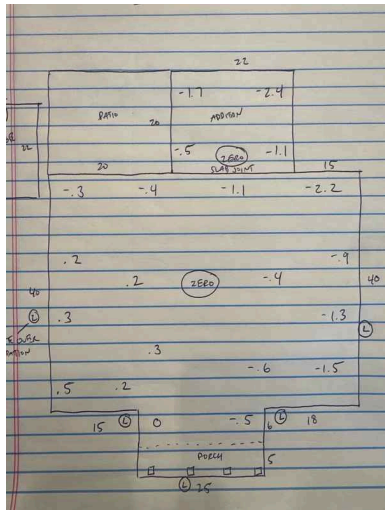
**1: Slab Foundation: Recommend Further Evaluation**

Multiple signs of differential movement of the foundation structure observed at the time of inspection. These signs include:

- Cracks at the interior drywall or ceilings
- Noticeable slope of floors at multiple locations.
- Doors rubbing the floor.
- Zip level readings taken at the time of inspection show deflection of the foundation in excess of 2", suggesting drop towards the right and back right of the home as well as the foundation addition. These issues, measurements and locations are indicative of heaving/settling.

It is the inspectors opinion that these issues are indicative of moderate differential movement of the foundation and I recommend further evaluation by a qualified professional to render a foundation performance evaluation.

- Recommend consulting with a qualified foundation company.
- Recommend correction of all issues stated in the Grading and Drainage section of this report to promote health of the foundation.
- Recommend consulting with a qualified plumber to evaluate the condition of the underground plumbing drain lines, as these lines often become damaged from foundation movement.
- Recommend you budget for repair of above stated issues and any other related items with foundation movement/repair.

Recommendation: Contact a qualified structural engineer.

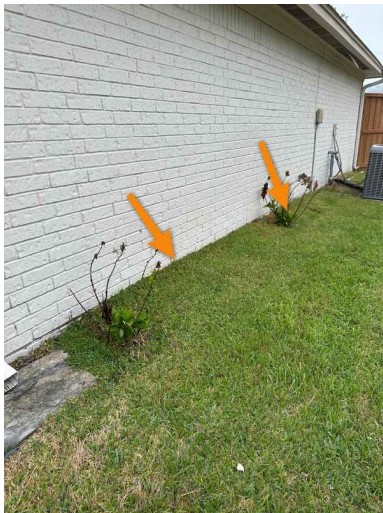
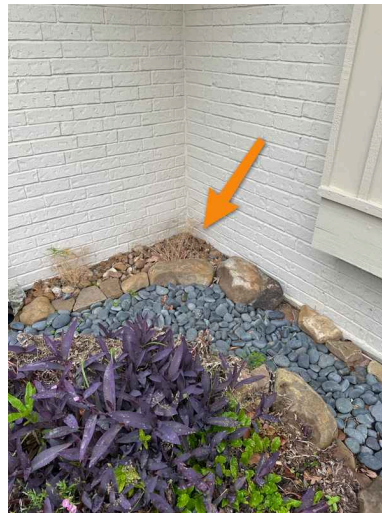
High soil conditions observed at the various locations around the structure. The soil level should be reduced to allow for a minimum of 2-4" of foundation exposure, while still providing positive drainage away from the home. Recommend correction.

Recommendation: Contact a qualified landscaping contractor

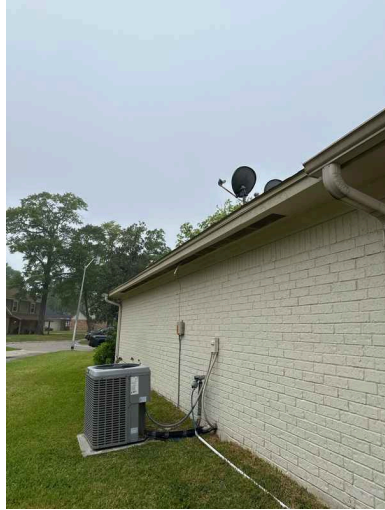
**2: Gutters absent**

Inspector noted that some of the roof slopes appeared to be missing gutter systems. Recommend correction to prevent erosion of the soil resulting in standing water near the foundation.

Recommendation: Contact a qualified gutter contractor

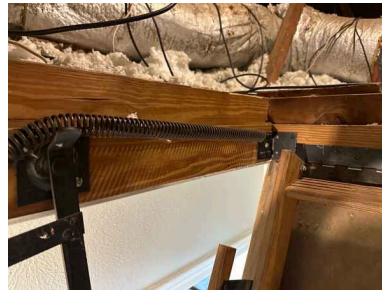
The above stated issues were observed in relation to the attic access door at the time of inspection. Attic access doors are required to be properly insulated, weatherstripped, and seal firmly for energy efficiency reasons. Pull down attic ladders are required to be properly secured to the ceiling framing with appropriate fasteners, the hardware on the doors should be kept in good condition and be regularly serviced for safety reasons. Recommend correction of any above referenced issues to ensure performance and proper installation.

Recommendation: Contact a qualified handyman.

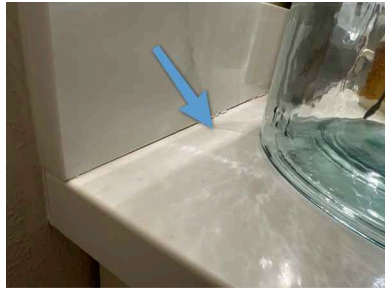
The above stated locations were identified as areas in need of proper caulking and sealing, or maintenance to the existing sealant. Examples of locations needing sealing are pictured for your reference. Recommend further evaluation of these areas and all others to determine the extent of needed repairs.

Recommendation: Contact a qualified handyman.

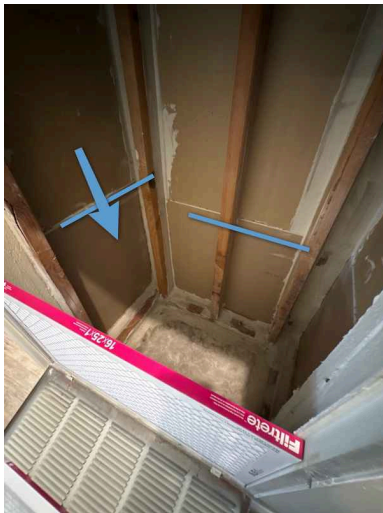
**6: Drywall replacement**

Inspector observed some indication that the lower sections of some of the drywall at the interior the home have been replaced as observed from the return air opening. This is typically indicative of a previous moisture damage in structure. Recommend any questions regarding previous issue be directed to the seller.

Recommendation: Contact a qualified professional.

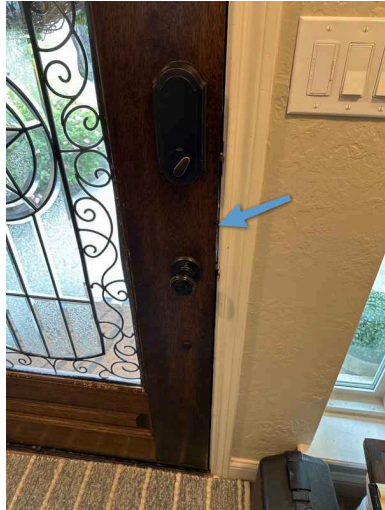
Gaps were observed in the weather seal around the exterior doors. Repair as needed to prevent moisture, pest, and air intrusion.

Recommendation: Contact a qualified professional.

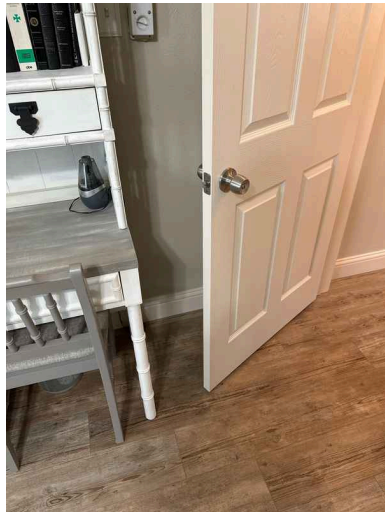
**2: Interior Door Hardware: Missing Door Stops**

One or more door stops were observed to be missing. Recommend adding door stops to prevent damage to drywall finish.

Recommendation: Contact a qualified professional.

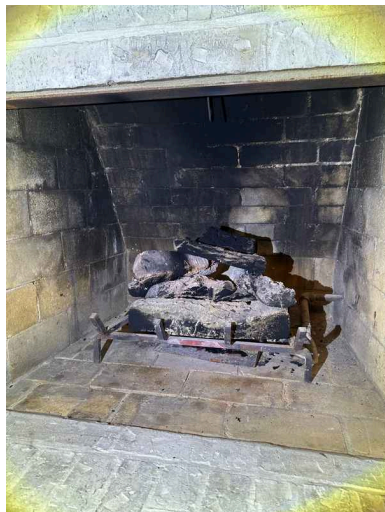
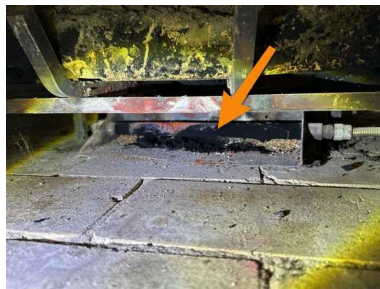
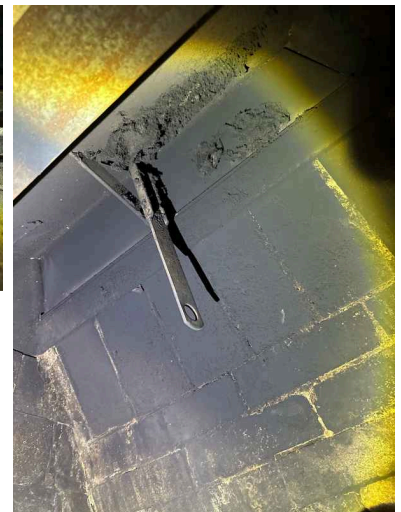
## 2: System issues and maintenance

Recommend evaluation of the unit by qualified technician to properly service prior to use.

Recommendation: Contact a qualified fireplace contractor.

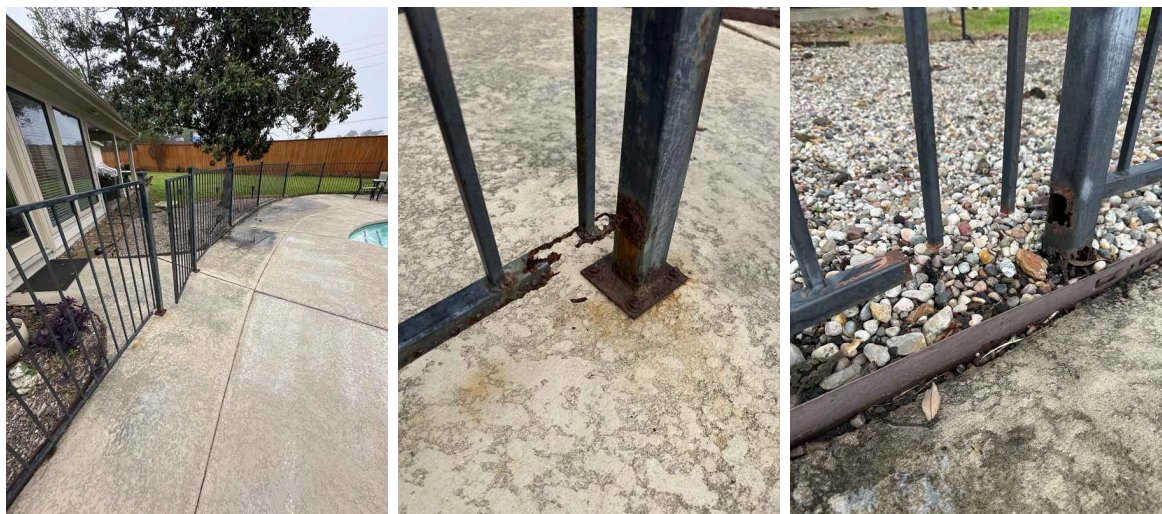
The metal fencing around the pool deck at the rear of the home showed excessive rusting and damage at multiple locations. Recommend further evaluation and budgeting for repairs as needed.

Recommendation: Contact a qualified professional.

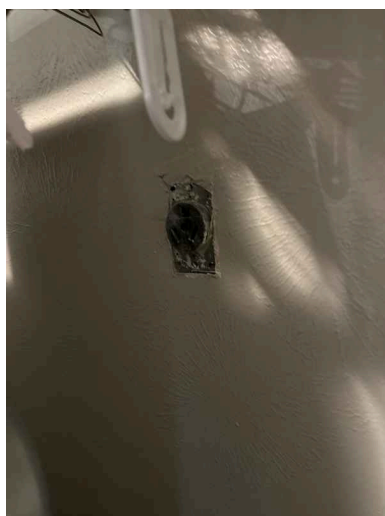
#### 5: 2-wire circuits

Inspector noted that this home is utilizing some of the original two wire ungrounded circuits to distribute power throughout the home and that multiple locations observed with newer three prong outlets install installed on this older wiring.

This condition presents a false sense of a ground wire being present and is a code violation.

Recommend that you consult with a qualified electrician to come and perform a full evaluation on the home specifically in regards to the older ungrounded wiring.

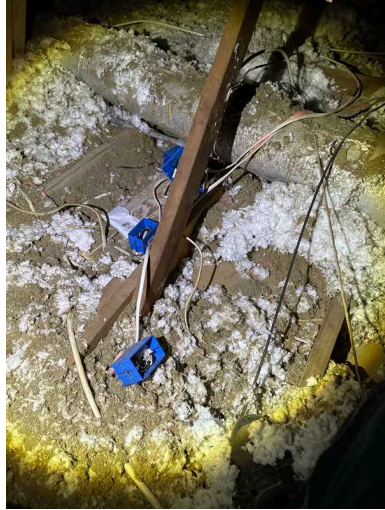
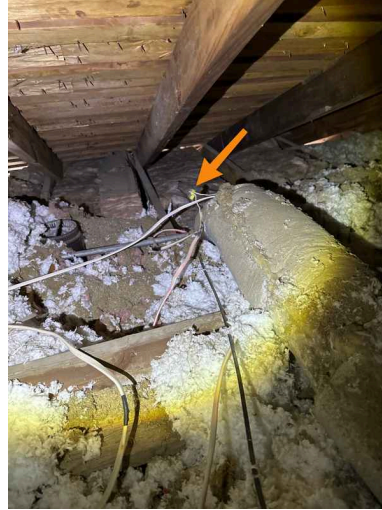
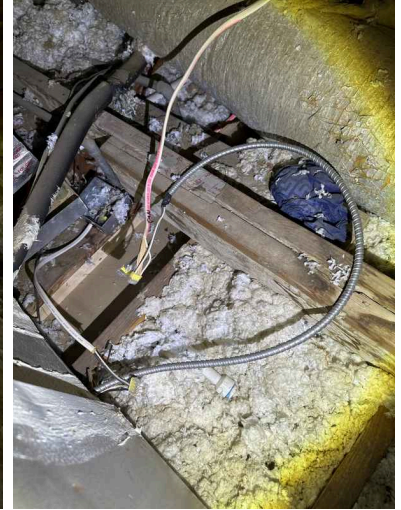
Inspector noted multiple issues related to the electrical at the attic space including open junction boxes, wiring not properly secured, and open splicing of the electrical wiring. Recommend further review by an electrician to determine the extent of the repairs needed.

Recommendation: Contact a qualified professional.

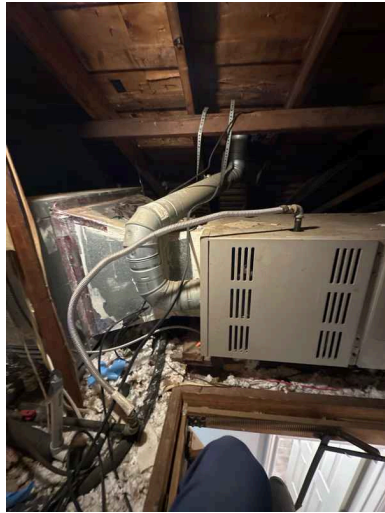
**2: Rusting around heat exchanger**

Inspector noted that the heating equipment did appear to operate at the time of the inspection, but that there was some moderate rusting or deterioration around the heat exchanger. Recommend review of the unit by qualified technician to ensure that all items are in good condition and to service as needed.

Recommendation: Contact a qualified heating and cooling contractor

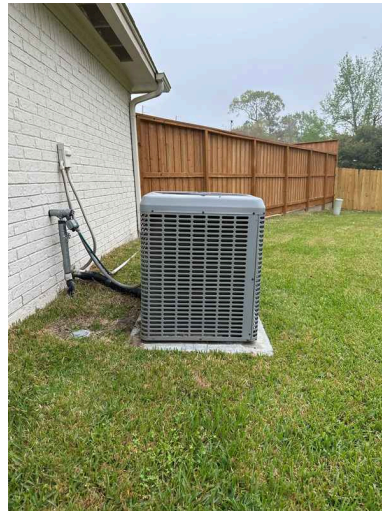
**2: Small AC system**

Inspector noted a separate HVAC system was installed in conjunction with the rear addition, but that it appears no longer functional as observed at the time of inspection.

Inspector noted that the breaker for the condenser was turned off and that the refrigerant lines appeared to be detached at the condenser unit.

Recommend consulting with the seller regarding the known issues or conditions with the system and recommend full evaluation by qualified HVAC contractor to determine the extent of needed repairs or the system will require replacement. Recommend budgeting for repair or replacement as needed.

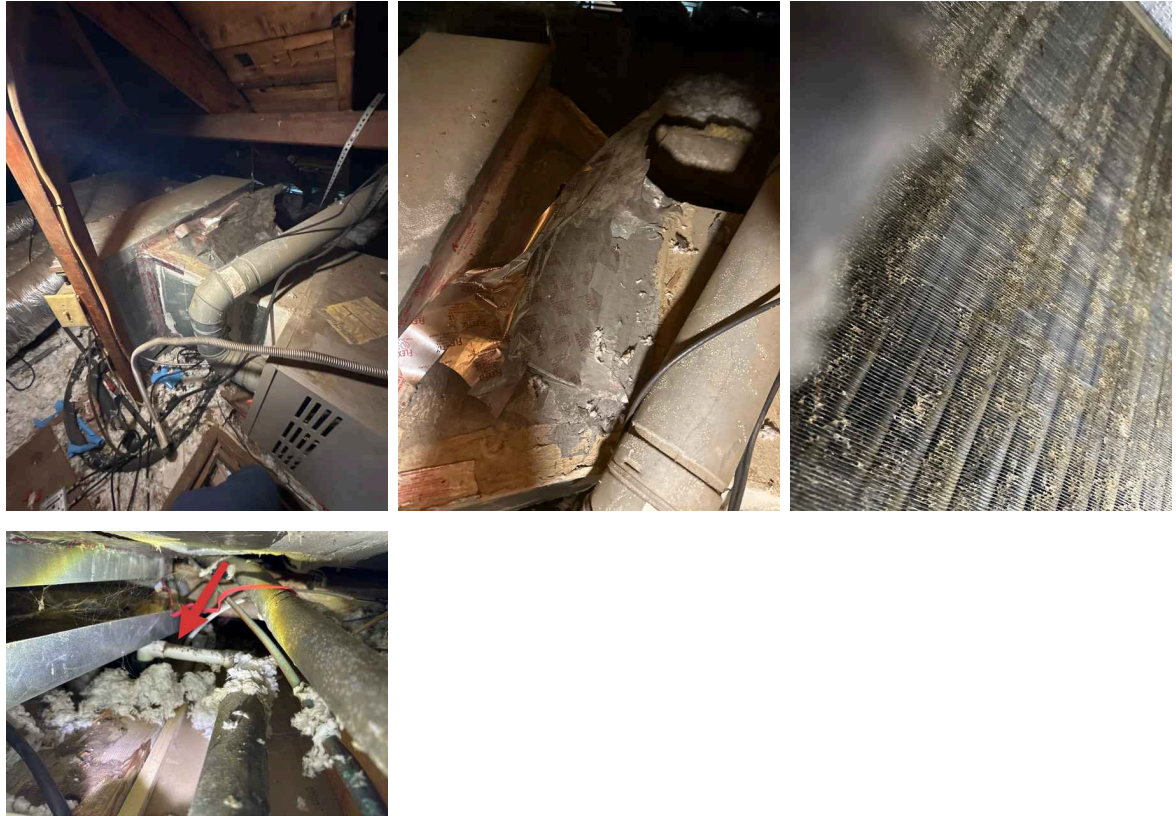
**3: Evaporator coil: service required**

Inspector noted need for evaluation and service in regards to the main home evaporator coil. Issues observed include:

- the tape and seal for the access to the evaporator coil was blown open and leaking volumes of conditioner into the attic space.
- the coil showed signs of being excessively dirty and in need of proper cleaning. The seller discloses previous issues with mold inside the home, and I recommend cleaning of the system and considering installation of UV light or other air scrubber to help improve air quality.
- inspector noted improper termination of the condensate drain, including no proper trap in place at the event connection as well as in adequate insulation and signs of previous issues around the drain. Recommend evaluation to ensure that the drain is properly insulated and installed.

Recommendation: Contact a qualified heating and cooling contractor

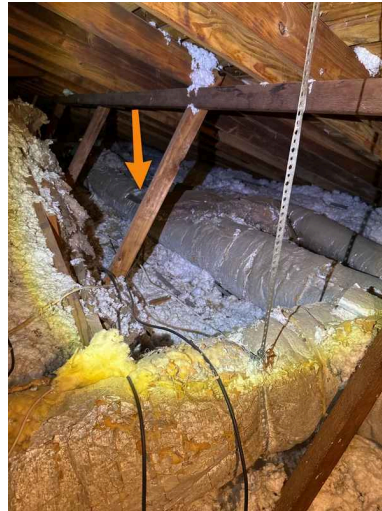
Unit dented

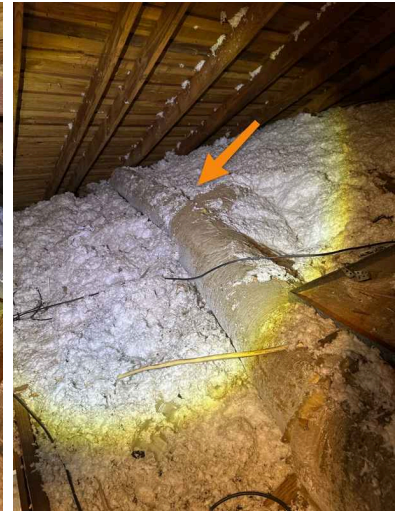
Ducts buried/not supported

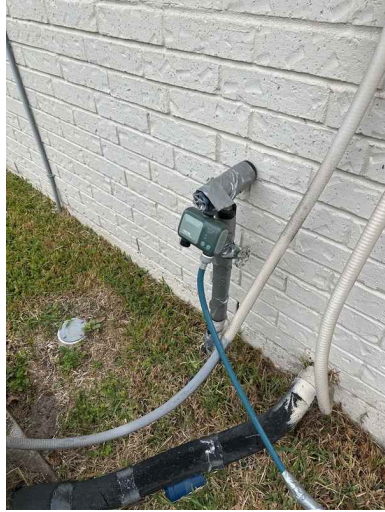
**1: Hose Bibb (outdoor faucet): Backflow Prevention Missing**

One or more hose bibb(s) Missing a backflow preventer. These devices are inexpensive, easily installed and help prevent contamination of potable water. Repair as needed.

Recommendation: Contact a handyman or DIY project

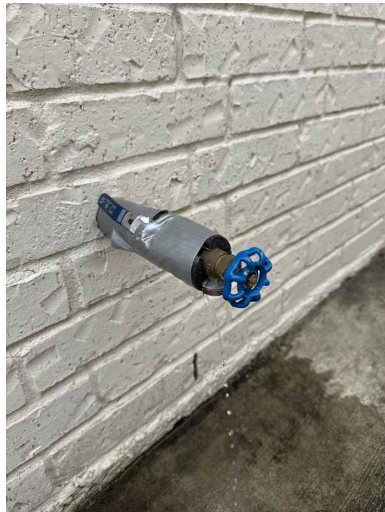
**3: Galvanized pipe**

Inspector noted several issues at the exterior hose valves, including some leaking around the valve at the left side as well as some leaking around the bowl stems when operated. Recommend evaluation to ensure that all hose valves are operating properly and have proper antisiphon protection.

Recommendation: Contact a qualified professional.

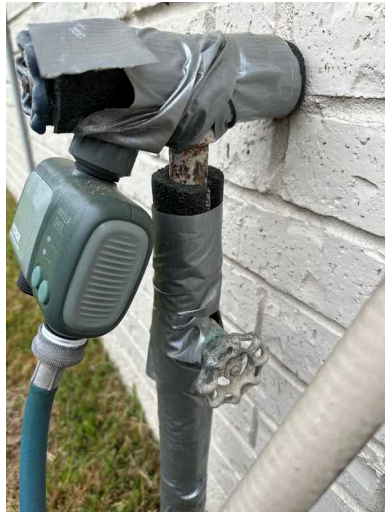
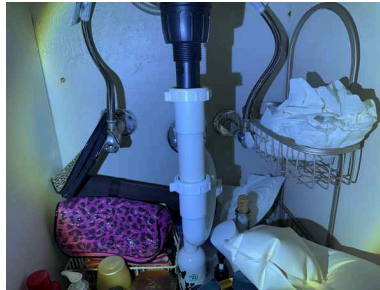
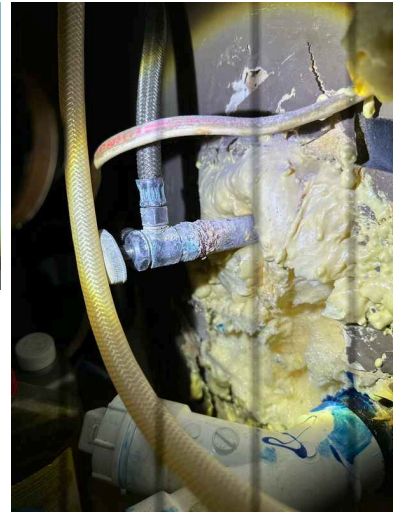
Inspector noted that the original galvanized pipe is still distributing water throughout the property. This pipe is known to develop issues overtime related to pour water pressure, dirty or discolored water, and leaks that develop due to extensive corrosion.

Inspector noted that the water pressure appeared adequate at the fixtures at the time of the inspection, but that multiple locations on the piping displayed some heavy corrosion or deterioration. This was most noticeable around the shut off valves and at the connections.

Inspector also noted some rusty colored water coming from some of the fixtures when first operated

These conditions are indicative that the galvanized pipe is deteriorating, and it is my recommendation that you consult with a qualified plumber to evaluate further and that you budget for replacement of the galvanized pipe.

Recommendation: Contact a qualified plumbing contractor.

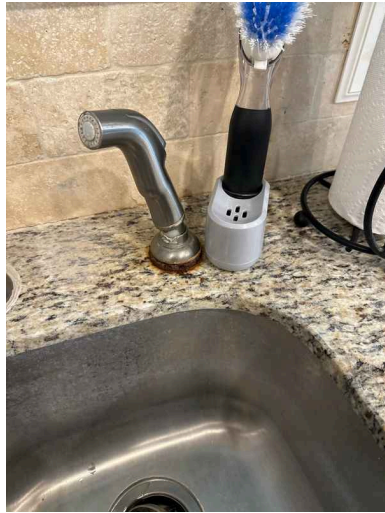
**4: Kitchen sink sprayer**

Inspector noted some rusting and corrosion around the sprayer at the kitchen sink fixture. Recommend repair or replacement as needed.

Recommendation: Contact a qualified professional.

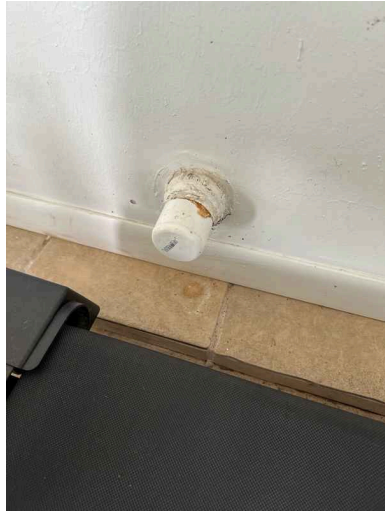
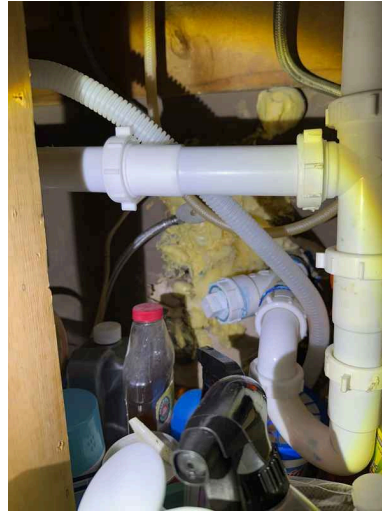
Inspector noted the old cleanout off the rear wall of the kitchen showed some signs of water escaping and recommend evaluation and service as needed.

Contact a qualified professional.

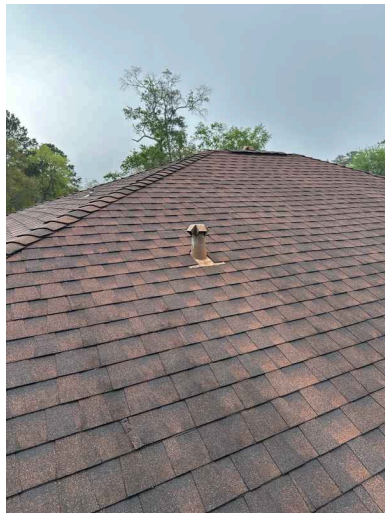
**1: Venting: Improper vent termination**

The cap in use at the roof termination of the water heater exhaust vent is not approved for use with combustion appliances. The vent does not adequately penetrate through and above the roof and is not properly capped. Recommend correction to ensure proper exhaust of the appliance.

Recommendation: Contact a qualified professional.

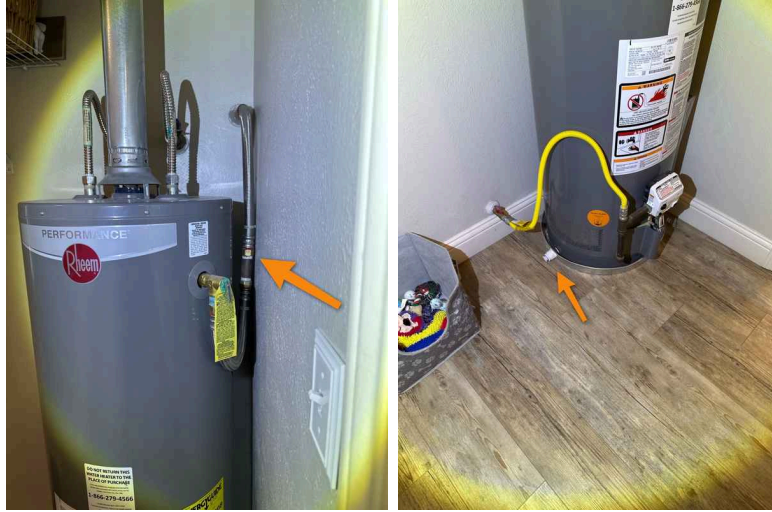
**2: General installation issues**

Inspector noted some installation issues related to the appliance. This includes the temperature and pressure relief valve runs in an upward direction as well as no drain line attached to the pan below the unit. These issues violate proper code installation and I recommend evaluation by a plumber to correct as needed.

Recommendation: Contact a qualified professional.

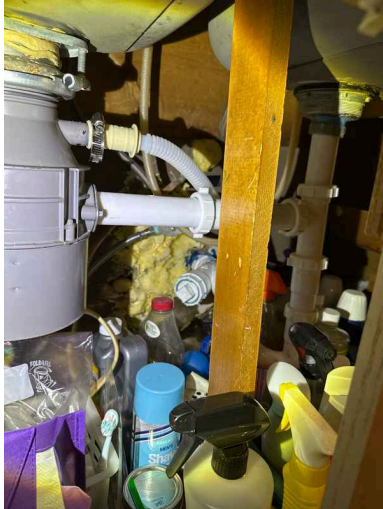
**1: Missing Anti-Siphon Loop**

There should be an anti-siphon loop or an air gap in the dishwasher drain line to prevent backwash from the waste disposal. Correct as needed.

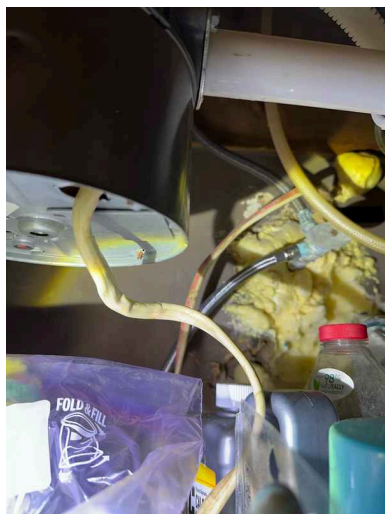
**1: Bare Romex Wiring**

Bare electrical wiring (Romex) was observed serving power to the food waste disposer. Exposed wiring creates a serious shock hazard and fire risk, as it lacks proper insulation protection. This condition requires immediate correction by an electrical contractor who can install the wiring in appropriate conduit or replace it with properly insulated cable.

Recommendation: Contact a qualified professional.

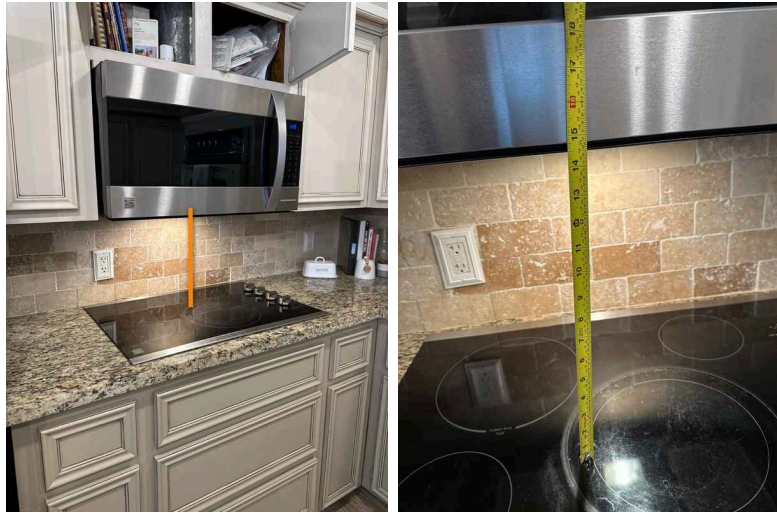
**1: Unit clearance**

Inspector noted low clearance of the microwave/exhaust unit to the cooktop surface. Typically a minimum of 18 inches of clearance is required to the appliance. Recommend correction as needed.

Recommendation: Contact a qualified professional.

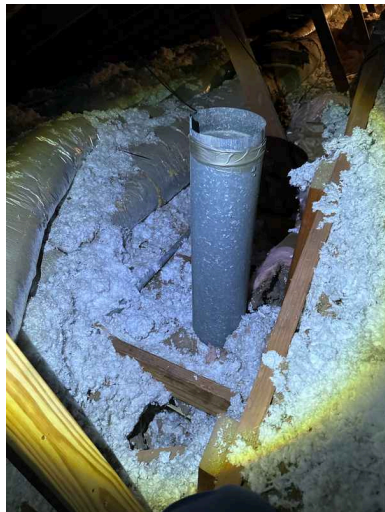
**2: Vent not connected**

Inspector noted that there is a duct for the range hood installed at the cabinet that routes into the attic space, but that it does not appear to be currently utilized. Recommend review of the range hood installation at the kitchen to determine the extent of needed repair repairs to allow for the unit to be connected to the exhaust. Recommend the exhaust be properly routed out through the roof it is to be utilized.

Recommendation: Contact a qualified professional.

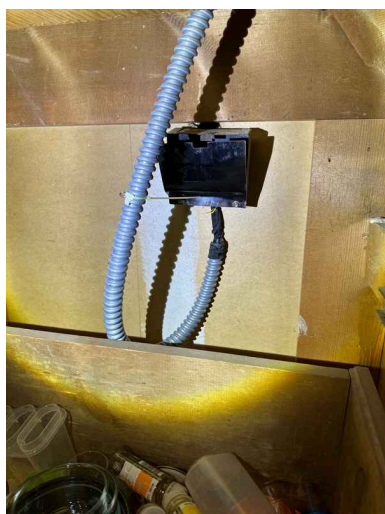
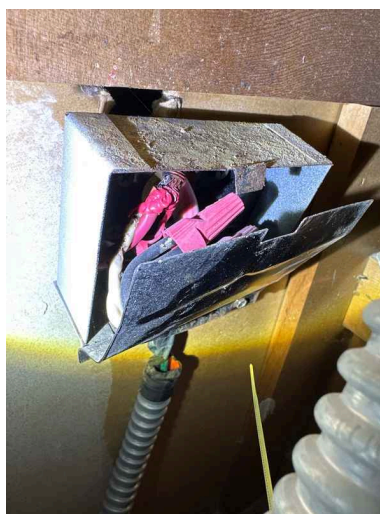
**1: Electrical issue**

Inspector noted an electrical issue when operating the cooktop appliance at the time of inspection. Some burning smell and signs of burn marking could be observed in the junction box below the cooktop when operated.

Recommendation: Contact a qualified electrical contractor.

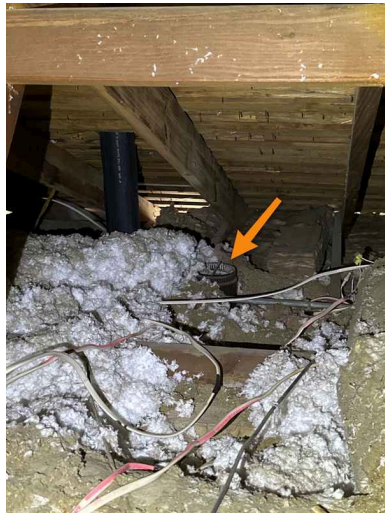
The bathroom exhaust fan vents terminated in the attic space. Exhaust fans should terminate to the exterior to prevent excess humidity in the attic space. Repair as needed.

Recommendation: Contact a qualified professional.

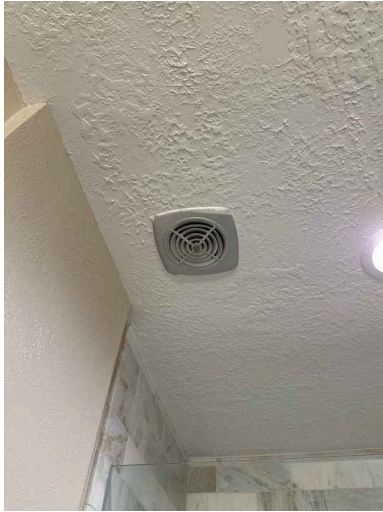
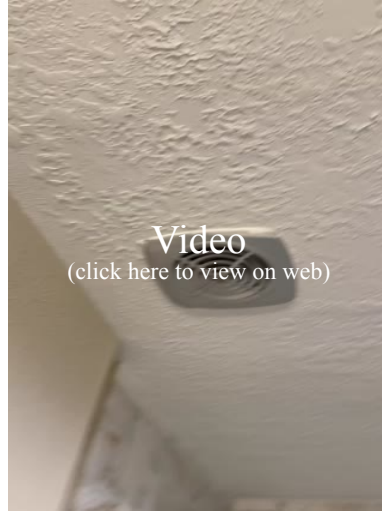
**2: Unit aged/noisy**

Inspector noted that the exhaust fans in the bathroom are aged and excessively noisy when operated indicating that the motor or components are wearing out. Recommend evaluation and budgeting for

Recommendation: Contact a qualified professional.

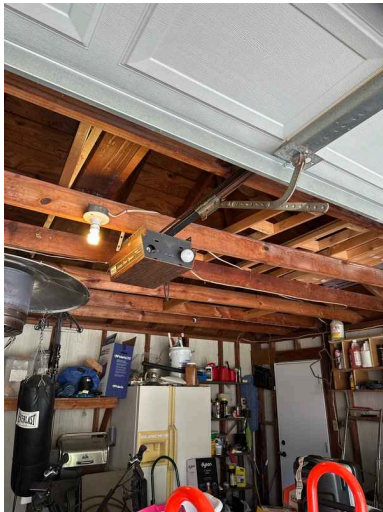
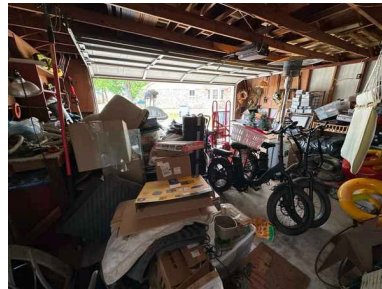
**1: Aged unit: No safety features**

Inspector noted that the overhead garage door opener is an older model that does not have modern safety features such as motion sensors and other devices. Inspection of the unit was extremely limited due to larger amount of stored items in the garage at the time of inspection.

Recommend evaluation of the unit by qualified technician to determine the extent of any needed repairs or service and that you consider modernization for safety reasons.

Recommendation: Contact a qualified professional.

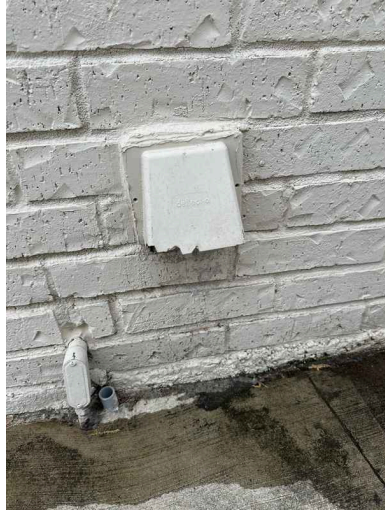
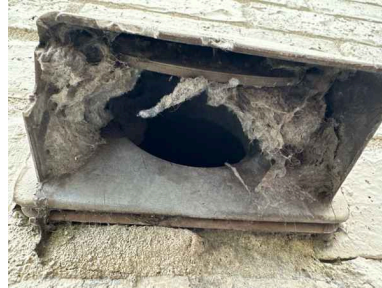
**1: Cap worn**

The vent cap for the dryer duct is worn and showed some heavy lint buildup. Recommend cleaning and repair as needed.

Recommendation: Contact a qualified professional.

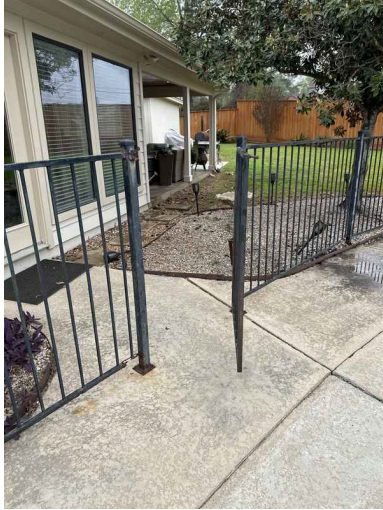
Several safety related items around the property were observed to not meet modern code requirements. These conditions include, but are not necessarily limited to: no self-closing feature and other latch requirements on gates as well as no audible alarm at home entry door. Recommend further evaluation and correction of these and any other modern safety requirements to avoid potential hazards, especially to children. Consult with a qualified contractor to determine extent of necessary repairs to meet modern safety and code recommendations.

Recommendation: Contact a qualified swimming pool contractor

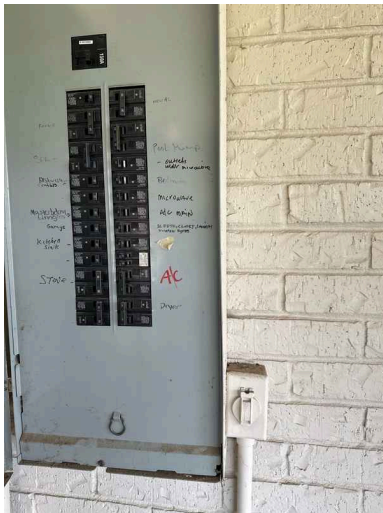
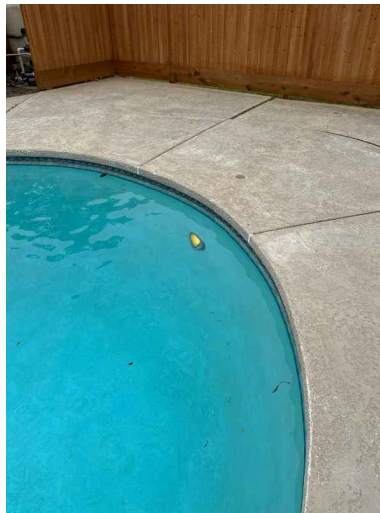
### 2: GFCI protection

Inspector noted no GFCI protection in place for the pool light circuit or for the equipment. This is a required protection and should be installed for safety reasons. Recommend review of all electrical for the pool and equipment by qualified electrician to ensure proper installation and code compliance.

Recommendation: Contact a qualified electrical contractor.

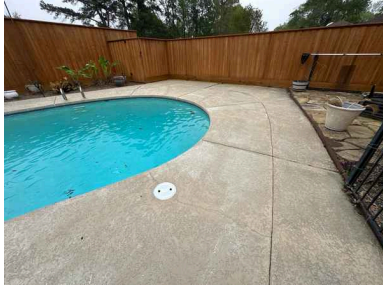
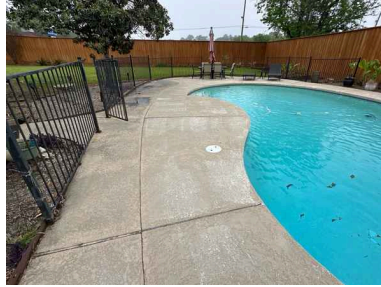
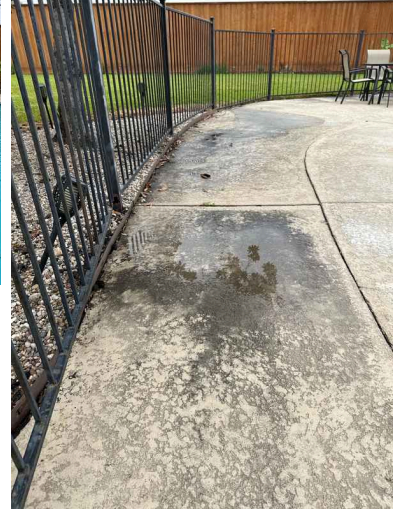
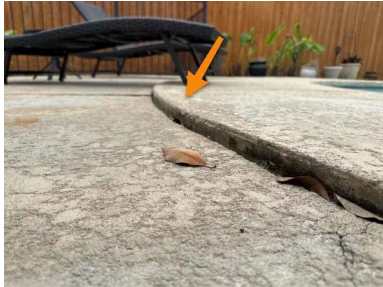
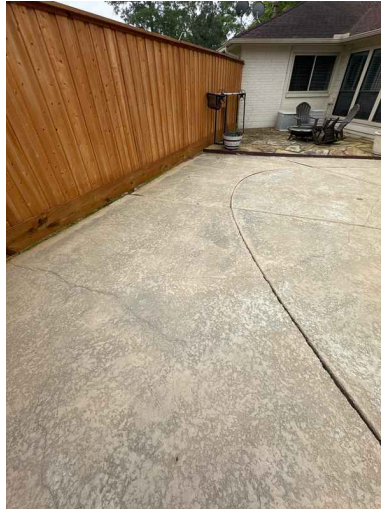
Inspector noted that the concrete flat work at the deck around the pool showed signs of heavy deflection or cracking at multiple locations. Areas could be observed holding water due to inadequate slope and no overflow drains. Recommend evaluation of the decking by qualified contractor to determine the extent of needed repairs or maintenance to ensure no further movement occurs and to ensure water is draining properly.

Recommendation: Contact a qualified professional.

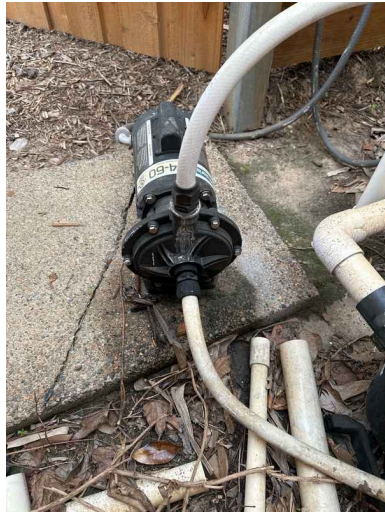
**4: Booster pump**

Inspector noted some signs of leaking at various connections on the pool booster pump assembly. Recommend full evaluation of the equipment and piping to determine the extent of needed repairs or maintenance.

Recommendation: Contact a qualified professional.

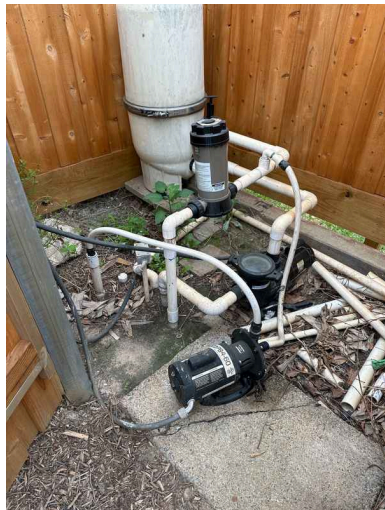
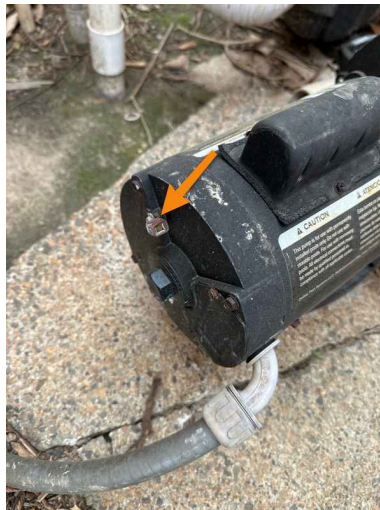
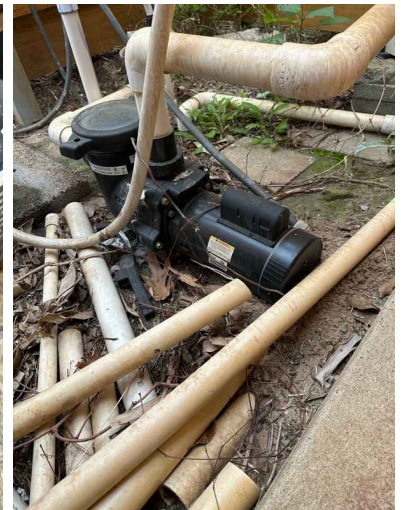
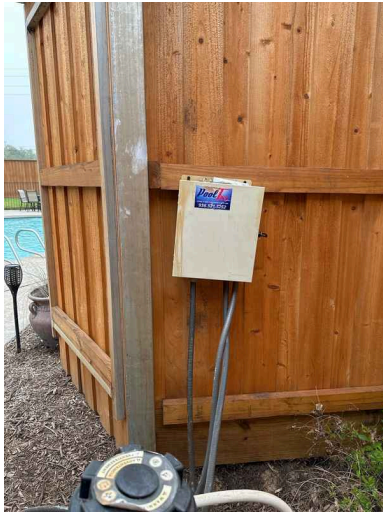
### 5: General equipment issues

Inspector noted several general issues related to the installation and condition of the equipment. These issues include, but are not limited to:

- no proper bonding of the booster pump and other related equipment
- open electrical wiring or loose conduit
- the timer box is poorly or inadequately secured

Recommend review of the installation of the equipment by qualified pool contractor to advise on needed corrective action and considering reconfiguration of the system to allow for proper access to all equipment.

Recommendation: Contact a qualified professional.

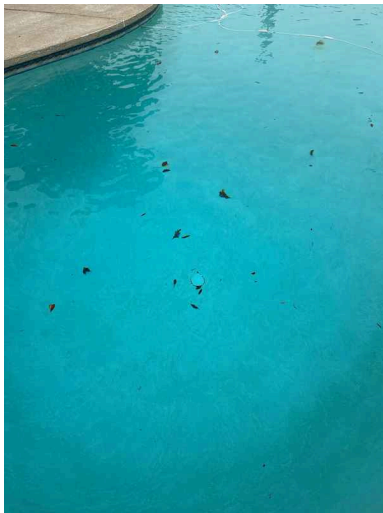
**6: Single floor drain**

Inspector noted that the pool is an older style with a single floor drain, which is no longer permitted. The drain does appear to have an anti-vortex cover. Recommend consulting with a pool contractor to determine if some corrective action should be done to improve safety in conjunction with the needed structural repairs.

Recommendation: Contact a qualified swimming pool contractor

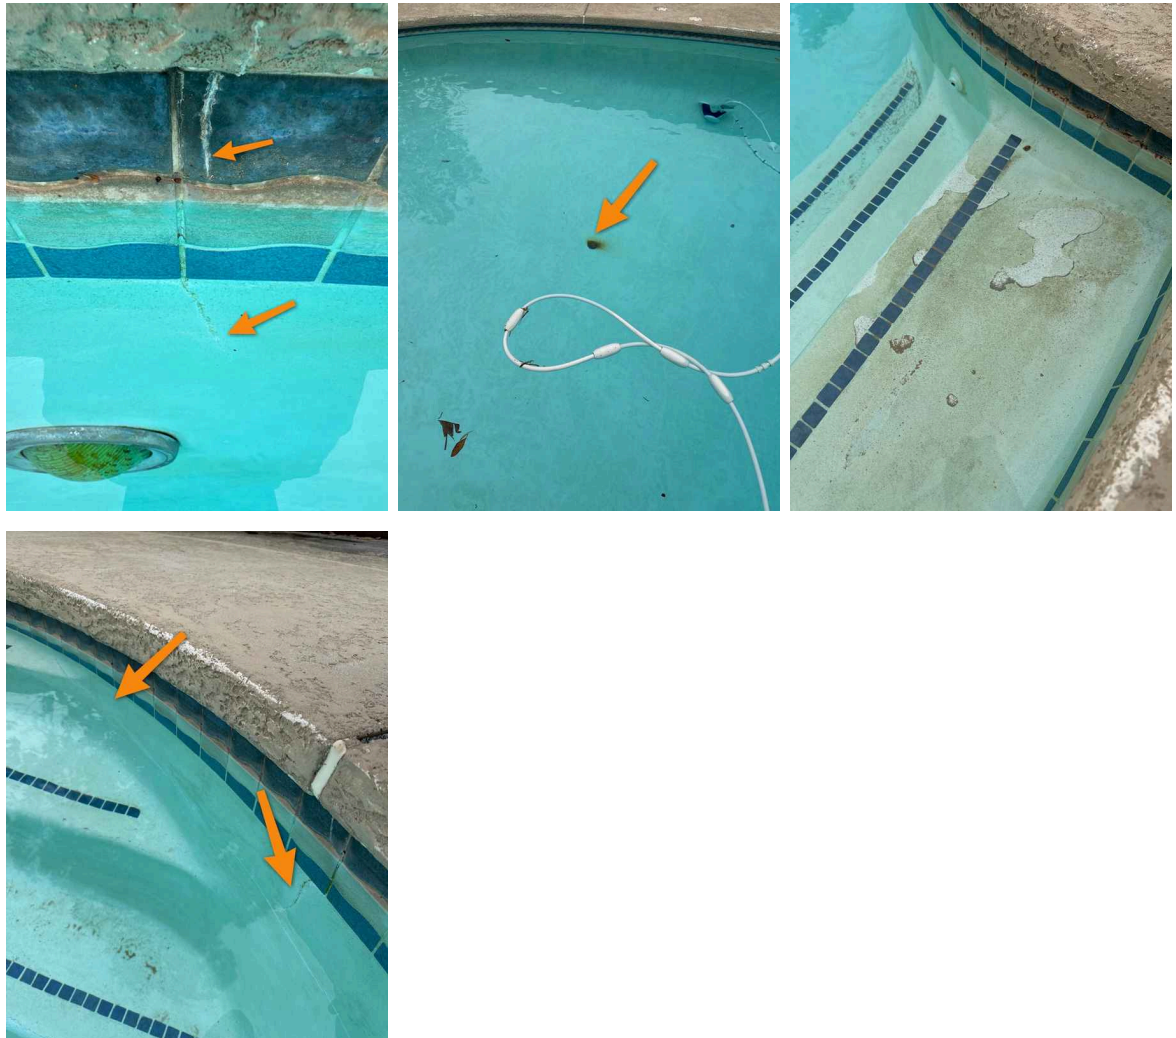
**7: Structural issues: Recommend further evaluation**

Inspector noted that the pool is an older structure that showed signs of deterioration and a need for refinishing and other maintenance/repairs. Moderate cracks could be observed in the shell at several locations and the plaster show signs of deterioration and a need for refinishing.

Recommend consulting with a qualified pool contractor to evaluate the structure further to determine the extent of any needed repairs and to quote for the needed refinishing and other required maintenance.

Recommendation: Contact a qualified professional.

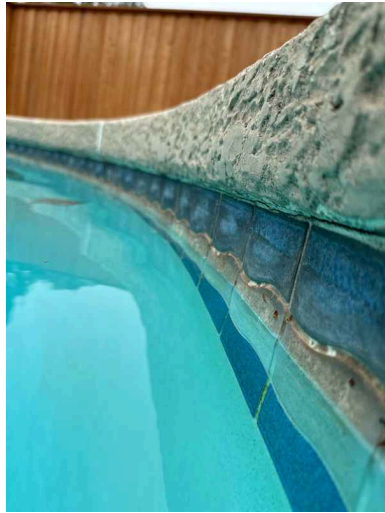
**8: Pool tile**

The tile around the perimeter of the pool appeared to be overall in good condition, but did show a need for cleaning and maintenance. Recommend coordinating with the pool contractor to determine that the tile will remain in conjunction with the pool refinishing and to budget for repair as needed.

Recommendation: Contact a qualified professional.

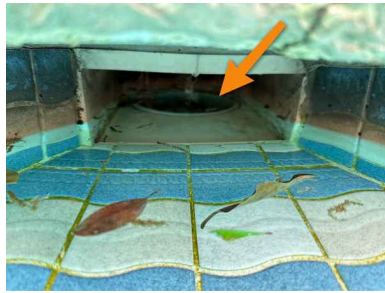
**9: Skimmer weir**

Inspector noted that there is no weir installed at the skimmer opening. Recommend correction to ensure proper function of the skimmer.

Recommendation: Contact a qualified professional.

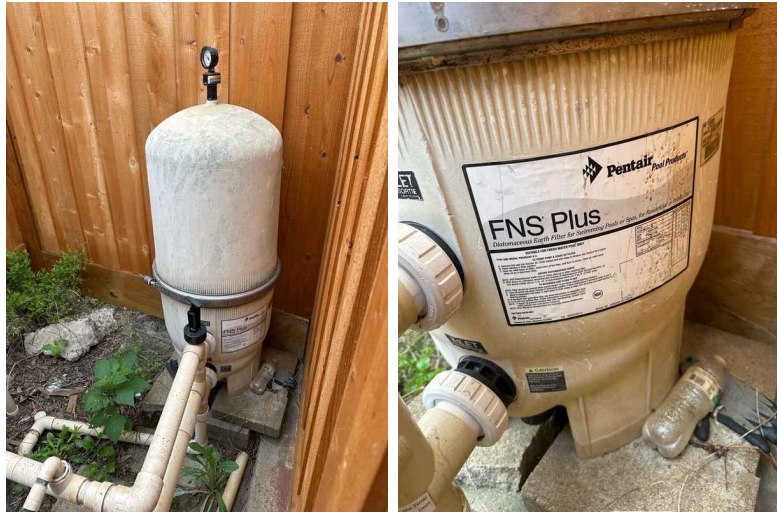
**10: Filter setup**

Inspector noted that the filter in place is a diatomaceous earth style, which requires proper backwashing and valve assembly. Recommend review of the equipment and piping by a qualified pool contractor to ensure installation of appropriate valve and termination of the backwash drain.

Recommendation: Contact a qualified professional.

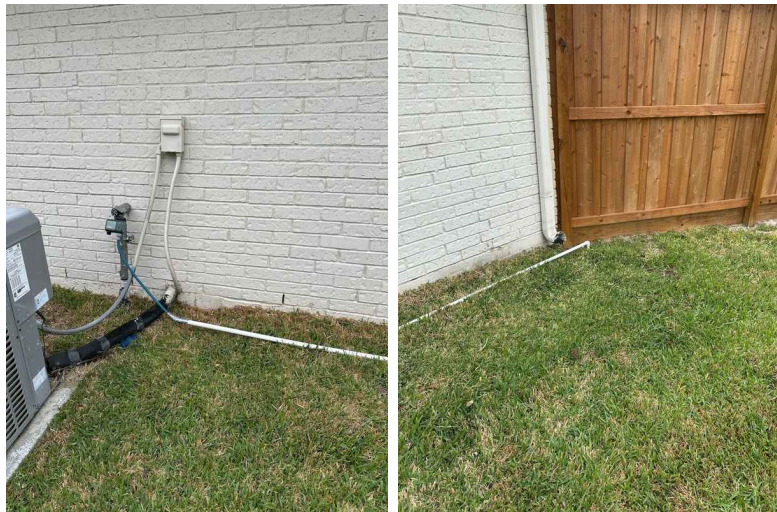
**11: Pool fill line**

Inspector noted a line attached to a hose valve at the right exterior that routes towards the back fence and believes that this is your pool fill line. This installation does not meet proper code as there is no proper check valve or backflow preventer. Recommend evaluation in conjunction with other needed pool repairs to ensure proper installation of the pool fill line.

Recommendation: Contact a qualified professional.
