HEDDERMAN ENGINEERING, INC.

FOUNDATION INSPECTION

28010 Fulshear Plantation Dr
Fulshear, TX 77042

05/04/2026

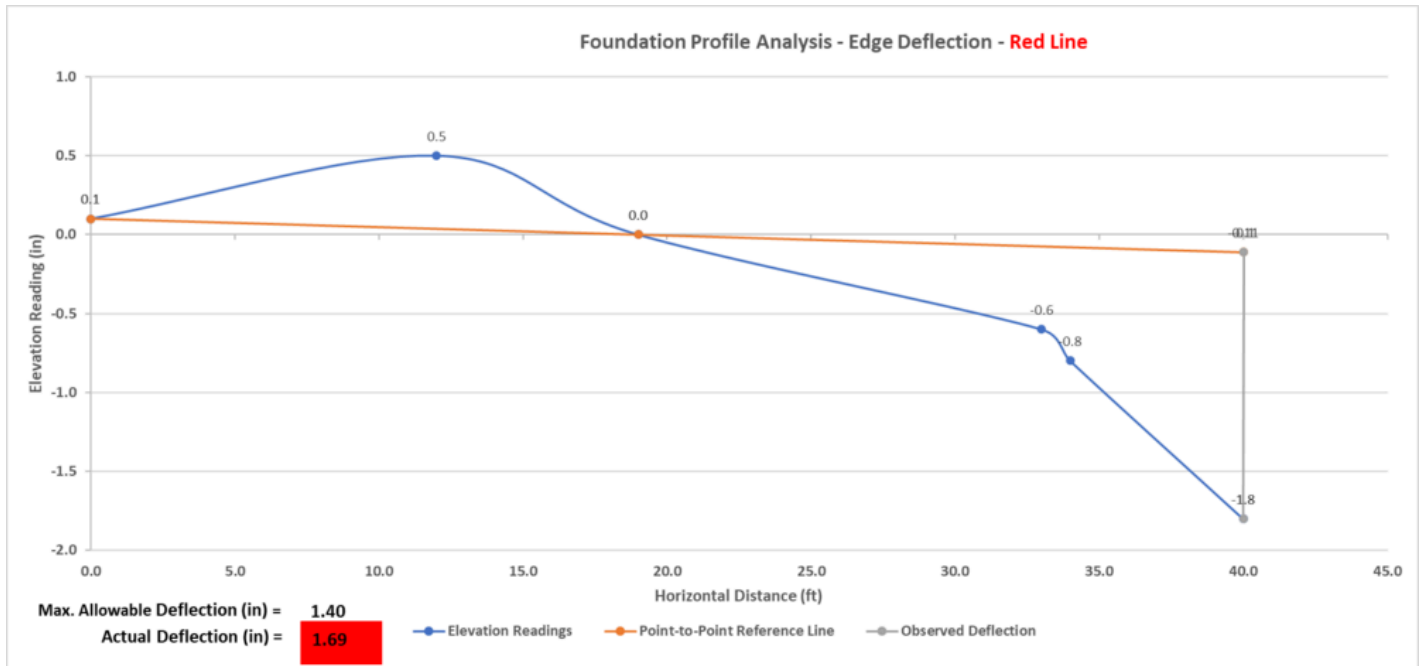
Elevation Readings
28010 Fulshear Plantation Dr.
(Not to scale)

The floors were checked with an electronic level, and were observed to be sloping towards the west side of the house. The difference in elevation between the high point and low point was 2.4 inches. The high point was located at the dining room, and the low point was located at the master closet. The unlevelness takes place over a horizontal distance of approximately 40-45 feet.
