Inspection for Property located at 27615 Brentsprings Run Lane  
05/06/2023  
Prepared for : Roy Howard

# PROPERTY INSPECTION REPORT FORM

27615 Brentsprings Run Lane, Katy, TX 77494

**Description:** One Story, Wood framed single family residence ; Brick exterior ;  
Composition roof ; Attached garage

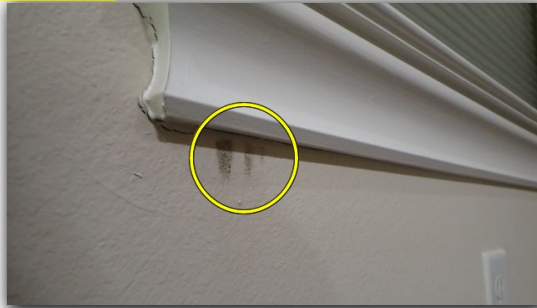
**Master Bedroom**

Water stains / damage or repairs observed at multiple locations. Dry at the time of inspection via moisture detection equipment.

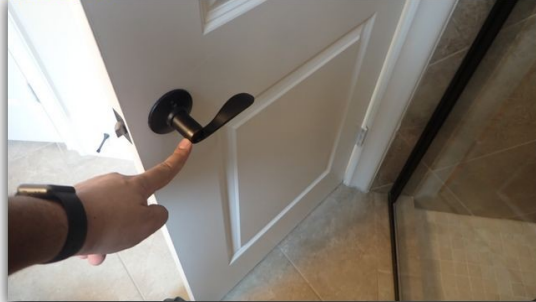
**Back Bathroom**

One or more door(s) have sticky hardware.

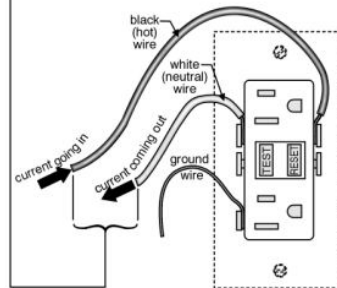
Light(s) found to be not functioning. Probably just a burned out bulb, or it could be a broken fixture / switch or improper wiring. Including but not limited to;

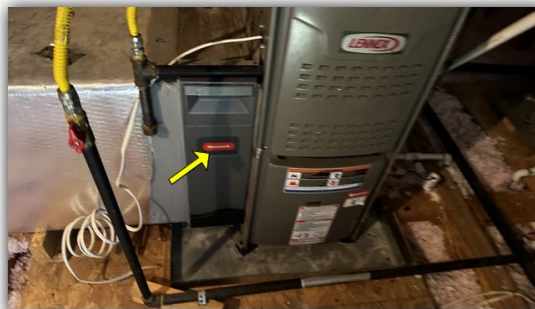
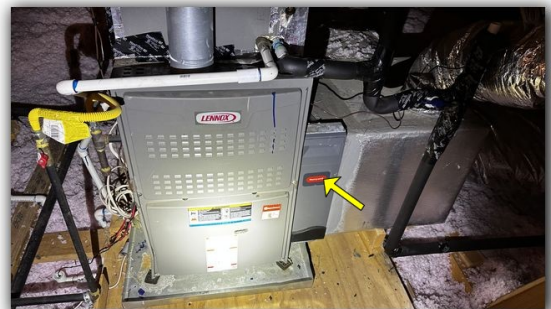
Comments: Media air filter(s) located in attic that requires changing/cleaning every 6 months, recommend checking guide for proper maintenance information.

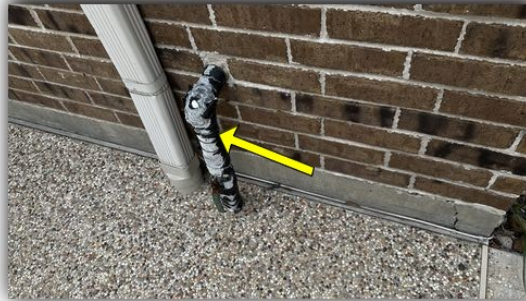
Static water pressure reading: 52 psi

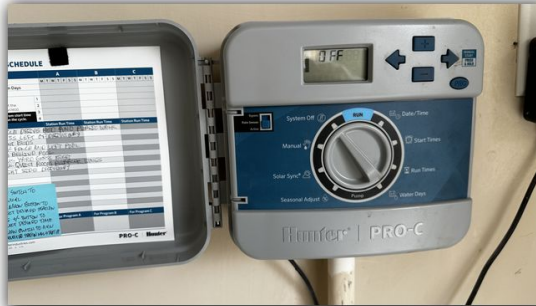
Damaged water line, water gusher in yard; Zone 1
