# Inspection Report

16958 Nicole Ln  
Houston TX 77084

**Sunbelt Inspections**

# PROPERTY INSPECTION REPORT FORM

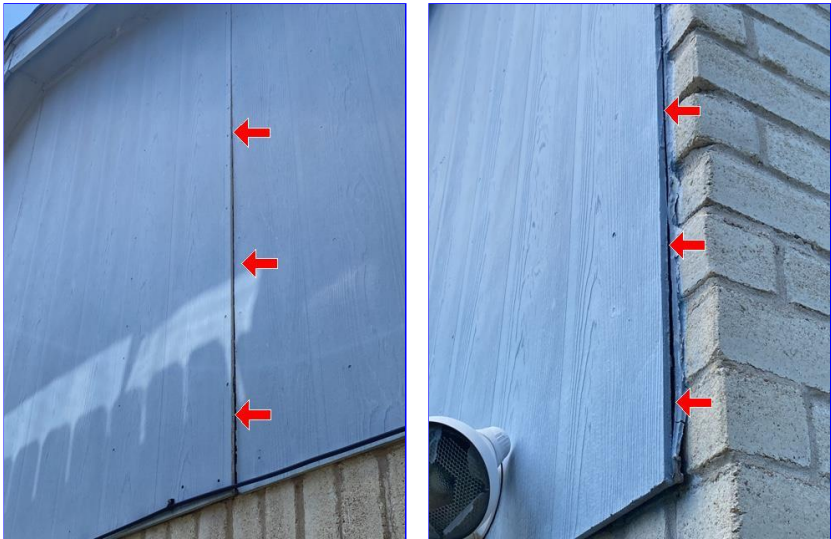
(5) The brick veneer expansion joint sealant has failed/missing, or not properly installed. Recommend correction.

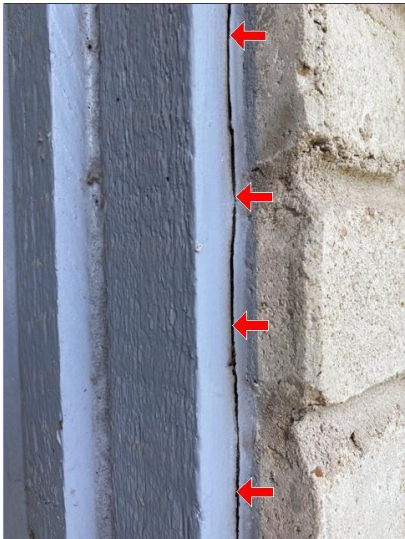
(7) There was missing mortar below the frieze board at one or more areas.

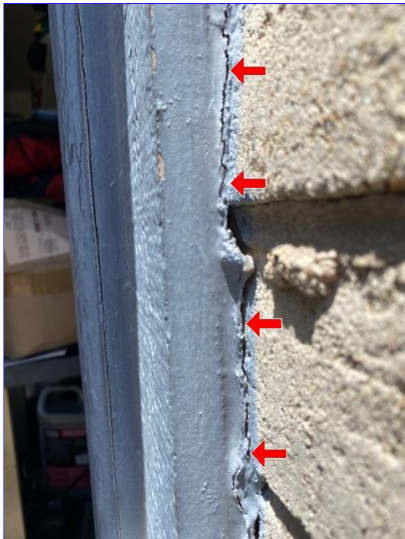
(4) The exterior perimeter sealant around door frames has deteriorated (back patio door).

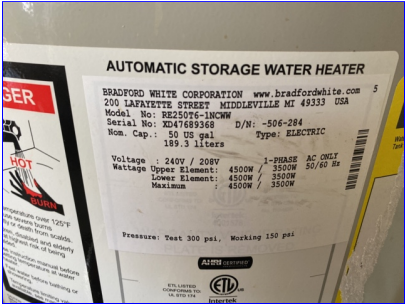
(2) The water heater is in need of an emergency drain pan under the unit. The drain pan should have a drain line ran to the outside. A water heater leak can cause very expensive repair to a home. Recommend correction.

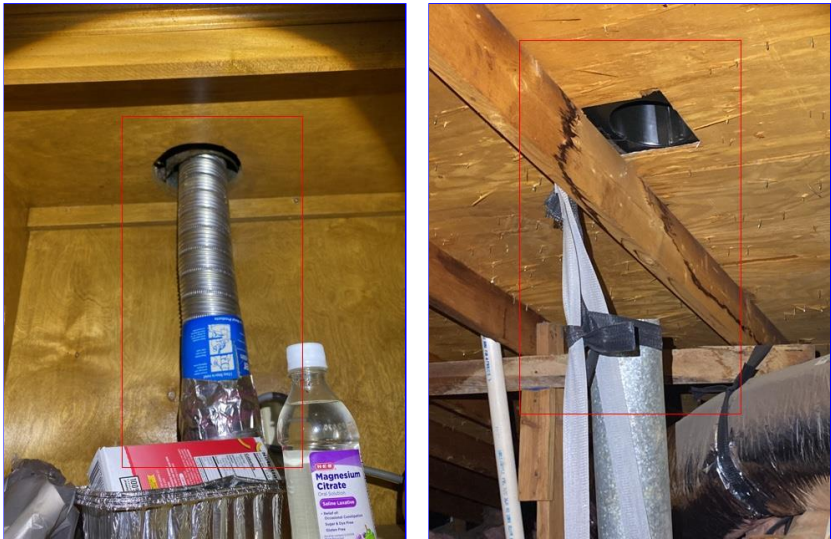
(2) The surface lights for the vent hood or under the microwave, did not work when tested. I recommend repair or replacement as needed.
