Maria Fernandez
2534 Halstead Dr
Spring, TX 77386

March 23, 2023

PROPERTY INSPECTION REPORT FORM

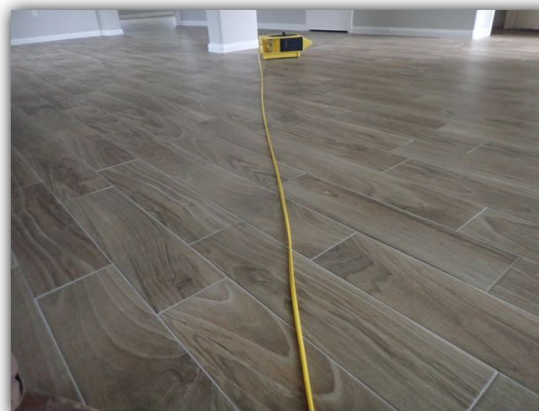
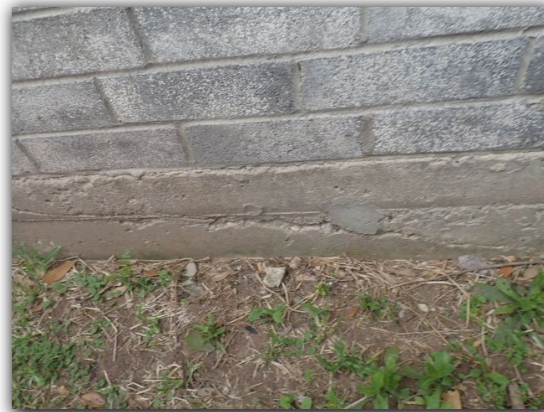
- The concrete beam was observed to have some deterioration (scaling and/or spalling) on the east side of the structure.

Note: One or more of the foundation perimeter beam corners were observed to be sheared off (corner pop). This is a common condition to observe and is due to thermal expansion and contraction of the different building materials. This condition does not adversely affect the foundation performance. However, in some cases, some cosmetic improvements may be necessary.

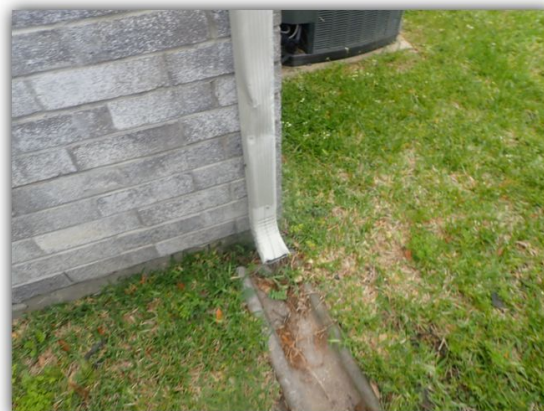
Gutter & Downspout System

- Damaged gutters were observed on the south side, north side of the roof structure.

Note: The gutter downspouts should discharge water at least thirty-six inches (36") away from the foundation perimeter beam. Storm water should be encouraged to flow away from the structure at the point of discharge.

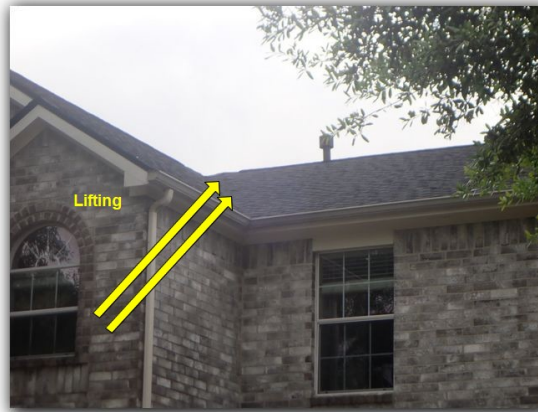
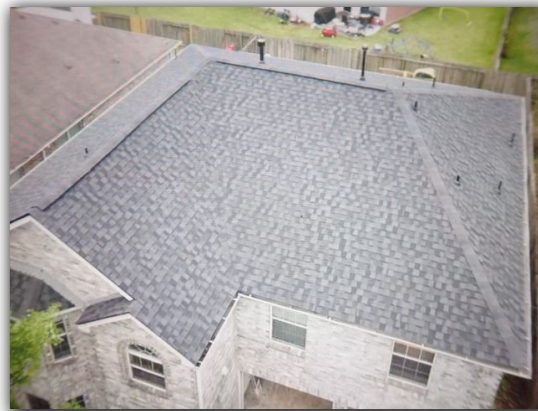
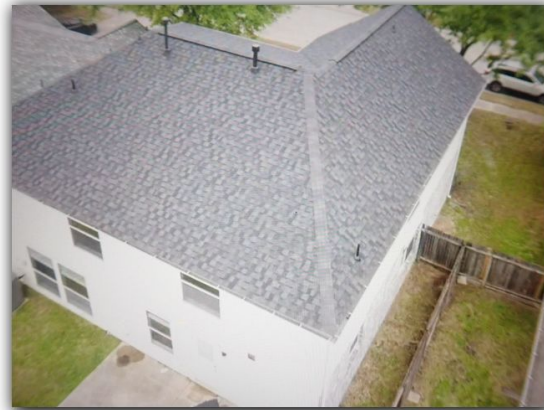
- One or more of the shingles were observed to be lifting on the north side of the roof structure.

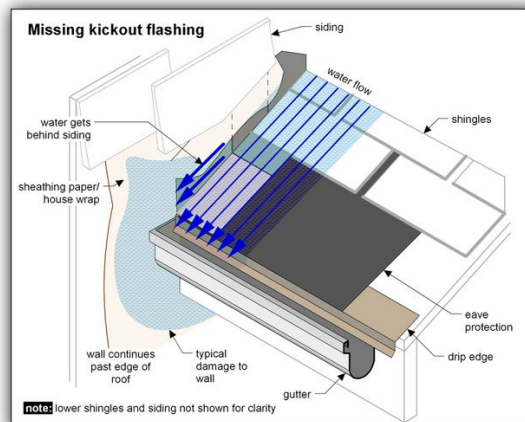
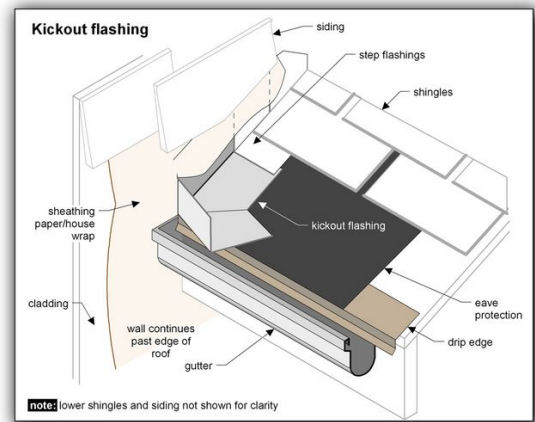
Flashing Details

- The flashing is lifting and/or pulling loose on the north side of the roof structure. This condition could allow water intrusion at this location.
- It is recommended to paint the flashing details to prevent rust and/or UV damage.
- One or more of the roof level plumbing vent stack flashing details are buckled downward around the plumbing stack. This condition could allow water penetration at this point and corrective measures are recommended.
- It is recommended to properly seal the storm collar(s) at the roof level gas equipment vent pipe(s) to help prevent water intrusion into the structure.
- There was no kickout flashing details observed at the lower bottom edge of the roof line interface and the sidewall that continues past the edge of the roof. The lack of this kickout flashing could allow water to penetrate at these points.

The flashing details should be checked, reset or repaired as necessary. The observations made to support the rendering of this opinion are listed but may not be limited to:

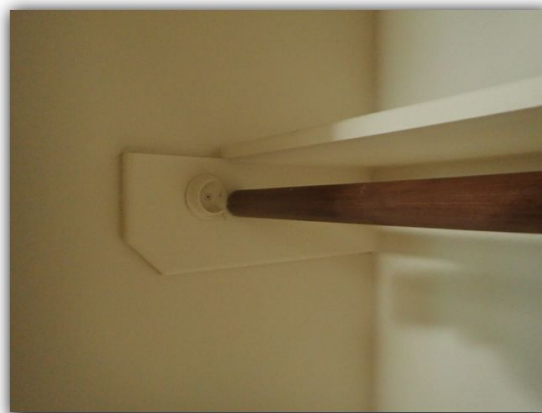
Cabinets & Cabinet Surfaces

- Some of the closets were observed to be unfinished.

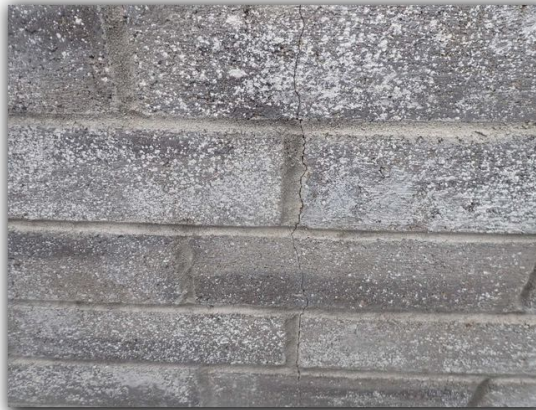
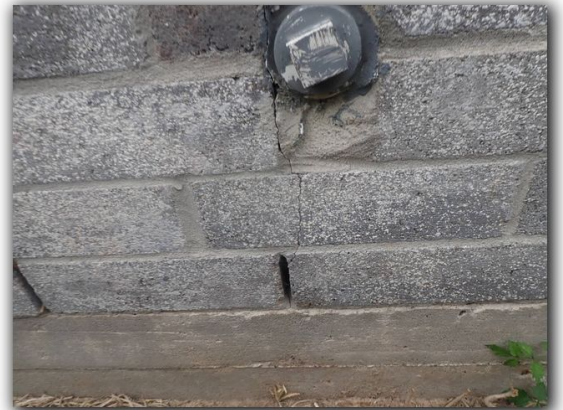
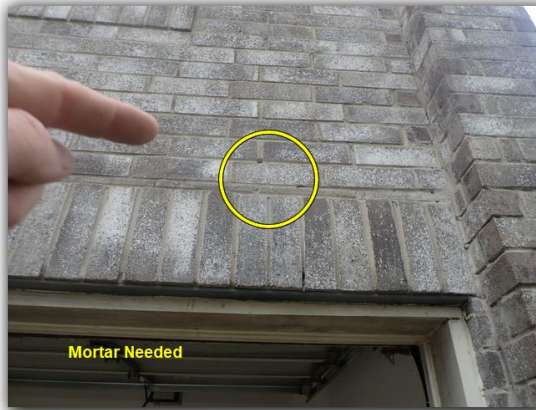
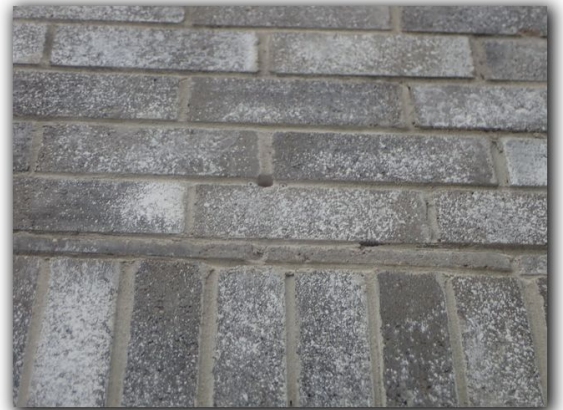
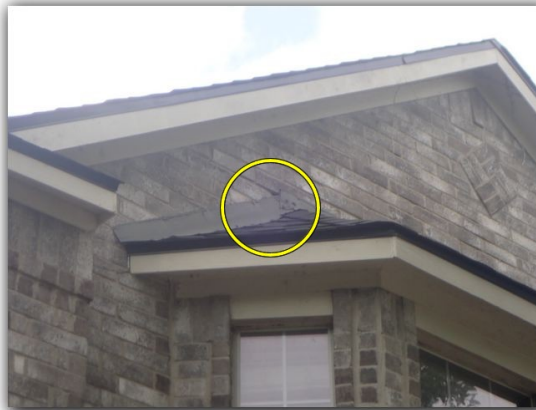
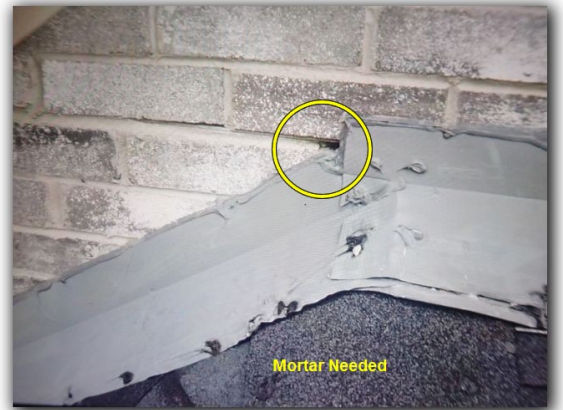
- The garage door trim has some deterioration and/or damage at the bottom.
- I was unable to locate or observe head flashing details above the projected wood trim on the exterior walls. Under current building standards, there should be through-wall flashing continuously above all projected wood trim on the exterior wall veneer to help prevent water intrusion from occurring at these points.

Note: Mortar and/or brick cracks were observed in the exterior veneer of the structure.

Note: Previous repairs to the exterior masonry mortar / grout was observed on the exterior of the structure.

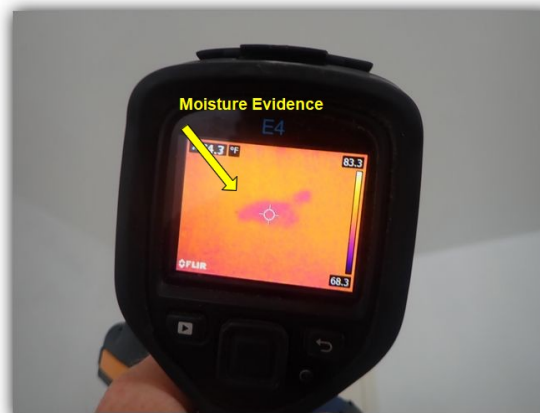
- Ceiling joint cracks were observed in the several locations throughout the house.
- There was an unknown mold like substance observed in the laundry room. Evaluation of this substance is beyond the scope of this inspection. If any concerns exist on the type and/or nature of this substance, we recommend further evaluation by a professional in the Air Quality sampling field.
- Elevated moisture levels were detected in the ceiling finished surfaces in the upstairs living room. The cause and remedy should be further evaluated and corrected as necessary. **Additional Note:** Due to the elevated moisture, other adverse conditions such as mold-like substance growth, wood rot/deterioration and wood destroying insects are possible.

Note: There is evidence of painting and patching to the interior finish and prior interior finish repairs. This condition could limit the Inspectors visual observations and ability to render accurate opinions as to the performance of the structure.

Note: Nail heads were observed to be pushing through the interior finish in one or more locations.

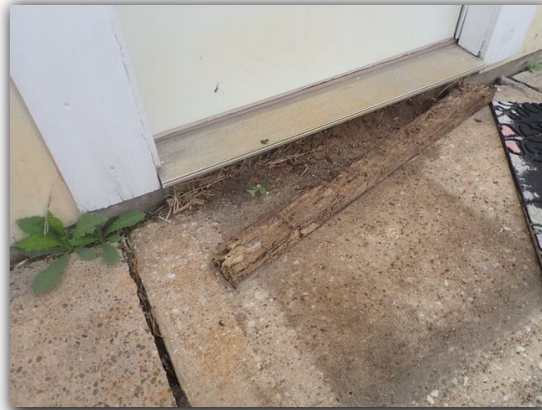
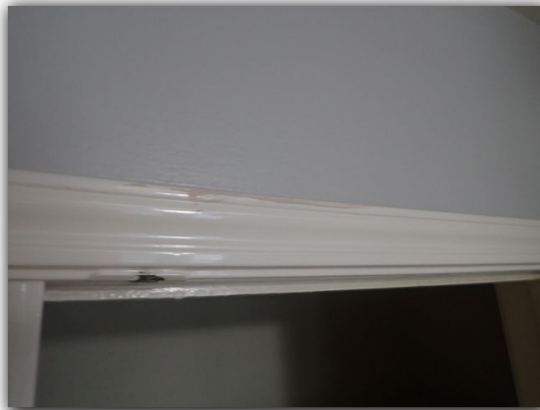
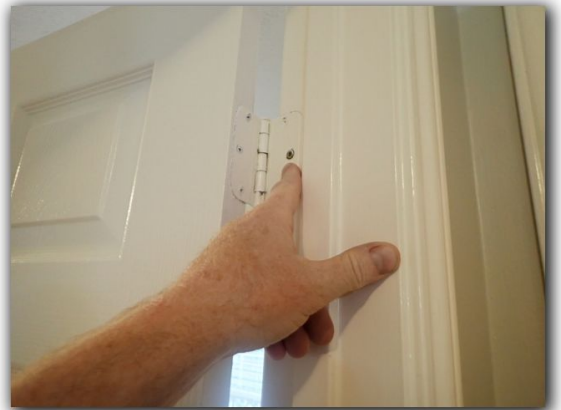
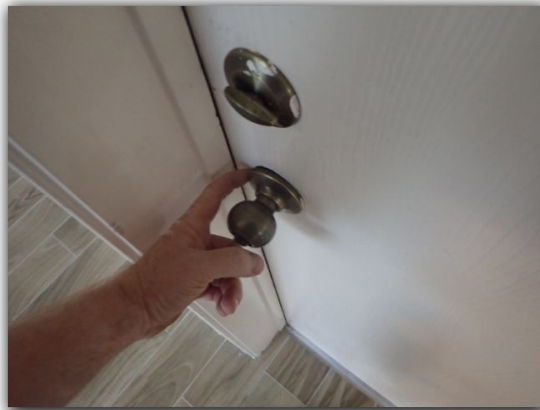
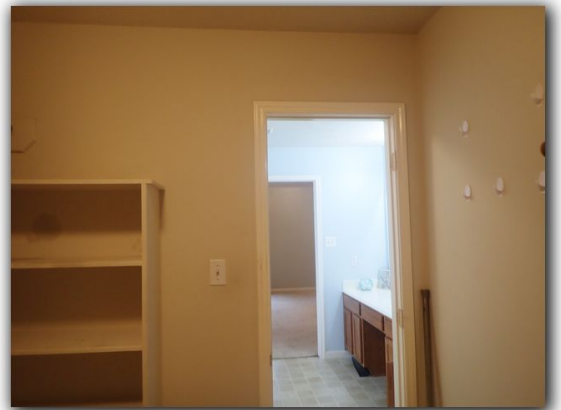
- The door frame is damaged to the several locations throughout the house.
- The door is damaged to the several locations throughout the house.
- The door hardware is loose to the several locations throughout the house.
- The door hardware does not function properly to the primary bedroom.
- The door is missing to the primary bedroom closet.
- The exterior door threshold has deterioration and/or damage to the backyard entry.

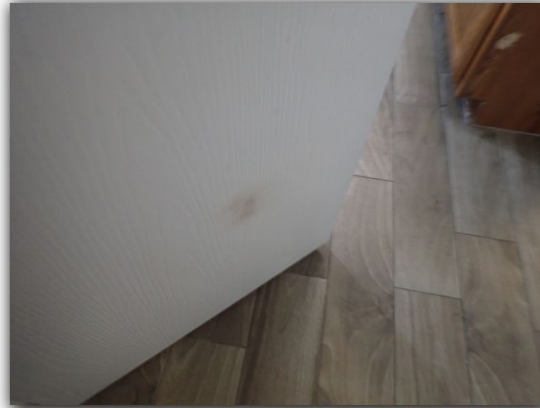
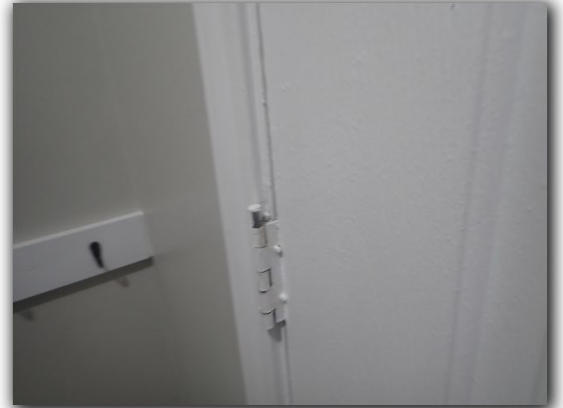
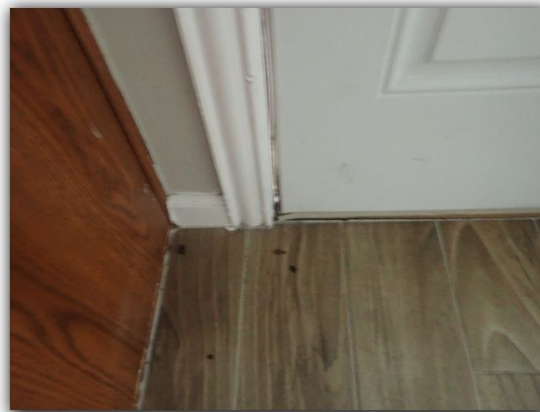
Exterior Doors

- Weather-stripping improvements are recommended for the front entry, backyard entry, garage entry exterior door(s).
- Visible evidence of previous water intrusion was observed at and/or around the exterior backyard entry, front entry door(s). The cause and remedy should be investigated and corrected as necessary.
- The door is damaged to the garage, backyard entry door.
- The door hardware does not function properly to the front entry door.
- The garage entry door is not equipped with a self-closing device.

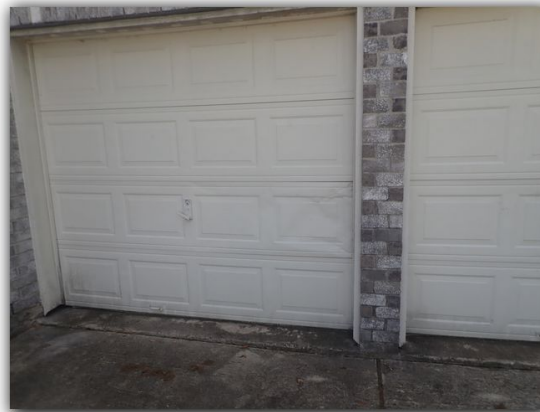
Overhead Garage Door

- Some damage to the overhead garage door was observed.

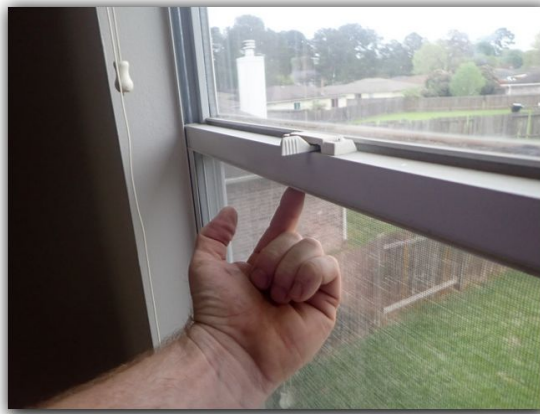
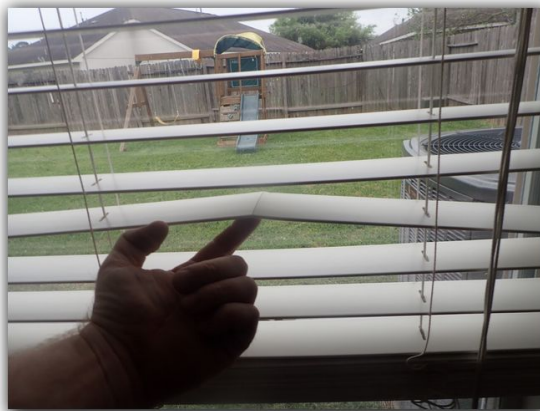
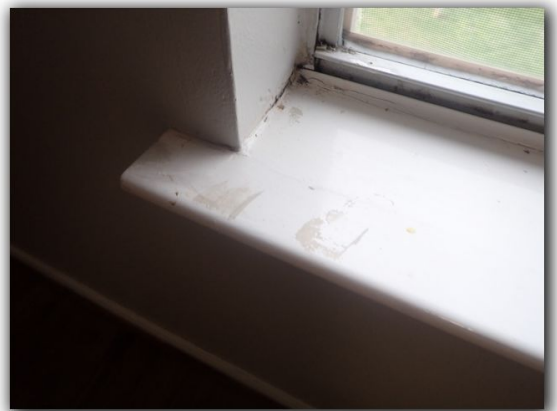
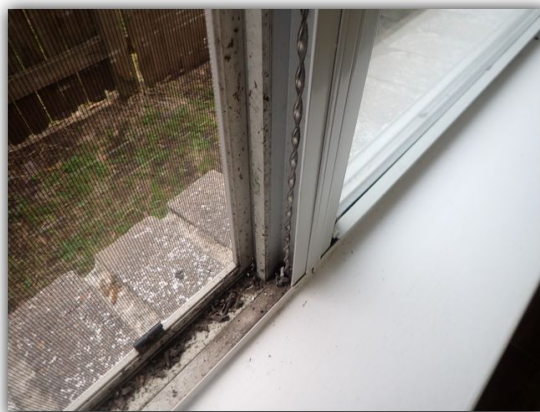
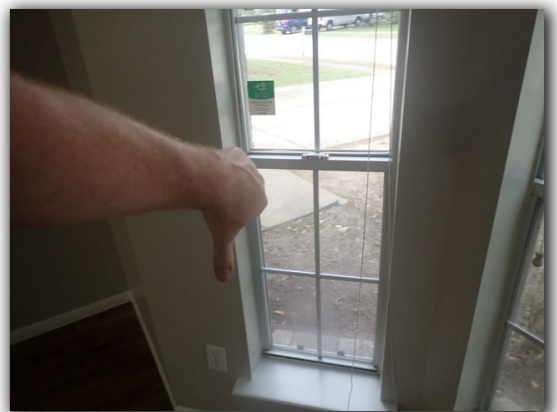
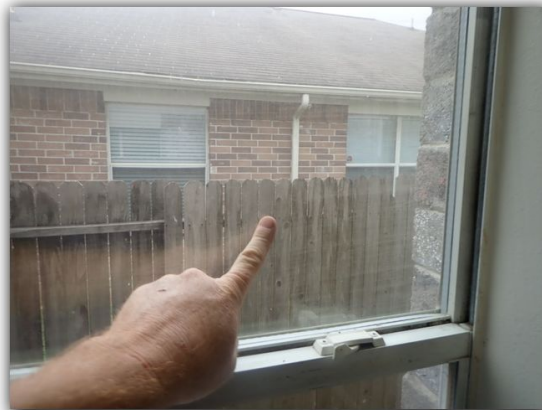
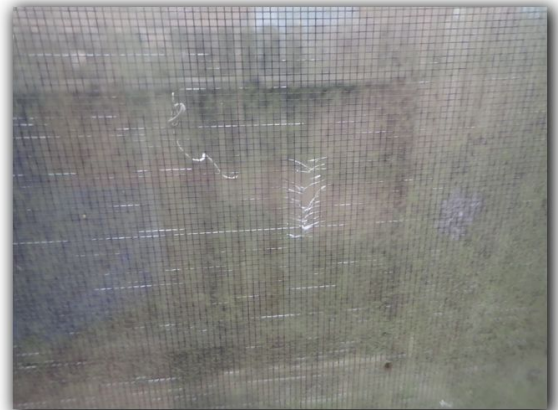
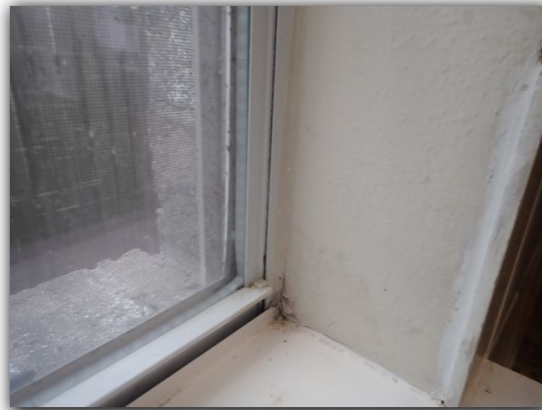
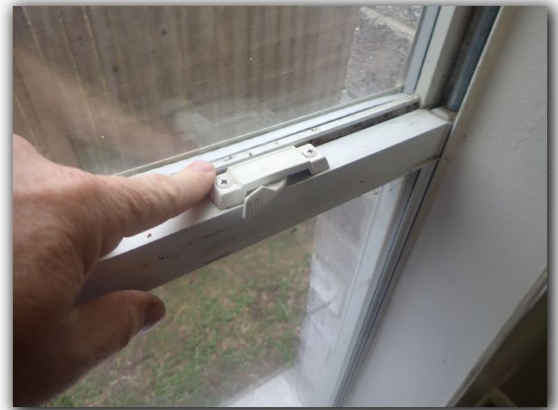
- One or more of the window screens were observed to be damaged.

- The window sill(s) have deterioration and/or damage to the several locations throughout the house.
- Visible evidence of previous water intrusion was observed at and/or around the window(s) in the several locations throughout the house. The cause and remedy should be investigated and corrected as necessary.

- The window lock(s) are not latching properly in the several locations throughout the house.
- The window frame is damaged in the rear corner bedroom.
- The window sash guide is damaged in the several locations throughout the house.

- The window guide is damaged and the window will not stay in the open position in the several locations throughout the house.
- One or more of the thermal pane windows were observed to have lost their seals. This has resulted in condensation or a fog like film to develop between the panes of glass. The thermal pane windows no longer function as designed when they lose their seal and replacement may be necessary. The windows that have noticeably lost their seals are listed but may not be limited to the following:
dining room.

- One or more of the windows are stiff and hard to operate in the several locations throughout the house.
- One or more of the window blinds were observed to be damaged/or not operating properly in the several locations throughout the house.

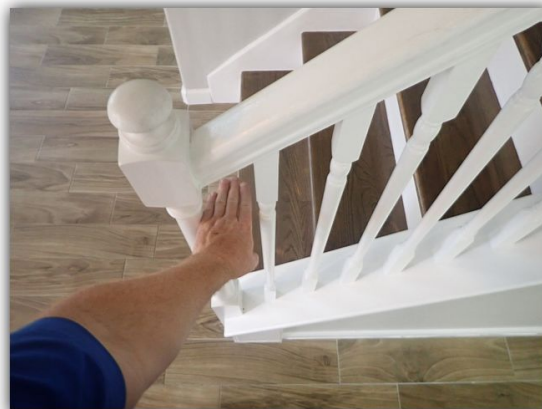
- The stairway guard balusters and/or spindles are installed too far apart under current building standards. This may be an “as-built” condition but per TREC standards of practice we are required to report this condition as a deficiency. You may consider corrective measures for improved safety.\

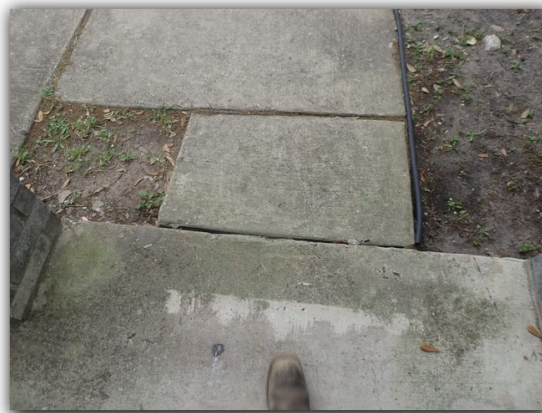
Sidewalk(s)

- The sidewalk has settled somewhat. If this condition persists or if the sidewalk becomes a trip hazard, improvements should be made.

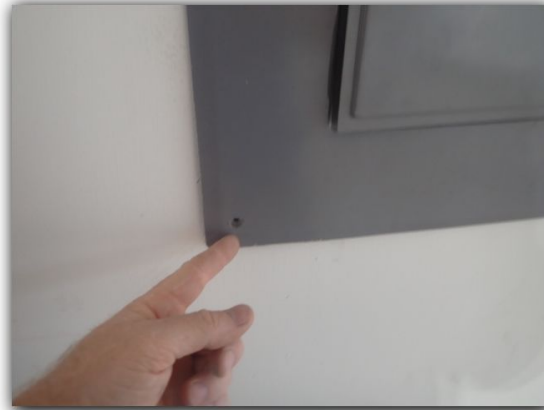
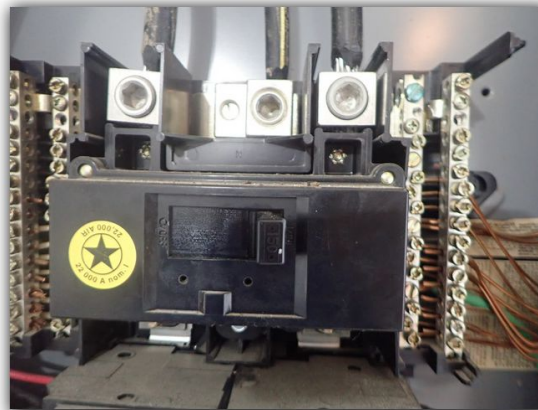
- The manufacturers listing plate on the outside condenser/coil list that the maximum over current device (breaker) to be used should not exceed 50-amp. There is a 60-amp breaker in place at this time. This breaker in place does not meet the manufacturers listing plate requirements.
- A buzzing/arcing noise was heard at the panel box. This could be due to overheating, loose breakers or improper connections. This condition should be evaluated by a licensed electrician and repaired to prevent future damage to the structure.

Note: The ground electrode rod is bent and poses a safety risk in the west yard.

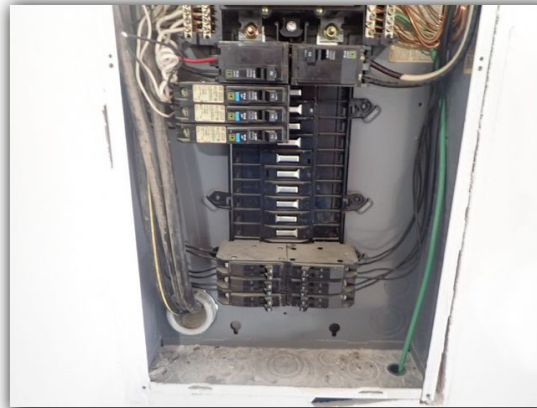
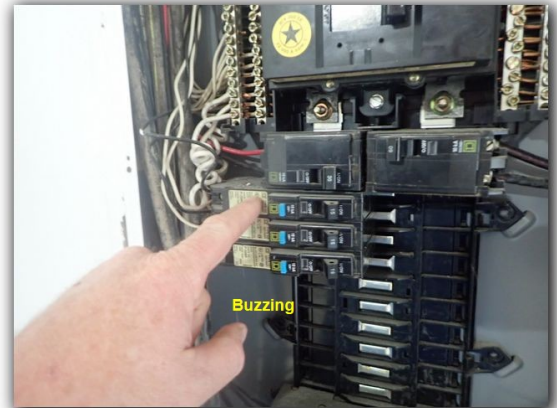
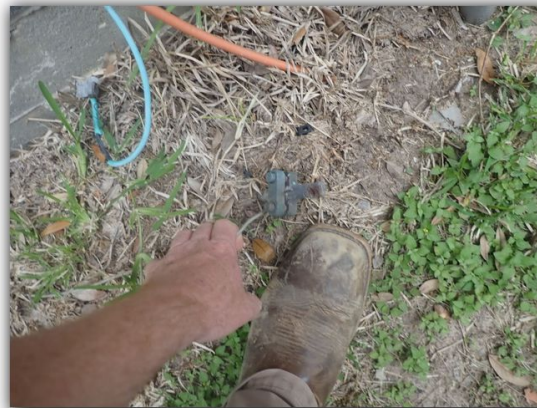
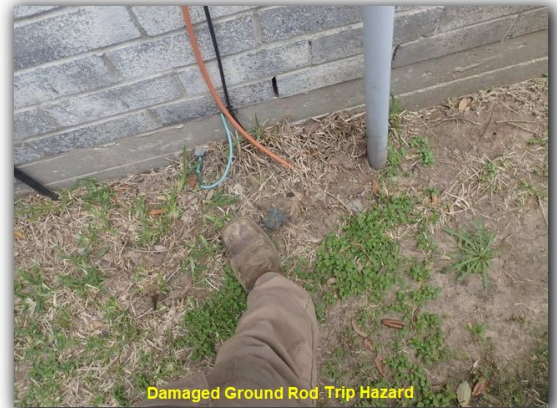
- Not all of the required dwelling unit devices, receptacle and lighting outlets (switches, receptacles and fixtures) are connected to an arc-fault circuit-interrupter (AFCI) circuit device. AFCI devices were first required under the 1999 National Electrical Code and under the 2014 NEC, all living space, kitchen and laundry room devices, receptacle and lighting outlets (switches, receptacles and fixtures) should be connected to an arc-fault circuit interrupter (AFCI) device.

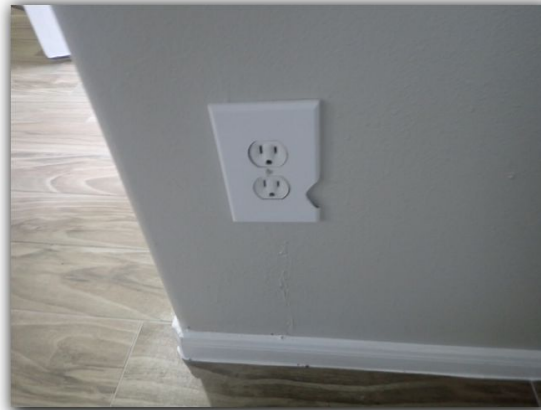
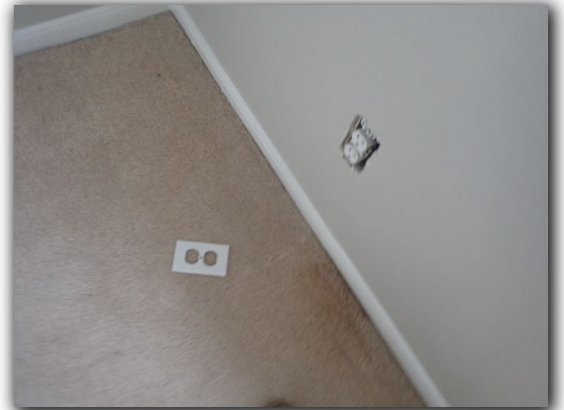
Arc-Fault Circuit Interrupter Protection (AFCI)

- Not all of the required dwelling unit devices, receptacle and lighting outlets (switches, receptacles and fixtures) are connected to an arc-fault circuit-interrupter (AFCI) circuit device. AFCI devices were first required under the 1999 National Electrical Code and under the 2014 NEC, all living space, kitchen and laundry room devices, receptacle and lighting outlets (switches, receptacles and fixtures) should be connected to an arc-fault circuit interrupter (AFCI) device.

- The switch/ or cover plate is damaged in the several locations throughout the house.

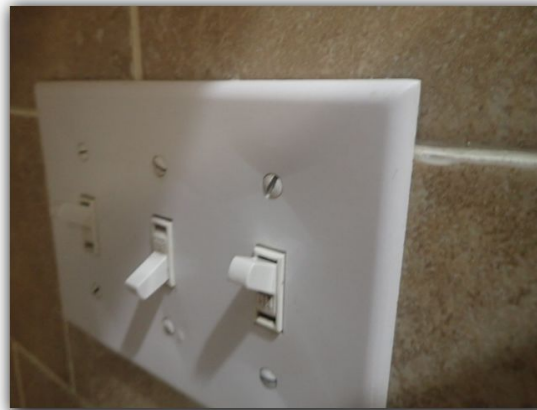
Fixtures

- One or more of the light fixtures are inoperative in the several locations throughout the house. This may be due to a bad bulb or some other unknown condition. This condition should be further evaluated and corrected as necessary.

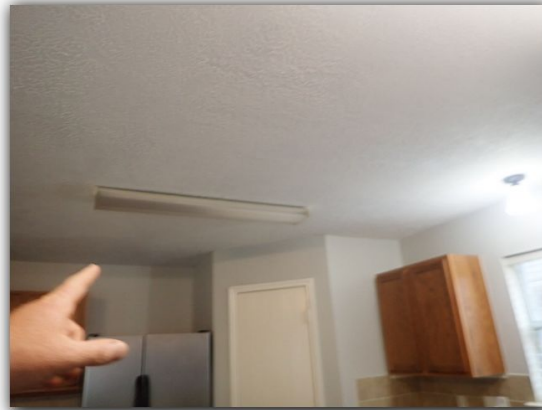
Smoke Alarms

- One or more of the smoke alarms are missing in the several locations throughout the house.

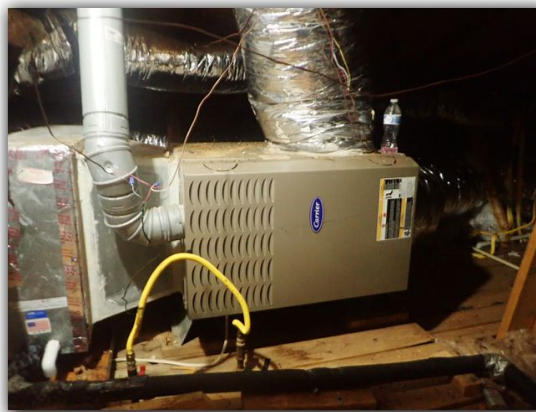
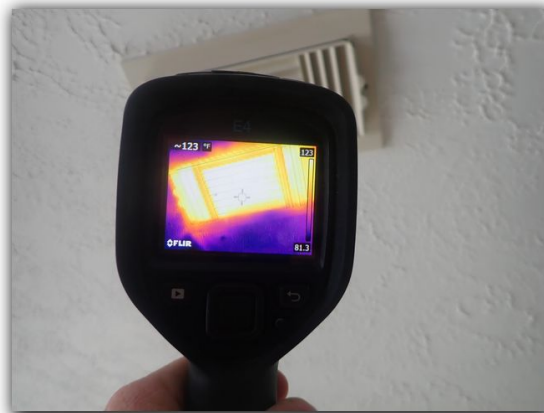
- The heating unit flue (vent pipe) has inadequate clearance from combustibles materials. Double walled vent pipes should have at least 1-inch of clearance and single walled vent pipes should have at least 6-inches of clearance from combustible material.

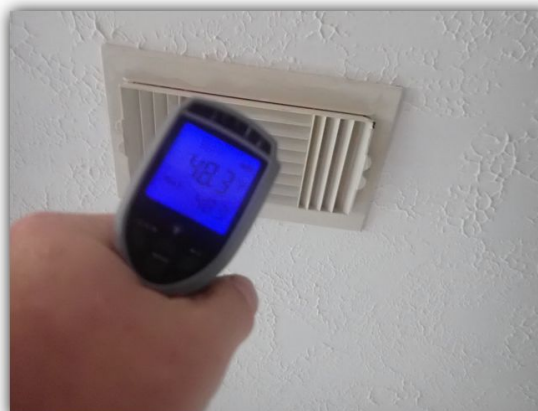
- The dirty air filter should be replaced.
- Damaged, deteriorated and/or missing insulation on the refrigerant lines should be repaired or replaced at the outside condenser.

- The auxiliary/secondary drain pan under the coil housing is rusted and should be replaced.
- The manufacturers listing plate on the outside condenser/coil list that the maximum over current device (breaker) to be used should not exceed 50-amp. There is a 60-amp breaker in place at this time. This breaker in place does not meet the manufacturers listing plate requirements.

- The electrical wire conduit has pulled loose at the outside condenser housing and/or service disconnect.
- The outside condenser show signs of rust and/or deterioration. This condition should be further evaluated and corrected as necessary.

- The service disconnect interior box is loose at the wall. This should be corrected for reasons of safety.
- The inspector identified rust stains on the exterior wall due to **previous** water leaking from the secondary drain line in the attic space.

Note: Previous water leakage was observed from around the base of the indoor coil housing. This condition should be closely monitored and corrected if necessary.

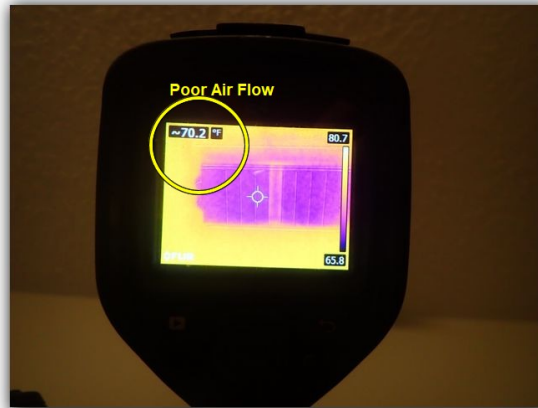
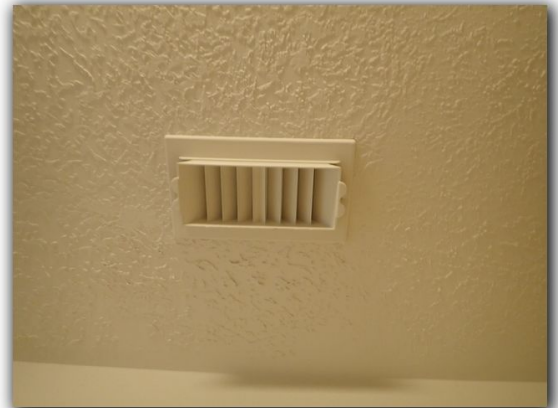
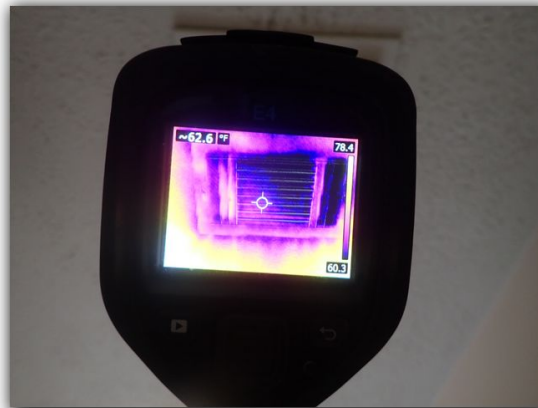
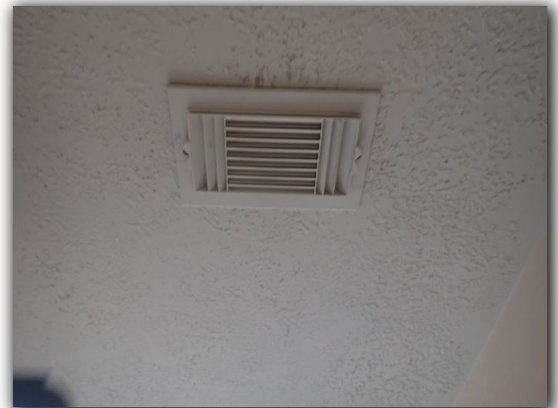
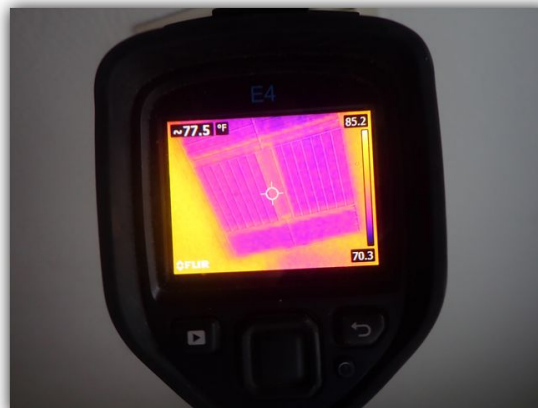
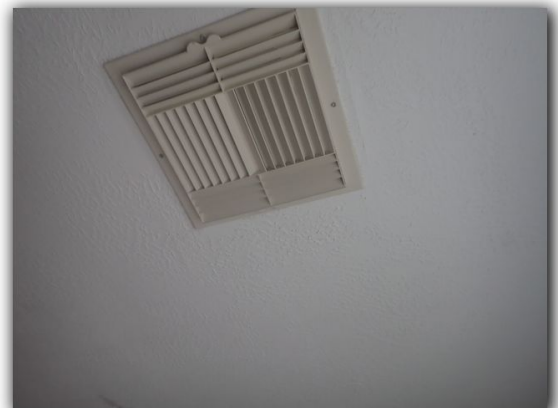
- The duct work in the attic area is not properly suspended and separated to help prevent condensation from developing. It is recommended to separate and suspend the duct work with supports in minimum intervals of 4-feet that have a minimum width of 1.5-inches.
- There is visible dust and/or mildew on some of the air registers. The cause and remedy should be further evaluated. It is recommended to have the air registers and duct system cleaned for air quality purposes.
- The air register is loose at the ceiling in the several locations throughout the house.
- The air register has poor air flow in the several locations throughout the house.

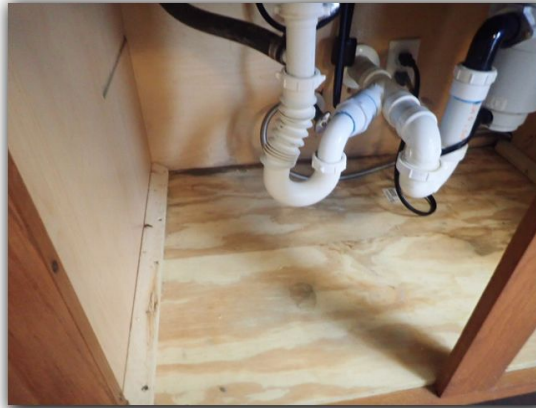
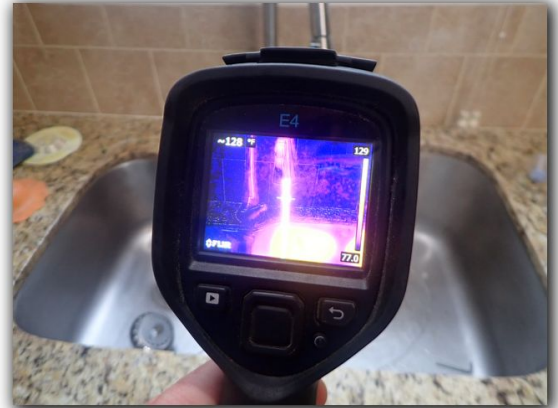
Primary Bathroom

- The sink has some surface damage.

- The faucet assembly is loose.
- Cracked, deteriorated and/or missing grout and/or caulking should be repaired or replaced as necessary.
- The faucet assembly is not sealed at the wall. This condition has the potential to allow water to leak back into the wall cavity.
- The shelf in the cabinet under the sink is damaged.
- Cracked, deteriorated and/or missing grout and/or caulking should be repaired or replaced as necessary.
- The shower spout is leaking at the neck connection.

The buyer should have the plumbing system checked by a Qualified Licensed Plumber. The observations made to support the rendering of this opinion are listed but not limited to the following:

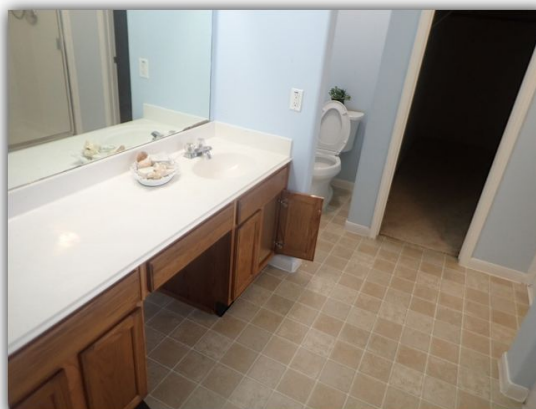
Commode / Toilet

- Debris was observed in the commode. This should be removed before operating.

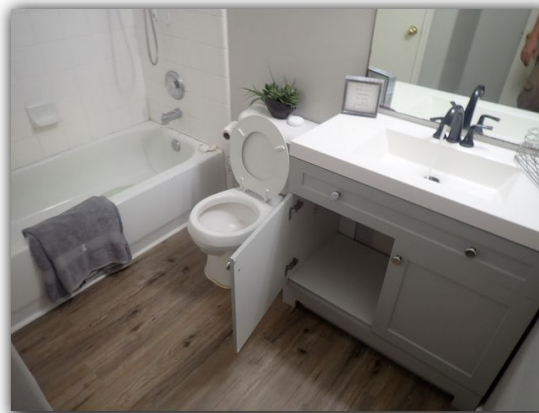
- The commode is loose at the floor mount.
- The commode leaks water onto the floor. The cause and remedy should be further evaluated and corrected as necessary.

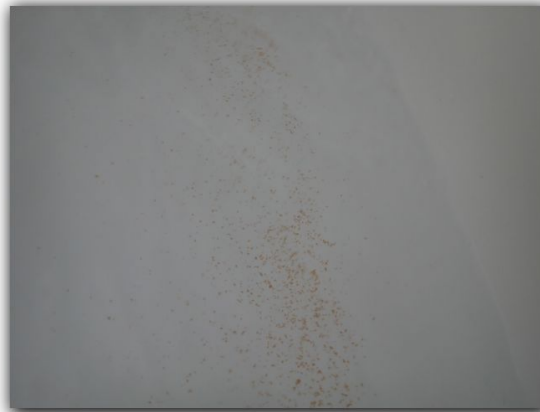
- There is debris at the water fixtures when the hot water is operated. This condition should be further evaluated and corrected as necessary.
- Some corrosion was observed at the water supply connections at the top of the water heater.
- The roof level flue storm collar should be properly sealed to help prevent water intrusion into the structure.

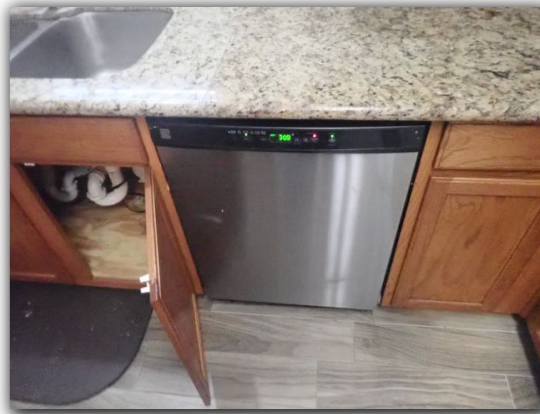
- The dishwasher is loose at the cabinetry and should be better secured.
- Some damage to the dishwasher door or door facing was observed.

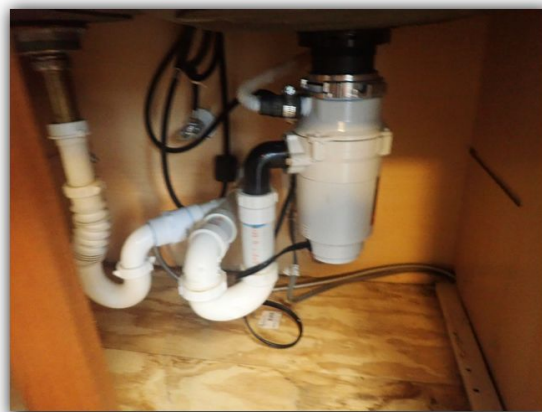
B. Food Waste Disposers

- The food waste disposer was noisy at the time of the inspection.

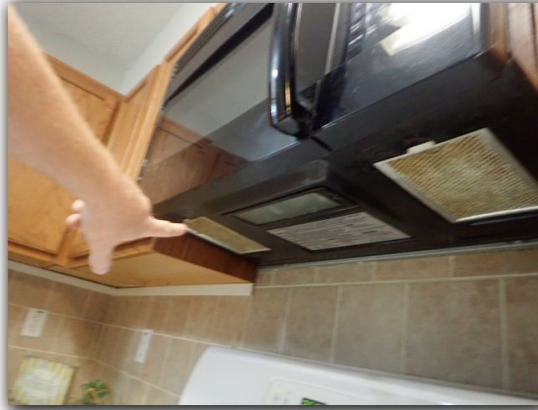
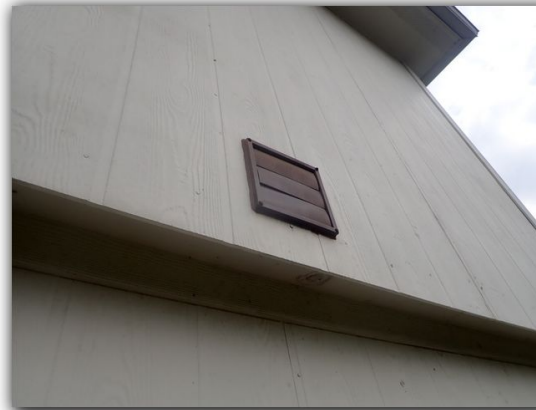
- The range exhaust vent is terminating into the cabinet area. Range exhaust vents should vent to the exterior of the house.
- The exterior termination cover was observed to be not operating properly.

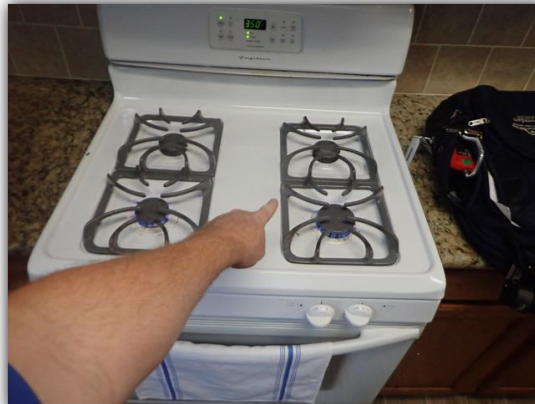
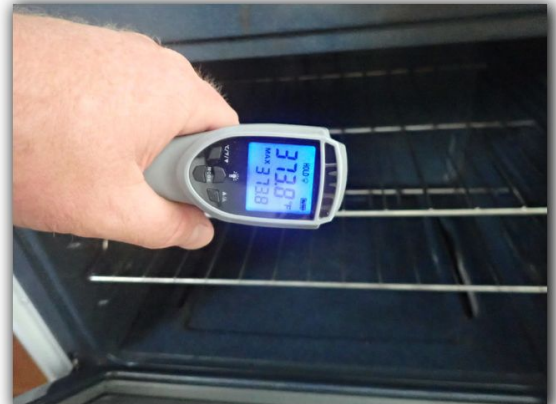
- The range can be easily tipped over and should be equipped with an anti-tip device, for safety.
- The ignition device is not functioning properly at the time of this inspection. One or more of the cooktop burners would not light by the pilot and should be further evaluated.

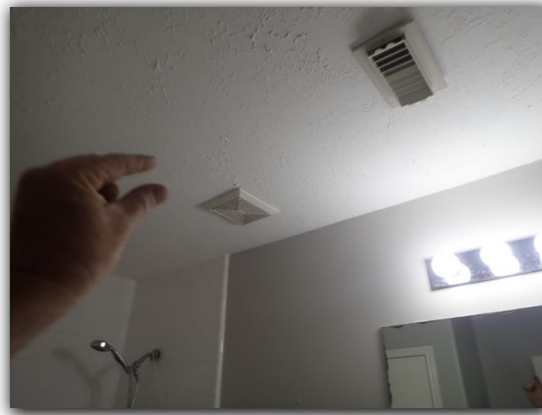
F. Mechanical Exhaust Vents and Bathroom Heaters

- The mechanical exhaust vent fan was noisy in the hall bathroom.

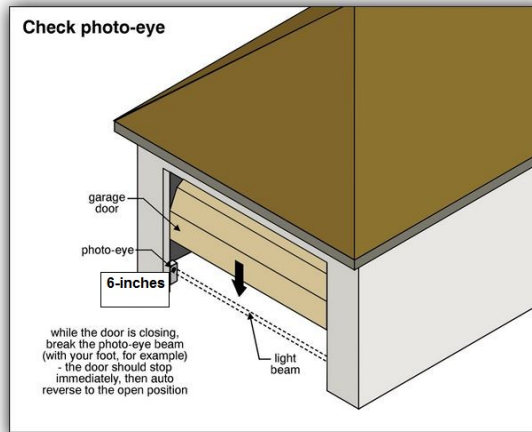
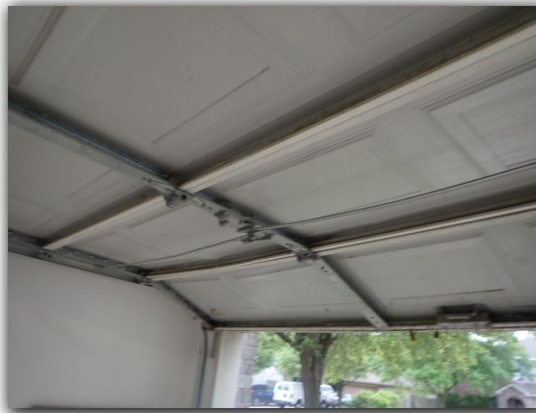
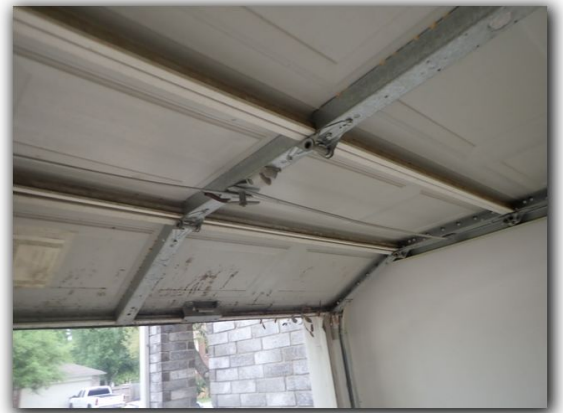
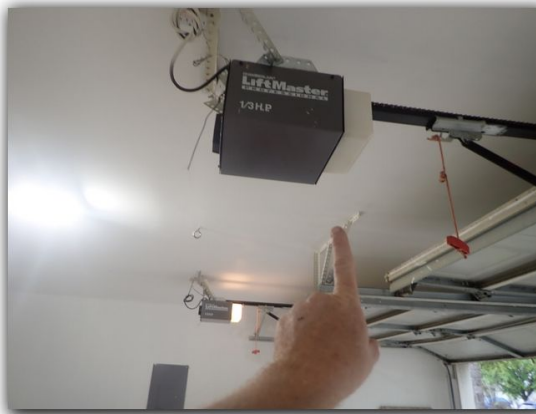
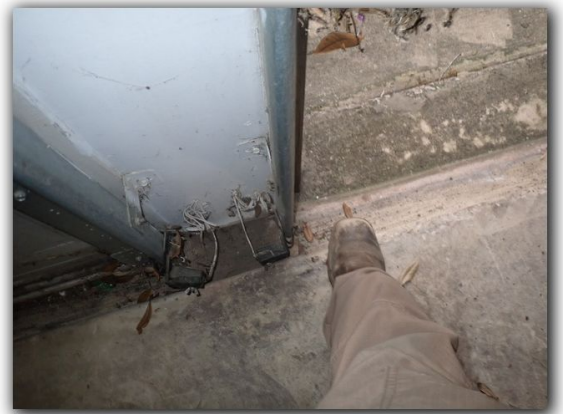
G. Garage Door Operators

- When an automatic garage door opener is in use, the manual lock should be disabled or removed.
- The garage door opener was noisy when operated. The cause and remedy should be further evaluated and corrected as necessary.
- The garage door light was inoperative at the time of inspection.
- The garage door reverse sensors are not properly installed. The garage door reverse sensors should be installed within 6-inches of the garage floor.

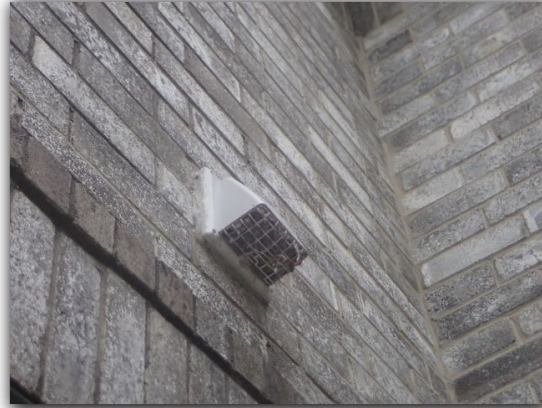
- The dryer exhaust duct (vent pipe) is dirty and needs to be cleaned.
- The dryer duct termination was observed to be screened. Screening the termination is not permitted under current installation standards. **Note:** Screening the dryer termination will cause the dryer duct to clog and will not allow the dryer to operate efficiently.

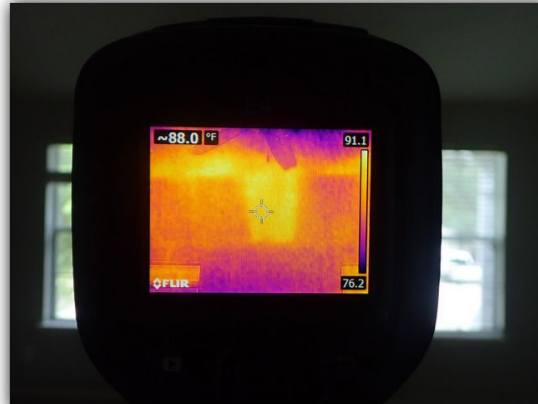
- Missing/or out of place insulation was observed in the primary bedroom.

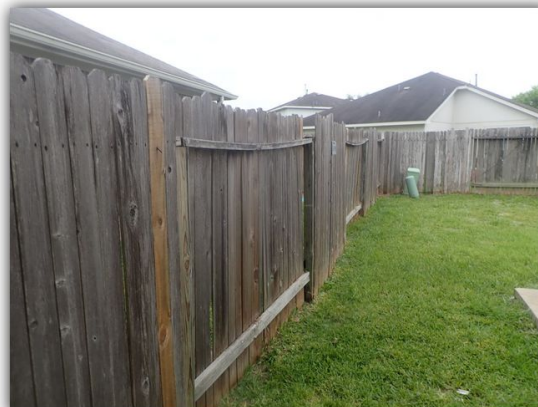
B. Fences

- The overall condition of the fence material, railing and posts are in poor condition and repair or replacement is recommended.
- One or more of the fence boards are damaged / deteriorated and repairs are recommended.
- The gate for the fence does not function properly and repairs are recommended.
- One or more of the posts are damaged and the fence panels are leaning.
- Termite damage was observed on several of the fence components.

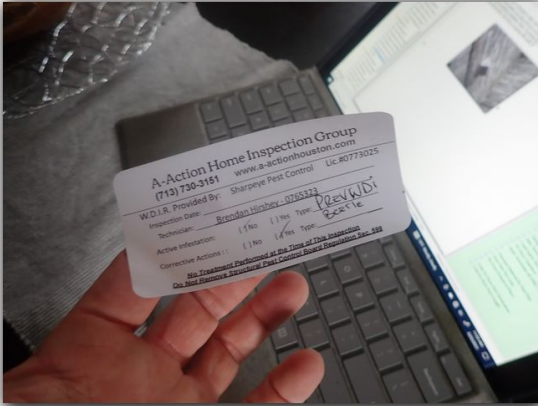
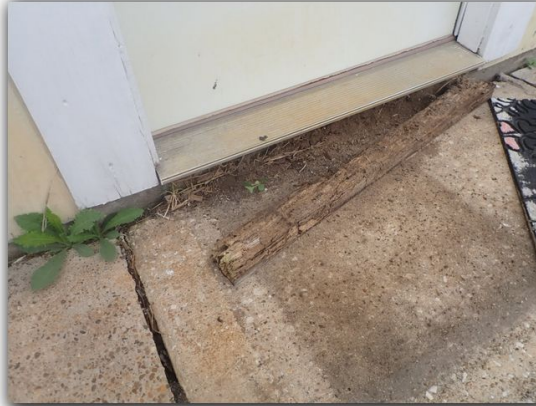
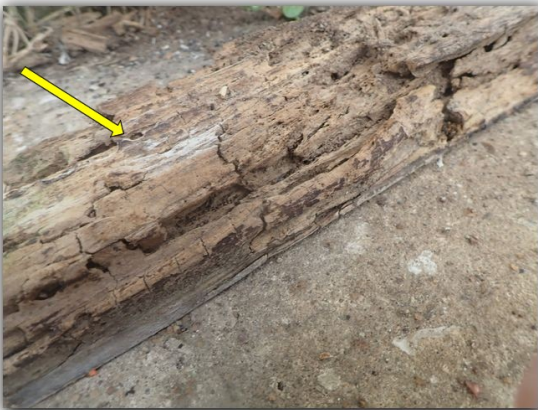
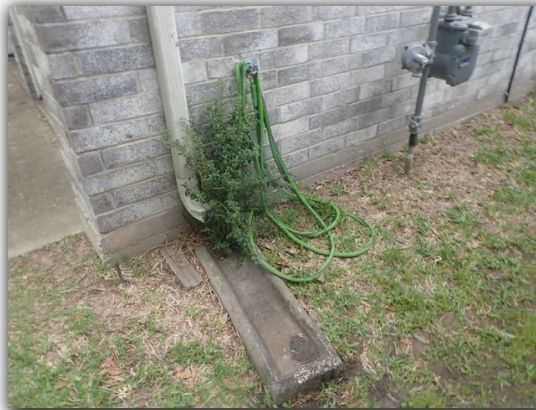
The digital pictures within this report are a representative sample of active/previous wood destroying insects, locations of active/previous infestations, inaccessible areas, conducive conditions, deficiencies or damages in place and should not be considered to show all. There will be active/previous wood destroying insects, locations of active/previous infestations, inaccessible areas, conducive conditions, deficiencies or damages not represented with digital imaging.
