Moisture Inspection Report

Inspected for
Adam Garst
2135 Quenby St
Houston, TX 77005
1/2/2026

Property Address: 2135 Quenby St , Houston TX 77005			
Property Information		Inspection Information	
Client's Name	Adam Garst	Inspection Type	Invasive Moisture Inspection
Client's Phone	281-610-1296	Date of Inspection	1/2/2026
Client's Email	garstadam@gmail.com	Inspector	Tony Trinidad EDI #TX-192
Type of Exterior	Hard Coat Stucco	Present at Inspection	Buyer(s), Buyer's realtor(s), Home Inspector
Substrate (if known)	Wood	Temperature	70-80 degrees
Property Age	46	Weather Conditions	Clear, Dry
Square Footage	4079	Last Known Rainfall	2-5 days
Stories	3		
Type of Windows	Metal

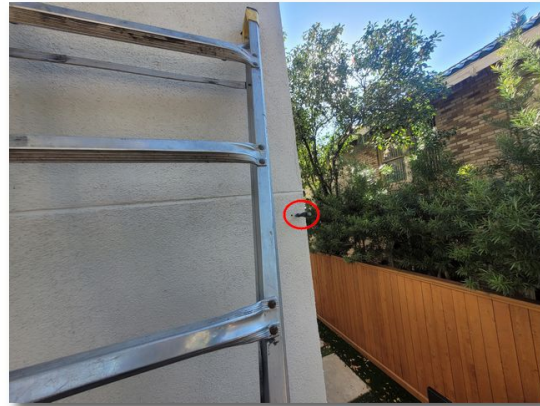
Soft or Missing Substrate - Refer to the *Moisture Testing page for the condition of the substrate at each test location*. If the substrate is not firm when inserting the moisture meter probes, this can indicate possible wood rot / damage due to previous or active water penetrations in the area near the probed location.

1- 1.2 Test Location J - Soft substrate encountered

Repair Process: It is recommended that these areas be further assessed and repaired by a qualified stucco contractor, as needed. Core sampling or inspection holes should be performed by your contractor to confirm any suspected substrate and / or framing damage found by the inspector. Test locations are not representative of the total area of suspected damage, but provide information on general areas where repairs may be needed. Typical repairs to remedy soft or missing substrate include doing a partial tear-off of the stucco around the location until clean dry substrate is found and repairing as needed. During repairs, the total area any underlying damage should be determined by your contractor. It is important to thoroughly review and understand the scope of work in the repair proposal provided by your contractor. In addition, it is recommended to discuss the potential for "Change Orders" that may occur once work begins.

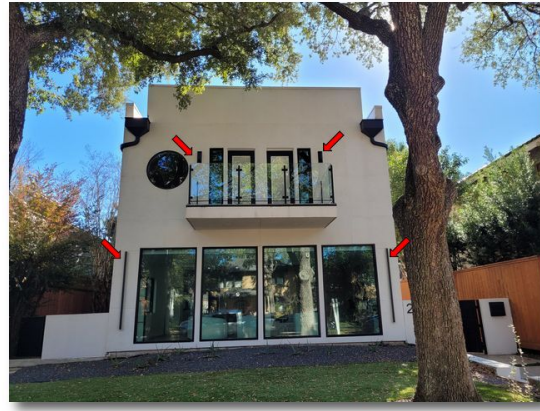
1- 2.4

1 - 2: Damaged / Aged / Missing Sealant: Damaged, aged, and / or missing sealant was found at wall penetrations, joints, windows, and / or other voids on the exterior. Properly installed sealant provides a barrier against moisture intrusion. Recommend repairs using a top quality, low modulus, polyurethane sealant or sealant recommended by the manufacturer of your system.

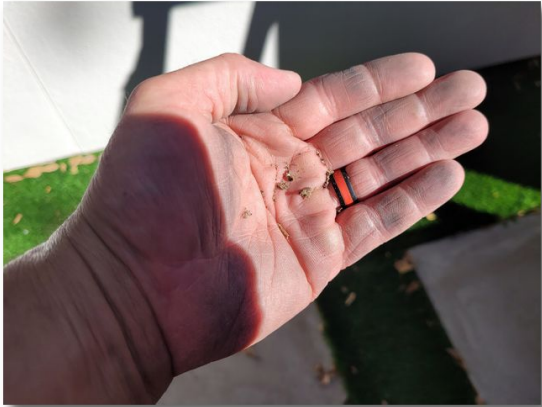
2 - 6: Damaged Substrate at Bottom of Wall: Damaged substrate was observed at the bottom of the wall by physically touching the substrate from behind the weep screed. It is recommended that these areas be further assessed and repaired by a qualified stucco contractor, as needed.

2- 6.1 Damaged substrate from behind the casing bead.

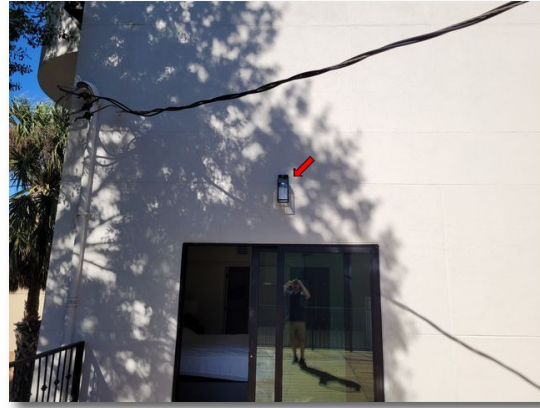
3- 1.2

3 - 1: Damaged / Aged / Missing Sealant: Damaged, aged, and / or missing sealant was found at wall penetrations, joints, windows, and / or other voids on the exterior. Properly installed sealant provides a barrier against moisture intrusion. Recommend repairs using a top quality, low modulus, polyurethane sealant or sealant recommended by the manufacturer of your system.

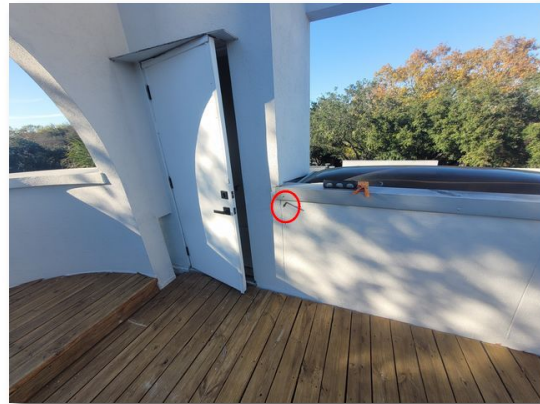
6 - 1: Moisture Intrusion: Areas of elevated moisture and / or possible substrate / framing damage was found at the following locations as reported on the "Moisture Testing" page:

Soft or Missing Substrate - Refer to the *Moisture Testing* page for the condition of the substrate at each test location. If the substrate is not firm when inserting the moisture meter probes, this can indicate possible wood rot / damage due to previous or active water penetrations in the area near the probed location.

6- 1.2 Test Location H - Soft substrate encountered

Repair Process: It is recommended that these areas be further assessed and repaired by a qualified stucco contractor, as needed. Core sampling or inspection holes should be performed by your contractor to confirm any suspected substrate and / or framing damage found by the inspector. Test locations are not representative of the total area of suspected damage, but provide information on general areas where repairs may be needed. Typical repairs to remedy soft or missing substrate include doing a partial tear-off of the stucco around the location until clean dry substrate is found and repairing as needed. During repairs, the total area any underlying damage should be determined by your contractor. It is important to thoroughly review and understand the scope of work in the repair proposal provided by your contractor. In addition, it is recommended to discuss the potential for "Change Orders" that may occur once work begins.

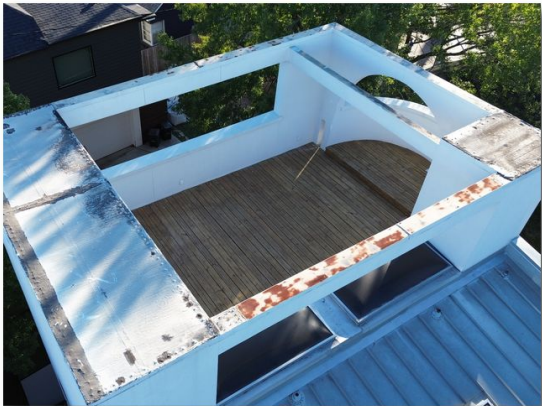
G - 4: Damaged / Aged / Missing Sealant: Damaged, aged, and / or missing sealant was found at wall penetrations, joints, windows, and / or other voids on the exterior. Properly installed sealant provides a barrier against moisture intrusion. Recommend repairs using a top quality, low modulus, polyurethane sealant or sealant recommended by the manufacturer of your system.

G- 4.1 Seal cap flashing around roof line
