# Inspection Report

**Property Address:**  
5623 Dumfries Drive  
Houston TX 77096

**Sandstone Inspections**

# PROPERTY INSPECTION REPORT FORM

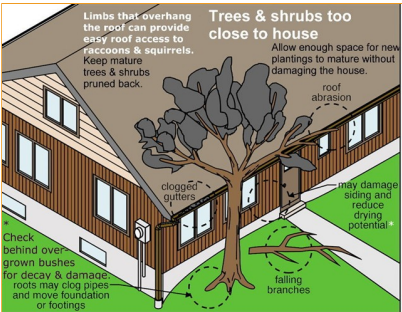
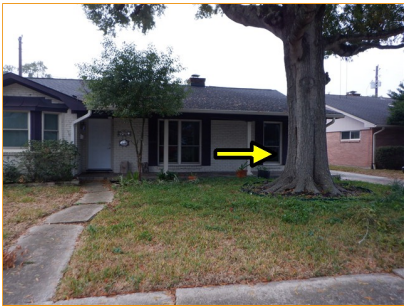
Observed large tree(s) near house foundation. This condition can have adverse conditions on foundation performance. It is recommended to install a root barrier or other preventive measure, and watering the tree away from the house periodically.

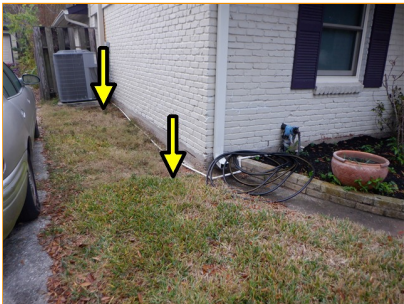
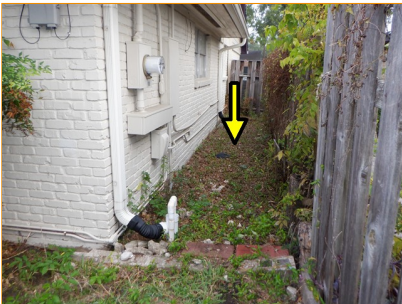
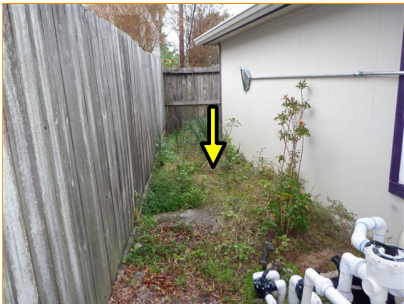
Soil grade and drainage patterns around some areas of the house and the garage do not appear to properly direct water away from the foundation to aid in controlling run off water. Water may pond/accumulate against the foundation. This condition may cause differential movement of the foundation and/or water penetration during heavy rains. Recommend filling in yard with soil to reach a grade slope away from the foundation of at least one inch per foot, and/or creating a drainage swale to help divert water away from the foundation.

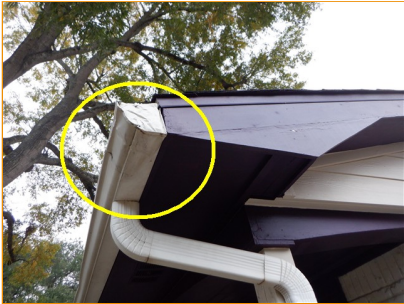
Damaged/leaking rain gutter observed at the front right side of the house.

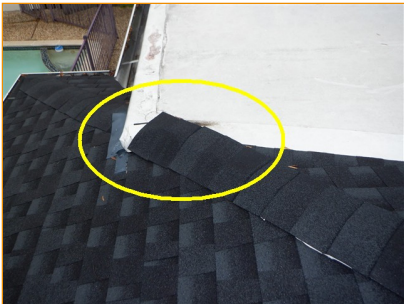
Questionable terminations/joints between two different roofing materials observed at south side of the house. The roof shingle was not properly cut and sealed.

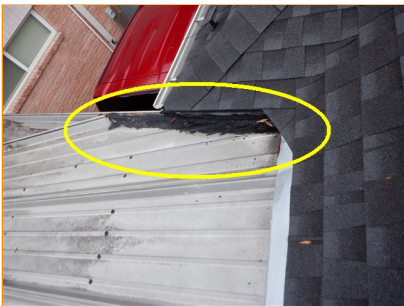
Observed previous tar repairs at carport. This type of repair is not permanent as tar dries and cracks allowing water penetration. Recommend a permanent repair by a qualified roofing contractor.

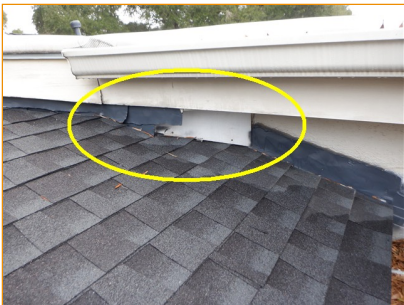
Deficient flashing detail observed at south side of the house (pool side).

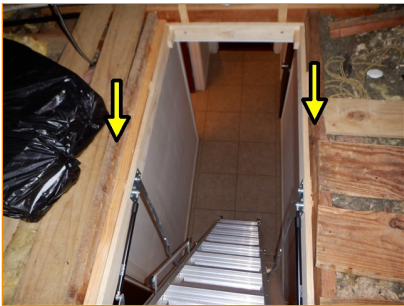
Observed ceiling joists on both sides of attic stairway are not doubled to compensate for cut / removed ceiling joist to allow installation of stairway. While specific double-wood framing is not explicitly mandated in the general Texas Building Code for every attic access, it is a standard and necessary practice when a ceiling joist is cut. Recommend consulting the builder/seller about this condition and repair as/if needed.

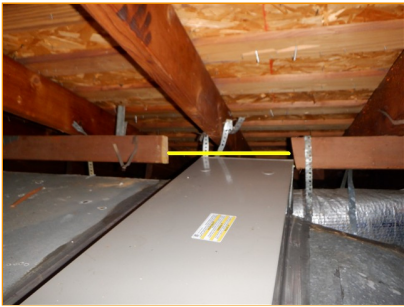
Observed roof support member has been cut/modified probably to accommodate new HVAC equipment. Recommend evaluation by a structural engineer.

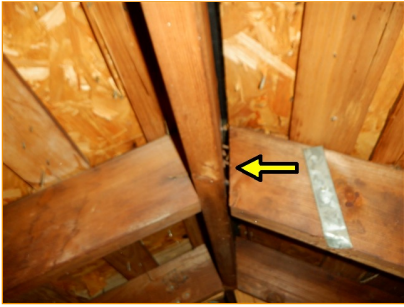
Roof support members (roof rafters) are pulled away/do not fit snugly against the ridge board at one or more locations.

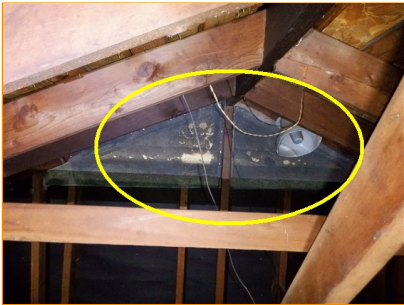
Observed air flow at the gable vents is blocked by debris, recommend cleaning.

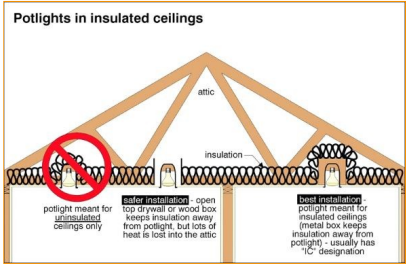
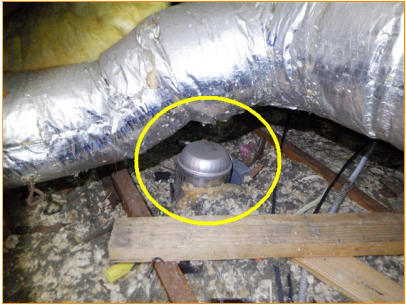
Observed insulation around ceiling light fixture not IC-rated. Only IC-rated recessed lights should be installed because they are airtight and can be covered with insulation. Ensure insulation is maintained a minimum of 3 inches and leave a minimum of 1 inch from around all recessed lights to reduce possible fire hazard.

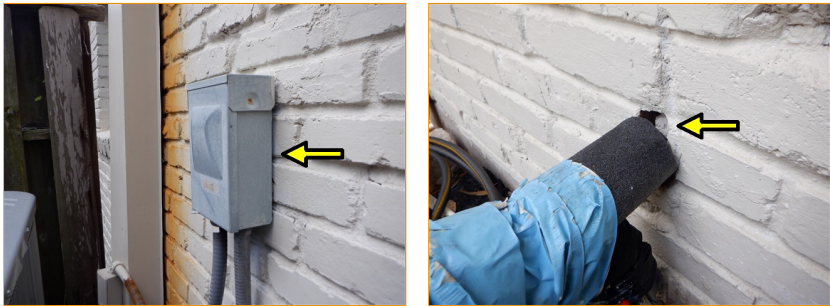
bottom open) to prevent water entry. including but not limited to light fixtures, electrical outlets/disconnects, service panels, dryer, bath vents, etc.

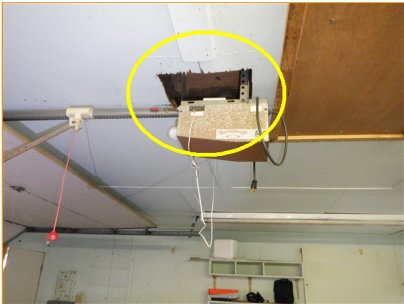
A hole in ceiling plywood was observed in the garage.

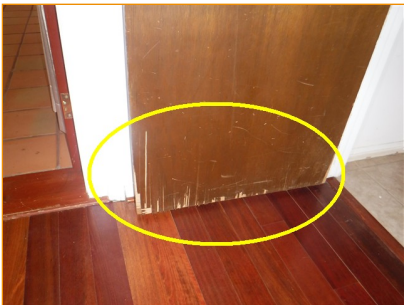
Wood damage observed at bottom of the primary bedroom door.

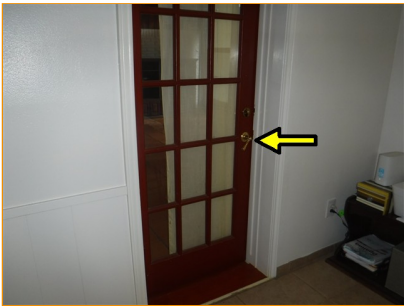
The door from the breakfast nook to the room addition does not latch.

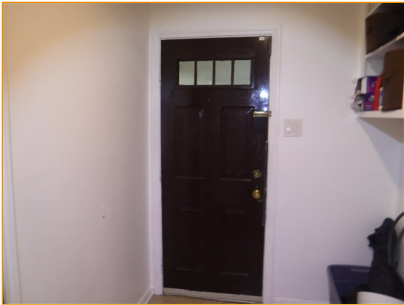
The backyard door from the laundry room is not plumb; door does not close properly.

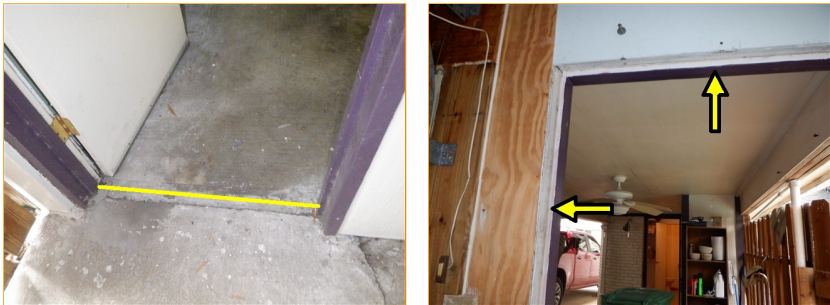
The garage pedestrian door is missing the threshold and weather stripping around the door frame.

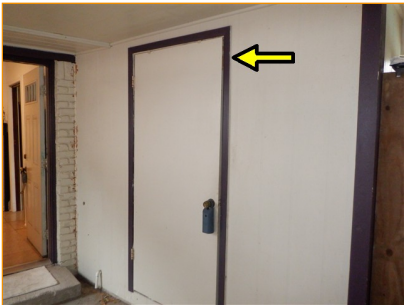
The backyard area storage room door sticks against the frame when closed.

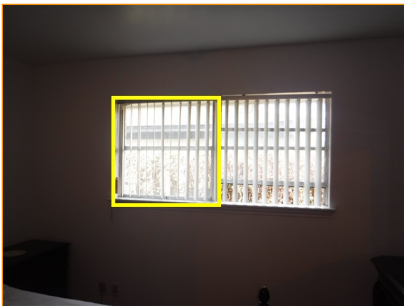
The primary bedroom left side window does not slide up open when normal force is applied.

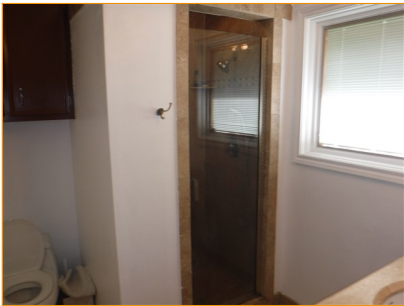
No markings observed on glass pane(s) of window at primary bathroom shower to indicate the presence of required tempered / safety glass. Per CODE IRC 308.4.5 enclosures for, or walls facing hot tubs, whirlpools, saunas, steam rooms, bathtubs and showers where the bottom edge is less than 60" above any standing or walking surfaces must be safety glass. Each pane of glazing should be identified with the applicable safety glazing standard with acid etched, sandblasted, ceramic-fired, laser etched, embossed, or be of a type which once applied cannot be removed without being destroyed. Recommend consulting

seller or a window specialist. If it cannot be proven to be tempered glass, replacement should be considered.

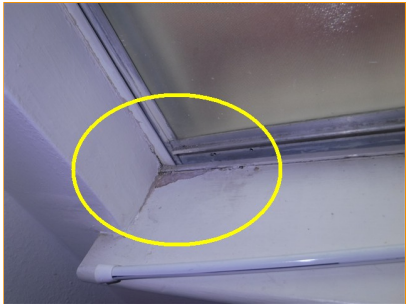
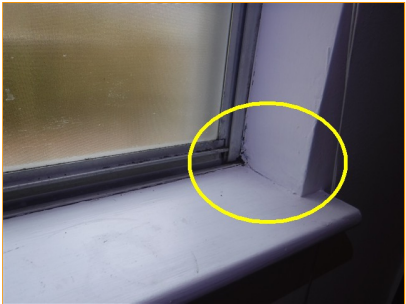
Various window sills are damaged/not properly sealed against moisture absorption and potential wood rot. Recommend having all edges [top, bottom, and sides] of all windows sealed to prevent moisture intrusion and extend life of wood frames.

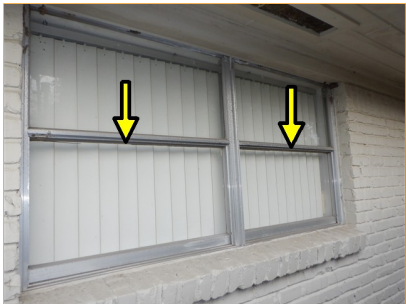
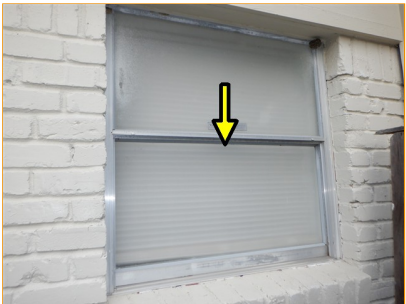
Observed window screens at east side of the house and in the garage are missing.

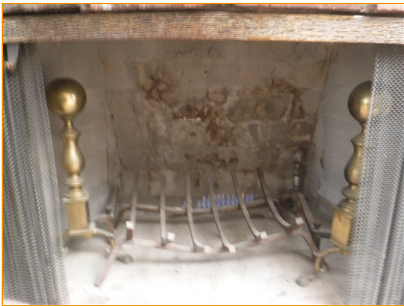
The fireplace was tested during the inspection and appeared to be functioning as intended

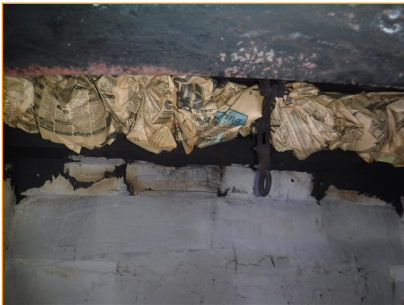
Observed fireplace damper arm is not functional. Recommend repair to prevent dust, insects, critters from entering the house through the fireplace flue.

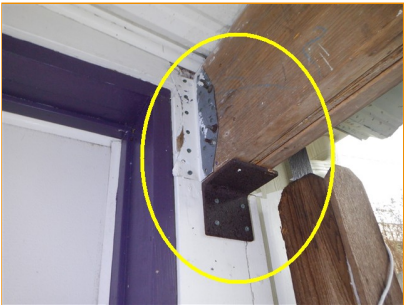
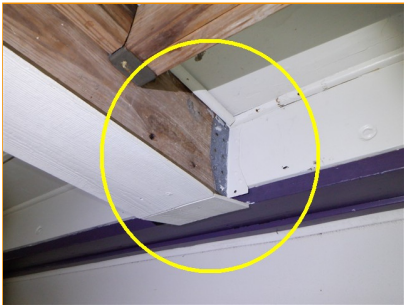
Questionable framing of carport arbor. missing lag bolts to secure boards to the garage wall. Only nails and screws were observed. Deck ledger attachment with minimum 1/2 inch lag screws or bolts 09 IRC [502.2.2.1] If Joist span is <6 feet lag bolts should be every 30 inches.

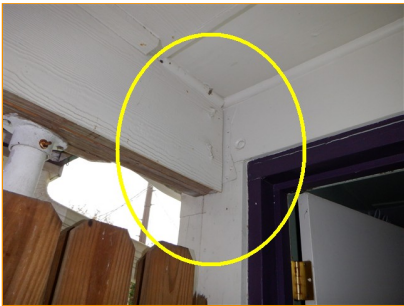
No Gusset plate (metal support) observed at the left side joist.

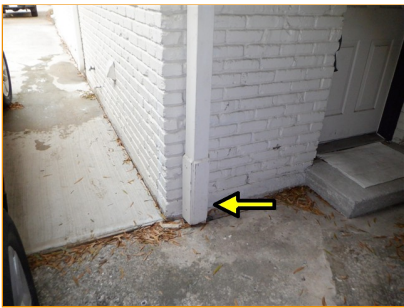
Observed wood support column at the covered garage walkway is loose from the ground.

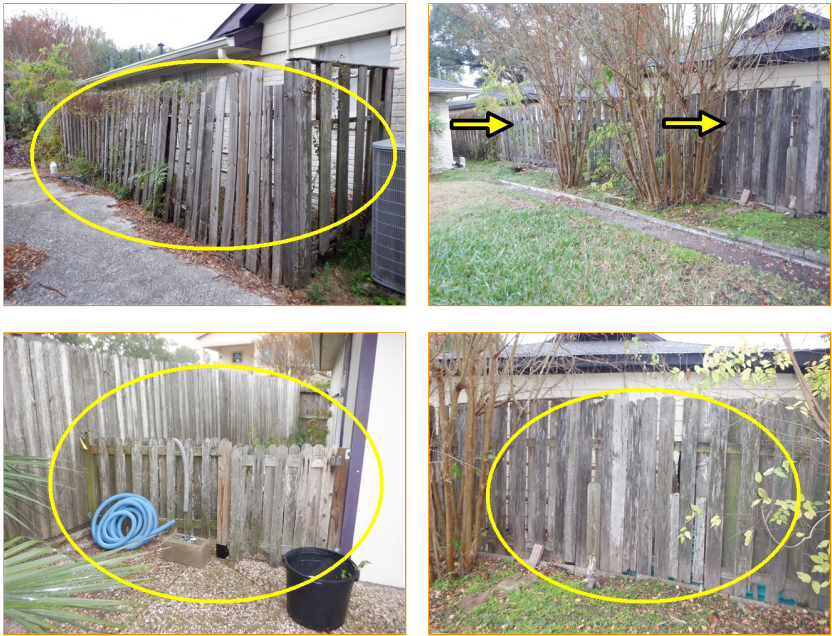
EXTERIOR FENCE

Significant wood damage observed at exterior fence. The fence boards are loose/broken/deteriorated/missing at various locations around the house.

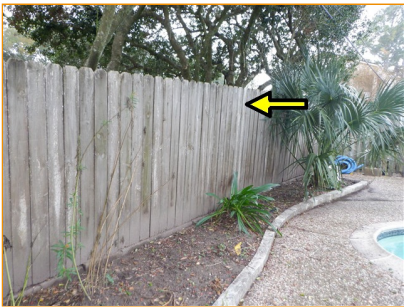
The exterior fence is not properly secured/leaning over at the south side of the house.

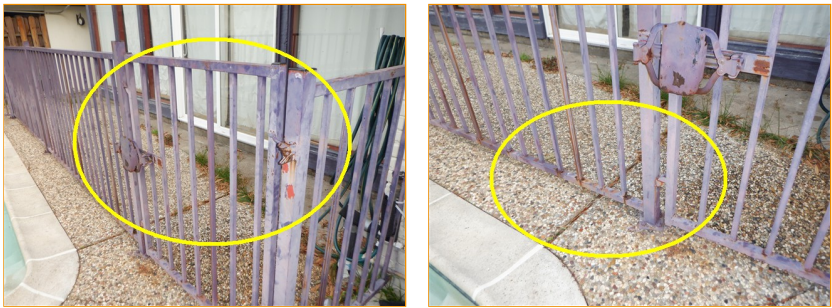
The swimming pool area metal fence is damaged/rusted at various locations.

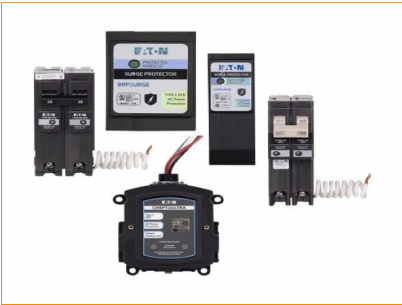
Since November 2020, a surge protection device is required at the main electrical panel. Current code NEC 230.67-70 requires that all new and replaced services supplying dwelling units must be provided with a surge-protection device. The surge-protection device must be an integral part of the service disconnect or be located immediately adjacent to the service disconnect. If the client is concerned or wants to update, I recommend consulting a licensed electrician.

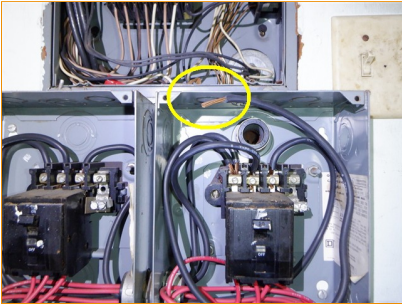
The electrical outlets coming from the sub-panel are not working/with no power observed in the garage.

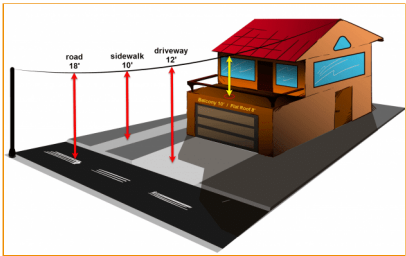
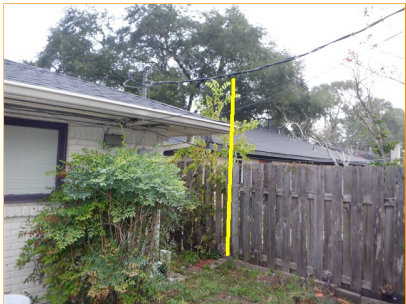
Clearance about 9 feet

Improper vertical clearance of service drop observed. For service-drop cables the vertical clearance should be at least 10 feet at the electrical service entrance to buildings, at the lowest point of the drip loop of the building's electrical entrance, and above areas and sidewalks accessed only by pedestrians. Where there is no anticipated vehicle traffic, a 10-foot minimum vertical clearance is needed. The vertical clearance should be at least 12 feet above a residential property (yards and grounds) and driveways.

According to current electrical code E3604.2.1, the service entrance conductors must have a clearance vertical clearance of at least 8 feet above the roof surface and at least 3 feet from the edge of the roof.

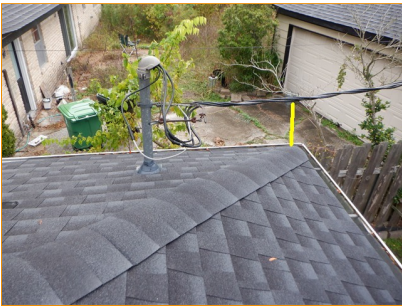
Antiquated electrical system observed. The visible wiring is of the older Romex type with cloth insulation and without the grounding/bare wire.I recommend further evaluation of the electrical system by a licensed electrician.

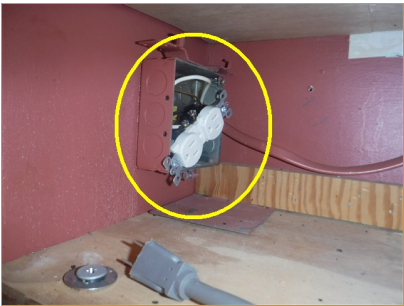
Electrical outlet not properly secured to the wall and/or missing the cover plate observed in the kitchen.

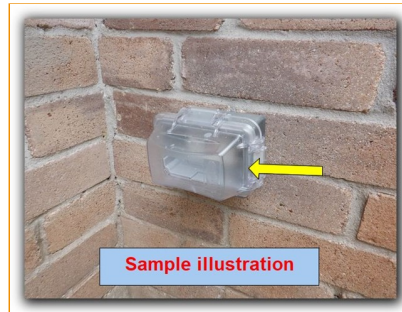
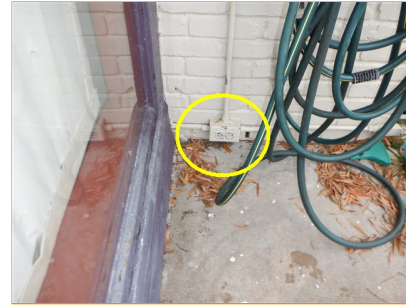
Observed exterior outlets are missing a weather proof cover. All exterior outlets whether in use or not are required to have in use weather proof cover per September 1st 2014 NEC Code Change. This condition represents a fire hazard. Recommend installing rain proof cover plates on all exterior outlets.

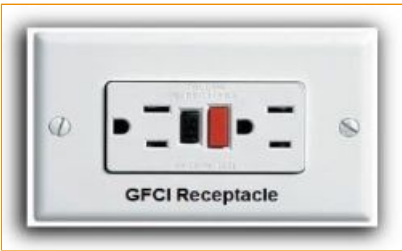
**No GFCI protection observed in the kitchen, the garage, the laundry room, or the exterior of the property.**

**Insufficient GFCI protection observed in the bathrooms.**

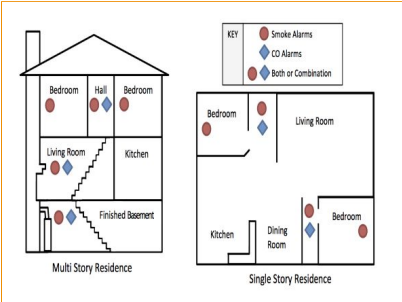
**Observed smoke detectors are missing in the secondary bedrooms.**

**No carbon monoxide alarms observed in the house.**

One or more smoke detectors do not beep when tested, which is an indication that detectors are damaged or needing new batteries.

Recommend installing all required smoke detectors and carbon monoxide alarms upon taking possession of the property.

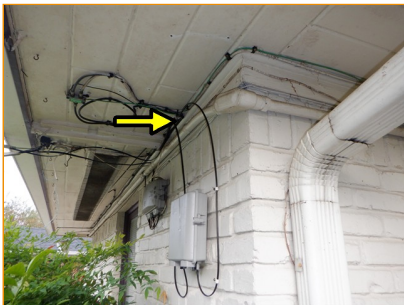
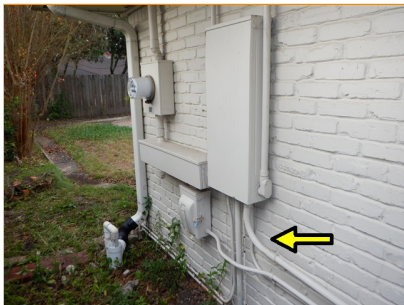
Observed electrical circuits coming form the electrical panel box were installed after the house was built. During a home inspection, the inspector can not fully evaluate the type of work and condition of the wiring. Recommend consulting the seller about the scope of work and warranty if available and/or further evaluation by a licensed electrician.

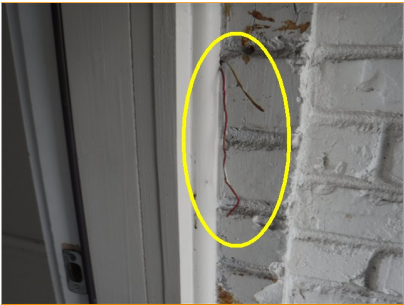
The doorbell switch was missing at the time of the inspection.

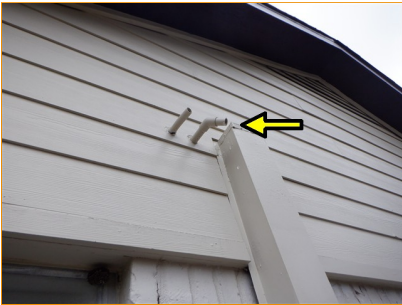
The primary drain line appears to have been installed to drain along the exterior wall, which may cause damage to the wall covering materials and causing soil depression next to the foundation. Recommend further evaluation/service by a licensed HVAC technician.

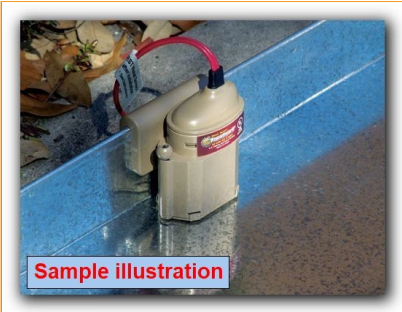
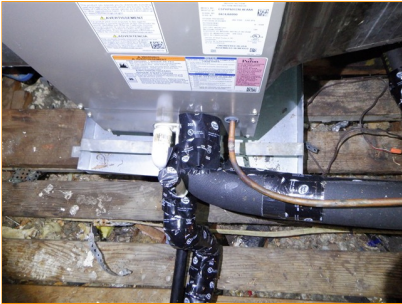
No overflow protection device/switch installed on the emergency drain pan. The overflow switch is not required by current code; however, it will shut your system down if it detects water in the pan to help prevent water damage to your ceiling.

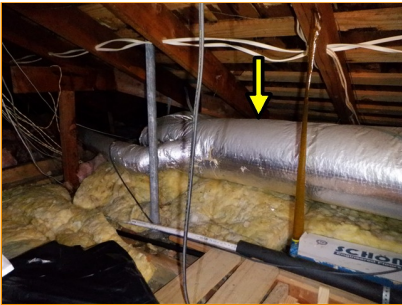
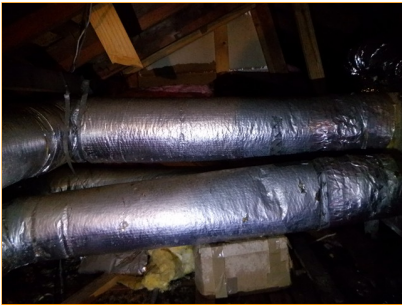
Observed older metal ducts still in use in the attic.

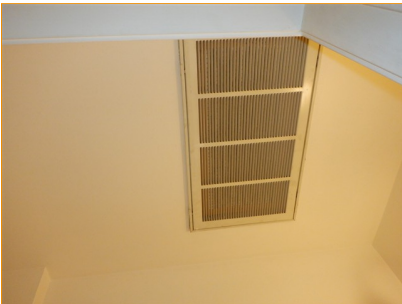
Observed air return vent located in the half bathroom. Code IRC M1602.2 does not allow air returns in bathrooms because bathrooms contain moisture (humidity) and odors that you don't want circulating back into your main air supply, which can cause mold or spread smells. Air conditioning air returns are typically located in central spots like hallways, living rooms, or near stairways.

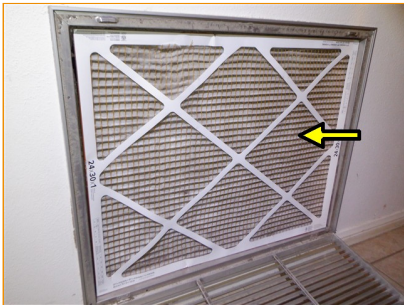
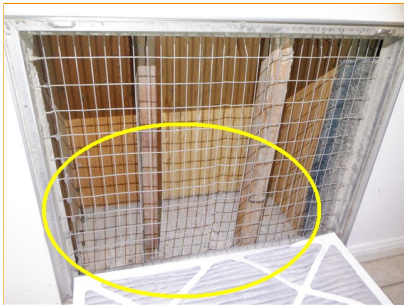
The return air chase needs to be cleaned and the air filter needs to be replaced to improve air quality.

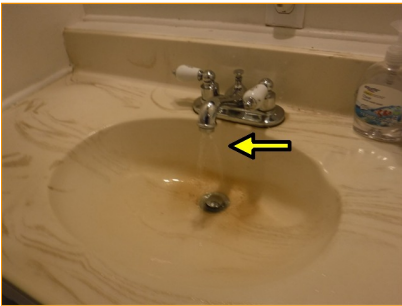
Low water pressure observed at the half bathroom sink . Recommend further evaluation and/or repair as needed by a licensed plumber.

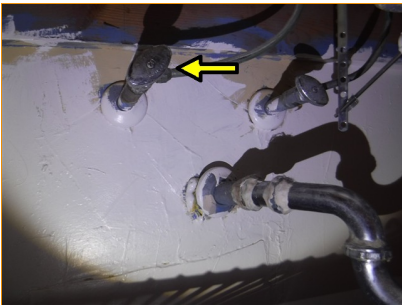
The hot water valve under the half bathroom sink is leaking.

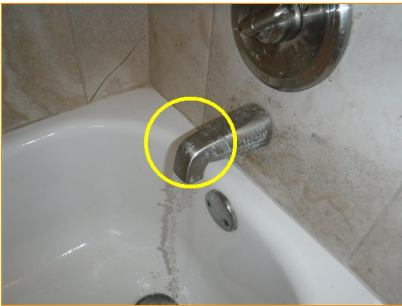
The shower diverter valve at the secondary bathroom is damaged. Water can not be directed all to shower head during operation.

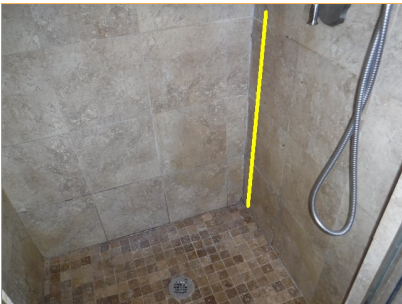
Observed grout / caulking needed in primary bathroom shower enclosure at vertical tile corners to prevent water entry behind wall.

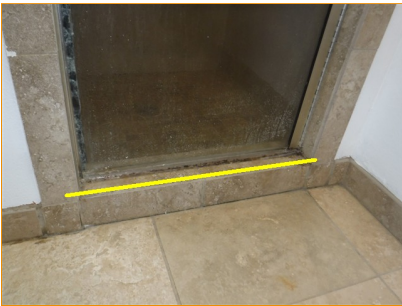
Observed lower weather stripping at primary bathroom shower glass door is damaged; possible water leaking from base of door, needs repair / replacement.

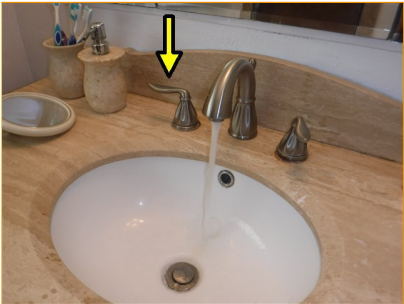
Observed reversed hot/cold water supply at the primary bathroom sink. Hot water should always be installed on the left side as per standard plumbing code

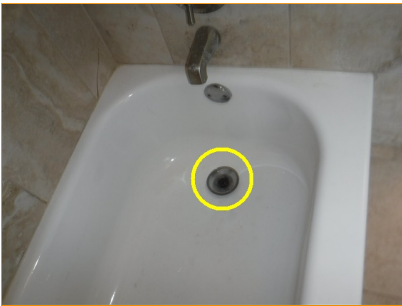
The drain stopper or pop-up lever assembly of the bathtub is missing.

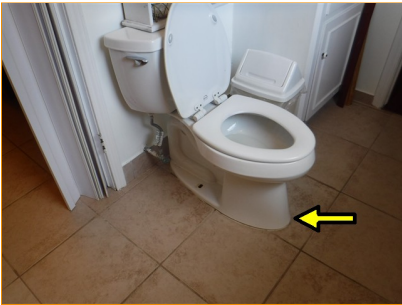
The secondary bathroom commode is loose/not properly secured to the floor.

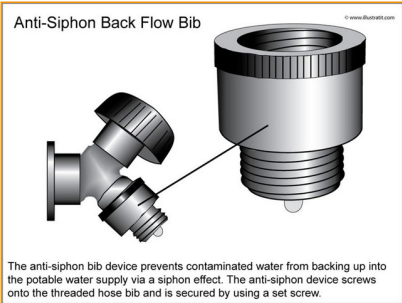
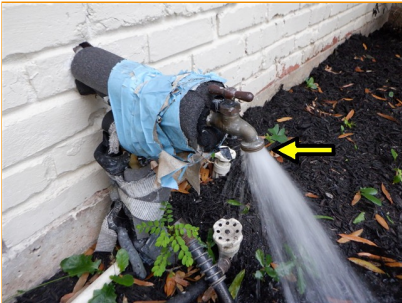
The exterior hose spigot(s) do not have code approved anti-back flow devices installed.

The main water shut off valve and all exterior exposed piping and hose bibs need to be properly insulated to prevent freezing during the winter.

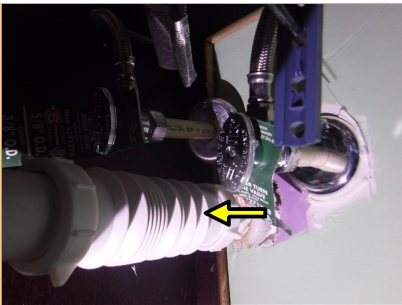
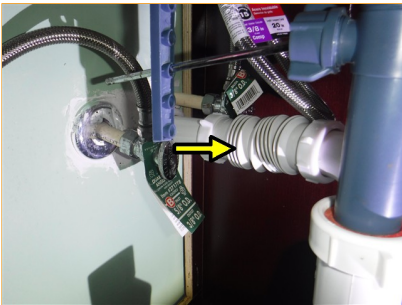
Improper drain material observed at the secondary bathroom sinks. Flexible material at sink P-traps is not allowed by current plumbing standards.

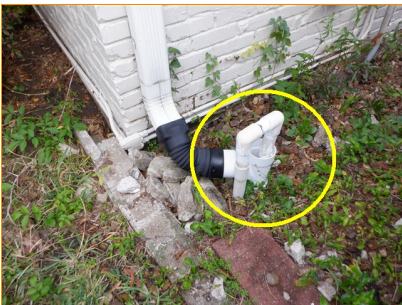
Observed plumbing cleanout located at east side of the house is missing the cover/cap. Cleanout is probably in use by pool equipment. Recommend further evaluation by a licensed plumber.

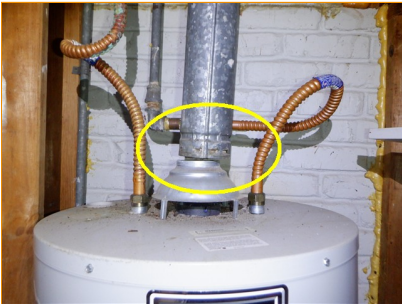
Observed water heater draft hood is not properly connected to the exhaust vent. Combustion gases escape into living/storage space. This condition represents a safety hazard; recommend repair.

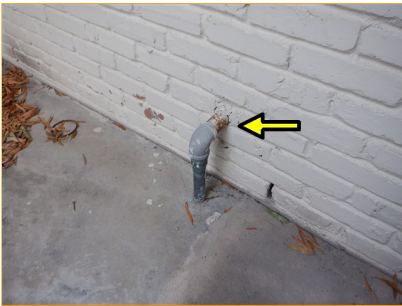
The ground rod/wire is missing at the metal gas pipe entering the house. The inspector did not see/could not verify proper bonding of gas lines CSST (corrugated stainless steel tubing). Current standards require CSST to be bonded to minimize the risk of damage to the building materials from a nearby lightning strike.

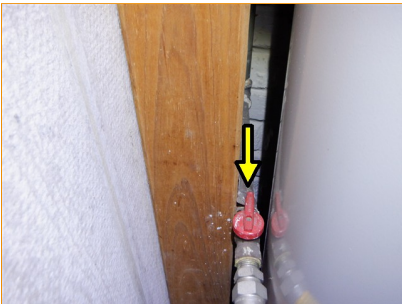
The installation of the water heater in the storage closet has rendered the gas valve inoperable. This condition represents a safety hazard. I recommend repair.

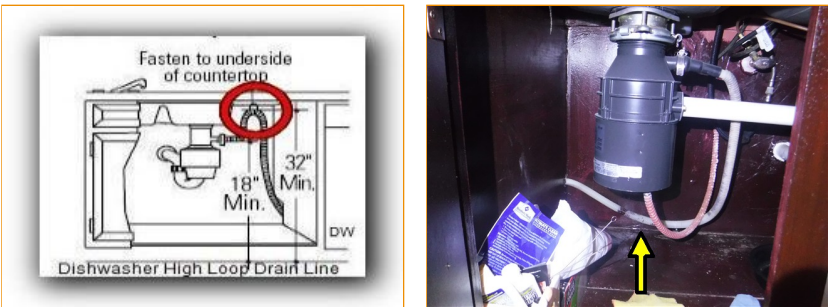
The drain line needs to be elevated above side inlet of disposal to underside of countertop to prevent debris and gray water from draining down line from disposal and back into dishwasher.

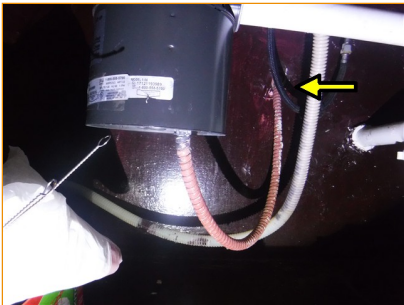
Observed garbage disposal unit is hardwired/ can not be plugged or unplugged from an outlet for easy access by service personnel.

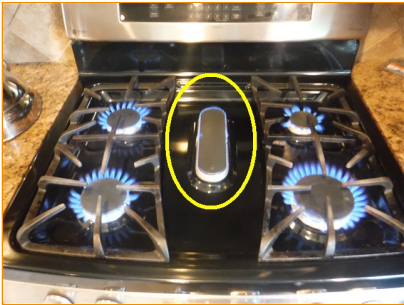
The middle burner has a weak flame.

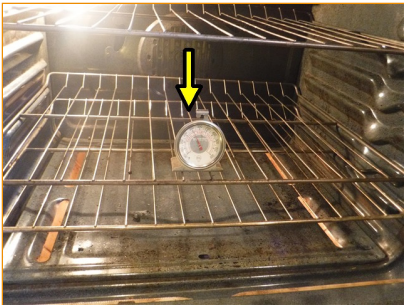
The oven does not reach the temperature at which it was set. Oven set to warm up to 350 °F , only only reached 300 °F.

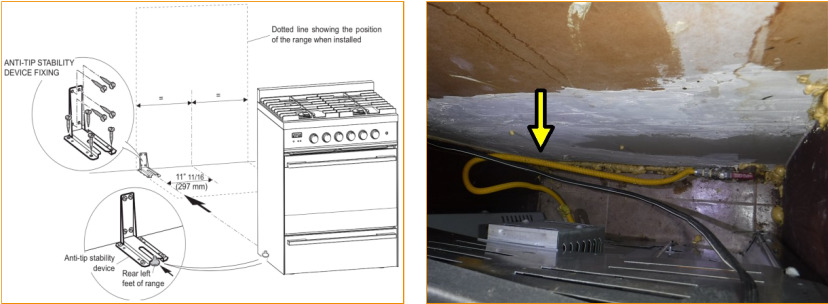
Observed cooking range is missing an anti-tip device, which is recommended as a safety measure to prevent the appliance from tipping over when being used.

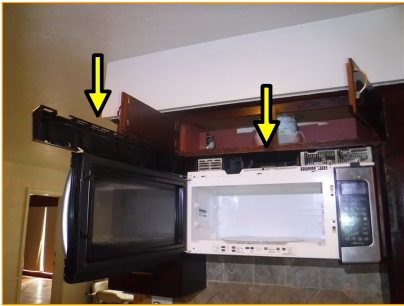
The microwave oven cabinet is damaged at the top.

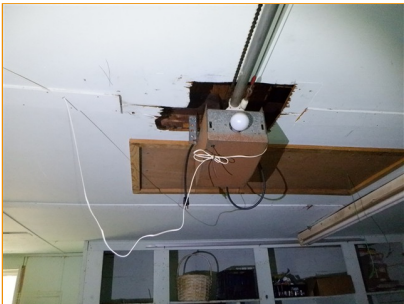
Observed older garage door operator does not appear to be in serviceable condition. Operator was not connected to power at the time of the inspection. No electrical outlet observed in the garage ceiling; motor not tested. The door was opened manually.

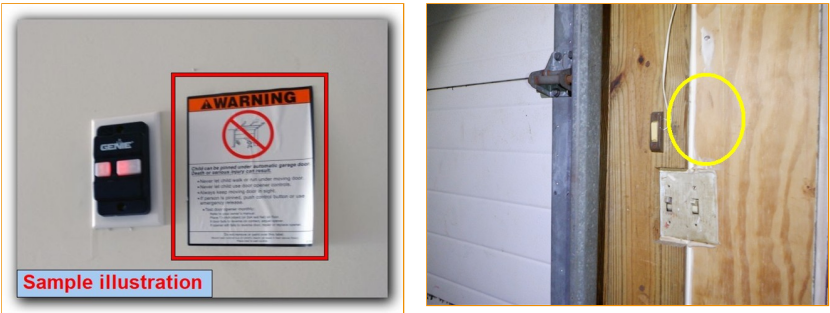
The garage door opener sensors are not installed/not present.

The equipped safety sticker / decal next to operator button is missing.
