# GOLDFISH HOME INSPECTIONS, PLLC

# PROPERTY INSPECTION REPORT FORM

04/19/2025 9:00 am

10935 Ashland Bridge Ln, Sugar Land, TX 77498

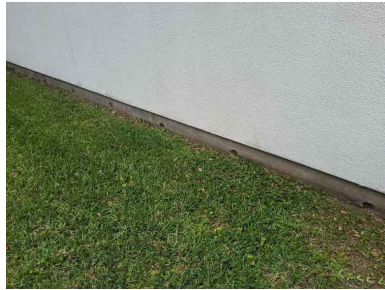
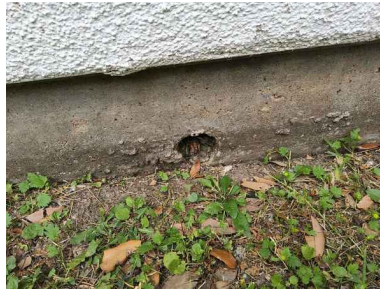
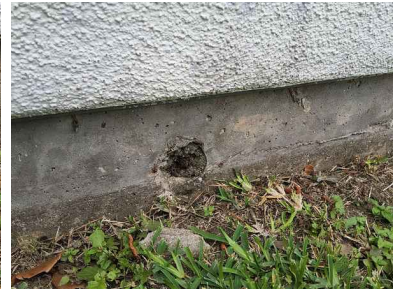
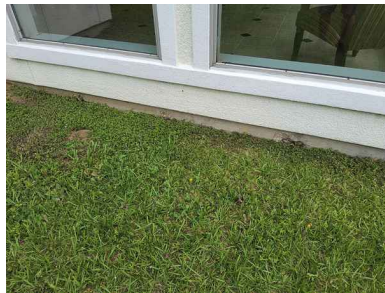
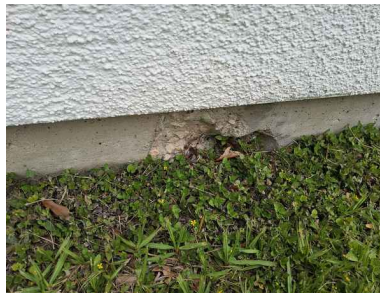
**1: Inadequate / Improper Slope in Grading**

Improper slope was observed in the grading. Inadequate slope in the grading may prevent drainage and may promote standing water near the foundation, possibly causing structural movement. Further evaluation is recommended.

Grade shall fall a minimum of 6" within the first 10' and grade should be sloped towards drain systems.

Recommendation: Contact a qualified professional.

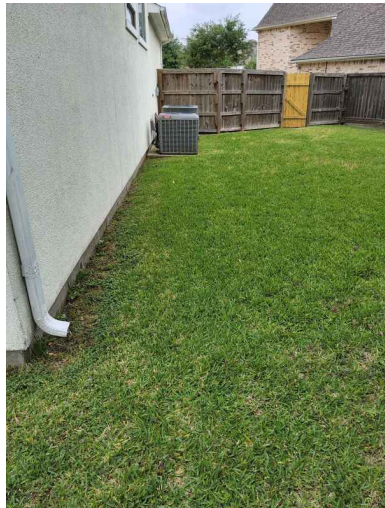
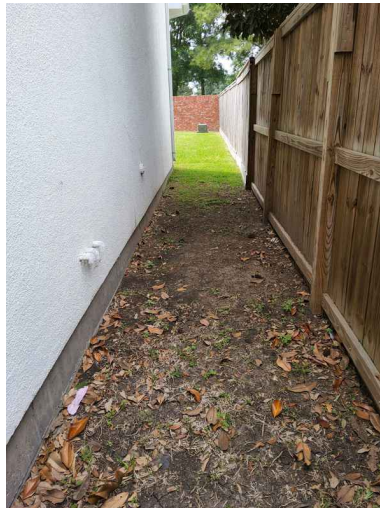
Low spots were observed in areas of the grading. These areas may be prone to holding water. Corrections should be made to promote proper drainage of water away from the structure.

Recommendation: Contact a qualified professional.

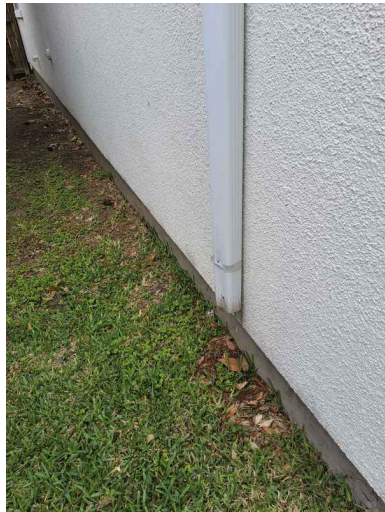
#### 5: Gutters: Splash block missing

Splash blocks were observed absent at the downspout termination. Splash blocks should be in place to prevent soil erosion at the termination points.

Recommendation: Contact a qualified professional.

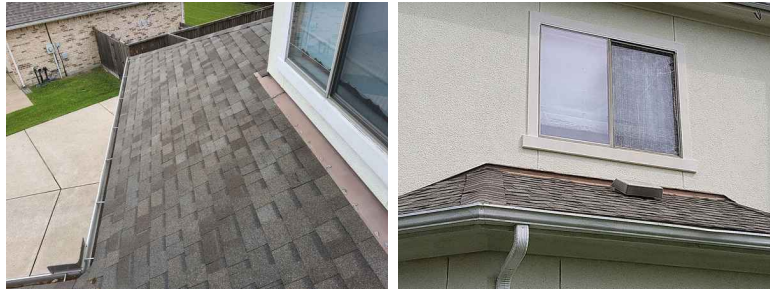
### 1: Exposed Nails

Under-driven or exposed nails were found in one or more roof coverings. These locations include vent jacks, flashings, and ridge caps. Proper sealing is recommended to prevent possible moisture intrusion. Recommend a qualified roofer evaluate and correct.

Recommendation: Contact a qualified roofing professional.

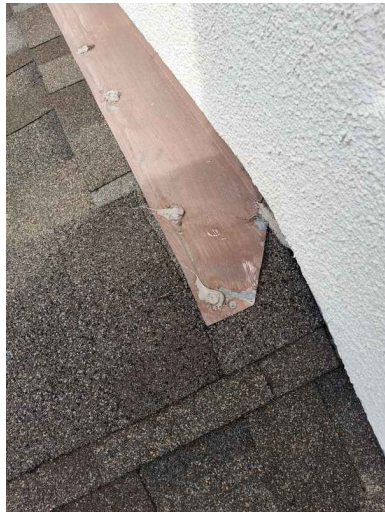
### 2: Unpainted materials

Flashings were observed unpainted. Exposed materials above the roofline should be painted to prevent deterioration.

Recommendation: Contact a qualified professional.

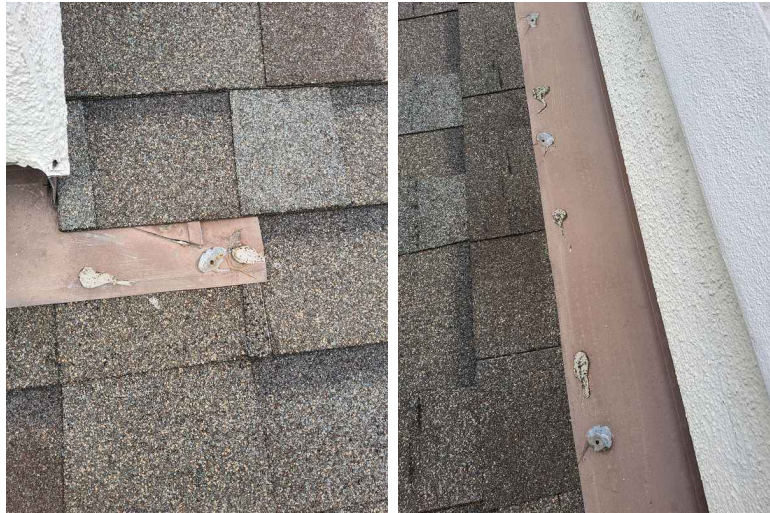
### 3: Loose or raised flashing

Loose or raised flashing was observed on roof or adjacent walls. These areas may be prone to moisture intrusion. Correction is recommended.

Recommendation: Contact a qualified professional.

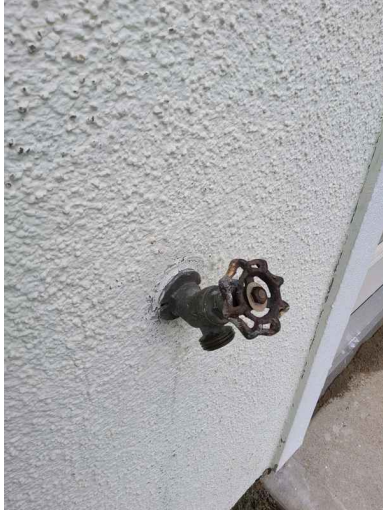
The above locations and photos were observed in need of proper sealing or maintenance. Further evaluation is recommended to all areas.

Recommendation: Contact a qualified professional.

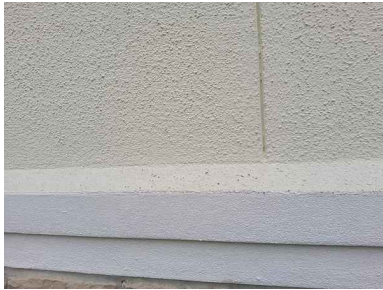
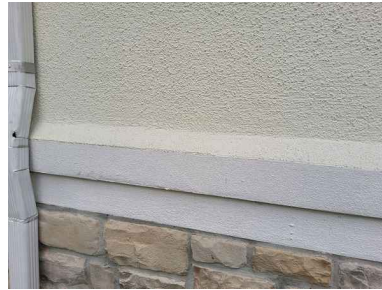
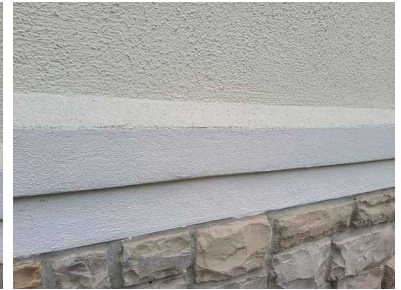
## 2: Stucco exterior- Multiple issues

Multiple areas around the exterior were observed with issues in the stucco wall covering.

- Cracks / openings
- Deterioration of the surface

These issues may lead to water intrusion of the wall system and may potentially compromise the wall covering. Further evaluation and correction is recommended.

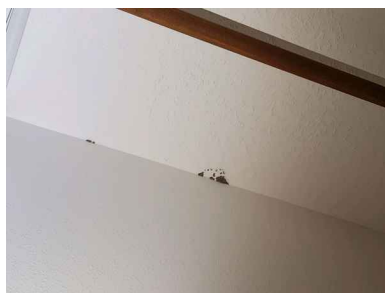
### 1: Ceiling - Minor cracks

Minor cracks were observed on the ceiling. Possibly from settlement of the structure. Repair and monitoring is recommended.

Recommendation: Contact a qualified drywall contractor.

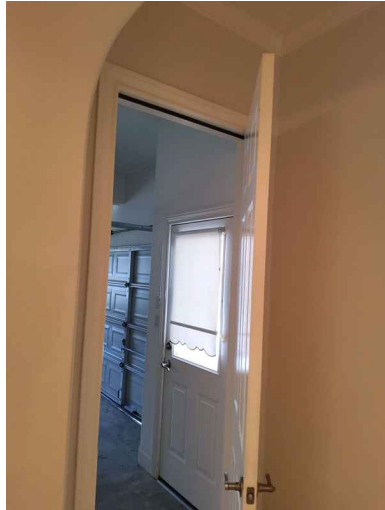
Small garage

#### 4: Door hardware issues

The deadbolt was inoperable and the key side on the bottom knob exterior was inoperable.

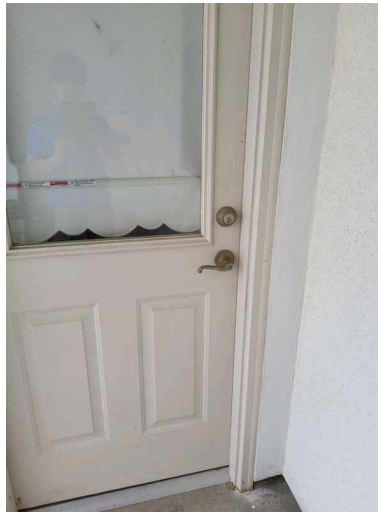
#### 5: Hardware damaged

The lever hardware was observed damaged and the right side door could not be unlocked.

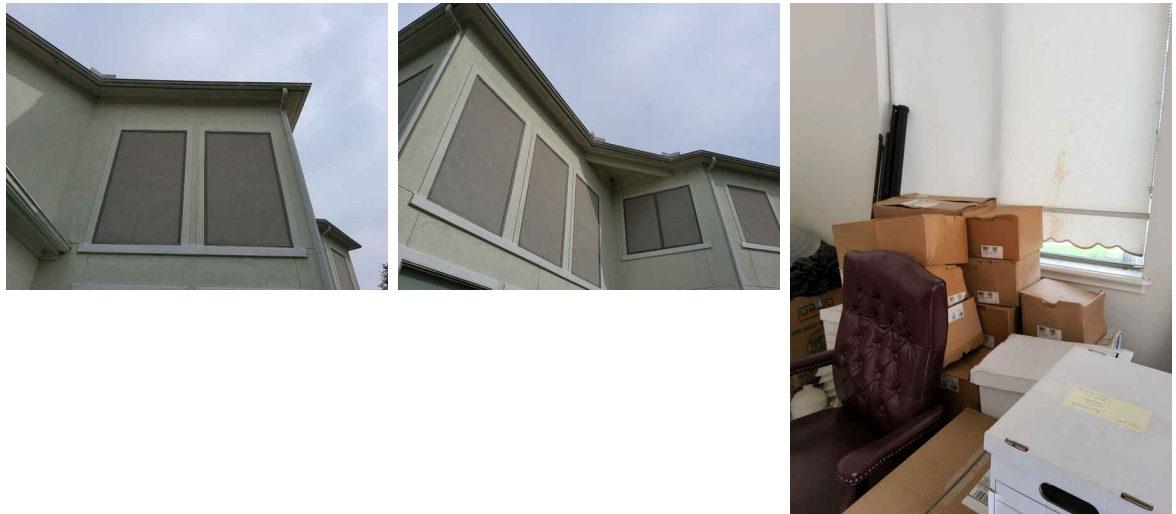
**1: Failed Seal**

Observed streaking between the window panes, which indicates a failed seal. Further evaluation and correction is recommended.

Recommendation: Contact a qualified window repair/installation contractor.

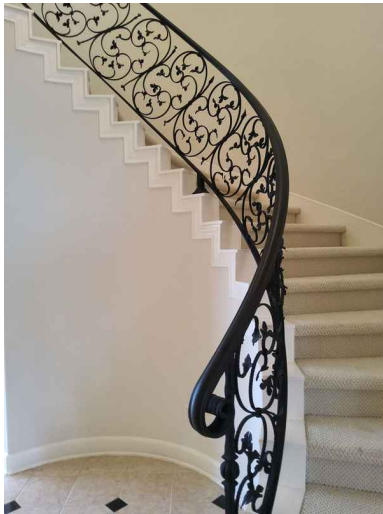
**1: Guard rail**

This arrangement may be a hazard for children or inhabitants climbing over the railing.

Recommendation: Contact a qualified professional.

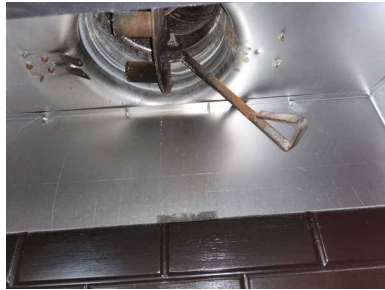
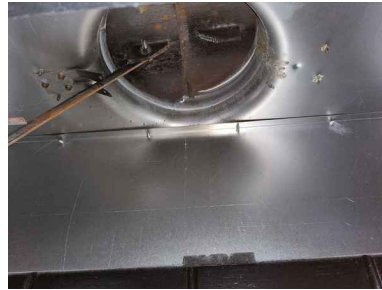
### 1: Damper Anti closing device absent

An anti-closing device was not present for the damper. This device is required for gas fire places to ensure proper ventilation for safety reasons.

Recommendation: Contact a qualified professional.

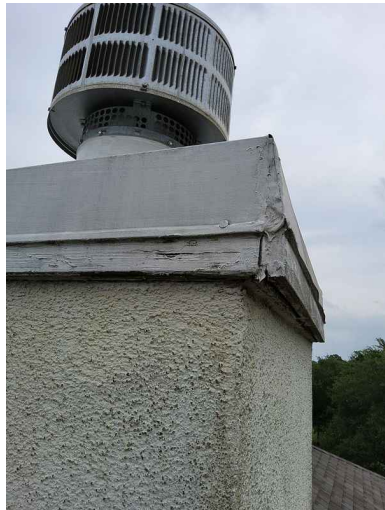
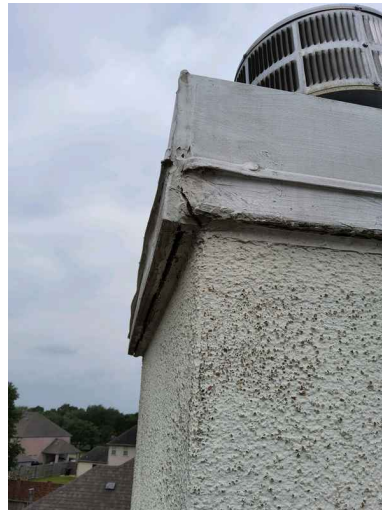
### 2: Chimney exterior issues

Sections of the chimney exterior were observed with moisture damage to the wood trim and areas requiring sealing to prevent possible moisture intrusion. Further evaluation and correction is recommended.

Recommendation: Contact a qualified professional.

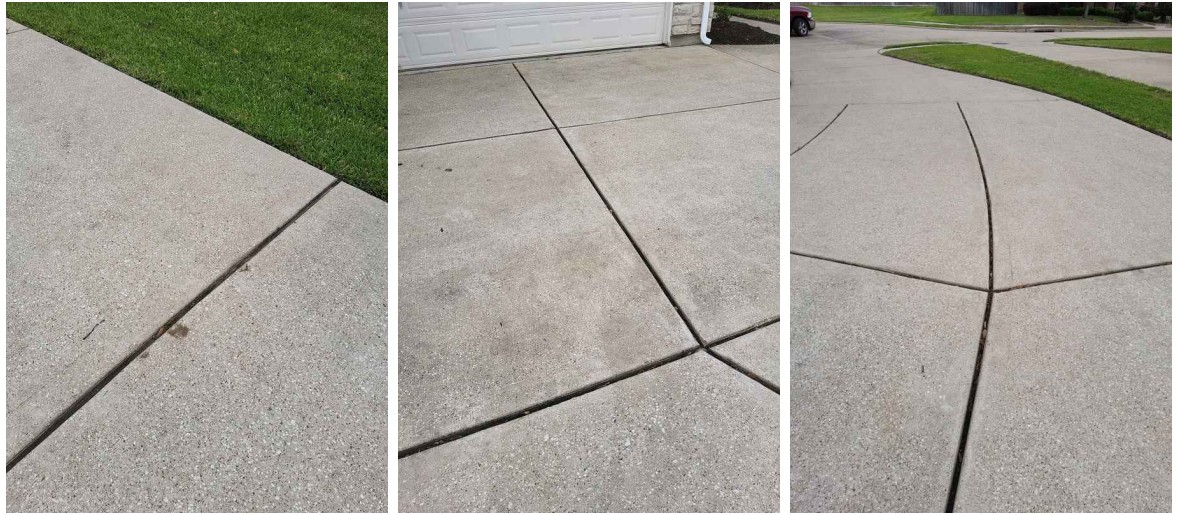
**1: Expansion joints missing/ deteriorated**

Multiple expansion joints for the walkway and driveway were observed missing or deteriorated. Correction is recommended.

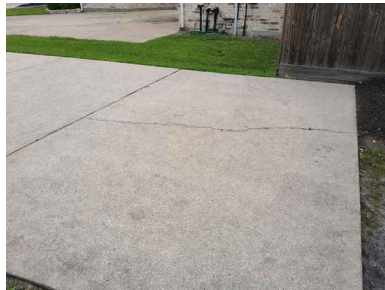
## 2: Driveway cracked

A section of the driveway was observed cracked. Correction is recommended.

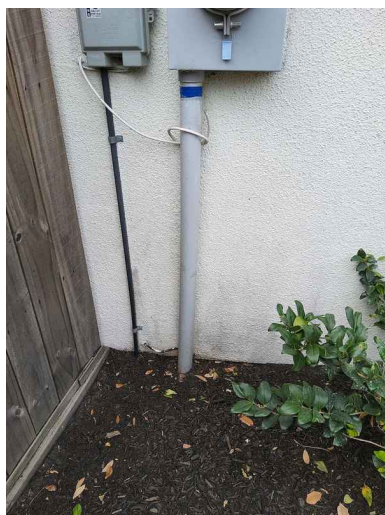
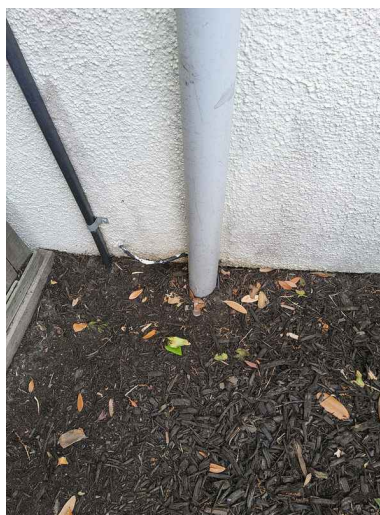
*Ground Rod not visible:*

The ground rod was buried in soil and could not be confirmed or further inspected.

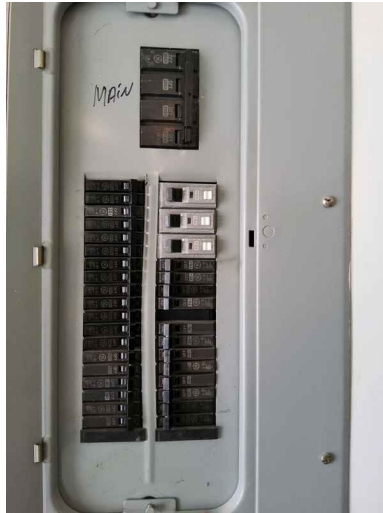
### 1: Arc-Fault Safety Protection Missing

Arc-fault safety protection was not installed for all currently required 15 and 20 amp circuits. While this protection may not have been required when this property was built, recommend you consider upgrading to satisfy modern code requirements and for safety reasons.

Recommendation: Contact a qualified professional.

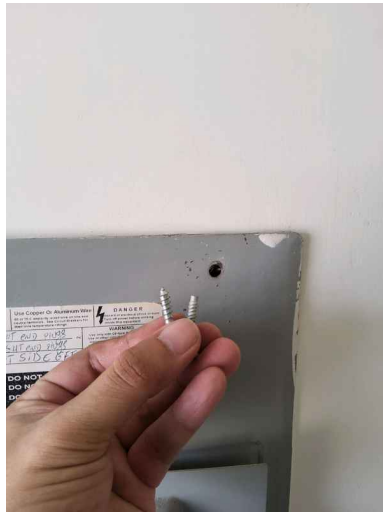
## 2: Improper panel screws

Sharp tipped screws were used on the panel cover. Blunt tipped screws designed for this application are recommended to prevent puncturing electrical wiring insulation. Remedy as needed.

Recommendation: Contact a qualified professional.

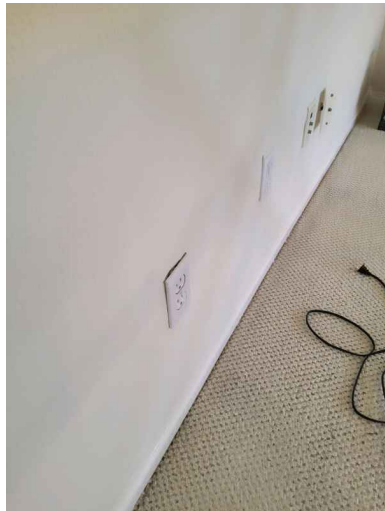
**1: Cover Plates loose**

The cover plate was observed loose. Correction is recommended.

Recommendation: Contact a qualified professional.

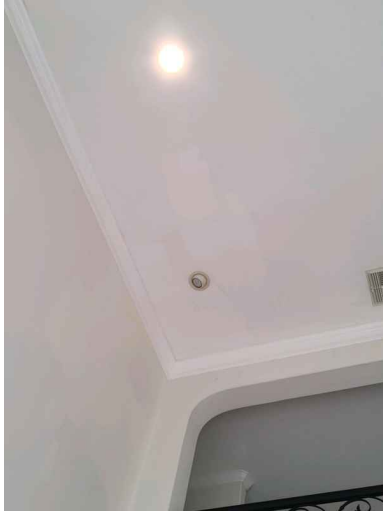
**2: Light Inoperable**

One or more lights are not operating. Further evaluation and correction is recommended.

Recommendation: Contact a qualified professional.

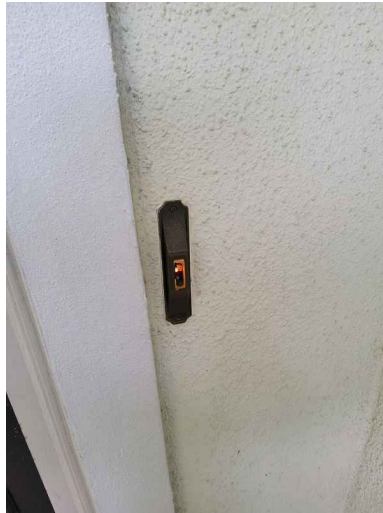
**4: Door bell button damaged**

The door bell button was observed damaged. Correction is recommended.

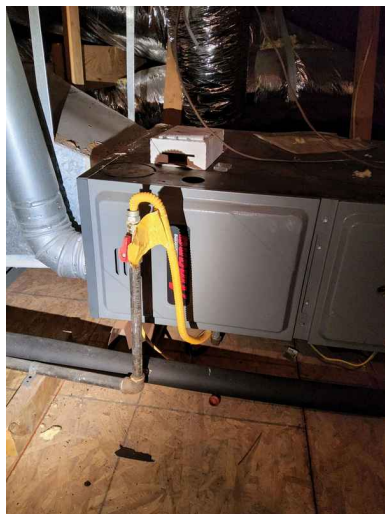
### 1: Gas line Missing drip leg or improper

Remedy as needed.

Recommendation: Contact a qualified professional.

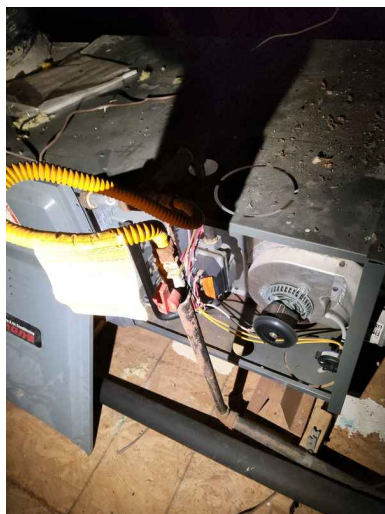
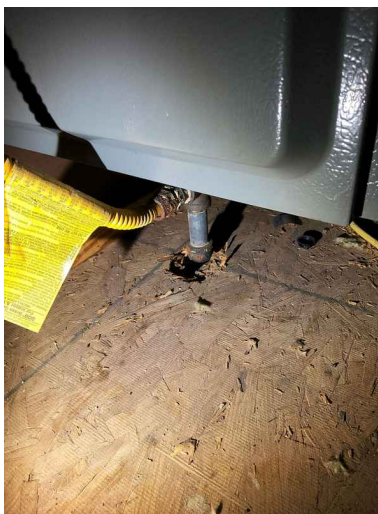
### 2: Rusted fittings

Corrosion was observed on the connections of the gas fittings serving the furnace. Further evaluation and correction is recommended.

Recommendation: Contact a qualified professional.

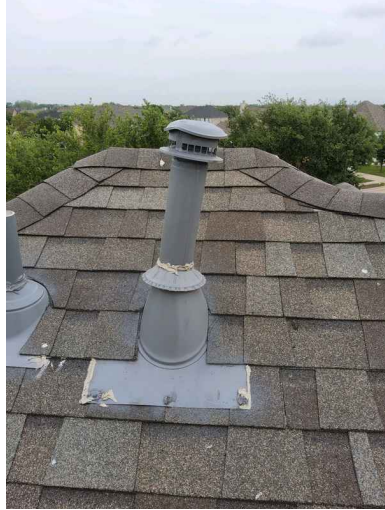
### 3: Flue damaged/crooked

The furnace flue was observed with damage and was crooked at the roof exterior. Further evaluation and correction is recommended.

Recommendation: Contact a qualified professional.

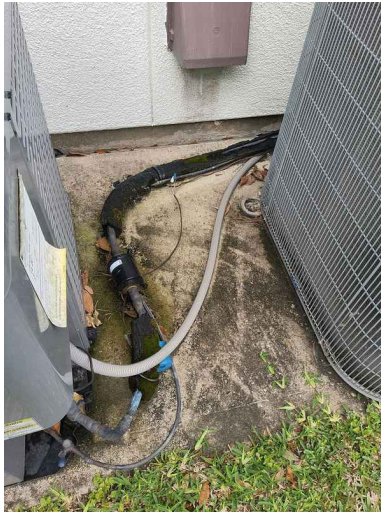
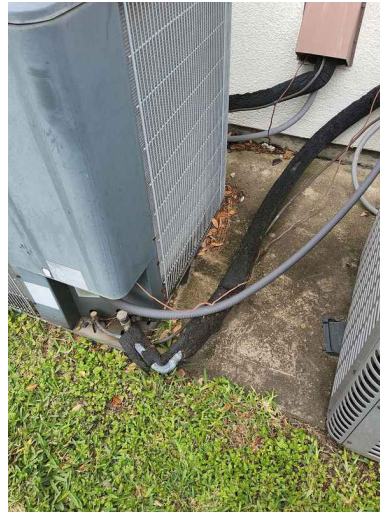
**1: Refrigerant line Insulation Missing or Damaged**

Missing or damaged insulation on refrigerant line can cause energy loss and condensation. Correction is recommended.

Recommendation: Contact a qualified HVAC professional.

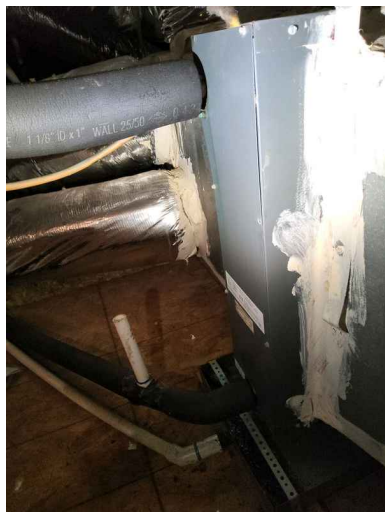
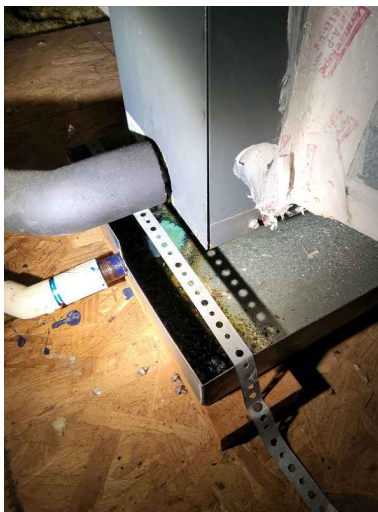
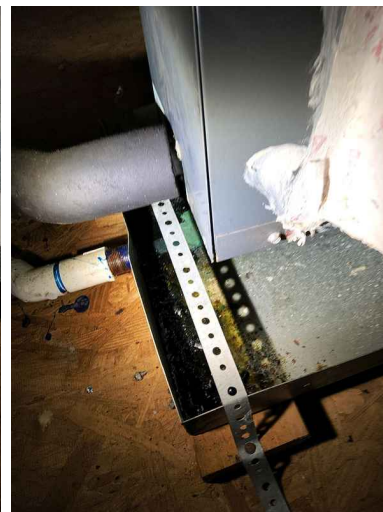
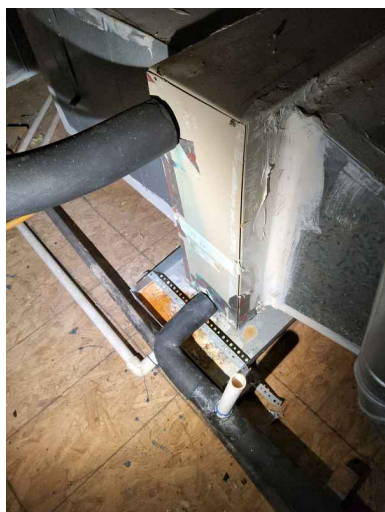
**2: Seal HVAC penetrations**

Areas around the penetrations through the evaporator coil need to be sealed properly to prevent air loss or condensation at the attic area. Further evaluation and correction is recommended.

Recommendation: Contact a qualified professional.

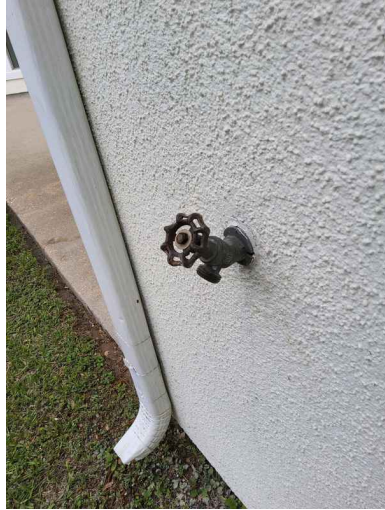
One or more hose bibb(s) Missing a backflow preventer. These devices are inexpensive, easily installed and help prevent contamination of potable water. Repair as needed.

Recommendation: Contact a qualified professional.

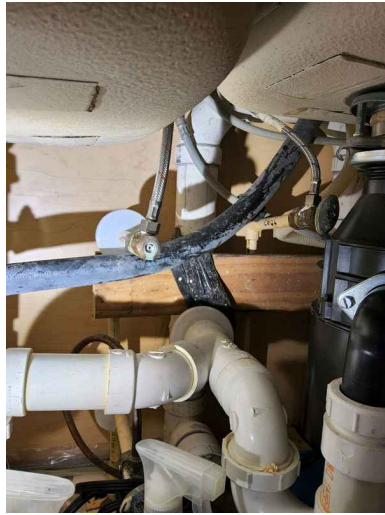
## 8: Corrosion

Multiple shut-off valves were observed with corrosion. Further evaluation and correction is recommended to prevent possible further deterioration.

Recommendation: Contact a qualified professional.

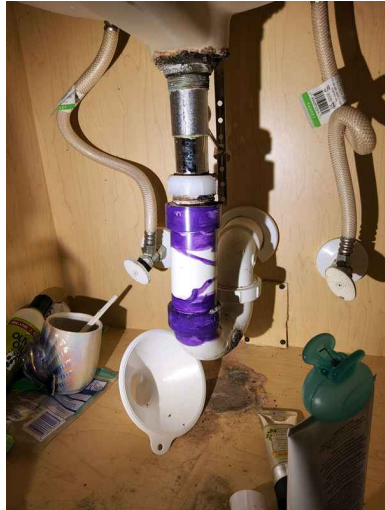
Deterioration was observed at the drain and sink connection. Corrosion is also present on some of the connections and evidence of a previous leak. Further evaluation and correction is recommended.

Recommendation: Contact a qualified professional.

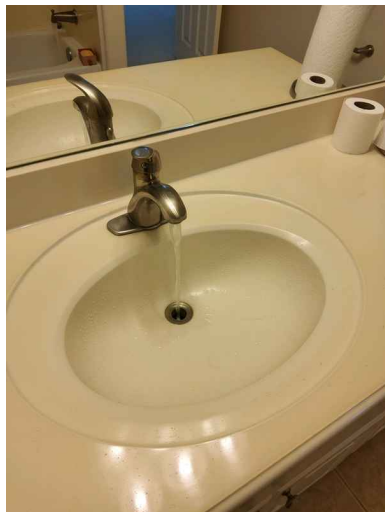
## 2: Drain stop issues

Drain stops for the sink was observed missing. Correct as needed to allow the drain to close when needed.

Recommendation: Contact a qualified professional.

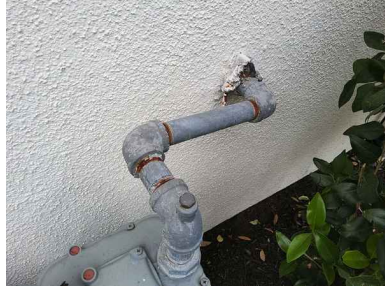
**1: Rusted connections**

Rust was observed on the gas meter connections. Correction is recommended to prevent possible further deterioration.

Recommendation: Contact a qualified professional.

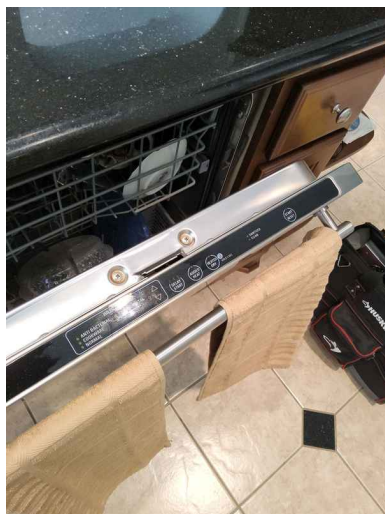
#### 1: Dishwasher operation

The dishwasher was powered via the switch and set by button controls to "Normal" Washer mode. It took several attempts until the unit began the wash cycle. The dishwasher eventually completed the wash cycle. Further evaluation is recommended.

Recommendation: Contact a qualified professional.

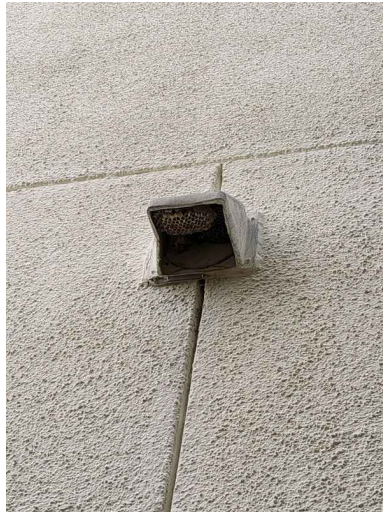
The exterior vent was observed obstructed by wasp nests. Correction is recommended.

Recommendation: Contact a qualified professional.

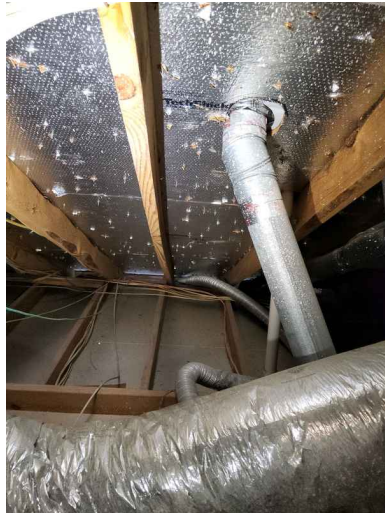
**2: Terminates to soffit**

The bathroom exhaust was observed terminating into a soffit vent. Exhausts should terminate directly to the exterior by a proper exhaust vent cap.

Recommendation: Contact a qualified professional.

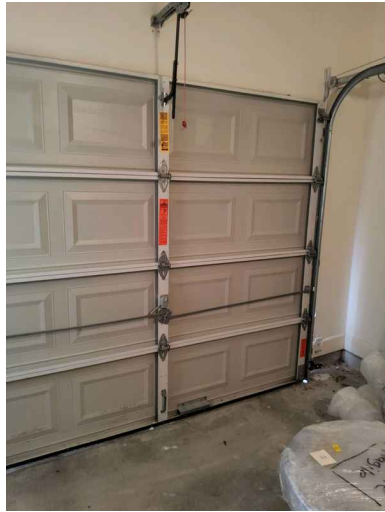
**1: Did not reverse pressure**

The garage door did not reverse with pressure even though the sensors were operable. The door should reverse with pressure to protect children and animals in case the sensors are inoperable. Recommend to

contact a garage door contractor to evaluate and remedy.

Recommendation: Contact a qualified professional.
