## MECHANICAL REPORT

10814 Overbrook Ln  
Houston, TX 77042

# PROPERTY INSPECTION REPORT FORM

10814 Overbrook Ln, Houston, TX 77042

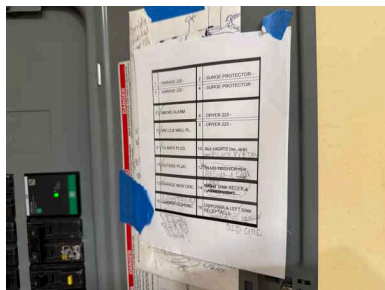
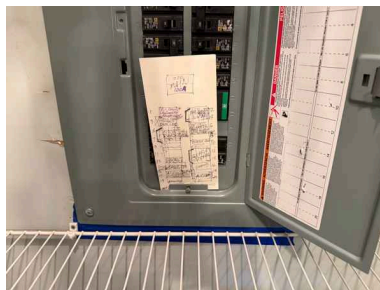
**Surge Protector - Functional:**

A surge protector was installed at the breaker panel and the device appears to be operating properly according to the illuminated operation light on the device.

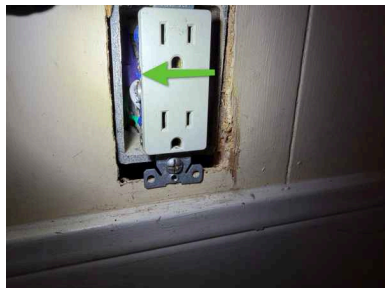
*Aluminum Wiring - Retrofit Present:* Copper pigtails observed -

checked and we did not check every switch or outlet for the retrofit. For safety reasons, it is recommended that you have an electrician check every connection to ensure that an approved retrofit has been properly installed.

**Further investigation is recommended**

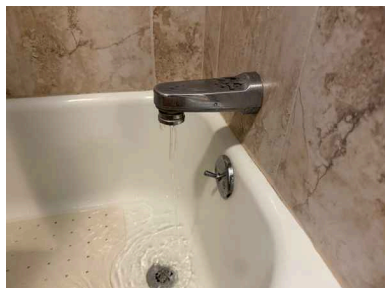
**3: Shower/Tub - Caulk valves**

Bathrooms

The tub and/or shower valves and/or faucet needs to be caulked to prevent water from entering the wall cavity behind the valves/faucet.

**Obtain Cost Estimate**

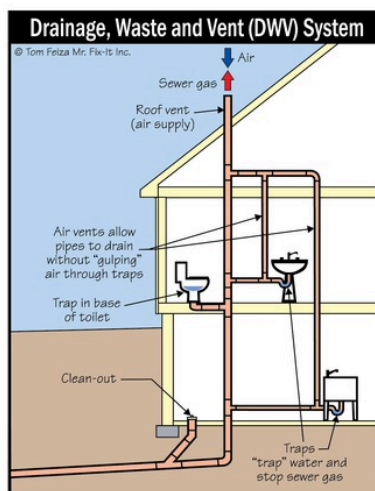
**Sewer Clean Out Present: Rear -**

A sewer clean out was present. The clean out is needed in the event of a stoppage in the main sewer drain line, and the clean out is where a sewer snake would be utilized to remove a clog in the sewer line.

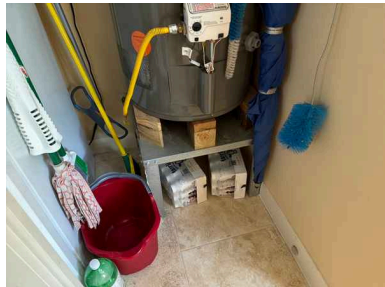
**2: Vent Pipe - fastened with screws**

The vent pipe was fastened with screws, which is improper. The vent is to be mechanically fastened only, and repair is needed.

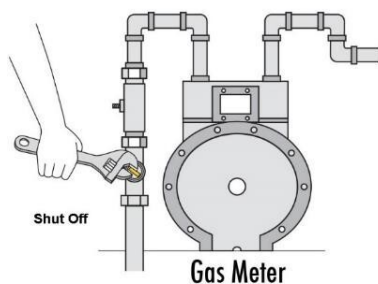
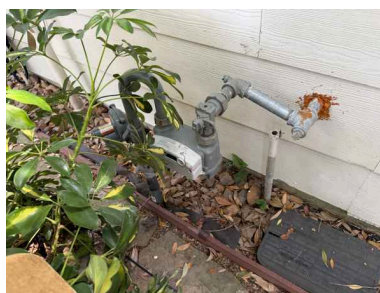
*Gas System - No repairs noted:*

No items were observed that were in need of repair at the time of the inspection for the visible gas supply piping.

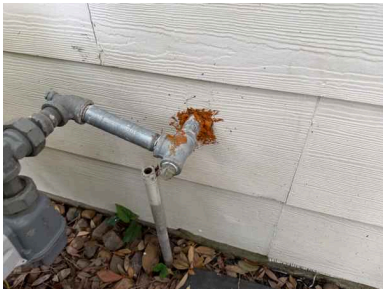
The gas supply line is required to be bonded at the gas meter to the main electrical panel. No bonding clamp was present on the gas supply line and repair is recommended. Contact a service company to make all needed repairs.

Recommendation: Contact a qualified professional.

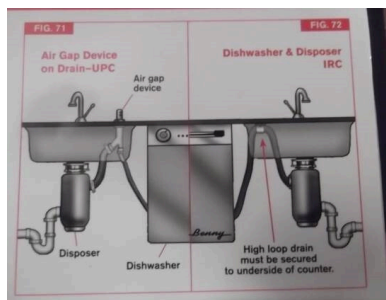
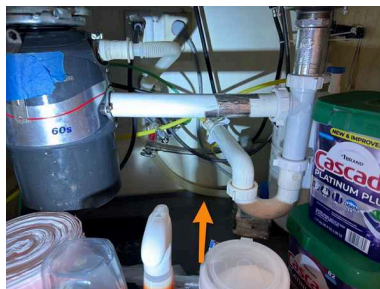
The drain line under the sink was not equipped with an anti-siphon device, nor was it looped up so that the top of the loop is at least six inches above the entrance of the drain line into the disposal. It is recommended at least that the drain line be looped to prevent the water from the garbage disposal from siphoning back into the dishwasher, or an anti-siphon device installed.

**Obtain Cost Estimate**

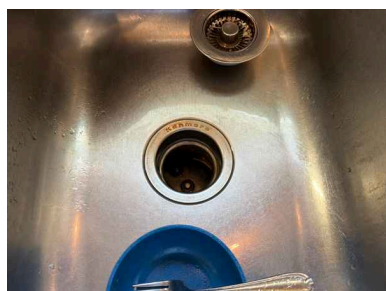
#### 1: Sink Splash Guard damaged/missing

The splash guard in the sink was damaged/missing.

**Obtain Cost Estimate**

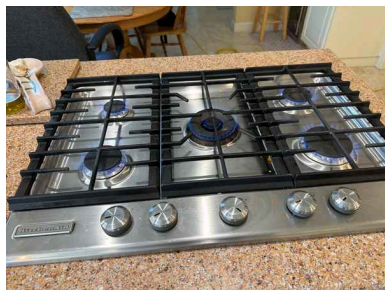
☒ ☐ ☐ ☒ **D. Ranges, Cooktops, and Ovens***Comments:**Gas Cooktop - Functional:*

The gas cooktop was functioning and responded to the controls when they were operated. All of the burners and controls were operating properly at the time of the inspection.

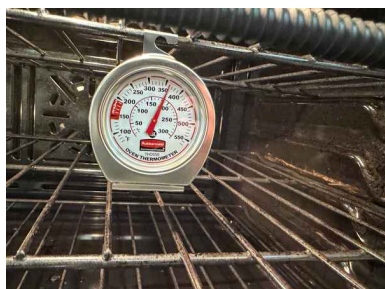
*Oven - Calibrated properly:*

No repair was needed to the calibration of the oven thermostat. The thermostat was set at 350 degrees, and the oven heated to within the allowable  $\pm 25$  degrees. The oven was checked with an oven thermometer and found to heat to 360 degrees.

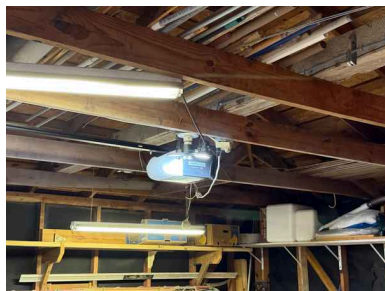
*Functional - Autoreverse and sensors:*

The garage door opener equipment was functional at the time of the inspection and opened/closed when the controls were operated. The auto-reverse mechanism was operational, and the sensitivity setting on the mechanism was adequate. Also, the infrared auto reverse mechanism was functional.

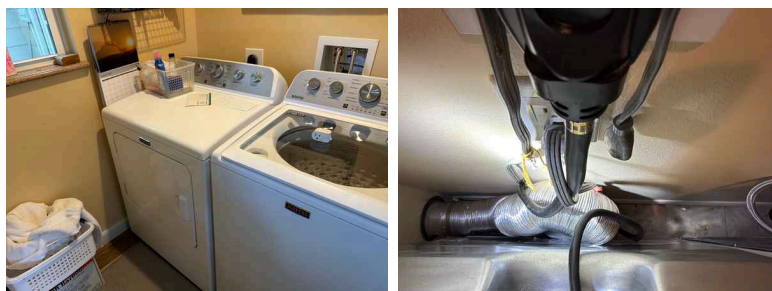
*Dryer vent - Dryer present:*

The vent was connected to the dryer but the connection was not dismantled, and the vent was not checked for lint buildup. It is recommended that the vent be checked for an excess of lint and that it be cleaned if necessary. (Information)

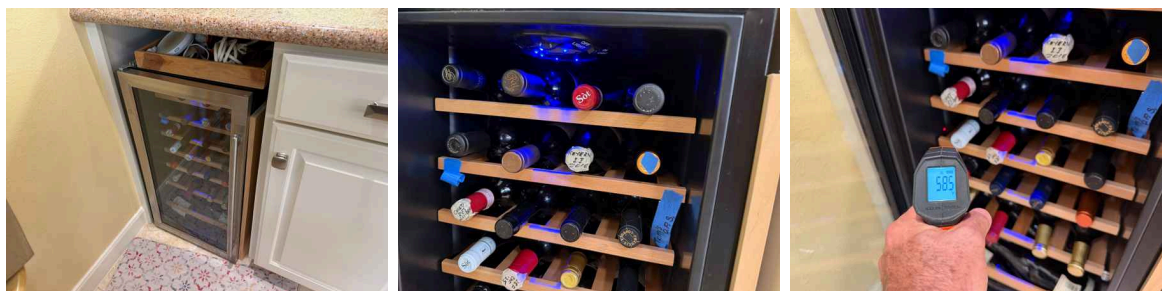
*Wine Cooler - Functional:*

No items requiring repair were visible at the time of the inspection for the wine cooler. The equipment was observed to be cooling adequately at the time of the inspection. It is noted that the unit was not dismantled and the interior components were not checked.

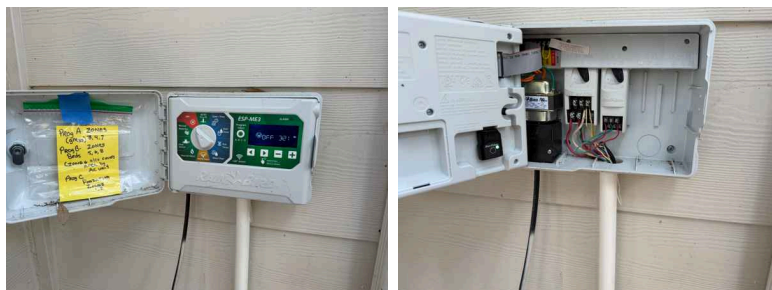
*Sprinkler System:* Rainbird, Controls located at rear of house, 8 zones -

An automatic sprinkler system was installed. The system included a control panel, one or more solenoid valves, underground water lines and with sprinkler heads.

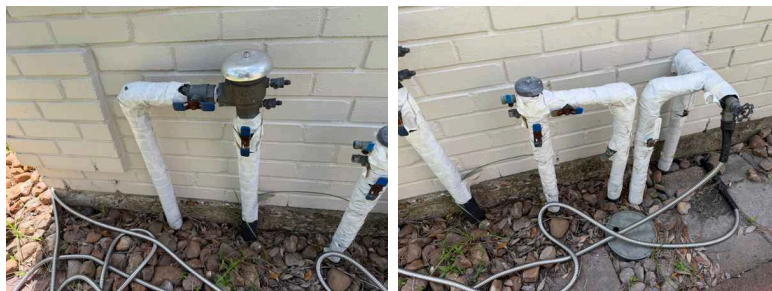
East

*Backflow Prevention Device - present:*

A backflow prevention device was present and was equipped with the two water shut off valves on the water supply line to the sprinkler system.
