## STRUCTURAL REPORT

10814 Overbrook Ln  
Houston, TX 77042

07/30/2026

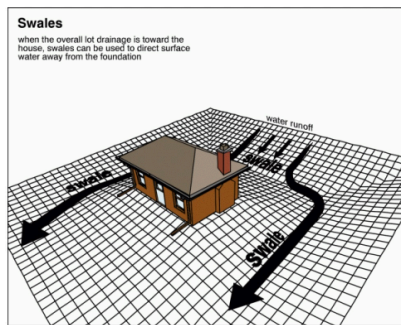
## Perimeter Grading/Drainage: Appeared adequate draining towards front

The perimeter drainage around the property appeared to generally be adequate, with drainage generally towards the front of the property. It could not be determined with certainty if water would pool at any localized low areas around the property. Further investigation with the homeowner is recommended to determine if there are any drainage problems or standing water after a rain.

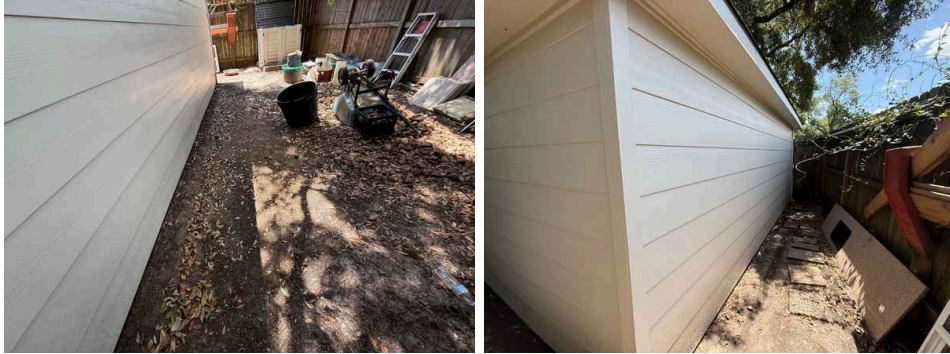
#### 4.6.2 Perimeter Grading/Drainage

### UNDERGROUND DRAIN, UNKNOWN EXIT POINT

The underground drainage system at the rear of the house was checked by running water into the drain, and the system was observed to be draining properly. However, we could not determine the exit point of the drainage system, and further investigation with the homeowner and/or a service company is recommended.

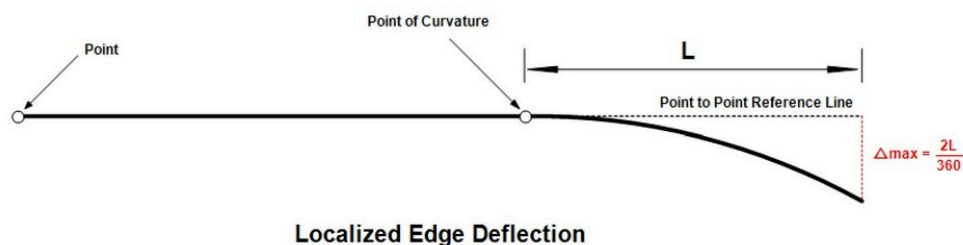
From the point of curvature located at the master bedroom to the east bedroom ( $L = 22$  feet), the maximum allowable deflection is 0.80 inches. We calculated a deflection of 1.60 inches at the time of inspection across this span, which is **greater than the maximum allowable deflection**. This observation can be observed along the **Red Line** in the sketch below.

Additionally, we analyzed the foundation a second time at a different location for **localized edge-condition deflections**. From the point of curvature located at the master bedroom to the south bedroom ( $L = 26$  feet), the maximum allowable deflection is 0.53 inches. We calculated an actual deflection of 0.86 inches at the time of inspection across this span, which is **greater than the maximum allowable deflection**. This observation can be observed along the **Blue Line** in the sketch below.

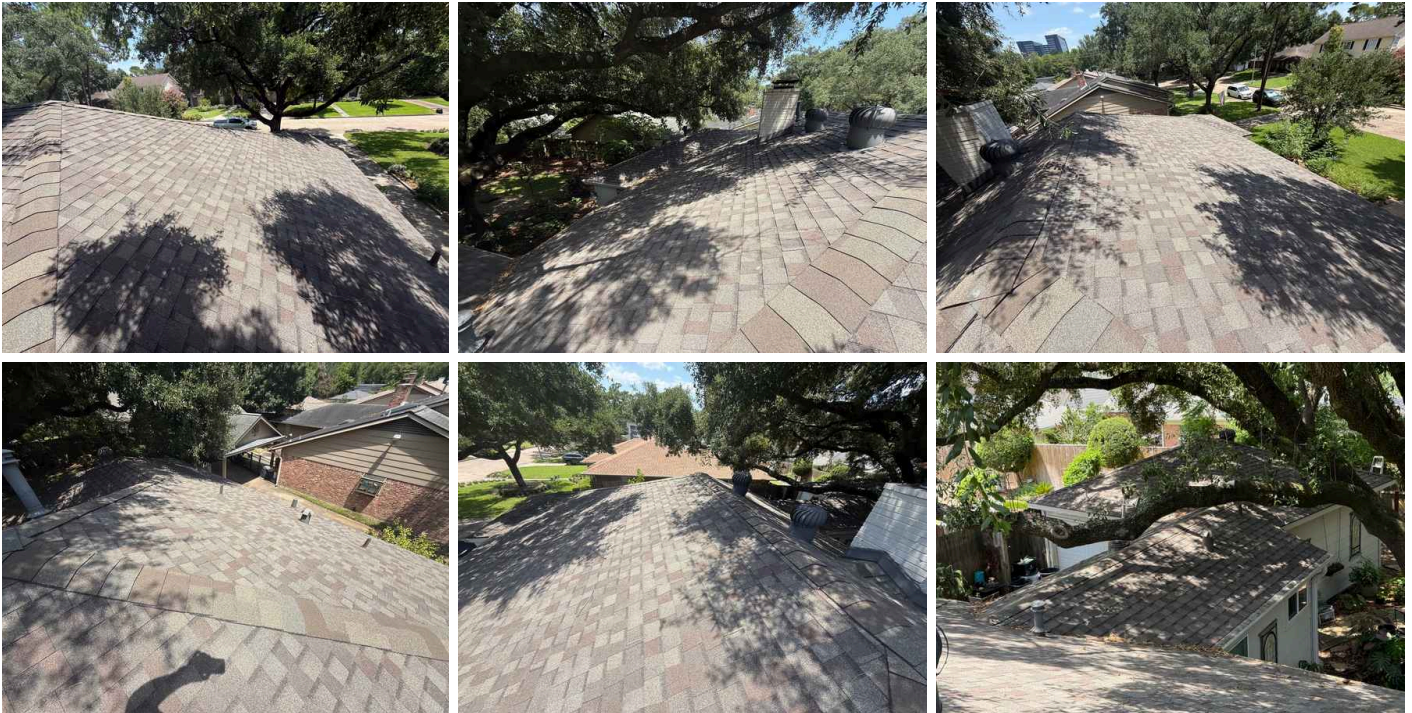
#### Age of Roof-Estimated by Inspector: Age of Roof: 1-3 years

The sellers disclosure statement was not available at the time of the inspection, and the age of the roof was unknown to the inspector at the time of the inspection. The roof appeared to the inspector to be approximately 1-3 years old.

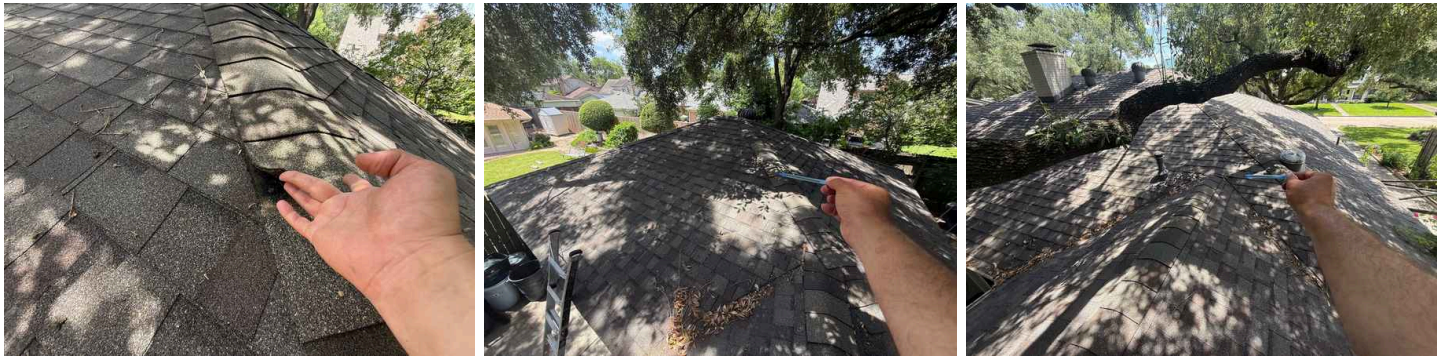
#### 6.8.2 Roof Details

### ROOF: MISCELLANEOUS

We observed some miscellaneous items related to the surface of the roof, including the items listed above. Have a roofing company determine the entire scope of the condition, and provide a cost estimate for repairs.

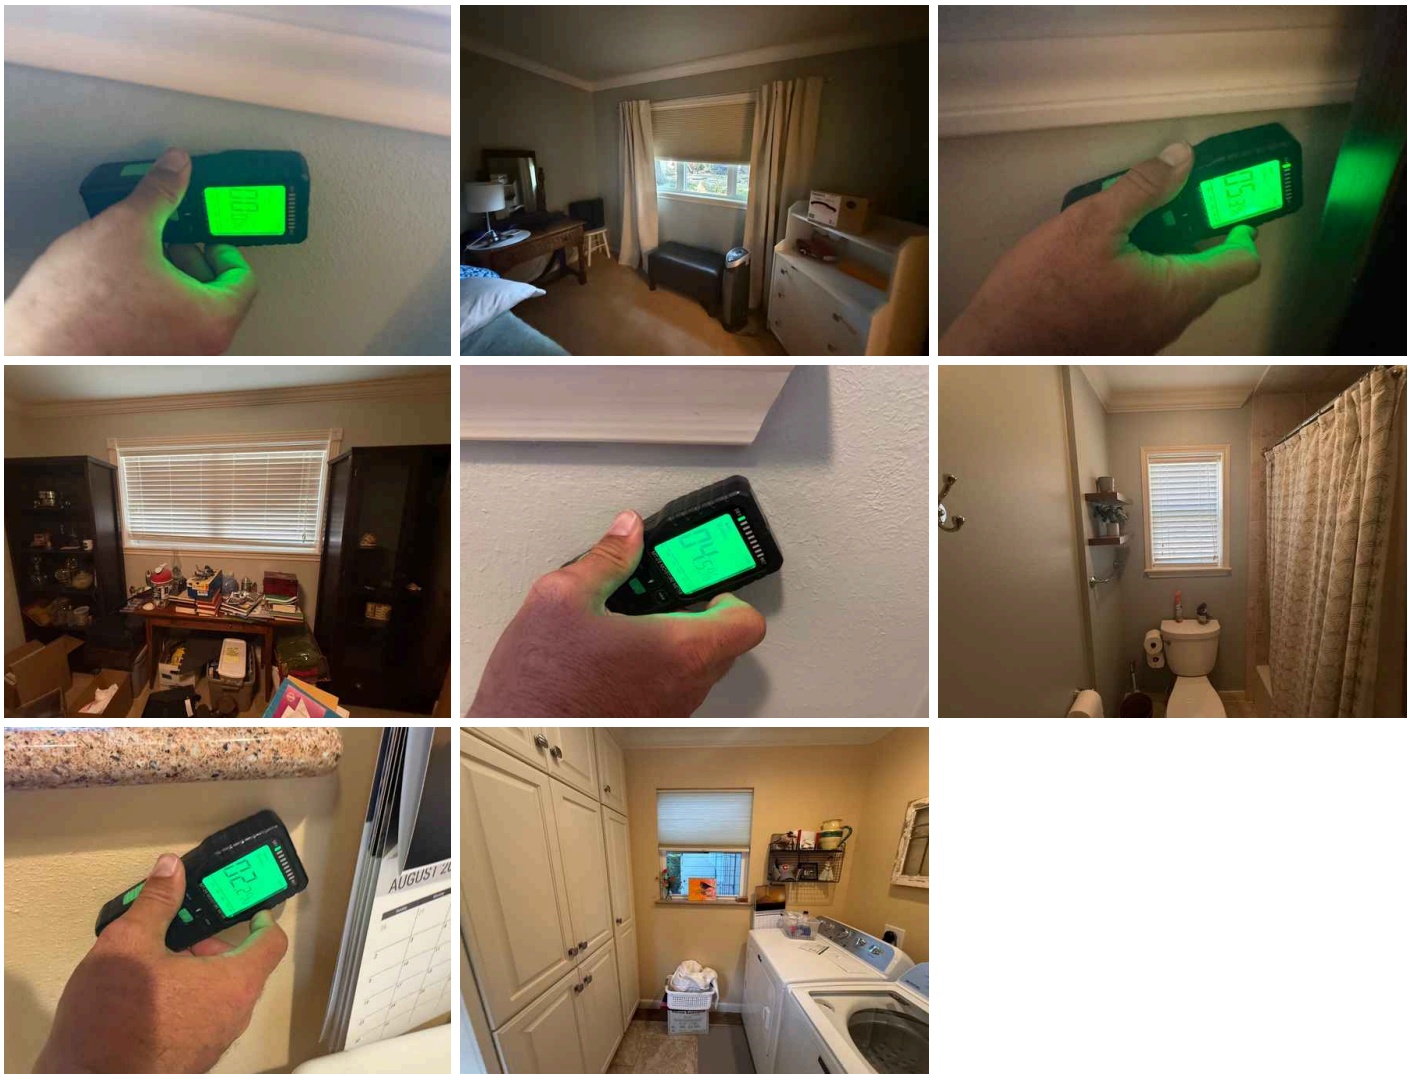
## MOISTURE METER - HIGH READING

Our moisture meter showed a higher than normal reading as shown in the photos below.

We checked around window and door openings and other locations susceptible to moisture with a moisture meter, and evidences of possible water penetration to the interior of the structure were observed, including the following conditions described above and shown below. Further investigation is recommended with service companies to determine possible source(s) of water penetration along with the scope of all secondary damages, and also to provide a cost estimate for all needed repairs.

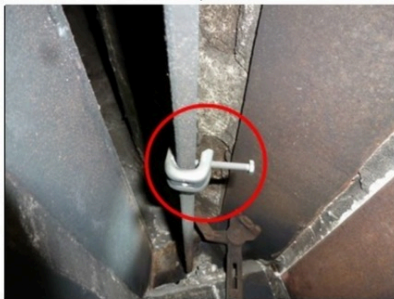
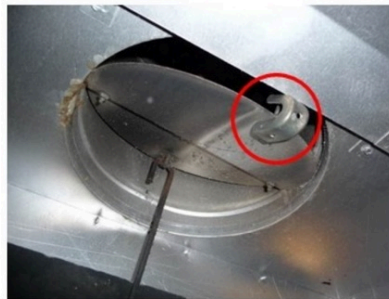
The damper was not equipped with a C-Clamp device to prevent closing the damper completely to allow the hazardous combustion gases a path to escape up the chimney.

HEI file photo showing c-clamp in masonry fireplace

HEI file photo showing c-clamp in metal fireplace

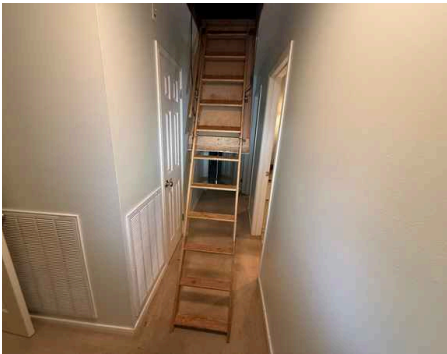
#### Ladder: Original ladder - Not rated

The access ladder into the attic appeared to be the original installation ladder, and the ladder was not labeled to indicate the rated capacity of the ladder. The ladder does not meet current code requirements for ladders into attics. Consideration should be given to replacing the ladder with a ladder that meets current code requirements.

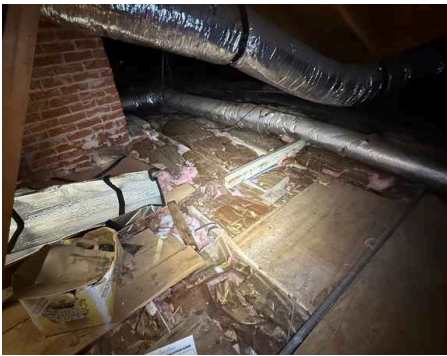
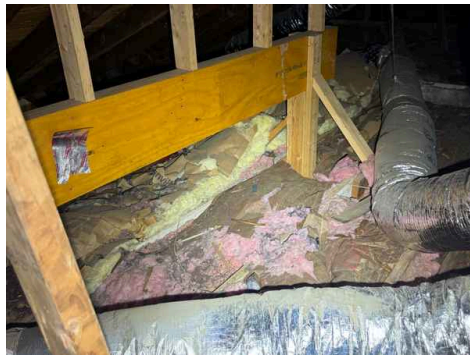
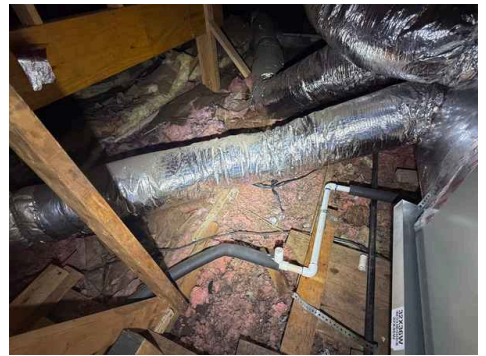
### Insulation: R19 - 6"

The insulation in the attic was average for a house of this age. The normal amount of insulation for houses of this age is approximately 6 inches, or an R19 energy rating. This attic appeared to have an average of approximately 5-7 inches of insulation in the ceiling. It is pointed out that the insulation requirements according to the latest standard for new houses in this area is an R38 energy rating.

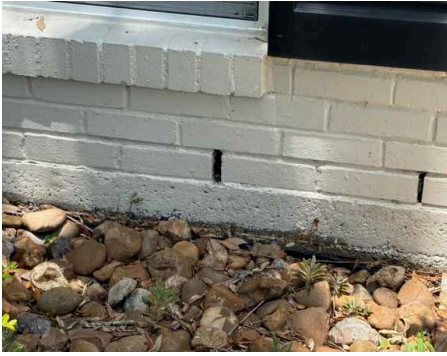
#### Brick/Stone Veneer: Some weepholes observed

We observed a minimal number of weepholes to be present in the brick veneer at the time of the inspection. Typically, weepholes are spaced no more than 33 inches apart.

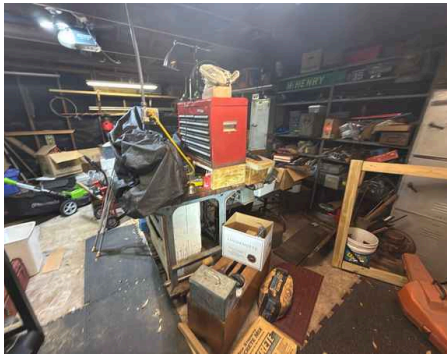
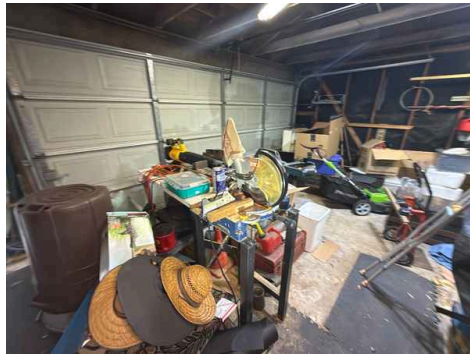
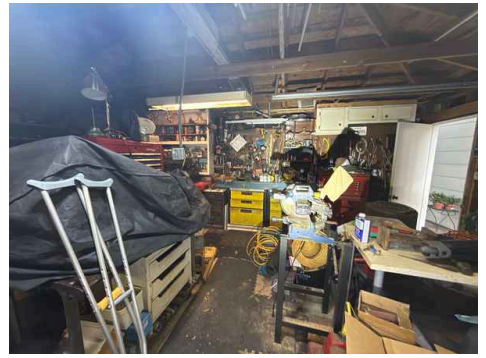
## Garage: Foundation Cracked-Monitor

The concrete floor of the garage was observed to have one or more cracks, but was still functional at the time of the inspection. The exterior perimeter of the garage has experienced some settlement, but the degree is not such at this time to recommend foundation releveling. The garage foundation should be monitored in the future for additional movement as it can be expected that additional movement can take place.

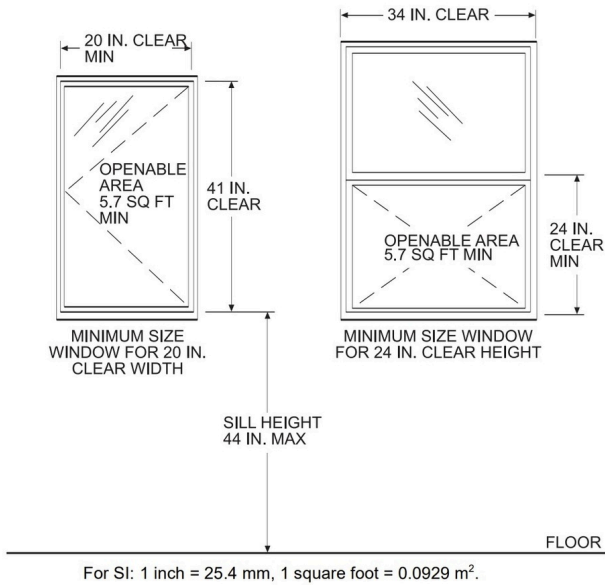
Figure R310.1  
EMERGENCY ESCAPE AND RESCUE WINDOW

The window was installed greater than 44 inches above the grade, which is considered to be a fire safety hazard. The height of the window prevents ready access for a fireman to enter the home through the window in case of a fire. Further investigation with a contractor is recommended to make all needed repairs.
