# ***Fox Inspection Group***

## **Frame Inspection Report**

13802 Arroyo Grande, Cypress, TX 77433  
Inspection prepared for: Jorge Galeano  
Real Estate Agent: Aaron Greeley - CB&A, Realtors

Date of Inspection: 9/21/2023 Time: 9:00 AM  
Age of Home: 2023 Size: 3001  
Order ID: 108701

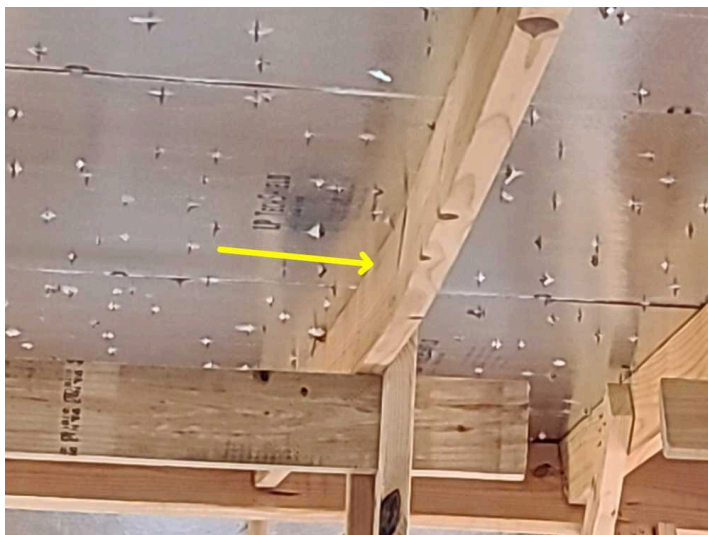
Rafters warped North side of attic above entry hall. Roof decking is not rated for the distance between rafters. May cause sags in roof decking and or soft spots.

Rafters warped North side of attic above entry hall. Roof decking is not rated for the distance between rafters

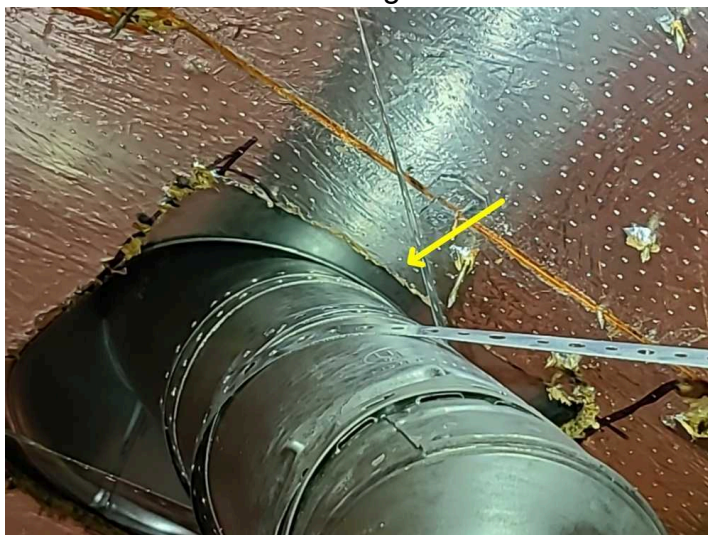
The furnace exhaust vent pipe is in contact with or does not have required minimum 1" clearance from combustible material

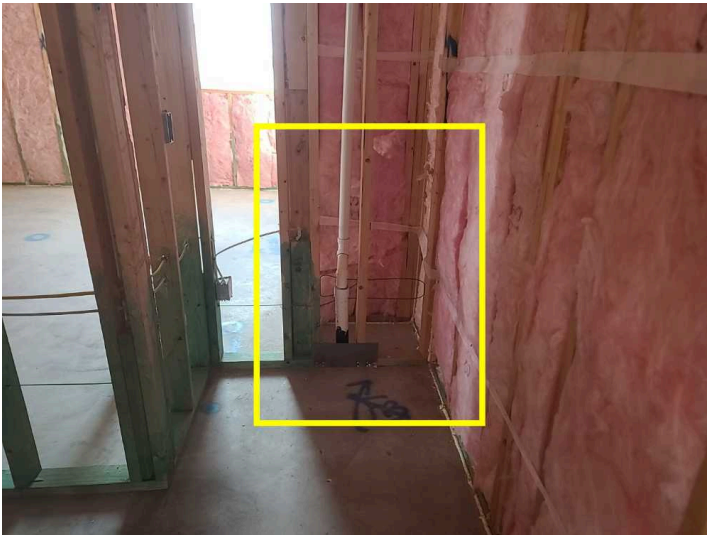
Sink water supply lines and sink drain at laundry room were not present at time of inspection. Should be addressed before sheetrock.

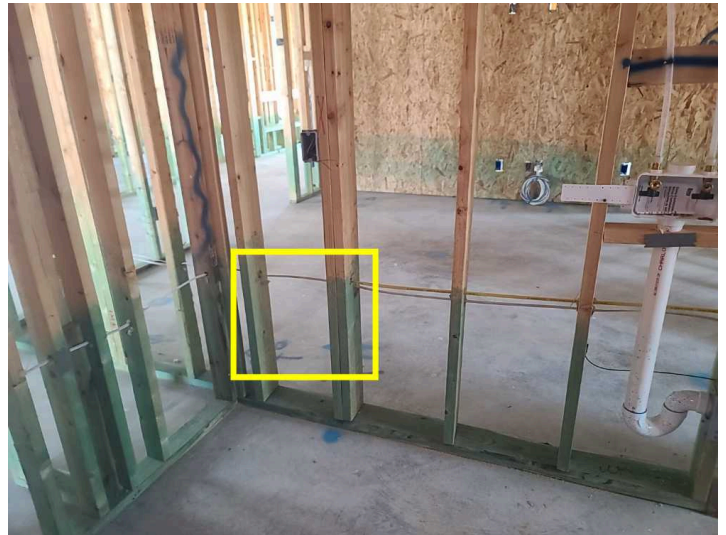
Refrigerator water supply line at laundry room was not present at time of inspection. Should be addressed before sheetrock

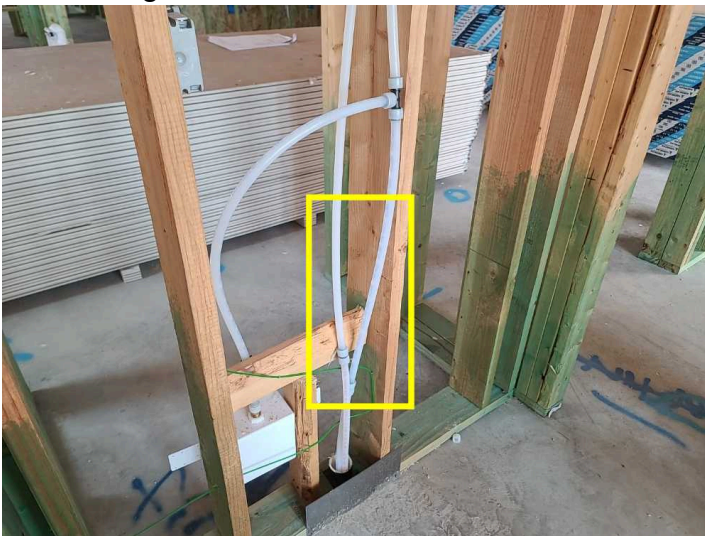
Water supply line not properly secured at; refrigerator area

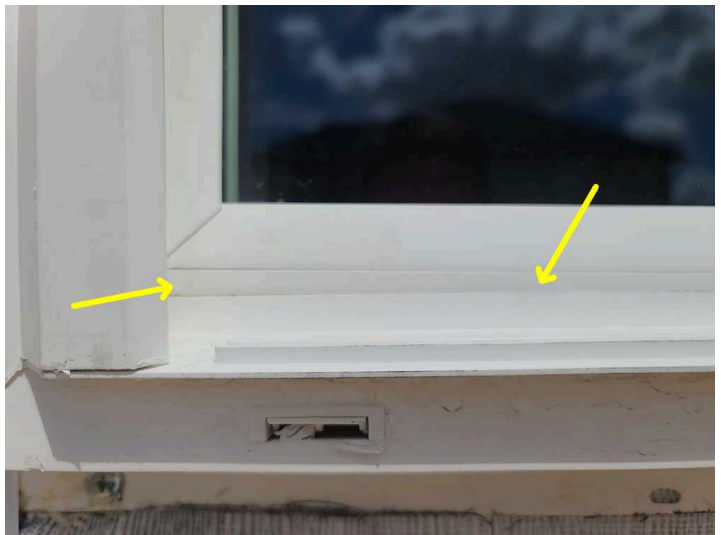
Lower window frames/ sills are not square/ not level. Flanges need adjustment; South bedroom

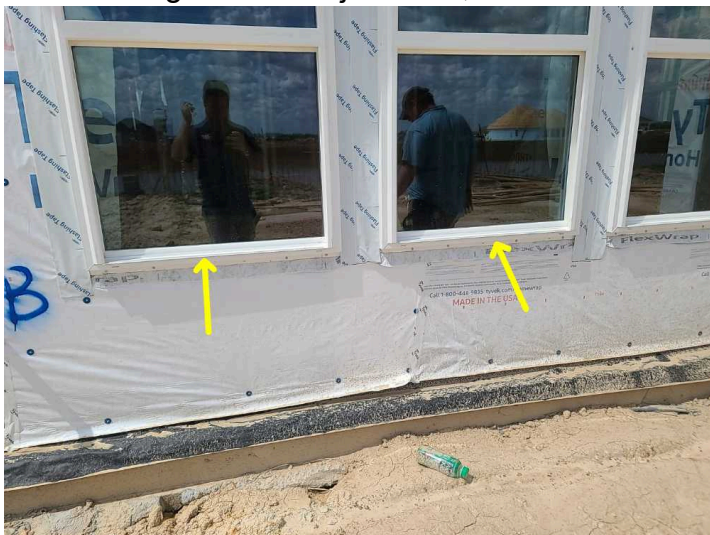
Lower window frames/ sills are not square/ not level. Flanges need adjustment; bonus/ flex room

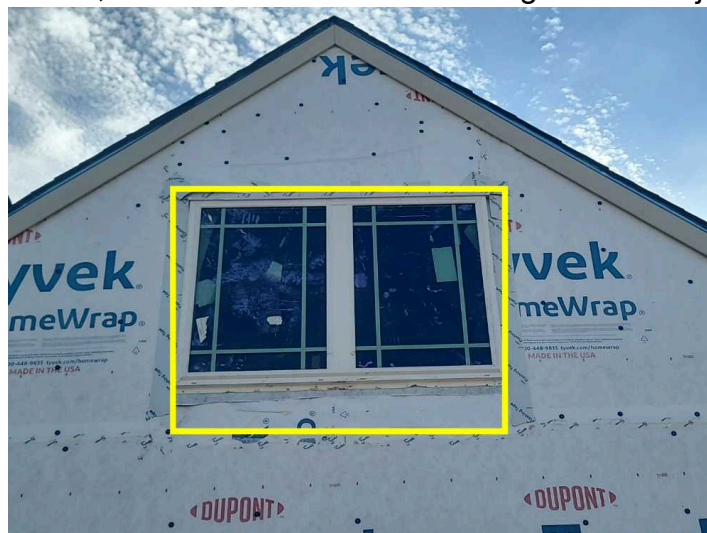
Garage attic windows lost their seals
