CONCERNING THE PROPERTY AT 5123 Crystal Bay Drive, Houston, Texas 77084

PROPERTY INSPECTION REPORT

Stacey Megginson License #22905
Bayou City Home Inspections

5123 Crystal Bay Drive
Inspection Prepared For: Caleb Karshner
Agent: Caleb Karshner -

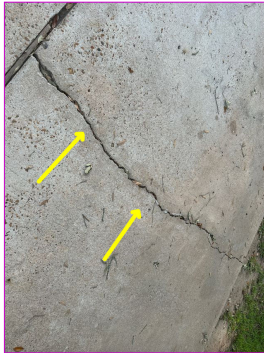
Common cracks (1/4-inch or less) were visible in the driveway. Cracks exceeding 1/4-inch should be filled with an appropriate material to avoid continued damage.

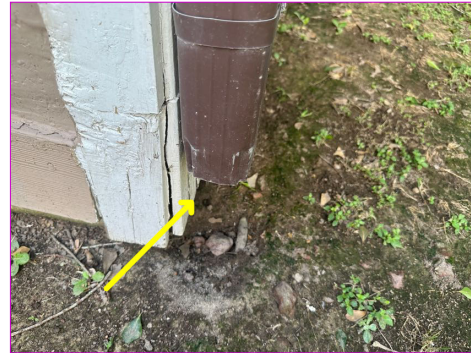
One or more downspouts discharged roof drainage next to the foundation. This condition can effect the ability of the soil to support the weight of the structure above and can cause damage related to soil/foundation movement. The Inspector recommends the installation of downspout extensions to discharge roof drainage a minimum of 6 feet from the foundation.

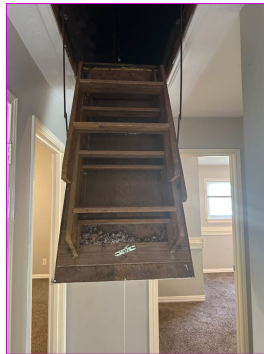
The attic access hatch cover was not insulated.

The Inspector recommends insulating the attic access hatch cover to reduce unwanted heat loss/gain.

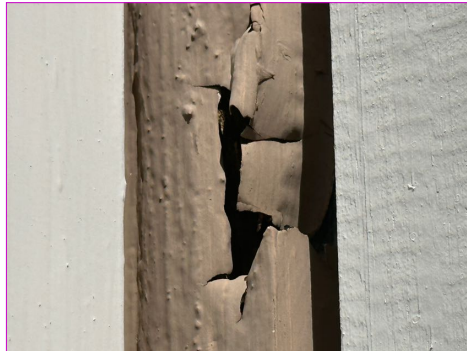
- Wood siding covering exterior walls of the home had areas of advanced deterioration that will allow moisture intrusion of the wall assembly. The Inspector recommends replacement of siding in any such areas to help prevent damage from moisture intrusion to the home materials and the exterior wall structure. All work should be performed by a qualified contractor.

Wood siding covering exterior walls of the home had areas of advanced deterioration that will allow moisture intrusion of the wall assembly. The Inspector recommends replacement of siding in any such areas to help prevent damage from moisture intrusion to the home materials and the exterior wall structure. All work should be performed by a qualified contractor.

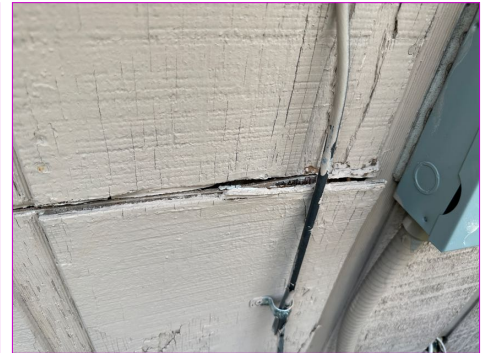
Wood siding covering the exterior walls of the home was old and exhibited weathering commensurate with the age of the home. It appeared to be adequately protecting the home at the time of the inspection.

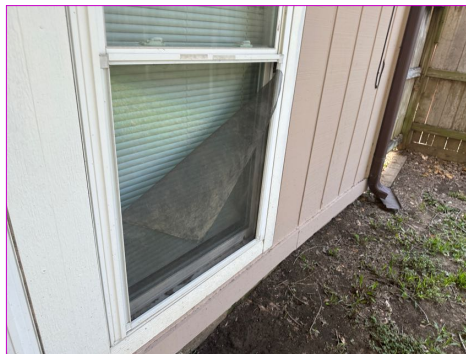
One or more windows have missing or damaged window screens. Recommend replacing or installing new ones.

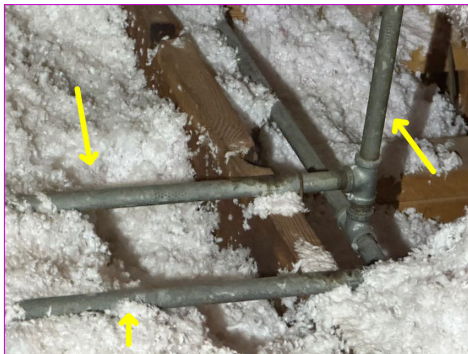
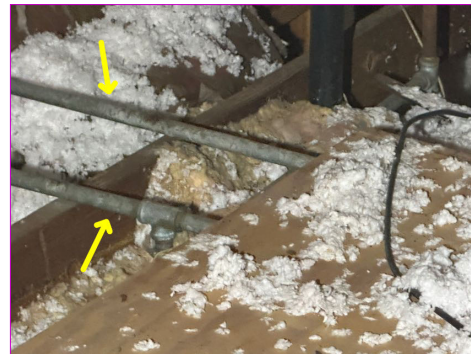
Some water supply pipes in the home were half-inch galvanized steel. This pipes are old, and of a material no longer installed for this purpose due to bore shrinkage from accumulation of interior corrosion that over time reduces water flow. These pipes may need to be replaced soon. The Inspector recommends that before the expiration of your Inspection Objection Deadline you consult with a qualified contractor to discuss the necessity, options and costs for replacement.
