# 25243 Saddlebrook Ranch Dr

| Type | <b>Home Inspection and Floor Plan Report - 25243 Saddlebrook Ranch Dr</b> |
| Inspected by | <b>HomeTeam Inspection Service - North Houston</b> |
| Completed | <b>September 13, 2025, 12:43 AM</b> |

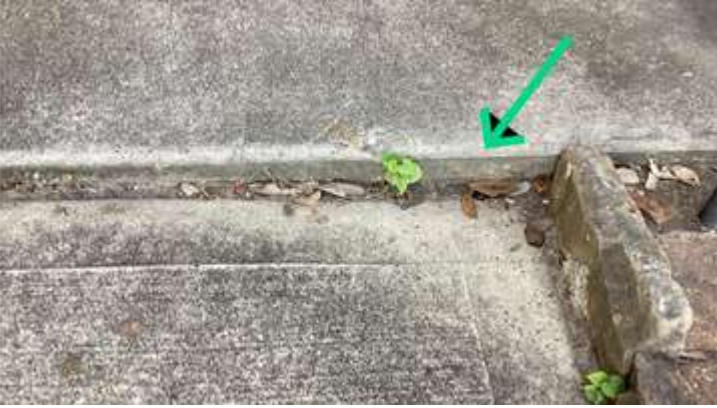
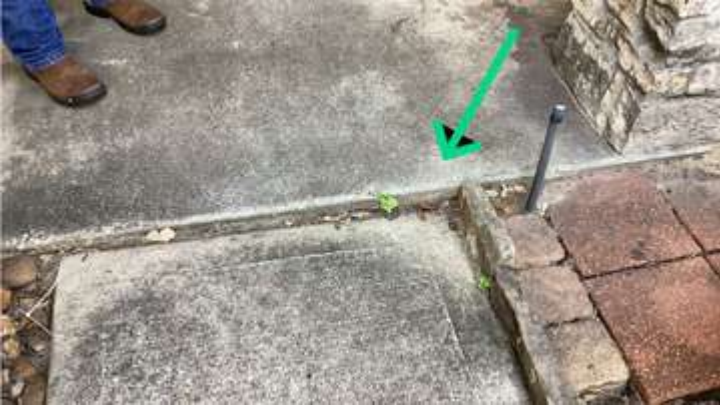
Trip Hazard

The sidewalk, patio, driveway, or walkway is unlevel.

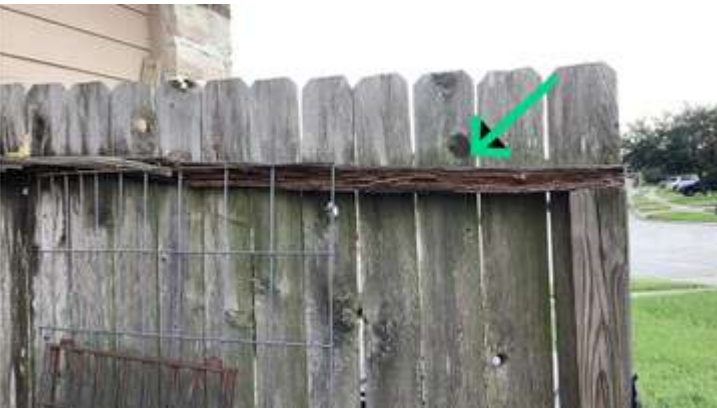
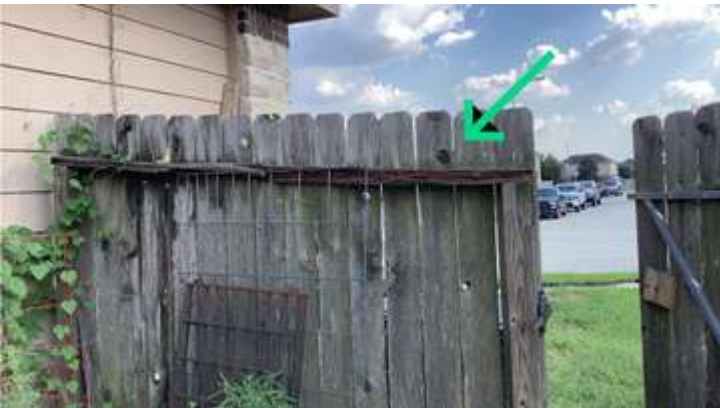
Damaged Fence / Gate

The fence or gate is damaged in one or more areas.

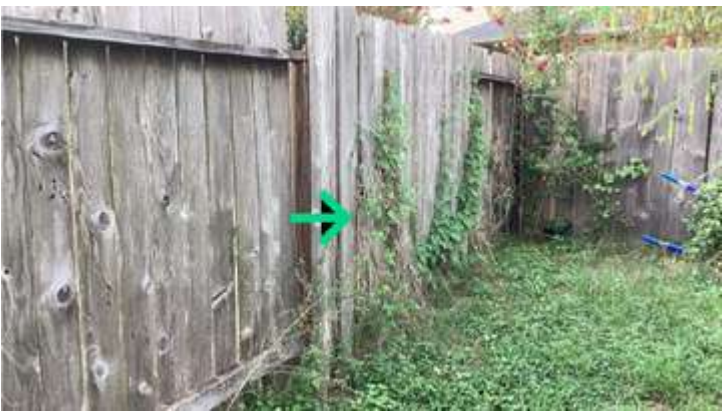
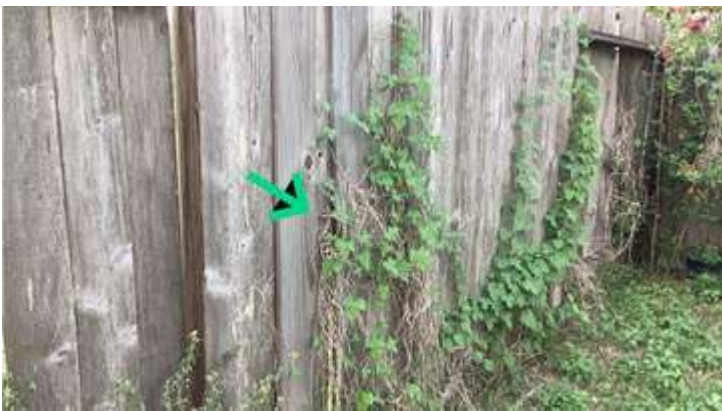
There is vegetation growing on the fence.

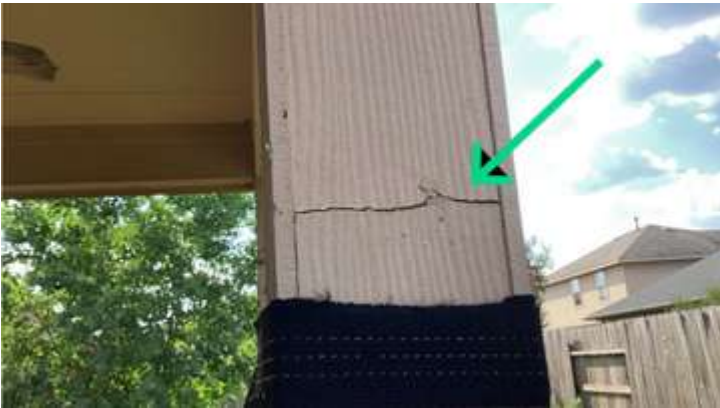
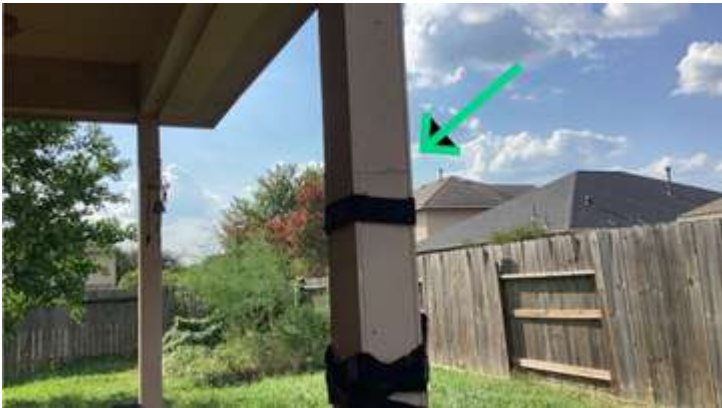
Monitor deficiency

**Minor Cracks in Patio / Porch**

There are minor cosmetic cracks on the patio / porch.

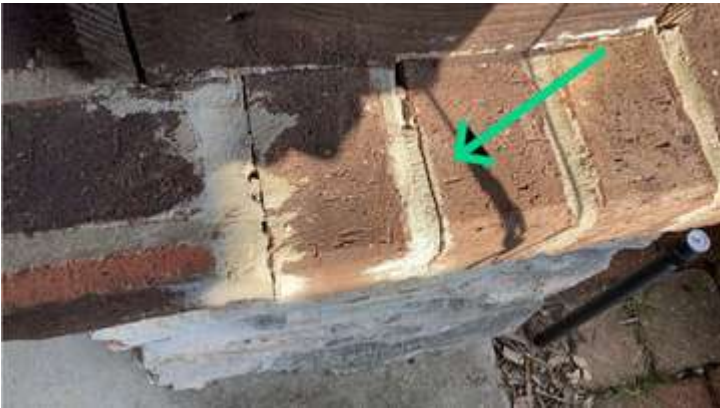
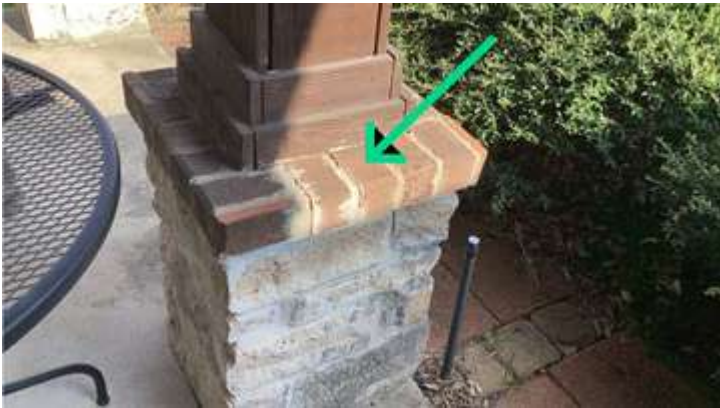
Repair deficiency

Damaged Brick Mortar

The mortar is cracked / damaged in one or more areas.

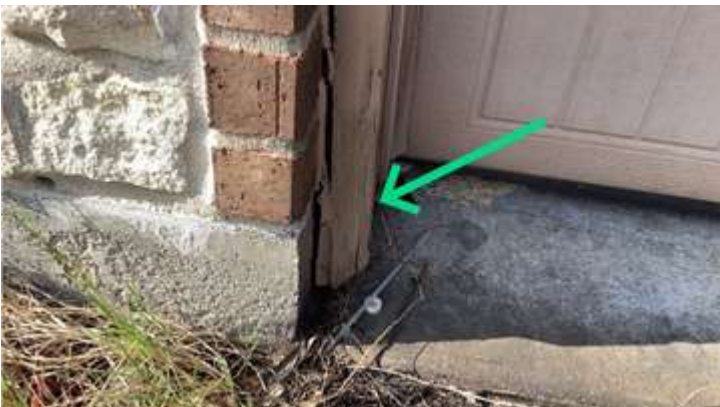
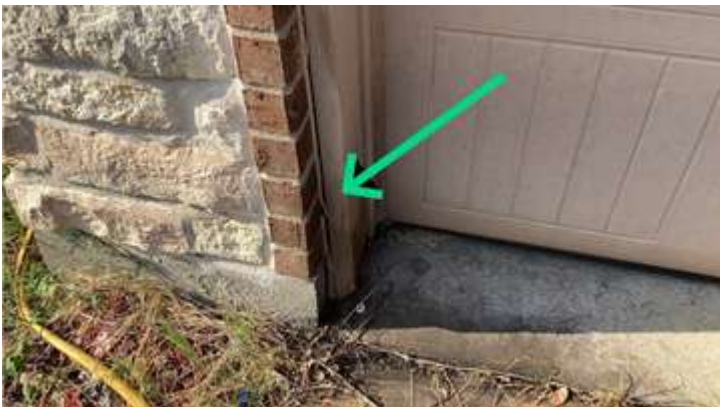
**Repair deficiency**

Damaged Trim

There are signs of damage to the trim.

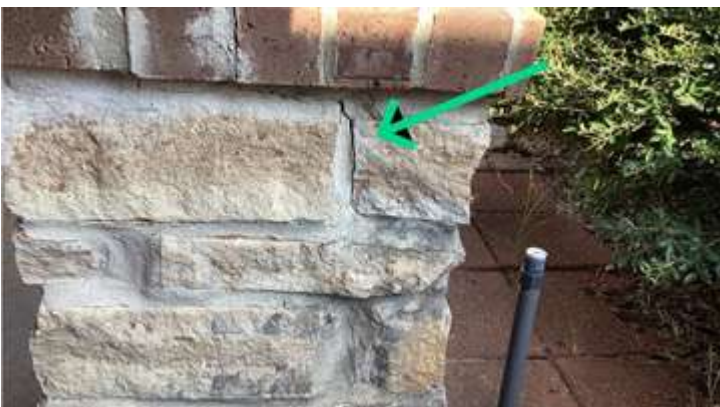
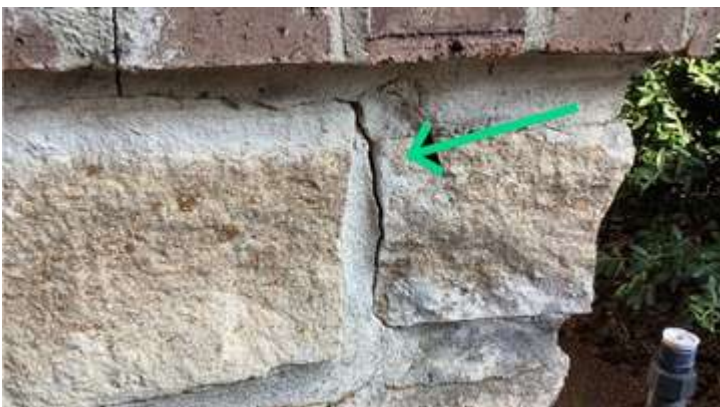
**Monitor deficiency**

Cracks and stone mortar

Multiple areas of the stone mortar has cracks

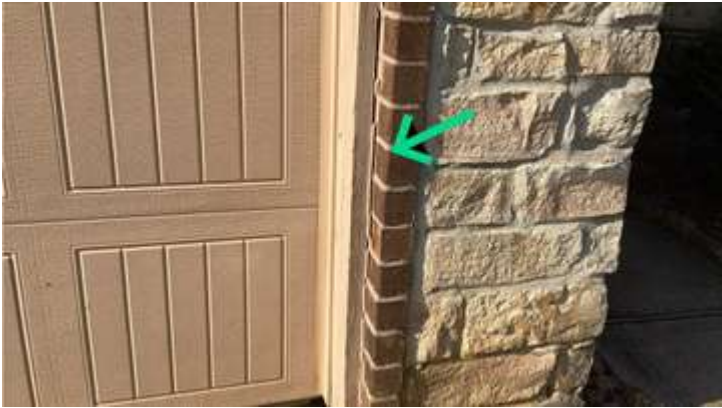
Monitor deficiency

Deterioration of trim caulking

One or more areas of the caulking sealing the trim is deteriorated

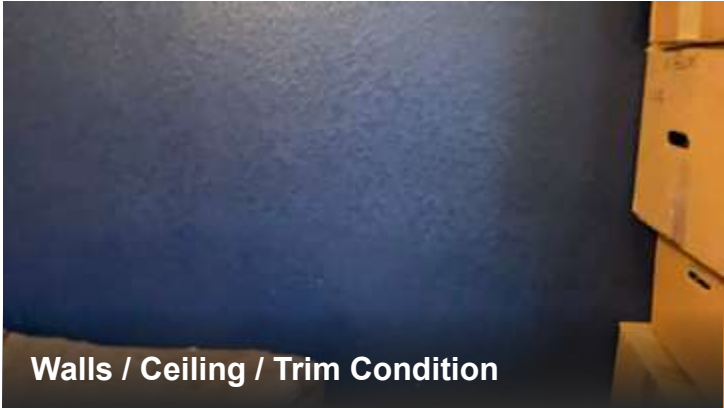
Walls / Ceiling / Trim Condition

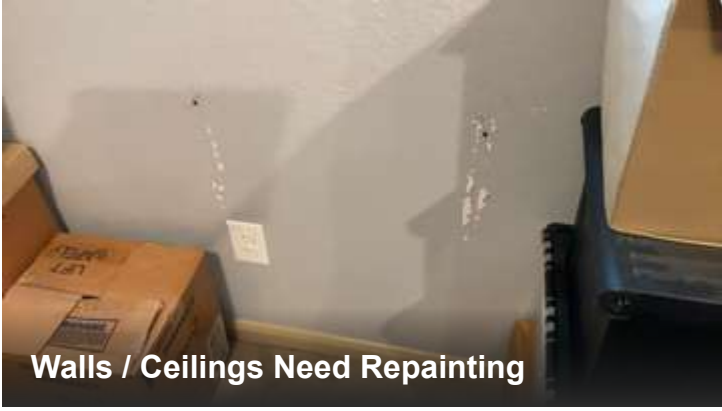
Walls / Ceilings Need Repainting

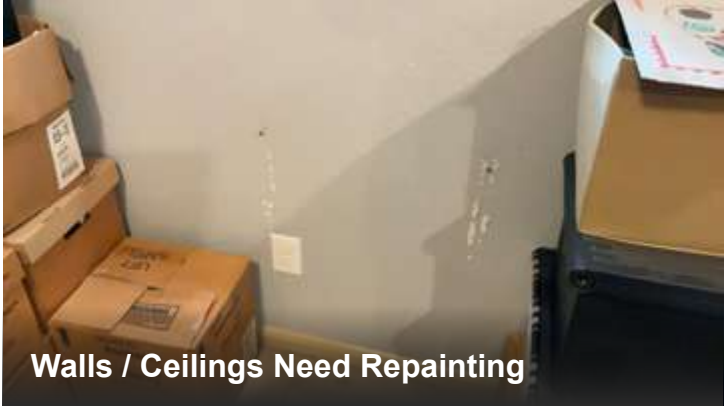
Walls / Ceilings Need Repainting

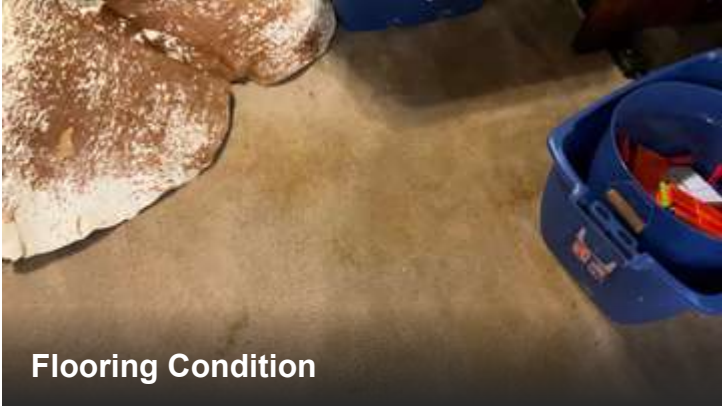
Flooring Condition

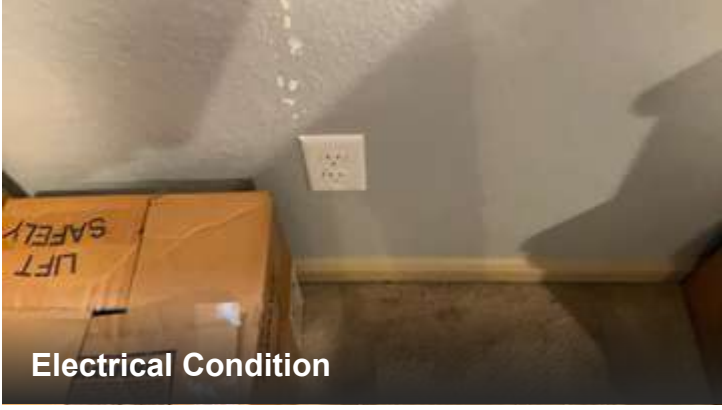
Electrical Condition

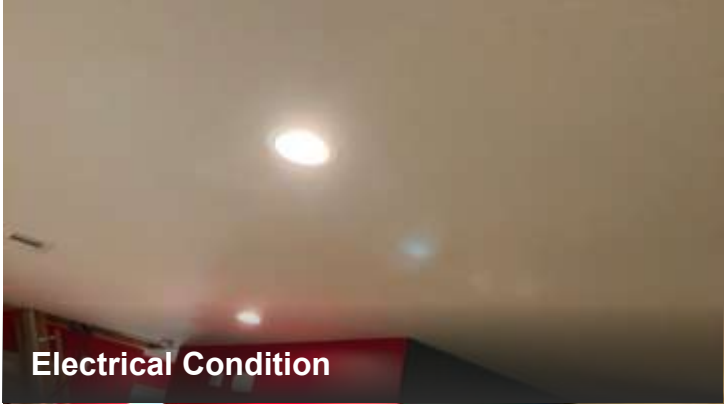
Electrical Condition

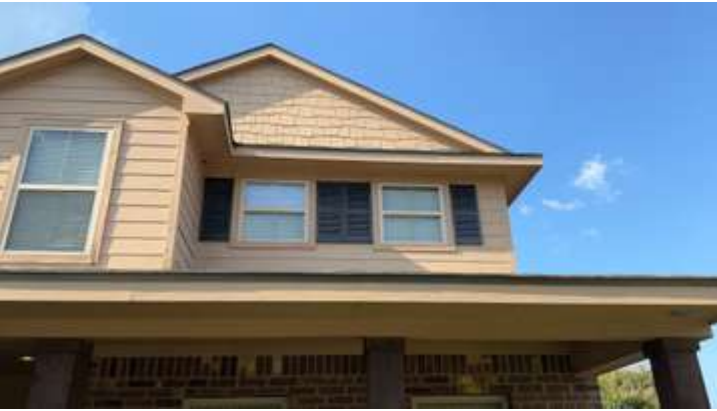
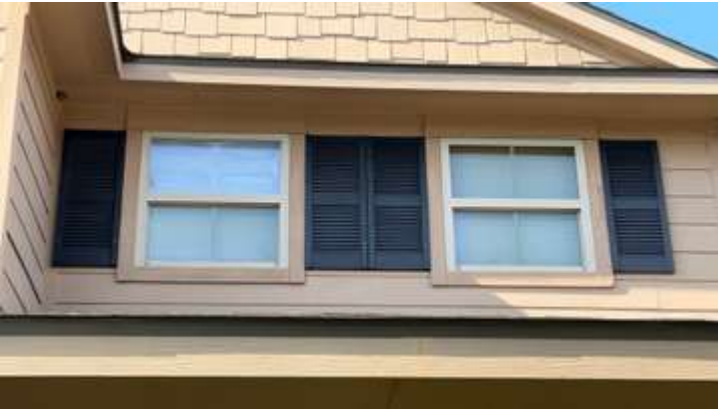
**Repair deficiency**

**Missing window screens**

The screens were missing.

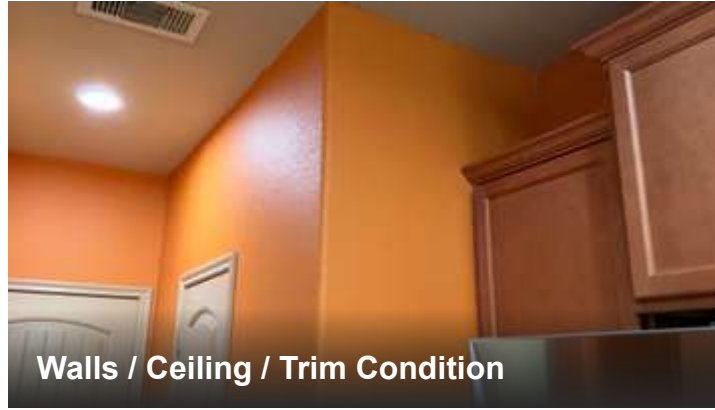
Walls / Ceiling / Trim Condition

**Noticeable Wear (Fading / Scuffs / Minor Damage)**

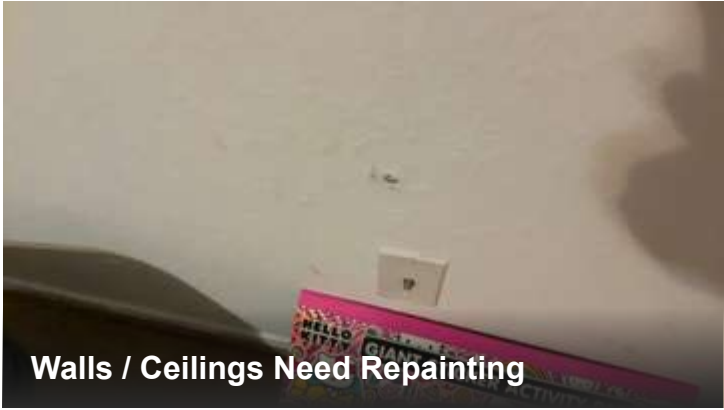
Walls / Ceilings Need Repainting

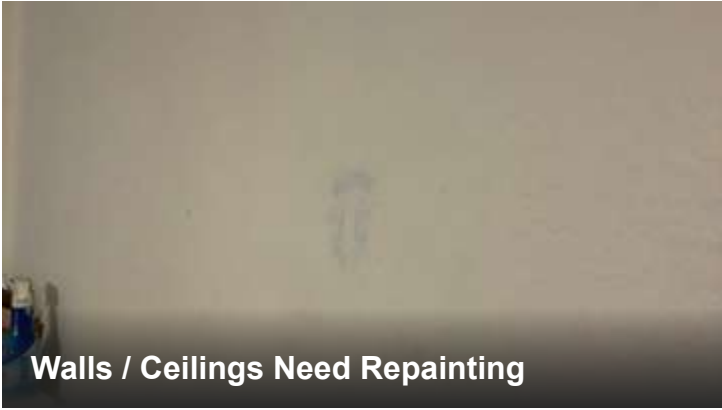
Walls / Ceilings Need Repainting

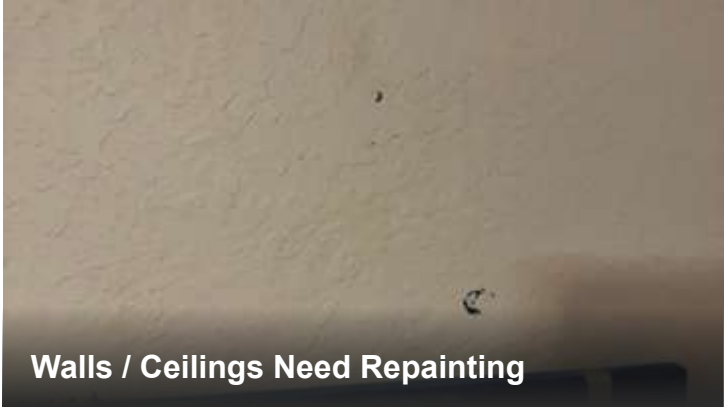
Walls / Ceilings Need Repainting

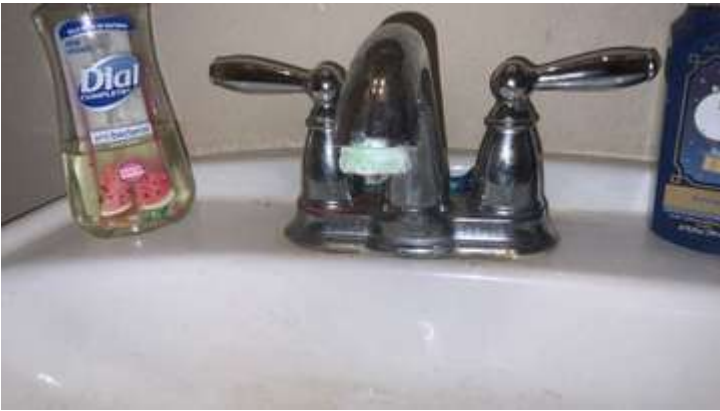
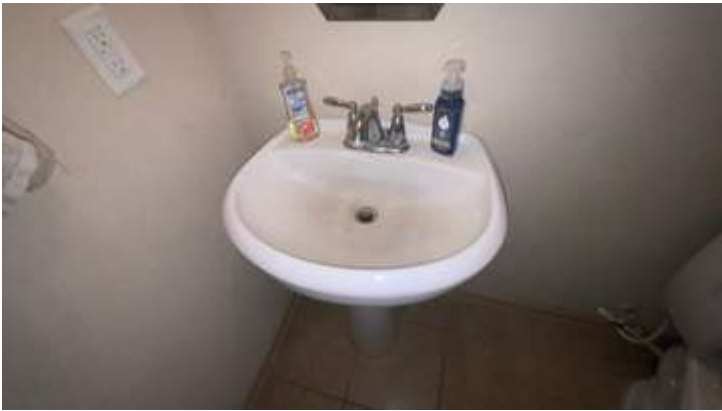
**Repair deficiency**

The water will not shut off completely.

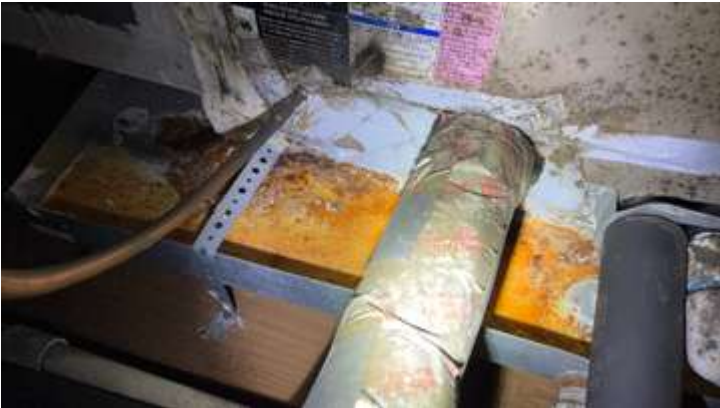
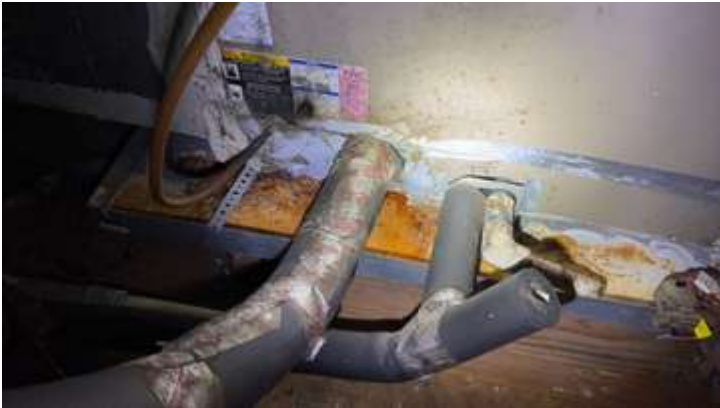
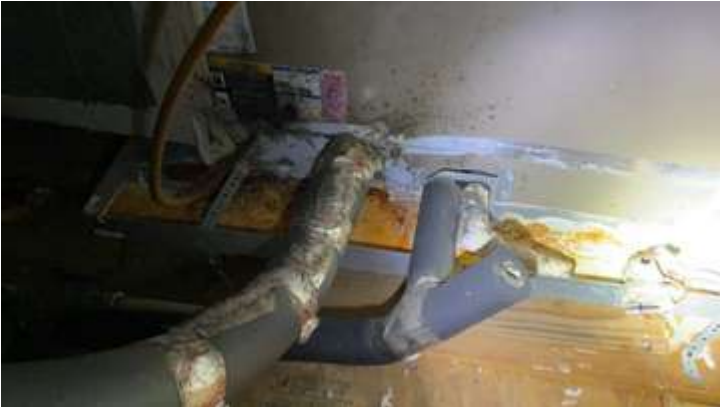
**Repair deficiency**

## Rusting or Damaged HVAC Drip Pan

The drip pan below the air conditioning unit is rusting or damaged.

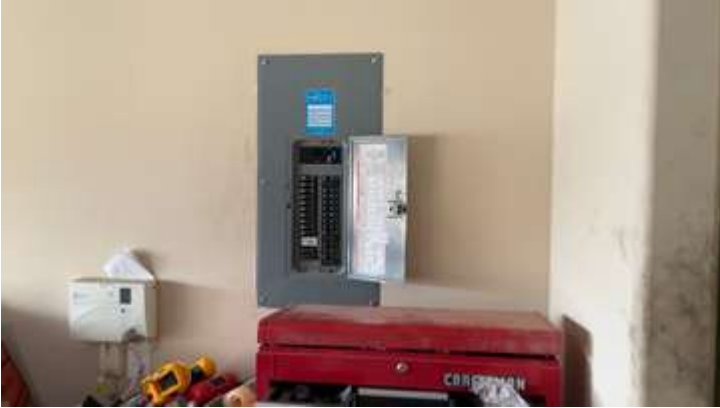
Limitation

Electrical Main Panel Condition: No Access

Stored items to include a toolbox, a bench and a deep freezer where blocking access to the panel preventing removal of the cover.

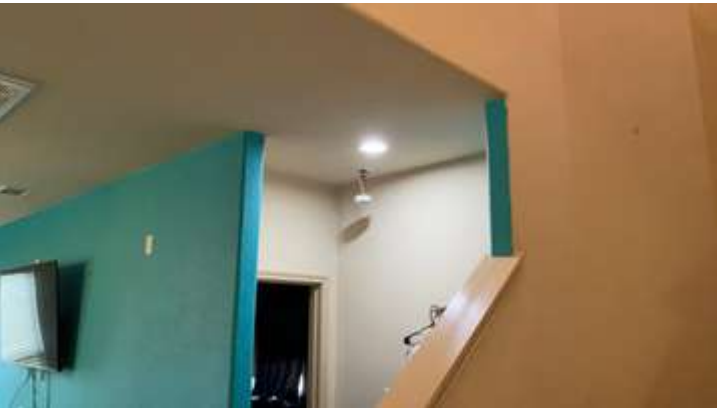
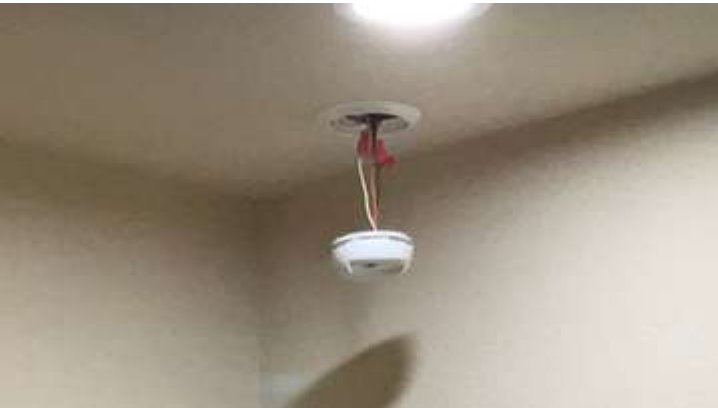
**Repair deficiency**

**Smoke alarm not installed properly**

Some smoke alarms were not installed properly.

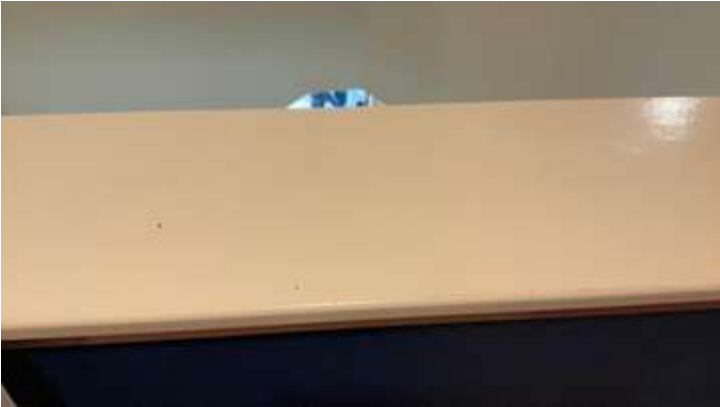
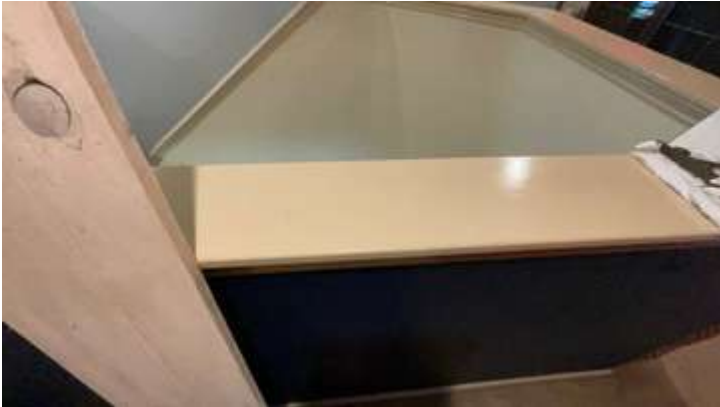
Repair deficiency

Pet odor was observed as mentioned in other areas of this report.
