# 166 Hawkhurst Cir

# Magnolia, Texas 77354

| Type | <b>Home Inspection and Floor Plan Report - 166 Hawkhurst Cir</b> |
| Inspected by | <b>HomeTeam Inspection Service - North Houston</b> |

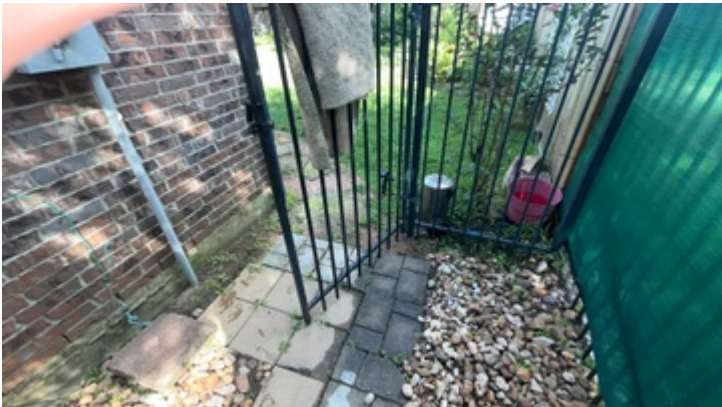
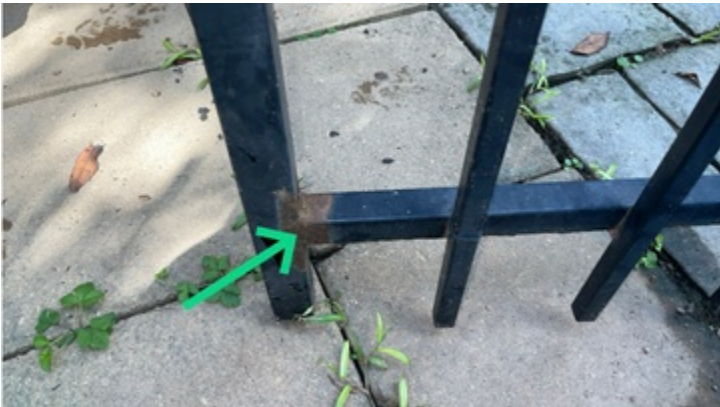
Monitor deficiency

Rusted Gate / Gate Hardware

The gate / gate hardware is rusted in one or more areas.

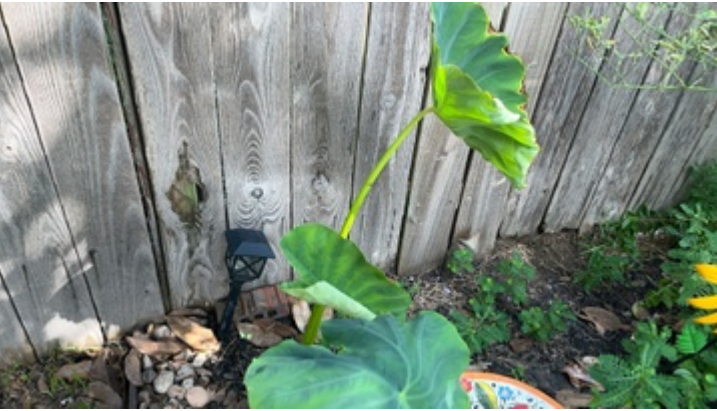
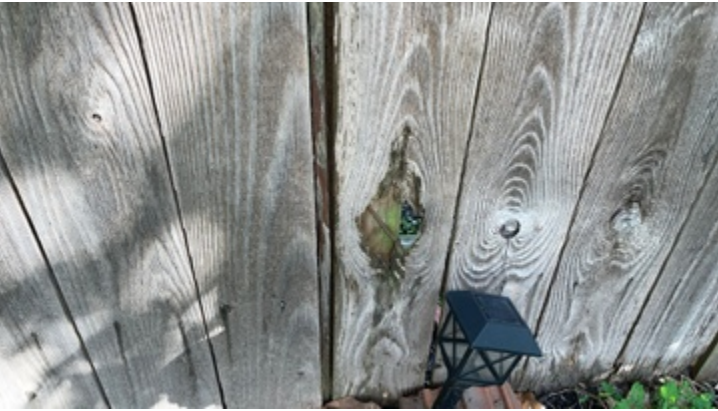
Monitor deficiency

## Damaged or Cracked Fence / Wall

The fence or perimeter wall has cracks or damage.

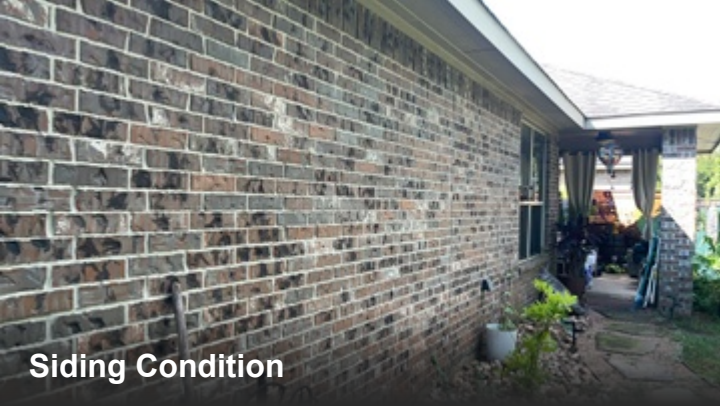
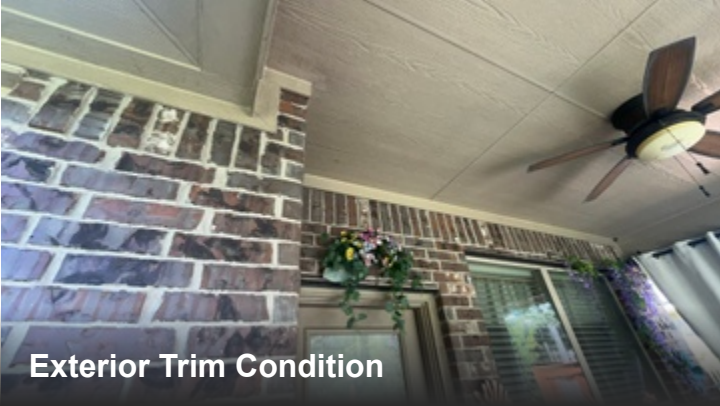
Repair deficiency

Damaged Trim

There are signs of damage to the trim.

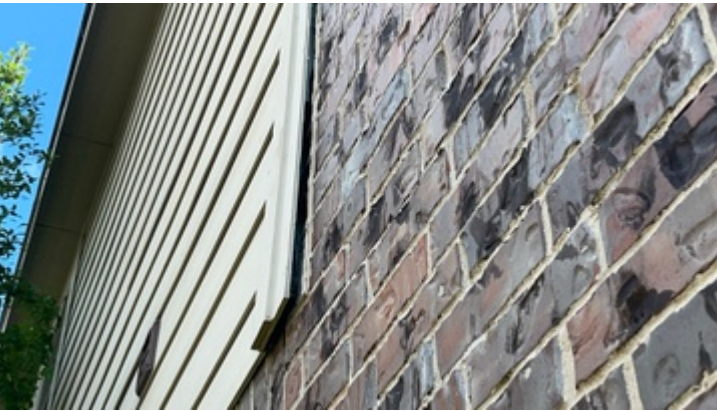
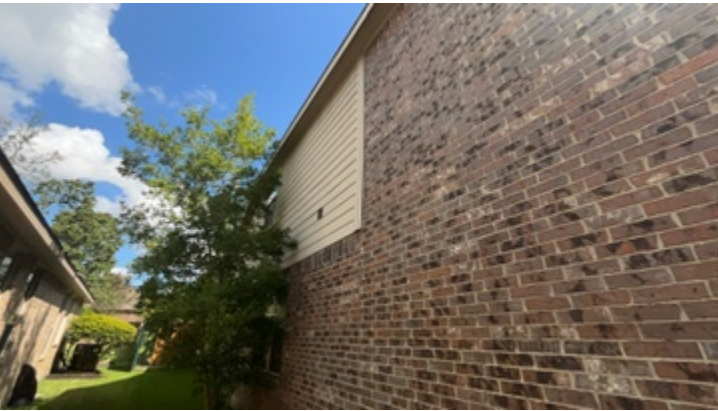
**Repair deficiency**

**Improperly Installed Siding**

The siding is incorrectly installed.

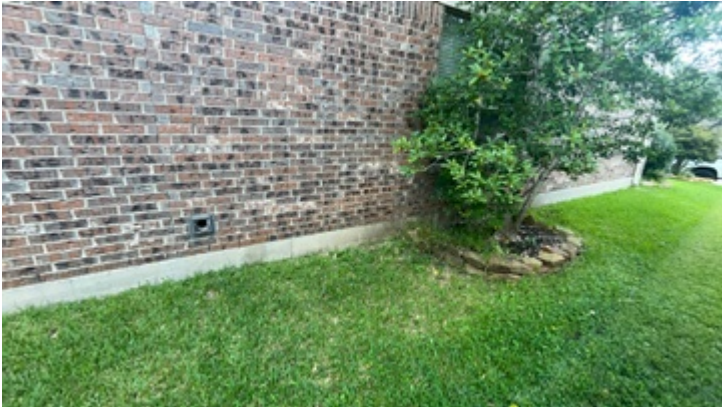
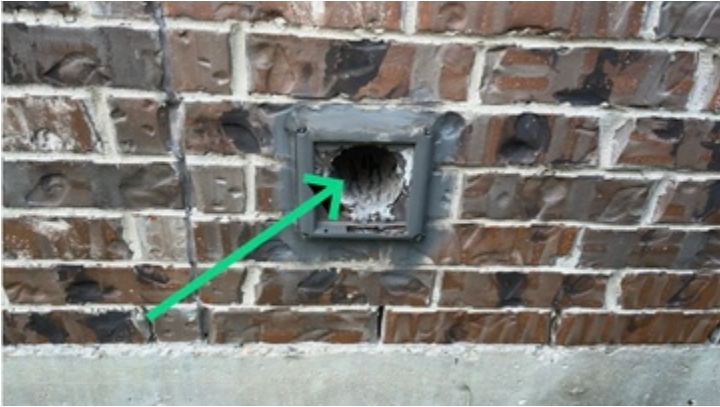
Repair deficiency

## Damaged / Missing Exterior Dryer Flapper

The outside flapper is damaged or missing.

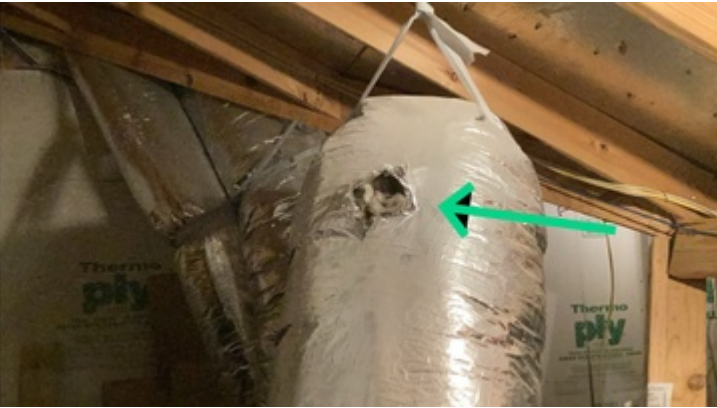
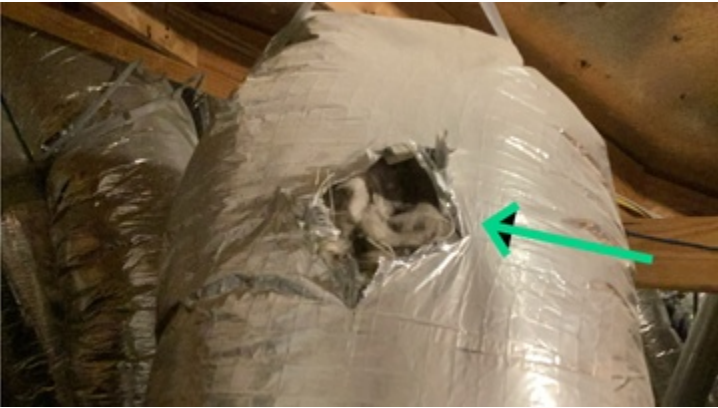
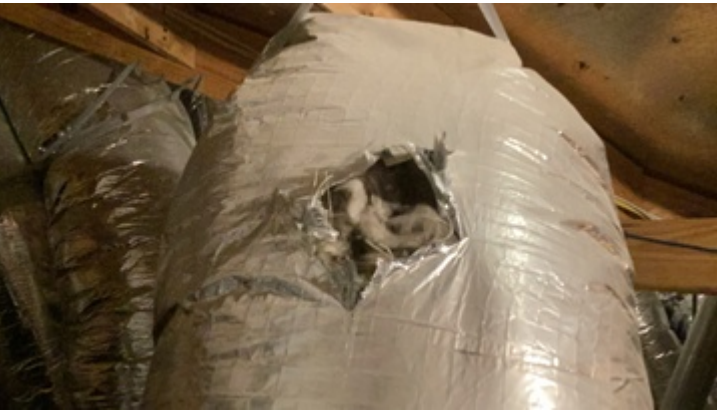
**Damaged / Deteriorating Ductwork**

The ductwork is damaged / deteriorating.

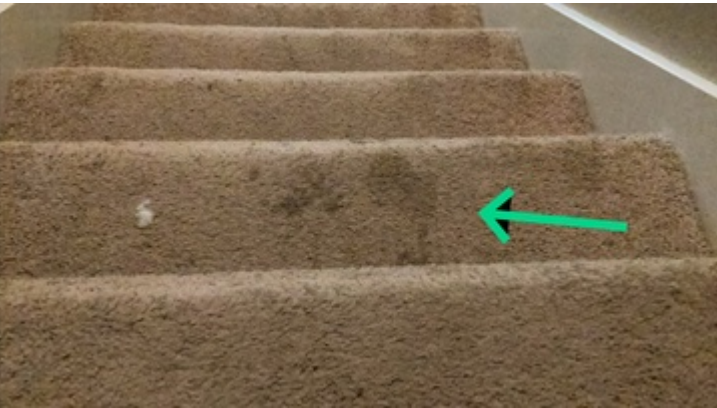
**Stained Carpet**

The carpet has areas of staining or discoloration.

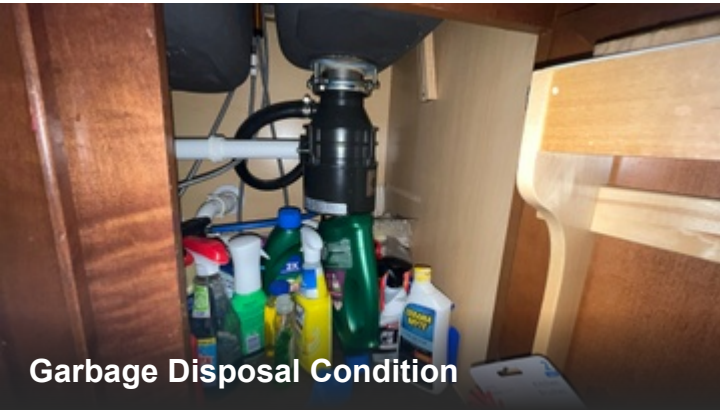
Garbage Disposal photos / videos

Garbage Disposal Condition

Non-Functional

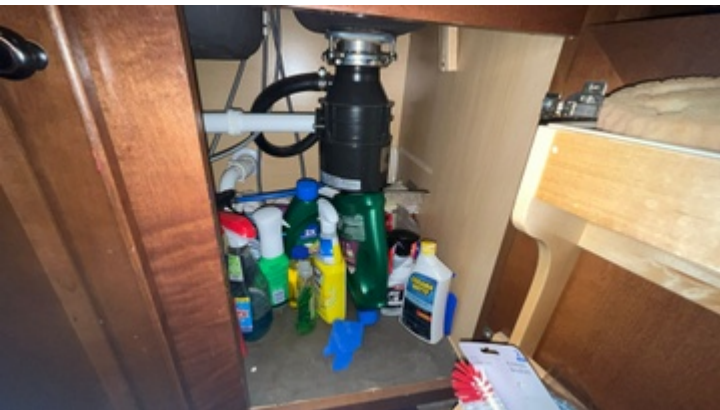
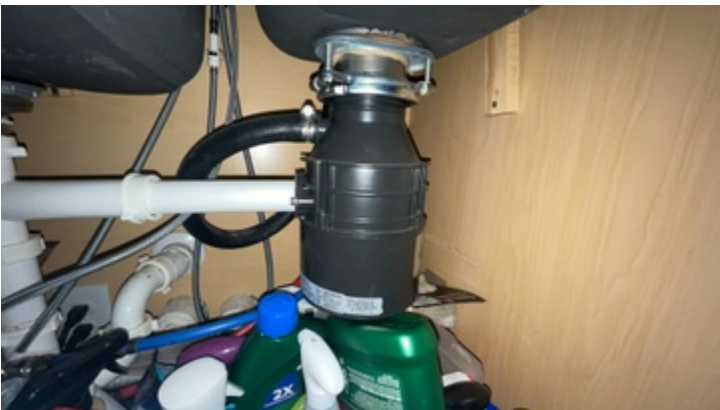
Garbage Disposal photos / videos

**Repair deficiency**

The garbage disposal is inoperable.

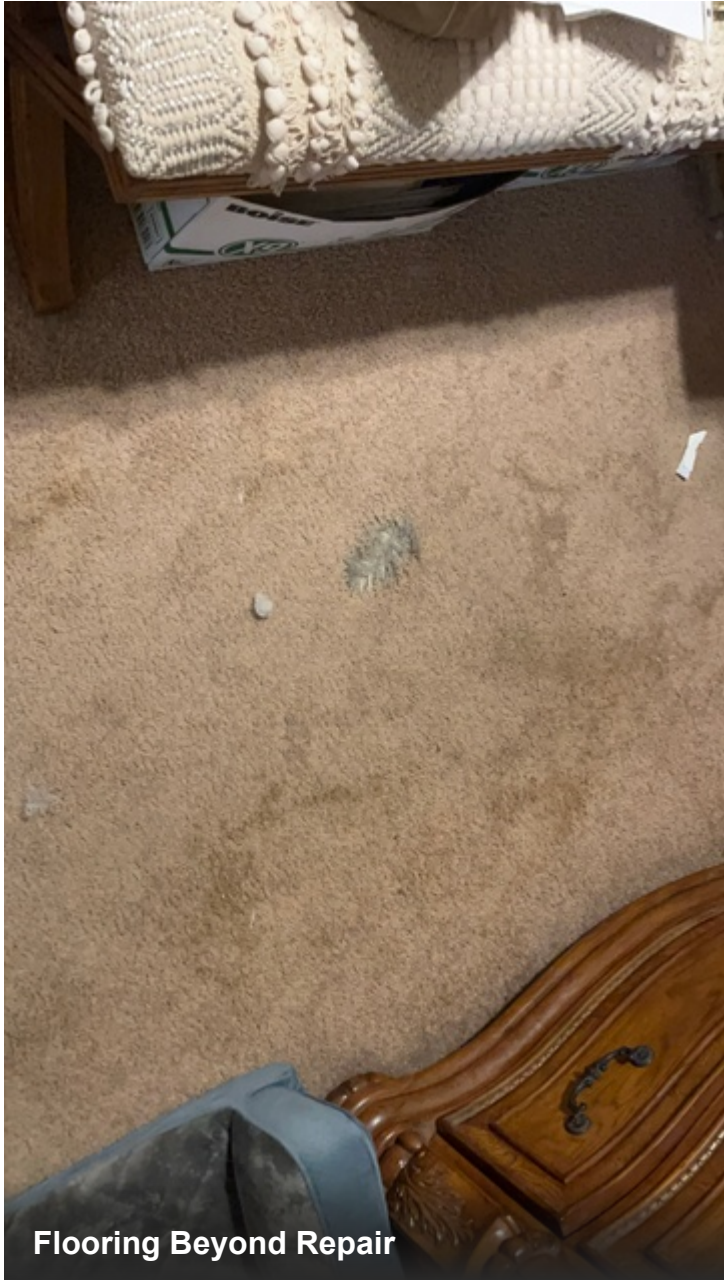
Flooring Beyond Repair

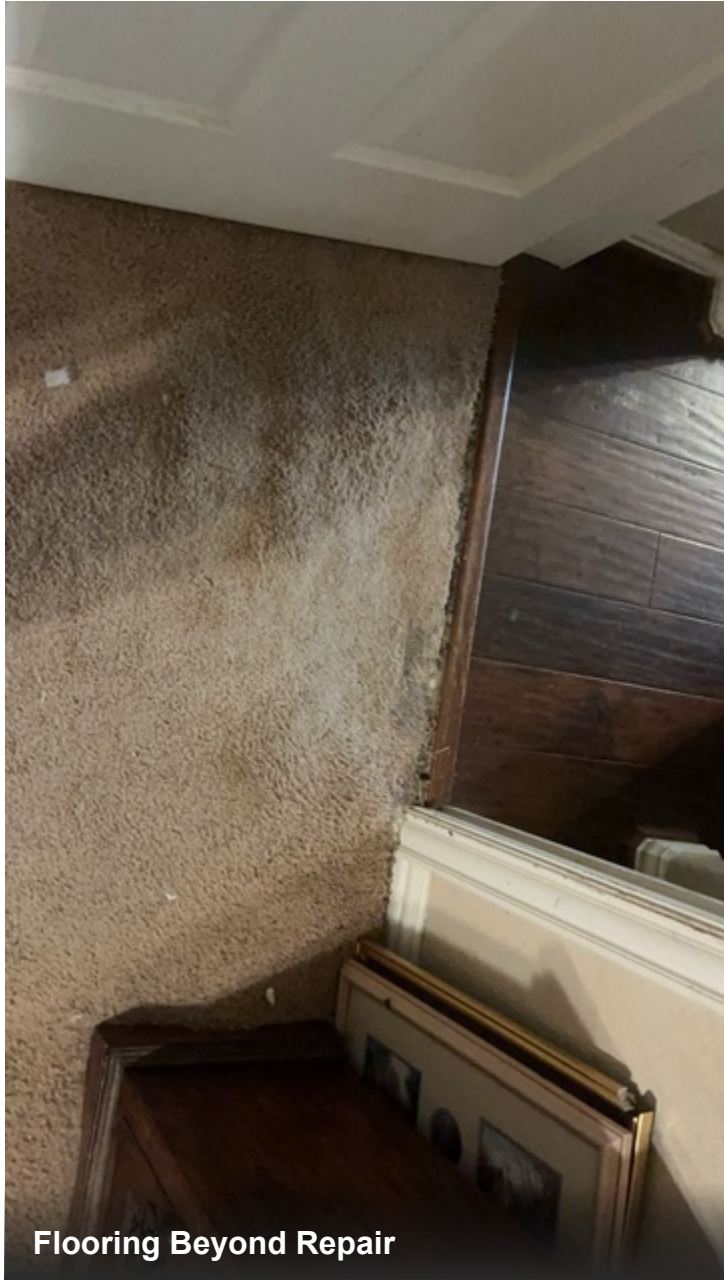
Flooring Beyond Repair

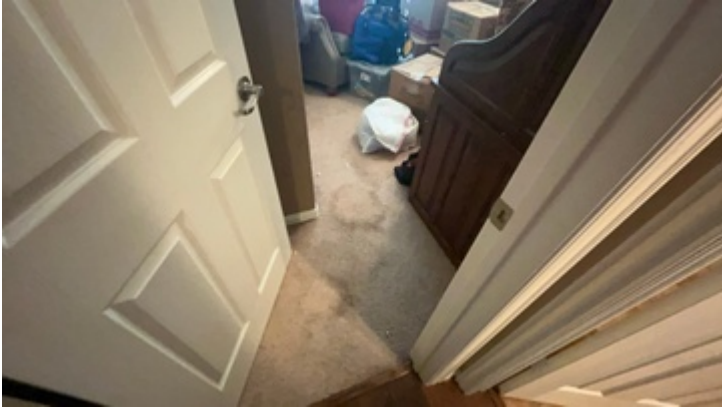
## Stained Carpet

The carpet has areas of staining or discoloration.

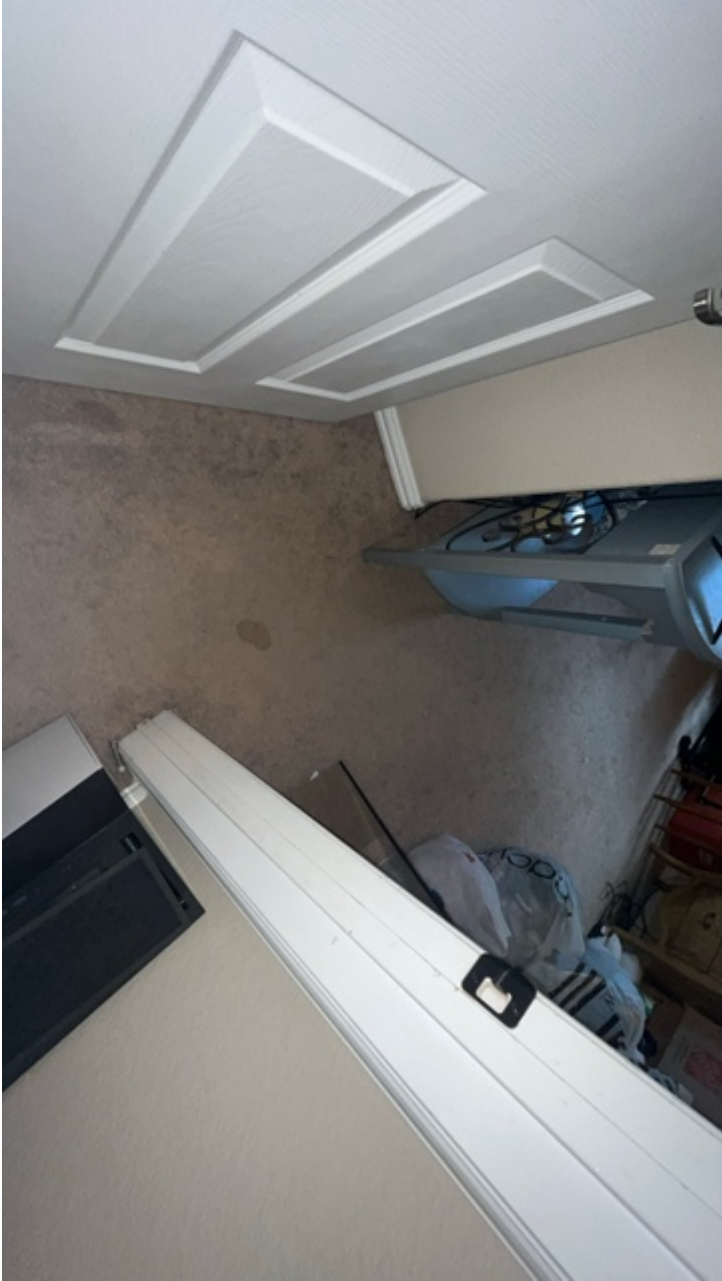
## Stained Carpet

The carpet has areas of staining or discoloration.

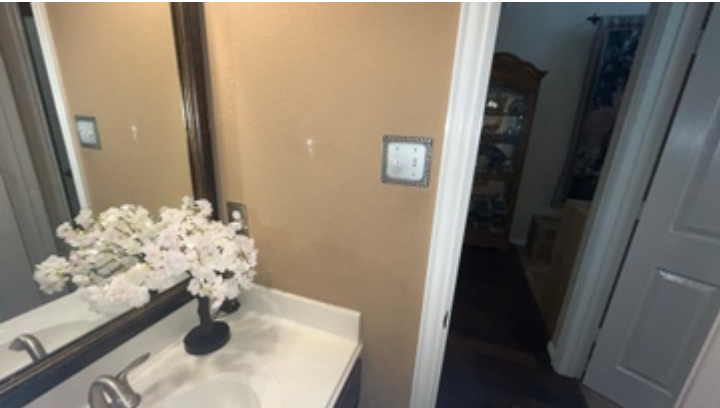
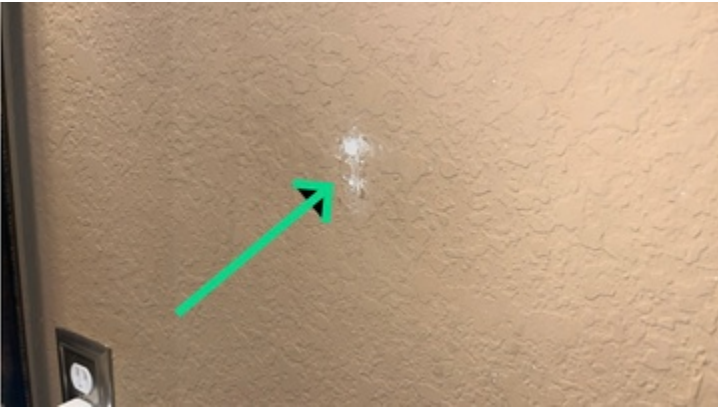
Interior Paint Needs Touch-Up

The interior paint needs to be touched up.

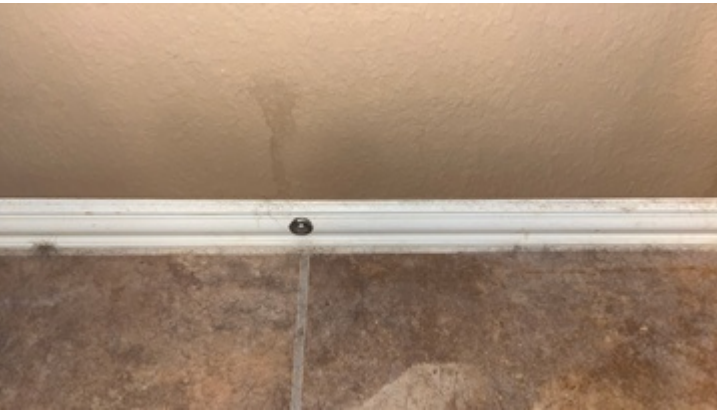
## Missing / Damaged Door Stop(s)

Door stops are missing or damaged for an interior door.
