True Grit Home Inspection

Property Inspection Report

12726 Shady Knoll Ln, Cypress, TX 77429

Date of Inspection: 2/6/2021 Time: 10:00 AM

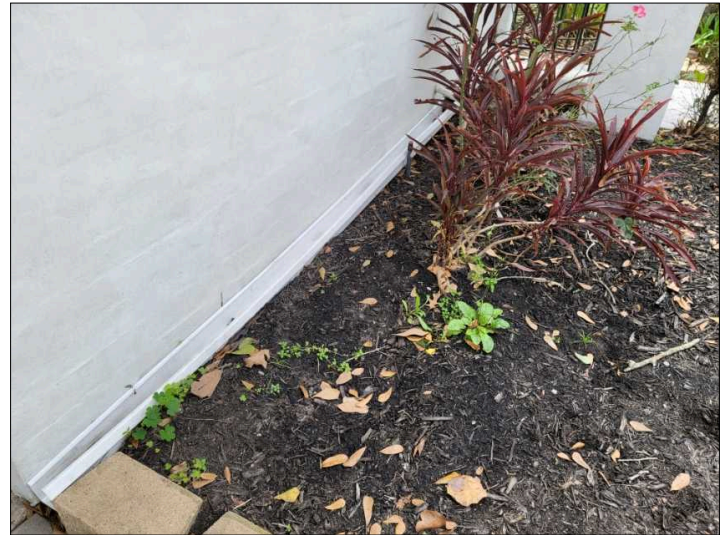
Flower bed too high..front

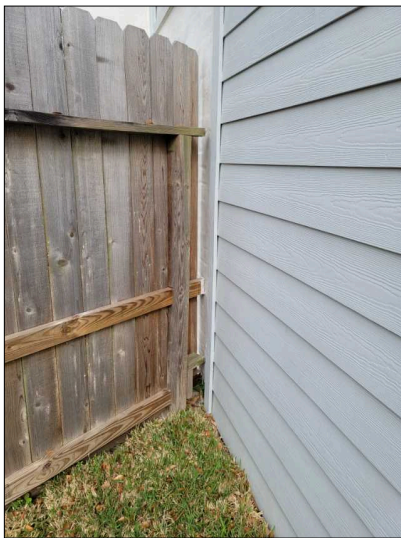
Wood fence in contact with wall..right side

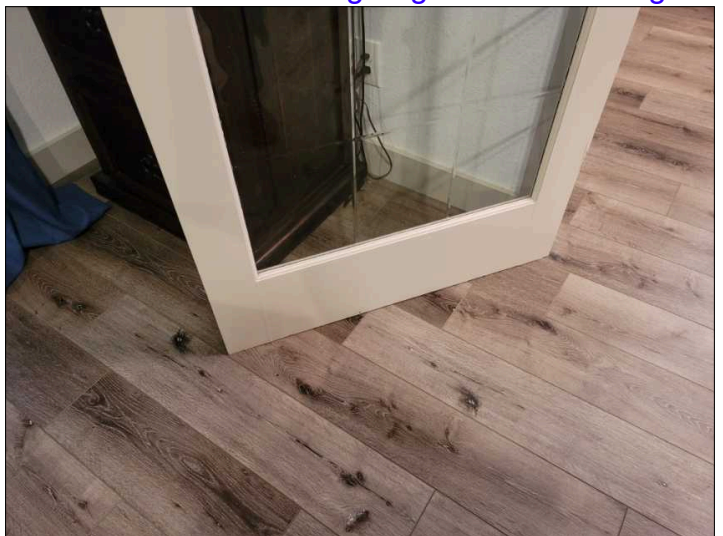
Dining room/entry door rubs at floor

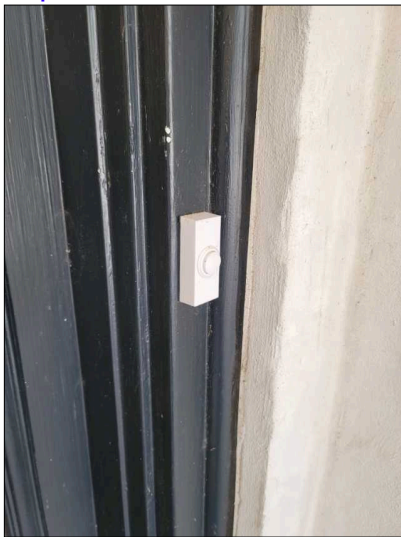
Doorbell barely functional, gives one chime only.

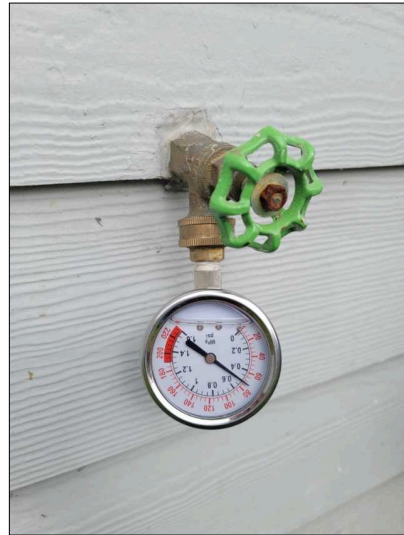
Approx 70 psi water pressure, hose bib lacks backflow preventer..rear

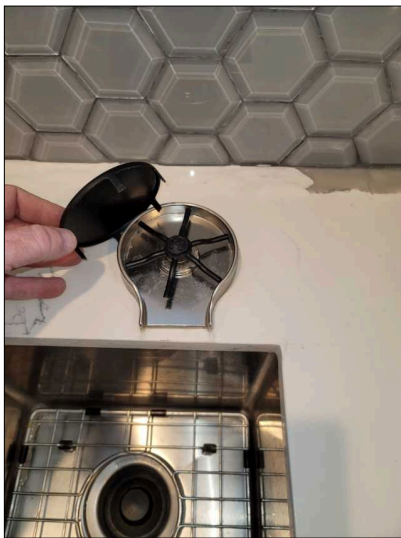
Glass rinser noted at kitchen sink, not tested

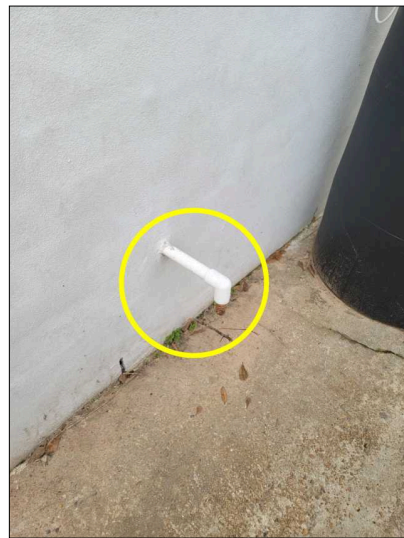
Unclear purpose..left side

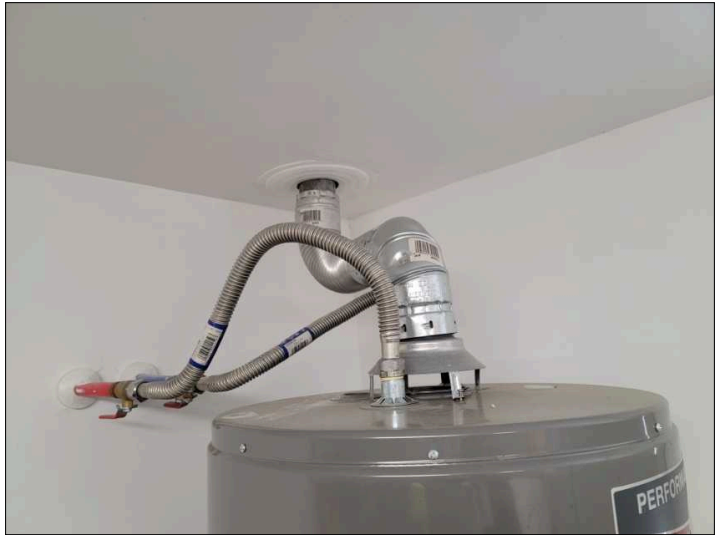
Water heater exhaust flue should remain straight for minimum first 12"

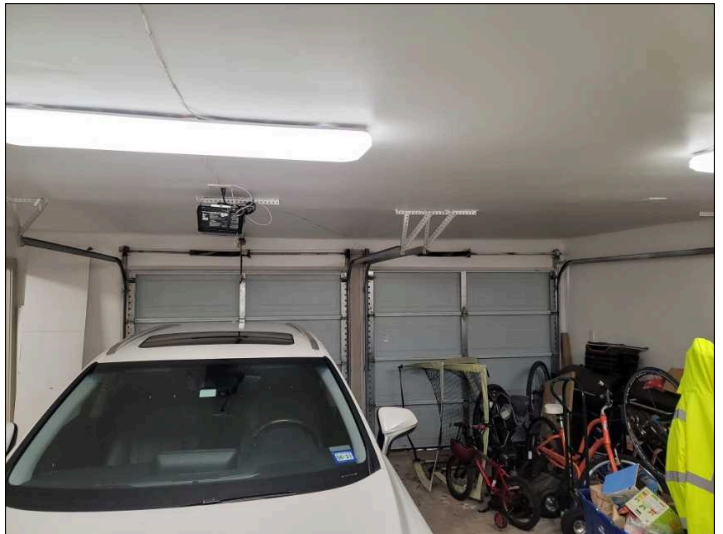
Two 7' steel doors, one opener

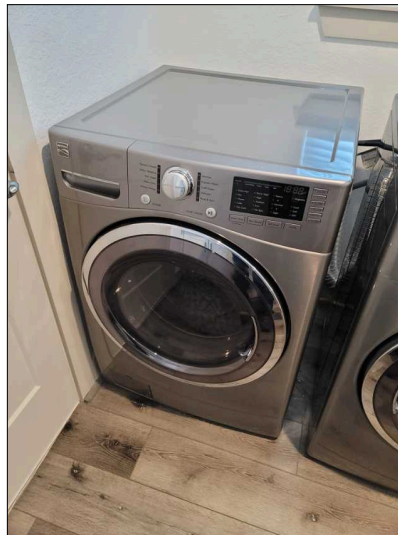
Dryer exhaust inaccessible, gas and electric connections available

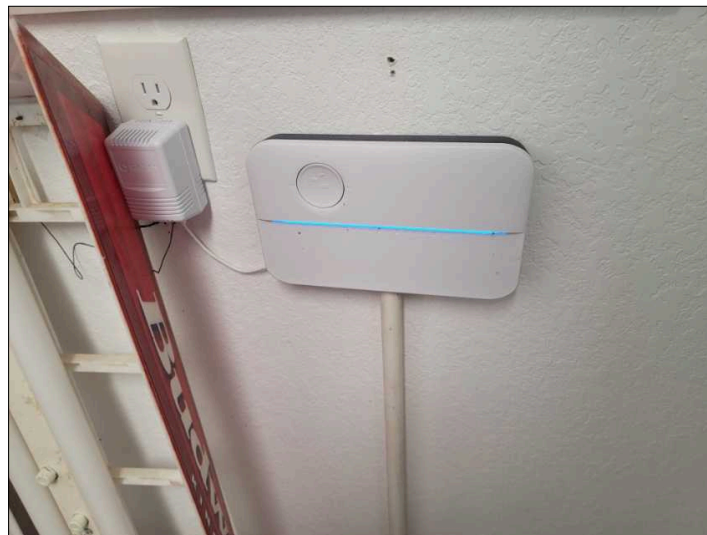
Sprinkler system controller in garage utility closet, not tested. Appears to require smartphone app to operate.
