16418 Teak Dr

Missouri City, Texas 77489

Client	--
Reference id	a4xPd000002uskXIAQ
Type	Home Inspection and Floor Plan Report - 16418 Teak Dr
Inspected by	HomeTeam Inspection Service - North Houston
State license	TREC 20811
Scheduled	October 11, 2025, 5:00 PM
Completed	October 12, 2025, 12:18 AM

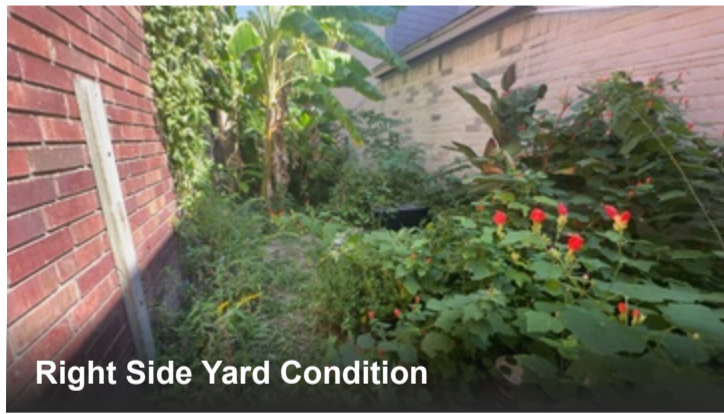
Right Side Yard Condition

There is vegetation too close to the structure. Recommend monitoring this, and further evaluation by a qualified professional.

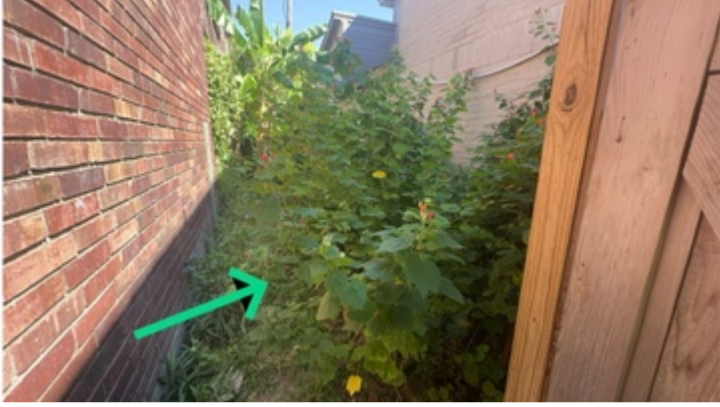
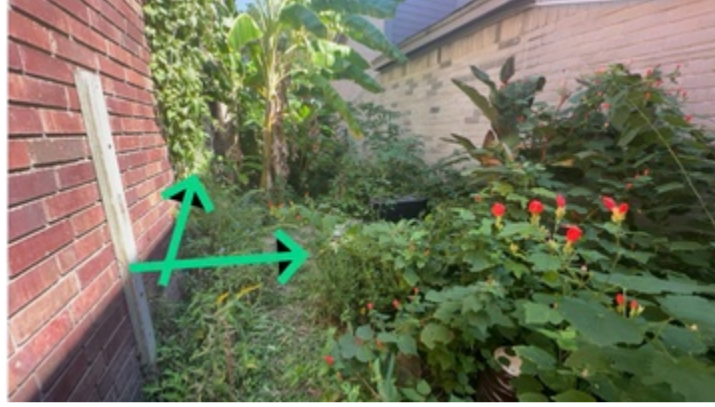
**Repair deficiency**

There is overgrown vegetation / weeds on one or more areas of the property.

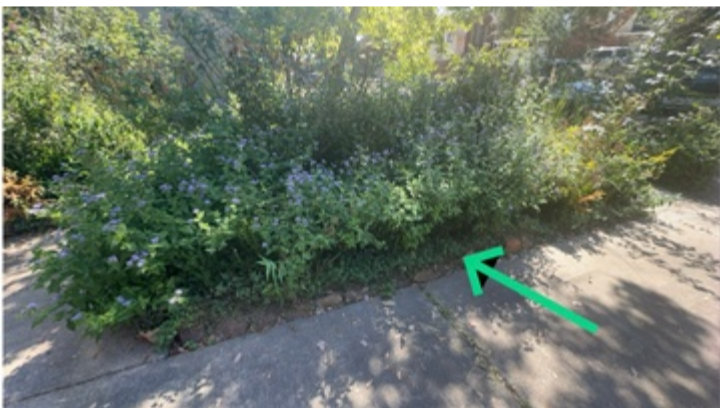
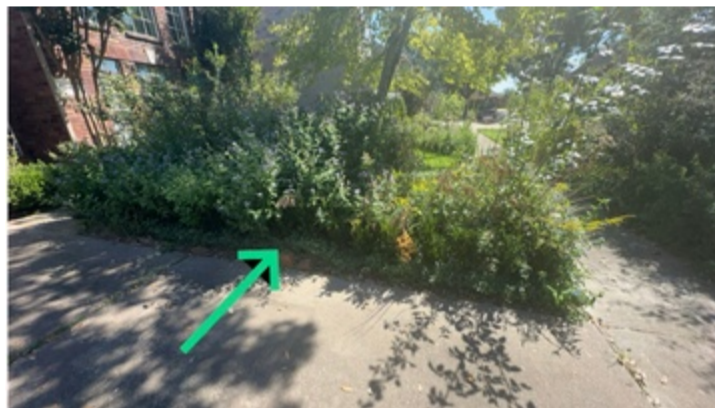
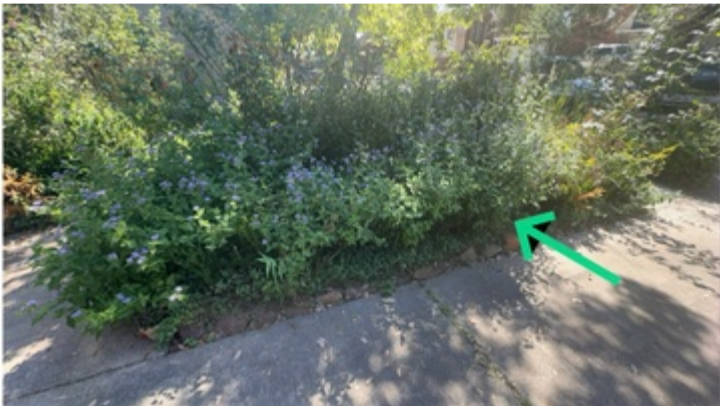
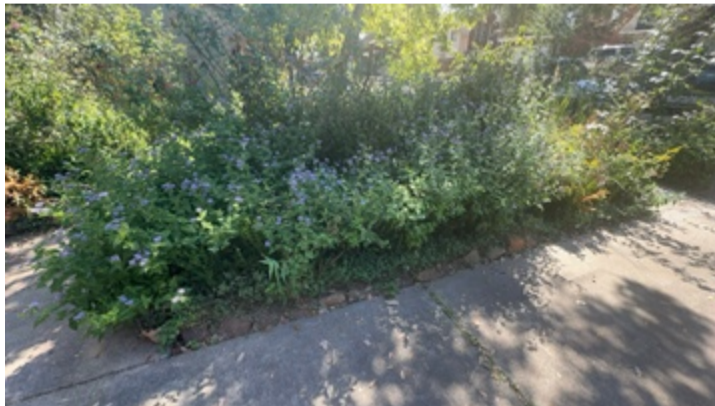
**Repair deficiency**

There is overgrown vegetation / weeds on one or more areas of the property.

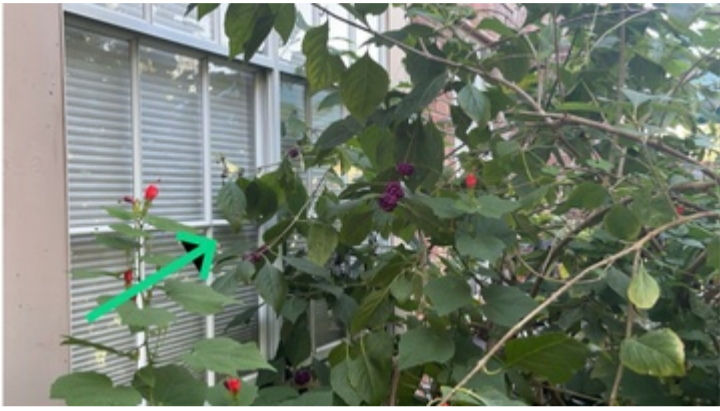
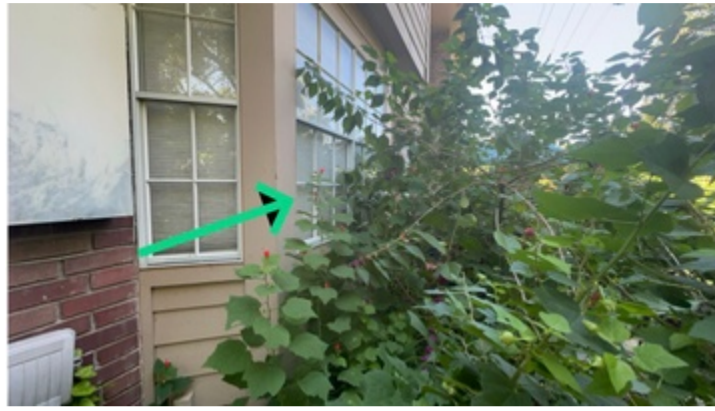
**Repair deficiency**

There is vegetation too close to the structure.

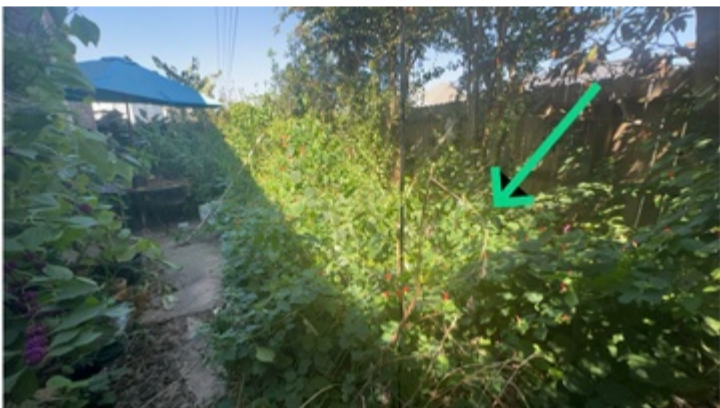
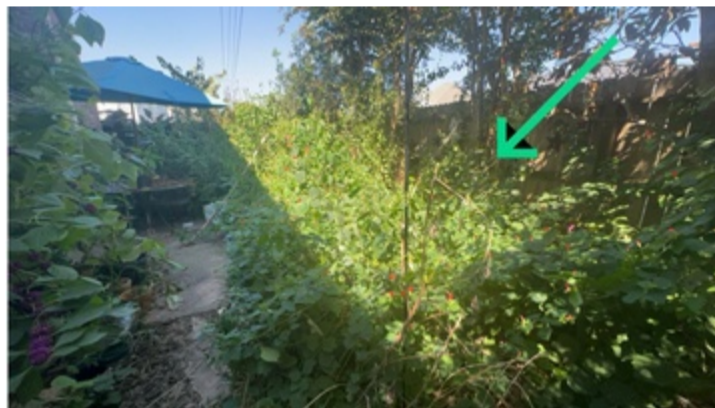
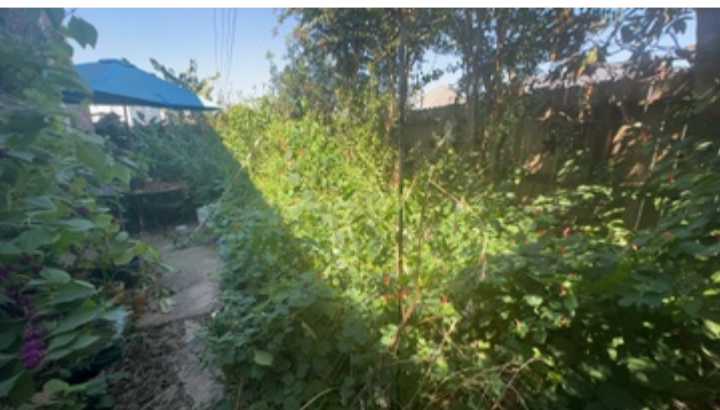
**Repair deficiency**

There is overgrown vegetation / weeds on one or more areas of the property.

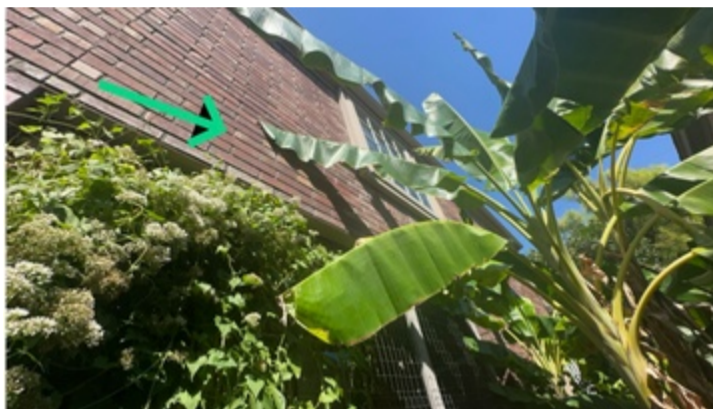
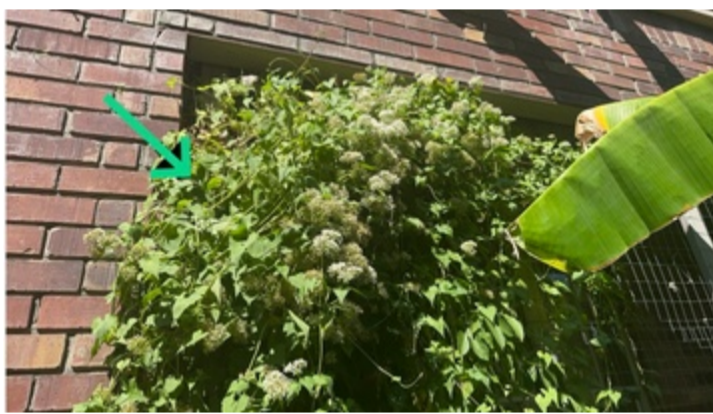
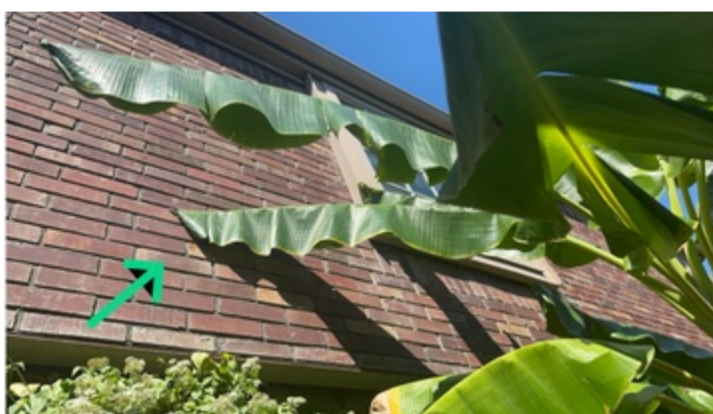
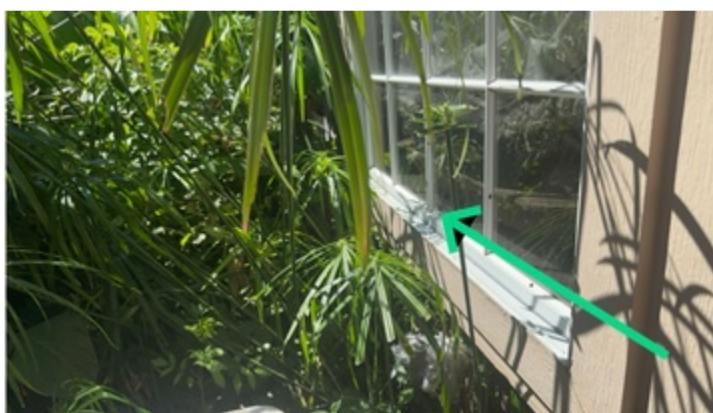
**Repair deficiency**

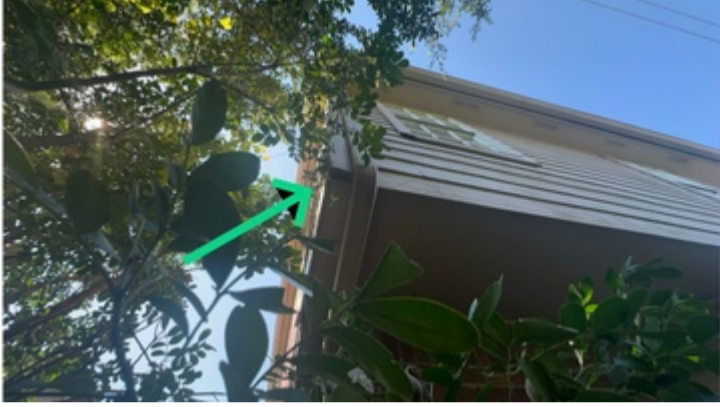
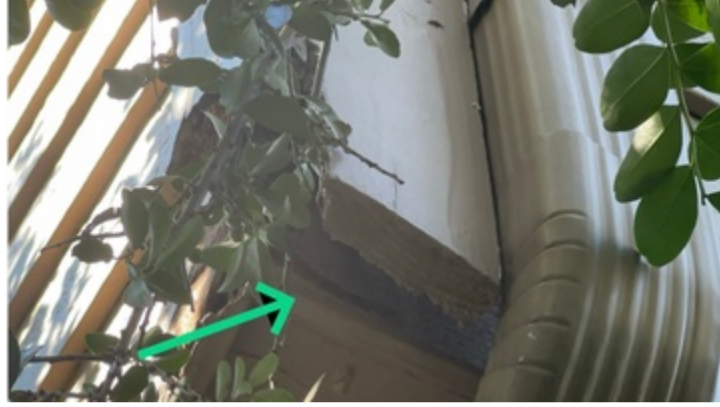
Damaged Trim

There are signs of damage to the trim. Recommend repairs or replacing by a qualified professional.

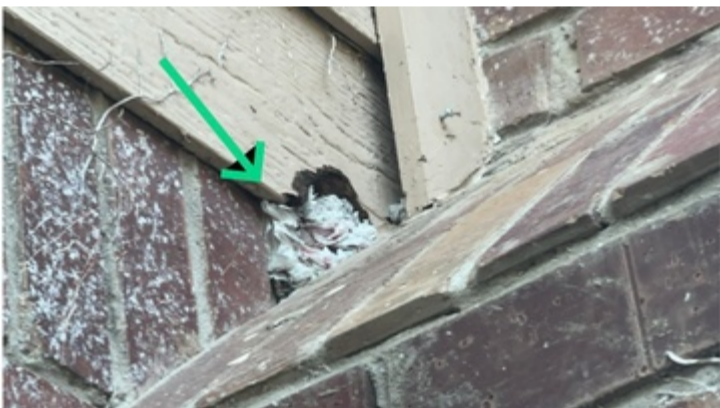
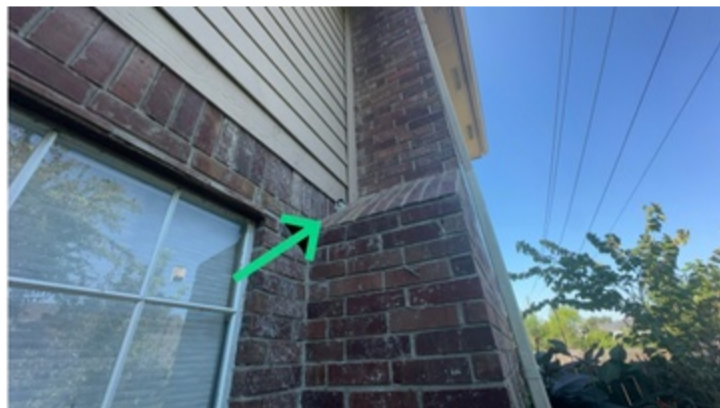
Damaged Siding

One or more areas of the siding is damaged. Recommend repairs or replacing by a qualified professional.

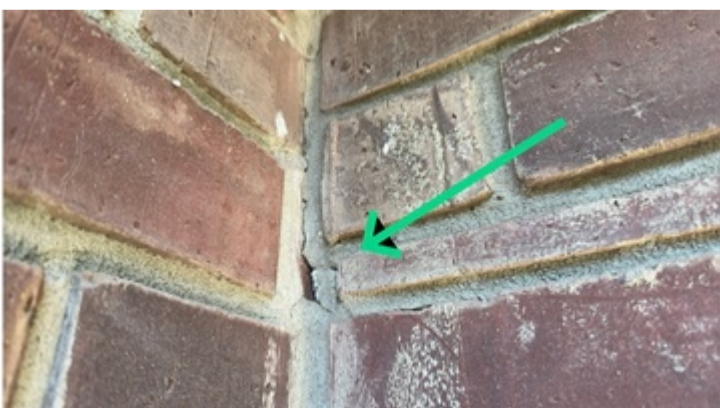
Damaged Brick Mortar

The mortar is cracked / damaged in one or more areas.

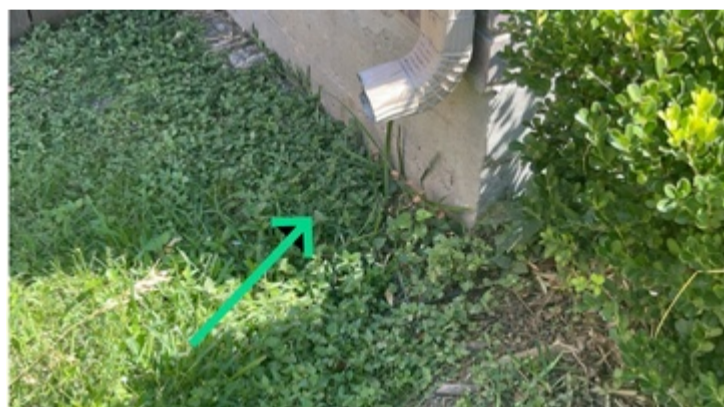
Missing Downspout Splash Blocks

There are no splash blocks for the downspouts. Recommend monitoring this.

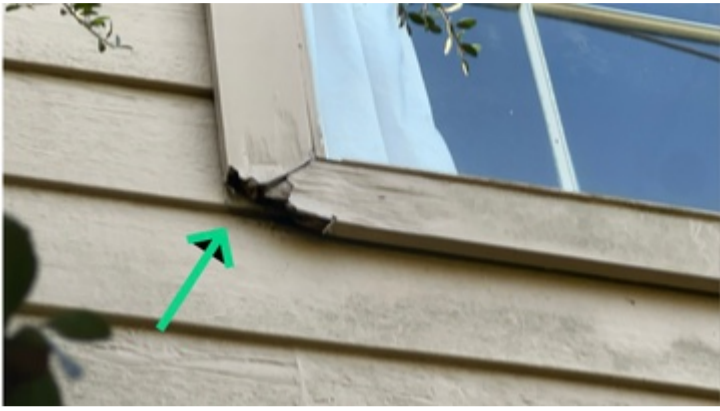
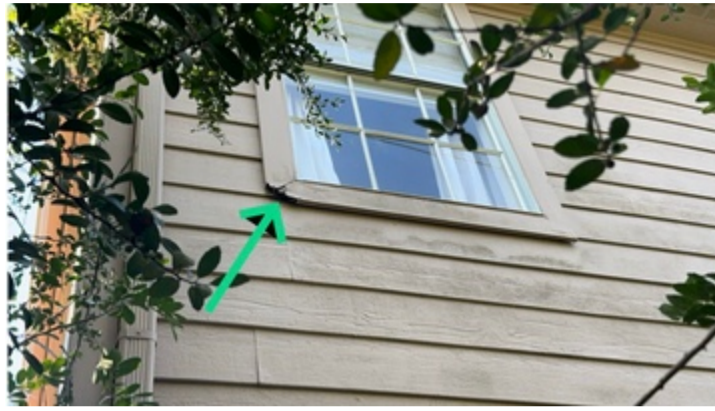
Missing / Damaged Window Trim

The window trim / sill is missing / damaged in one or more spots.

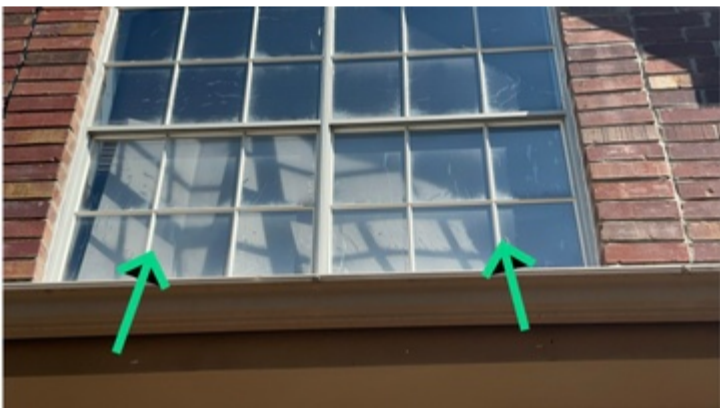
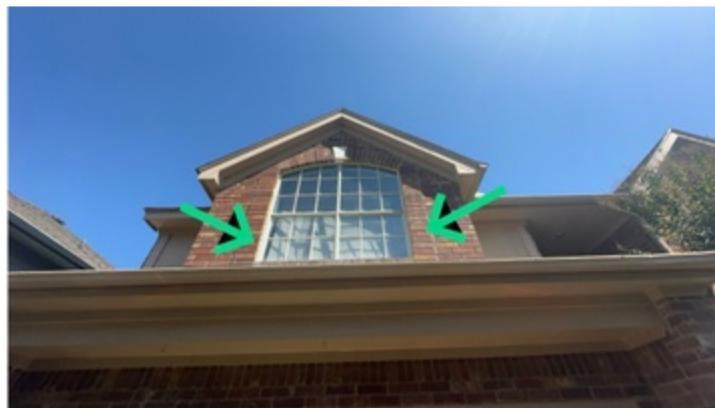
Missing Window Screen

One or more windows are missing a screen.

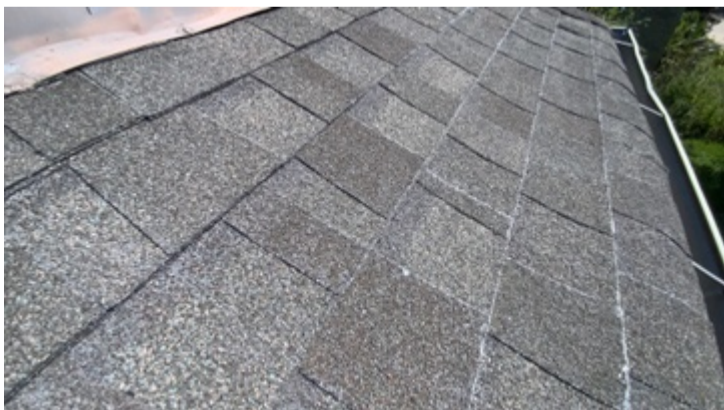
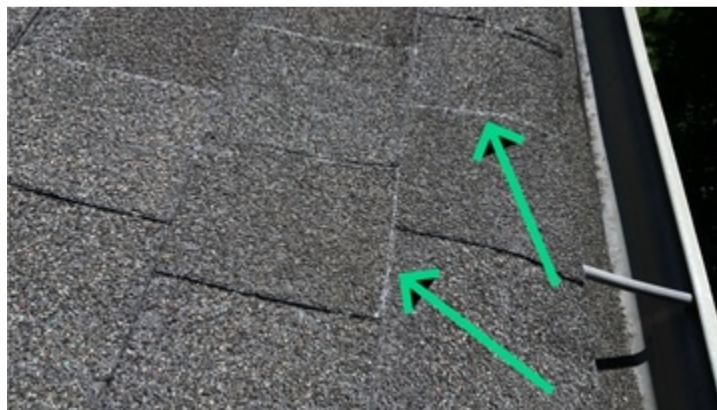
There is granular loss on one or more areas of the roof. Recommend further evaluation, and repairs or replacing by a qualified professional.

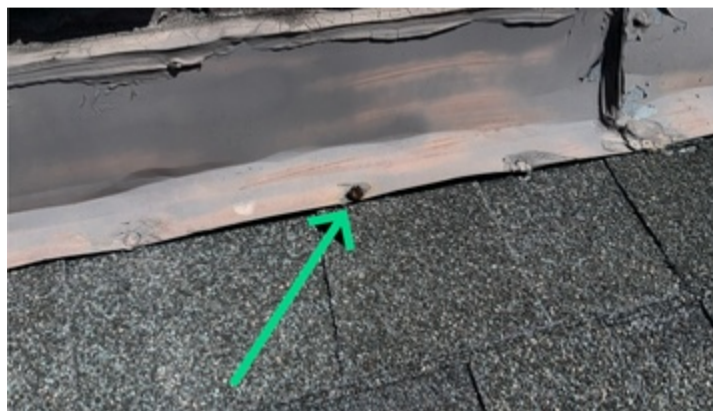
There are exposed fasteners for the flashing. Recommend repairs or replacing by a qualified professional.

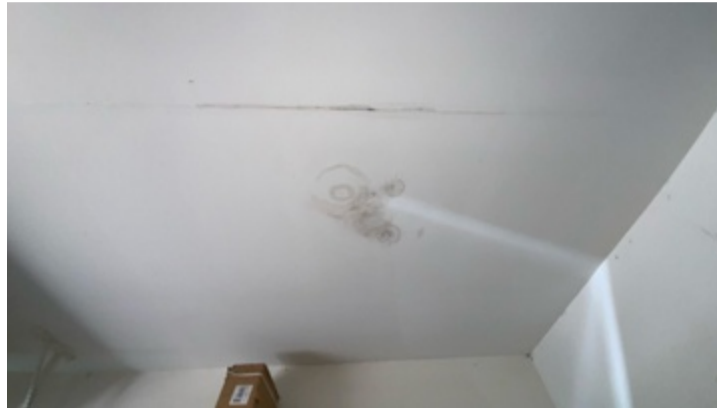
Water Stained Ceiling

The ceiling has one or more moisture stains. Recommend further evaluation, and repairs or replacing by a qualified professional.

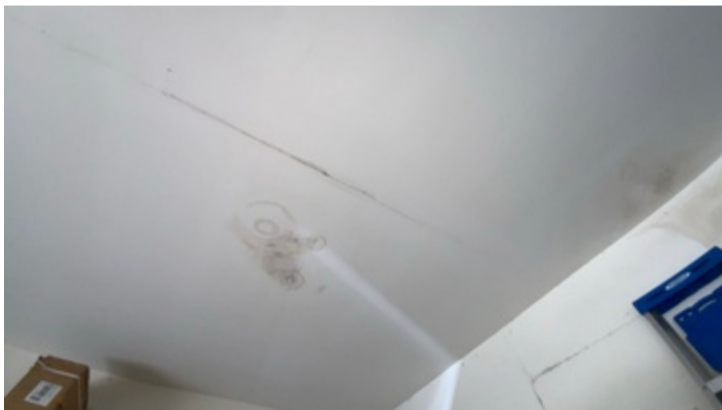
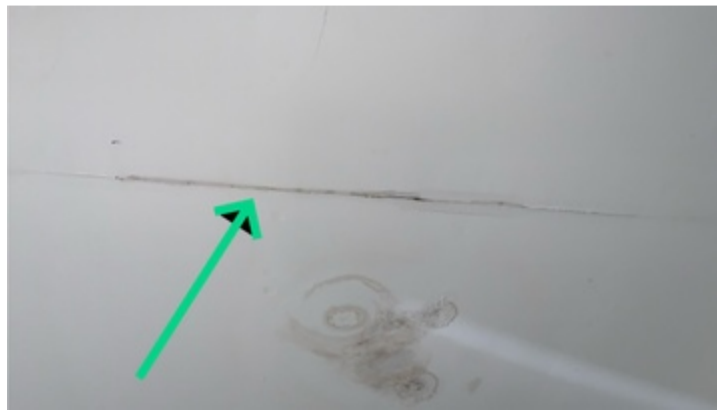
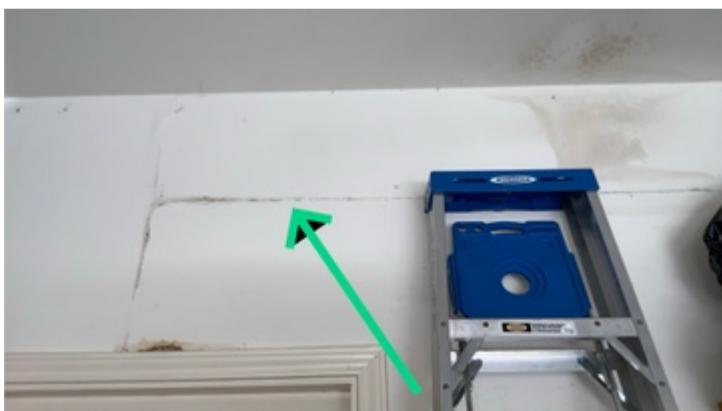
Minor Wall Cracks

There is minor cracking on the wall / ceiling. Recommend repairs or replacing by a qualified professional.

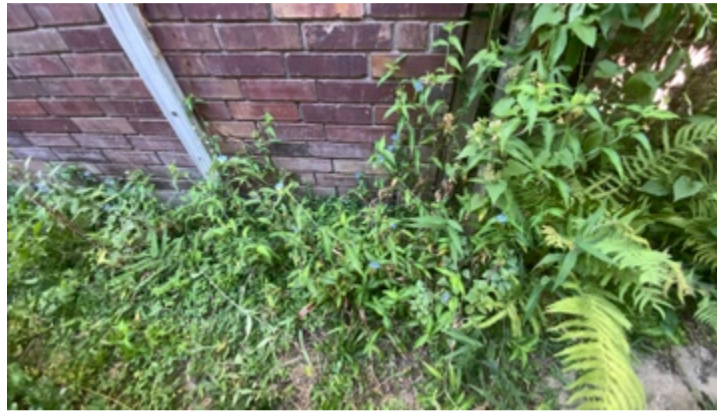
High Soil Grade

There are areas of high soil around the foundation.

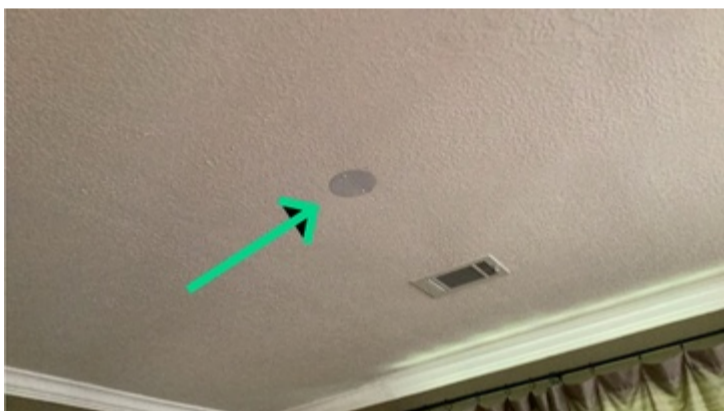
Missing Light Fixture

One or more light fixtures are missing.

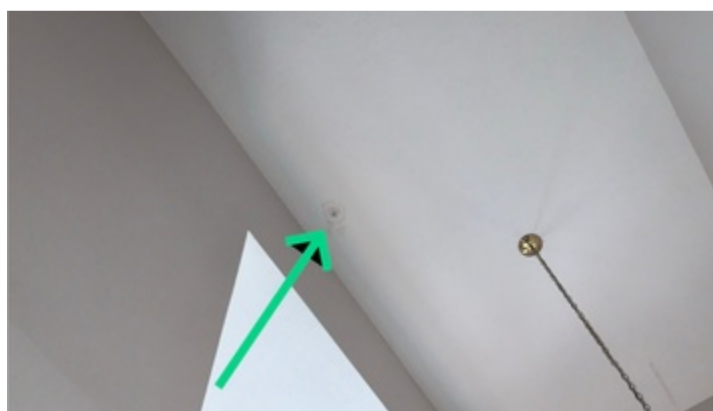
Water Stained Ceiling

The ceiling has one or more moisture stains. Recommend monitoring this, and further evaluation by a qualified professional.

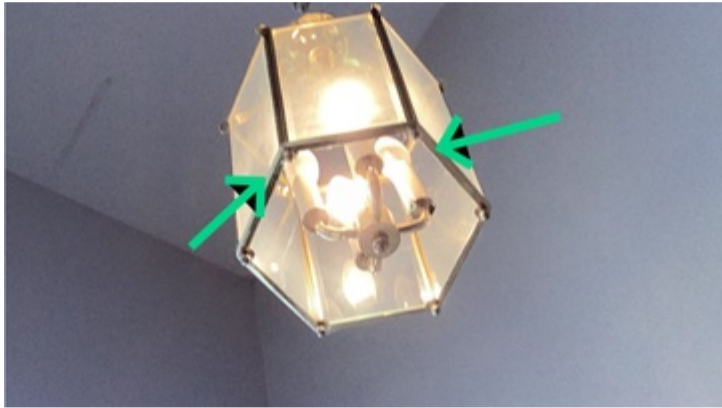
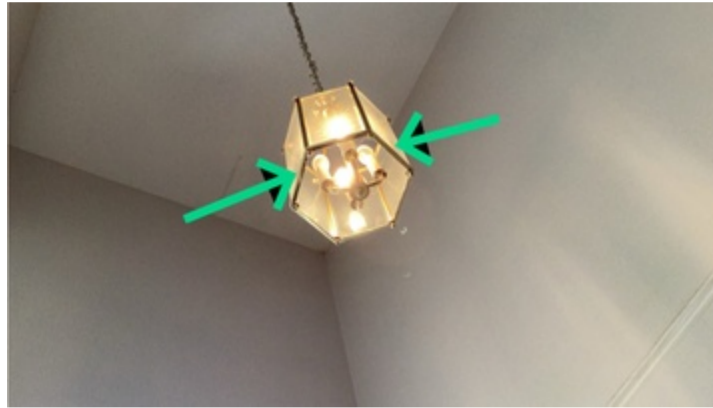
Inoperable or Missing Light Bulb

One or more light bulbs have burnt out or are missing.

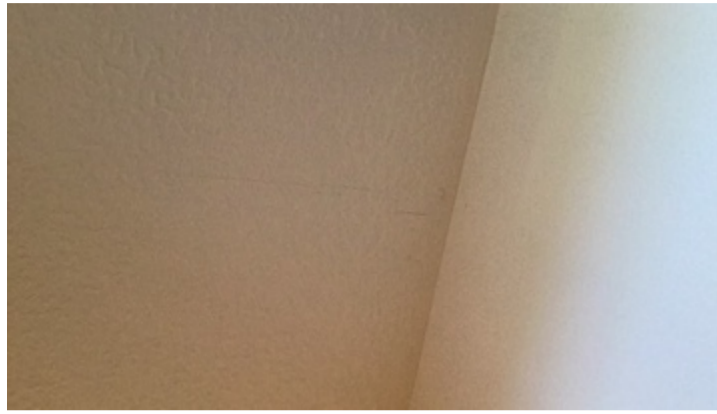
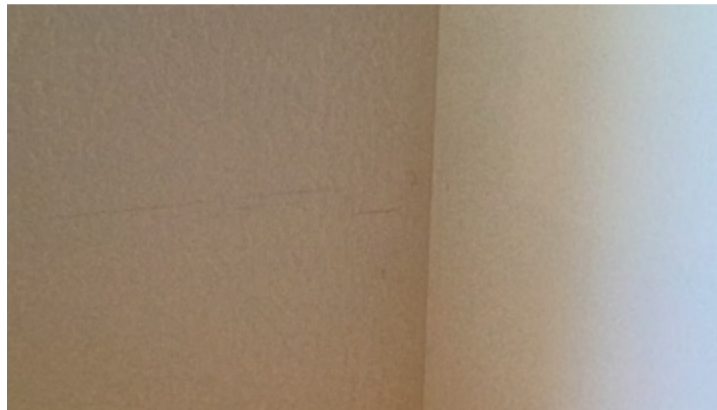
Small minor cracks in ceiling

One or more small minor cracks in ceiling Recommend repairs or replacing by a qualified professional.

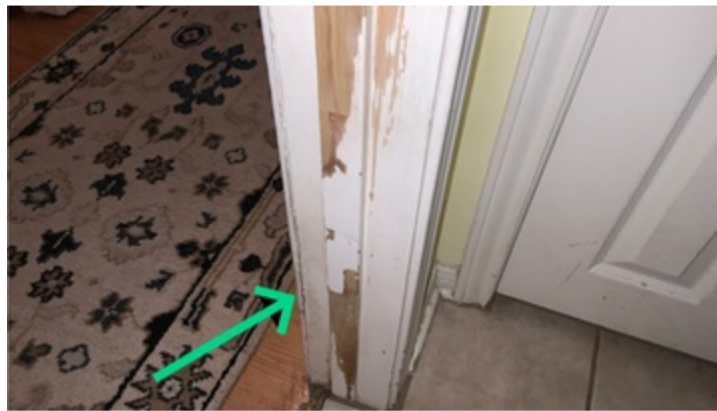
Missing or Damaged Door Trim

The door moulding / trim / casing is damaged or missing. Recommend repairs or replacing by a qualified professional.

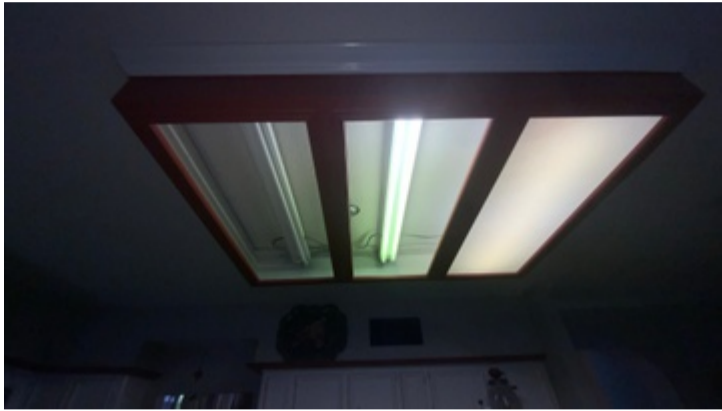
Kitchen General photos / videos

Missing Light Cover

One or more light fixtures have exposed bulbs. Recommend repairs or replacing by a qualified professional.

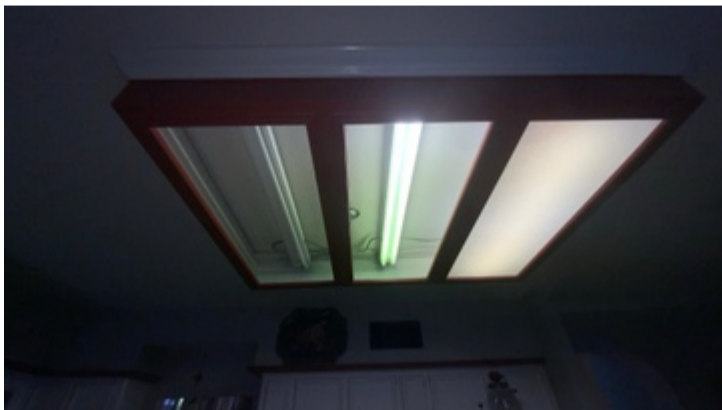
Kitchen General photos / videos

Inoperable or Missing Light Bulb

One or more light bulbs have burnt out or are missing. Recommend repairs or replacing by a qualified professional.

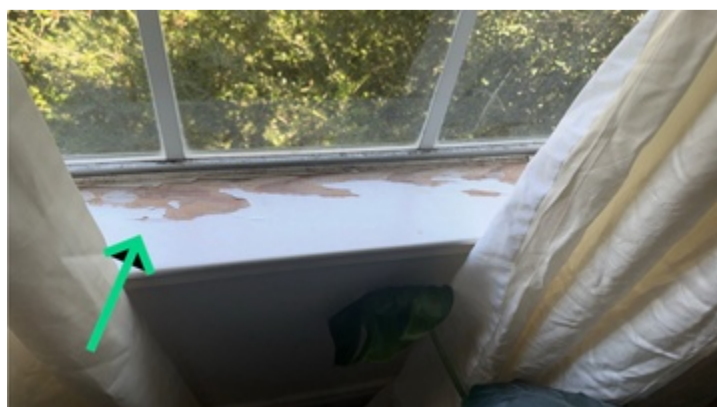
Primary Bedroom photos / videos

Damaged window frame paint

One or more area of the window framing is missing chipping paint Recommend monitoring this.

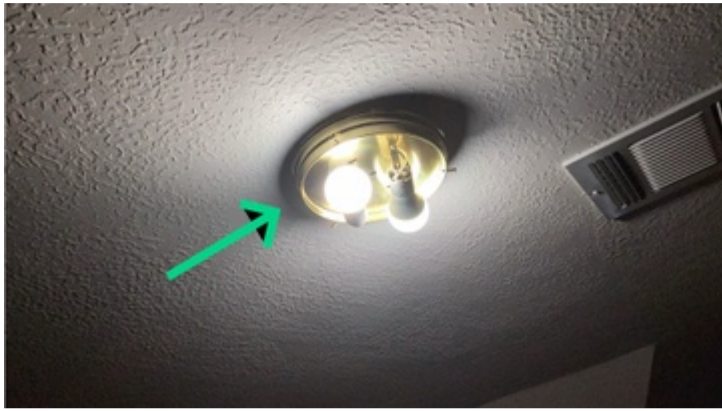
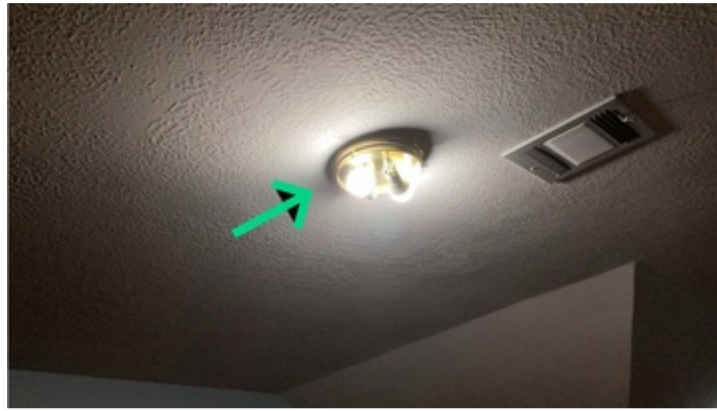
Bedroom 2 photos / videos

Missing Light Cover

One or more light fixtures have exposed bulbs.

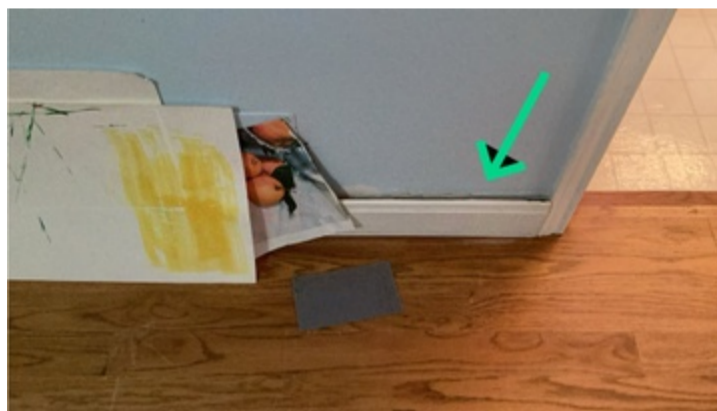
Bedroom 2 photos / videos

Damaged / Broken Baseboards

One or more areas of floor baseboards are damaged or broken. Recommend repairs or replacing by a qualified professional.

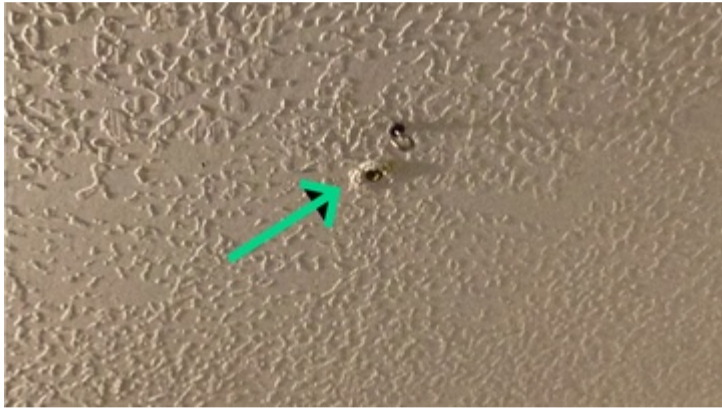
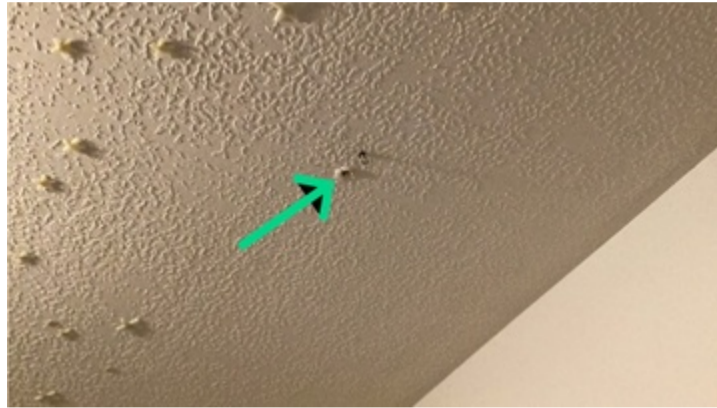
Bedroom 4 photos / videos

One or more nail pops located on the ceiling Recommend repairs or replacing by a qualified professional.

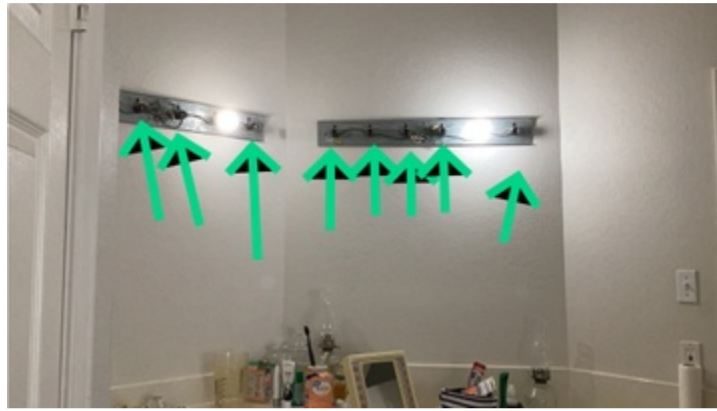
2nd Floor, Bathroom

Inoperable or Missing Light Bulb

One or more light bulbs have burnt out or are missing. Recommend repairs or replacing by a qualified professional.

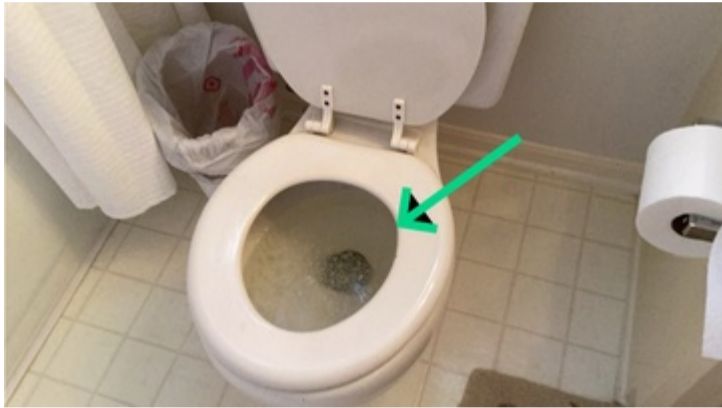
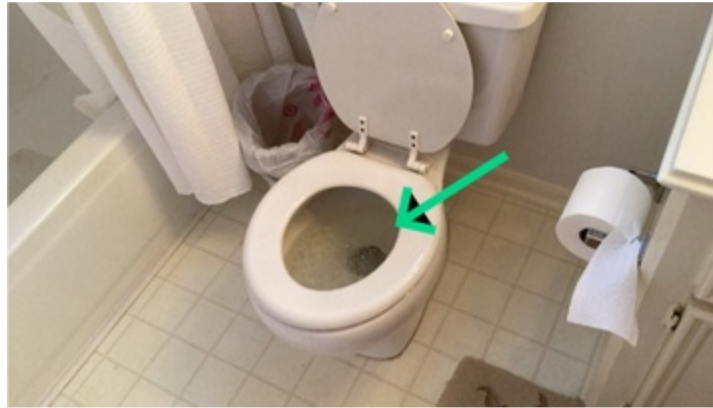
Inoperable / Broken Toilet

The toilet is inoperable / not working. Recommend further evaluation, and repairs or replacing by a qualified professional.

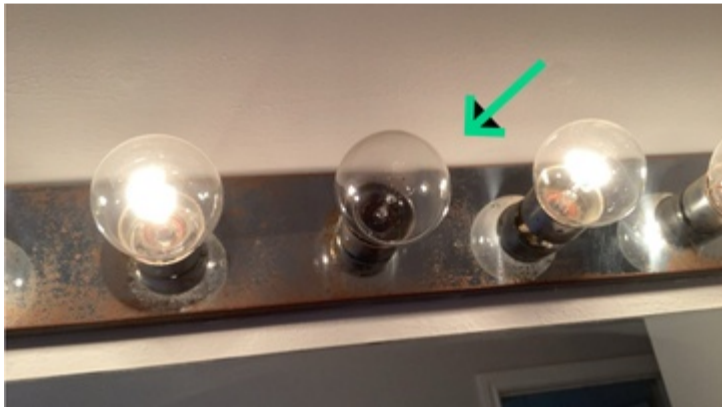
Inoperable or Missing Light Bulb

One or more light bulbs have burnt out or are missing.

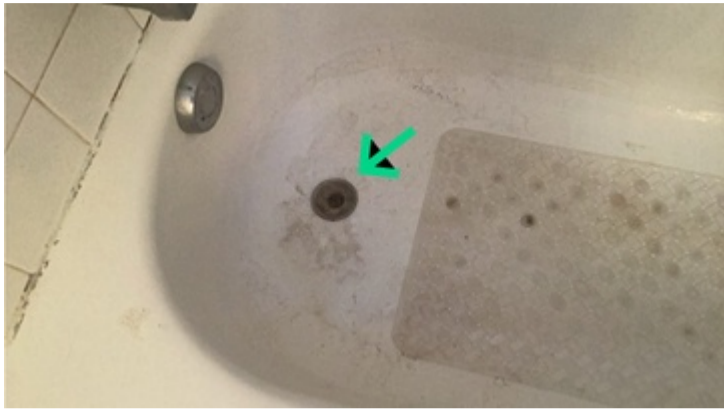
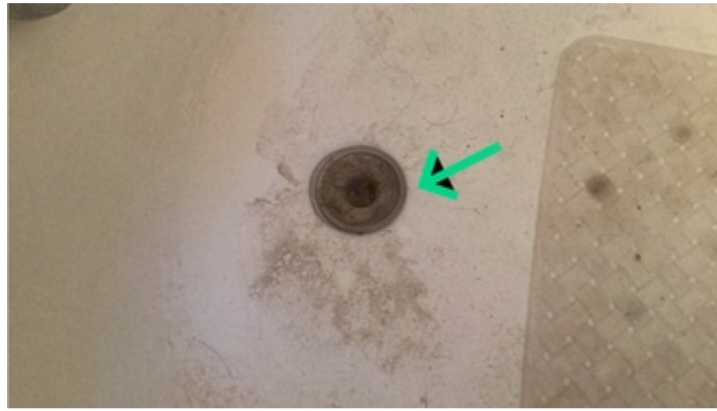
Damaged / Missing Drain Stopper

The drain stopper is damaged or missing.

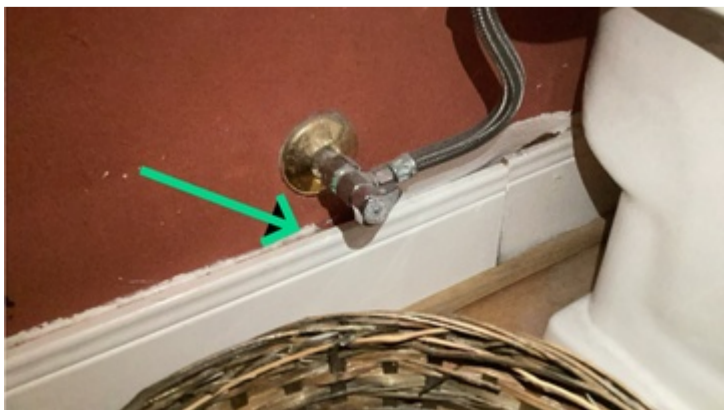
Damaged / Broken Baseboards

One or more areas of floor baseboards are damaged or broken.

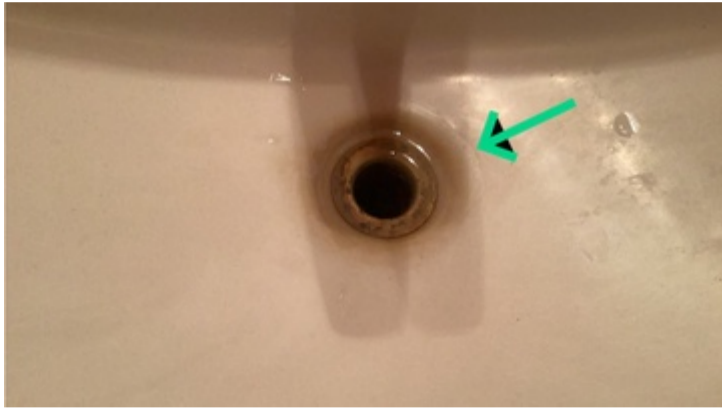
Damaged / Missing Drain Stopper

The drain stopper is damaged or missing.

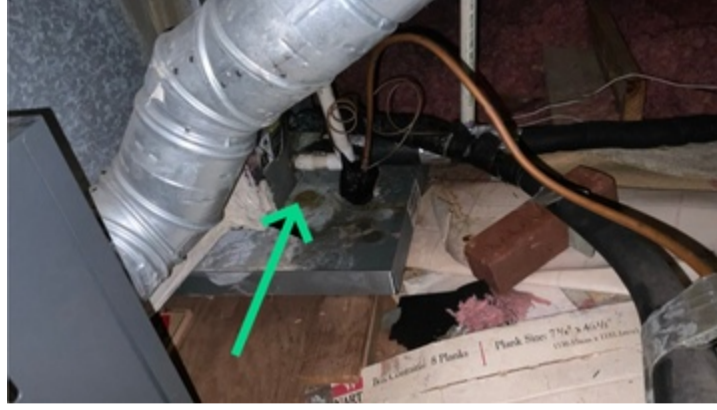
Rusting or Damaged HVAC Drip Pan

The drip pan below the air conditioning unit is rusting or damaged.

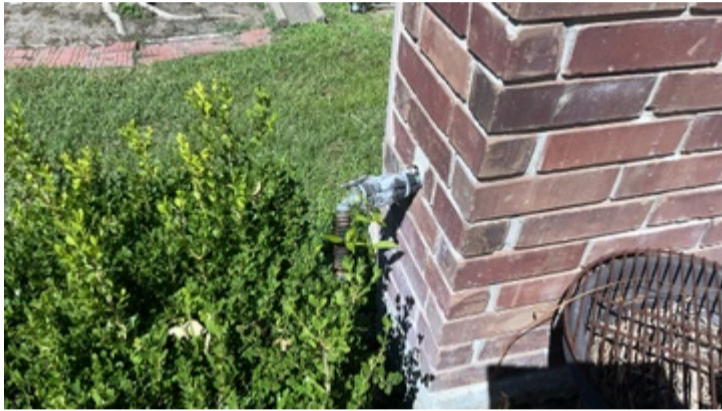
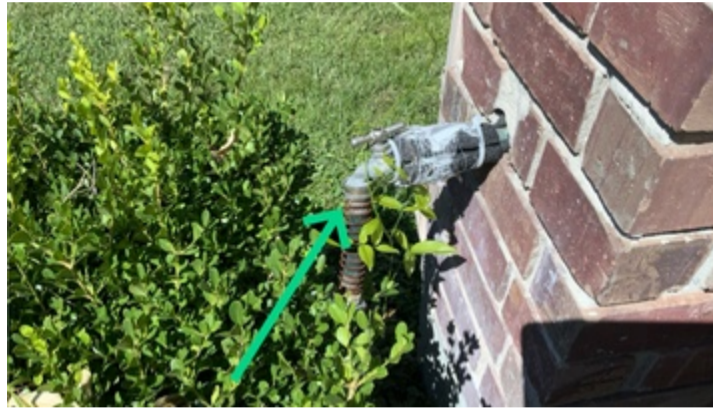
Missing Anti-Siphon Valve

There is no anti-siphon device present.

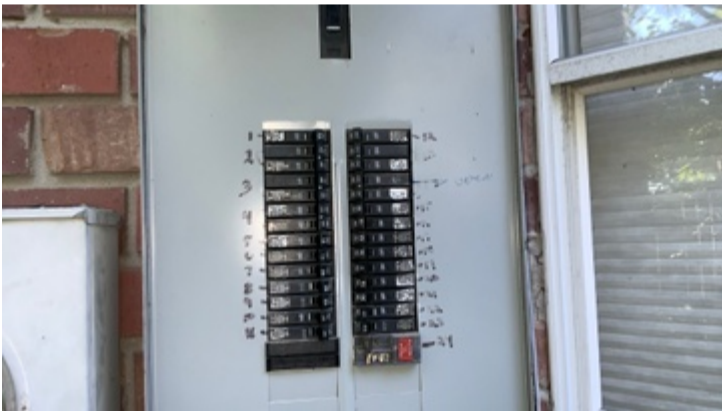
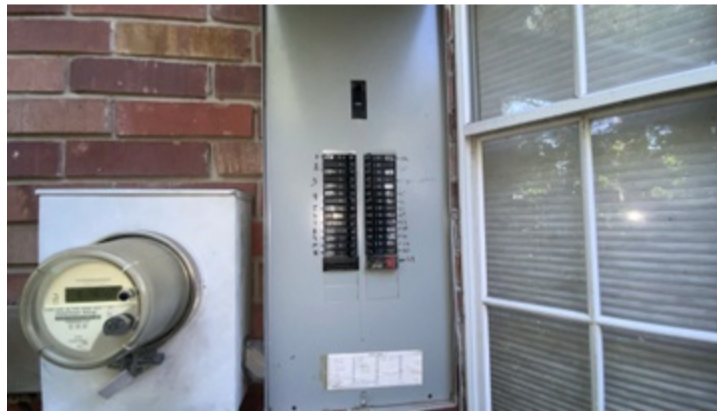
Breaker not appropriately labeled

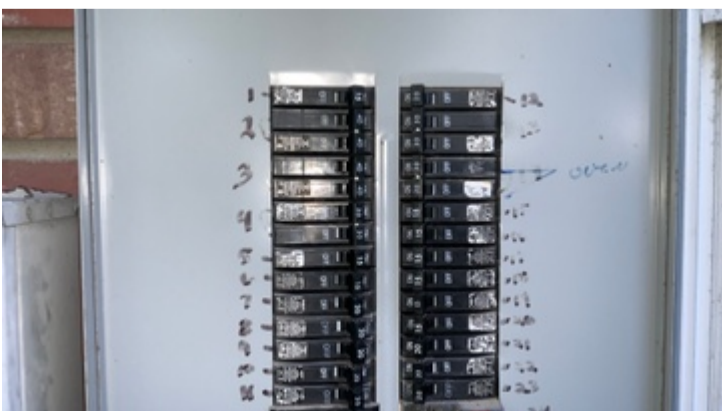
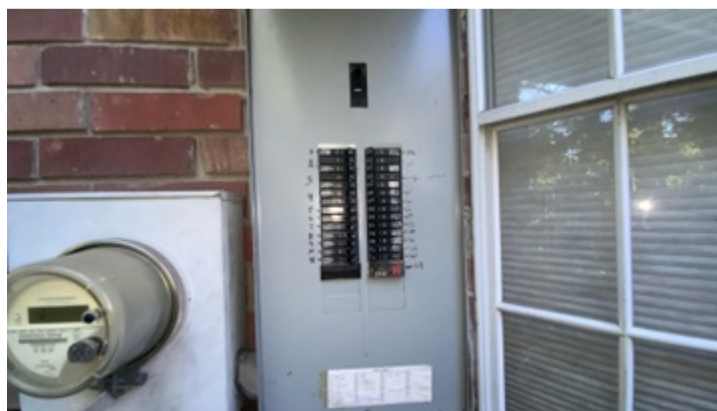
Missing AFCI Breaker

A required Arc-Fault Circuit Interrupter is missing.
