# 7510 Rosepath Ln

# Richmond, Texas 77407

| Type | <b>Home Inspection and Floor Plan Report - 7510 Rosepath Ln</b> |
| Inspected by | <b>Noble Property Inspections - Houston</b> |

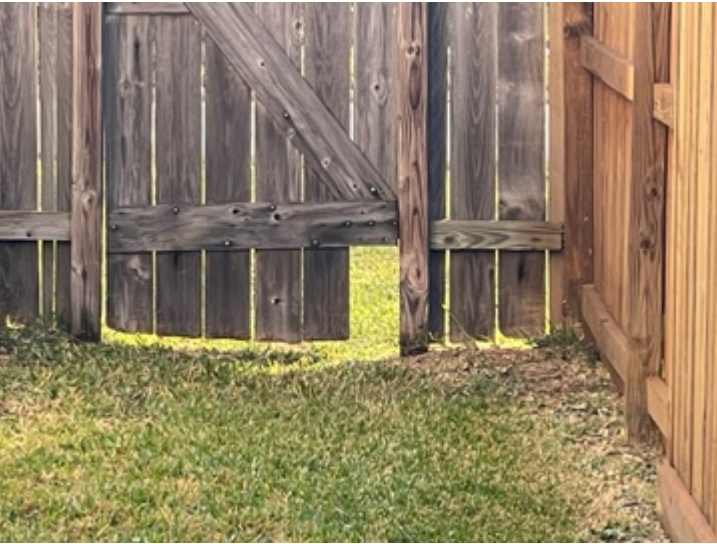
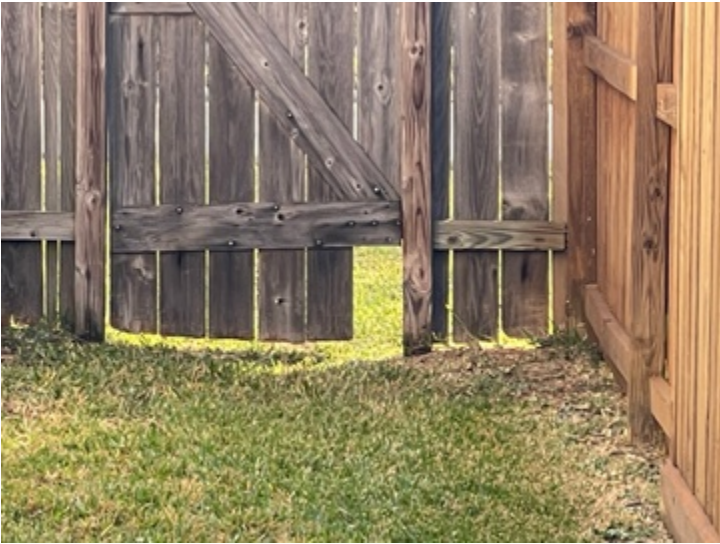
**Repair deficiency**

Damaged Gate

The gate is sticking.

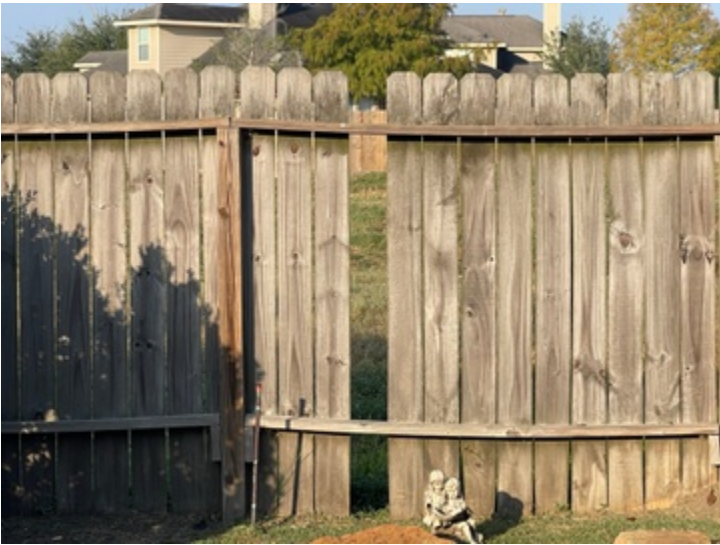
**Repair deficiency**

Damaged / Missing Fence Boards

One or more fence boards are missing or damaged.

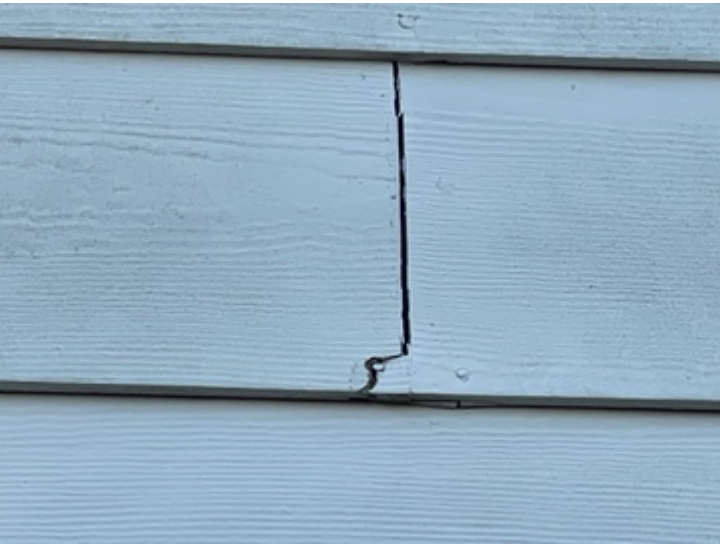
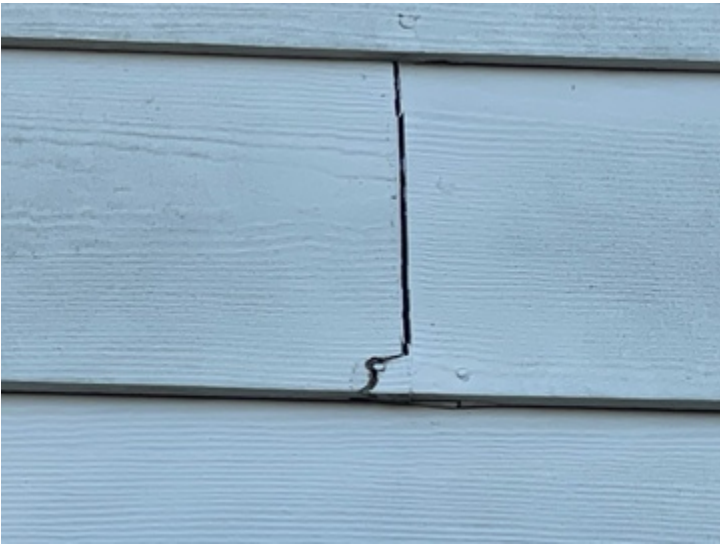
Damaged / Cracked Hardie Plank Siding

The Hardie plank siding is cracked or damaged.

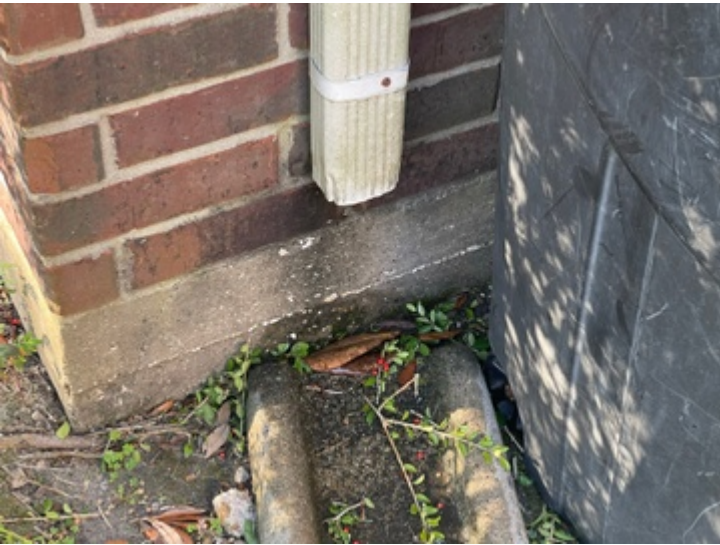
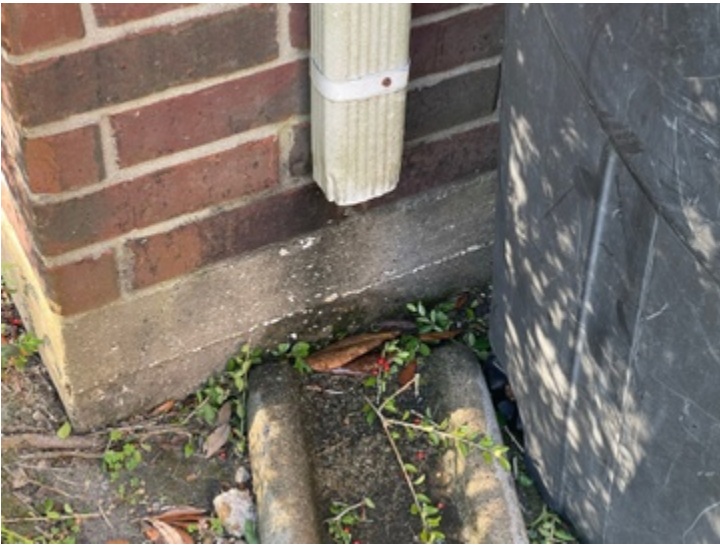
**Missing Downspout(s)**

The downspouts are missing in one or more areas.

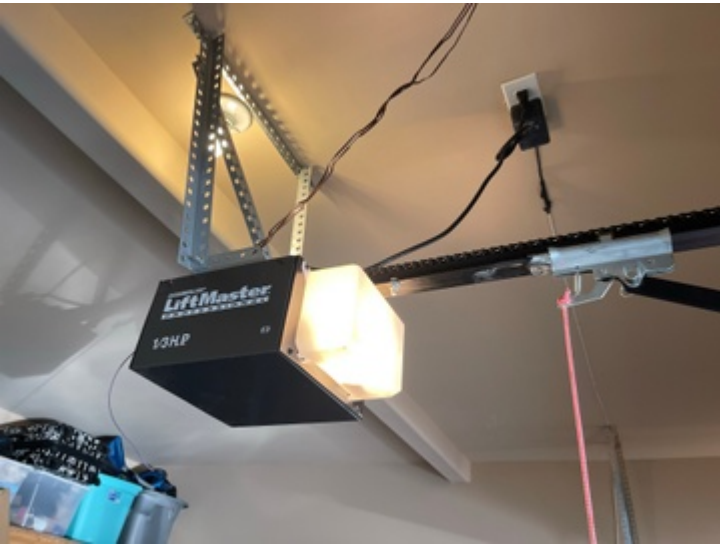
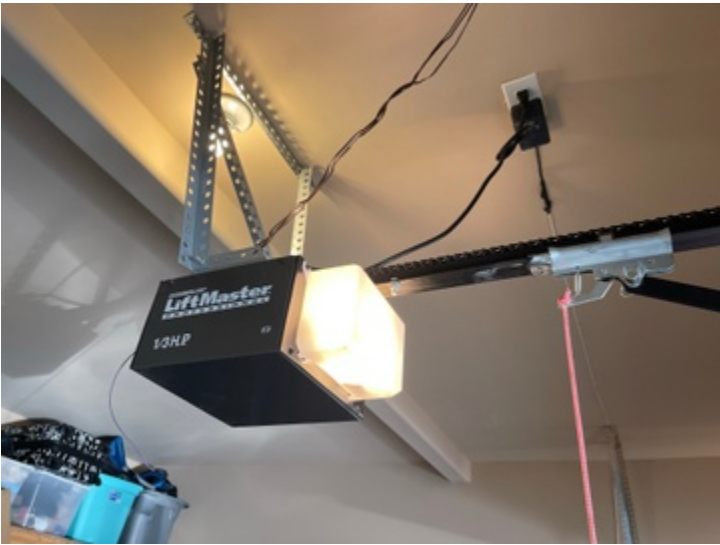
**Repair deficiency**

The garage door motor needs to be repaired or replaced.

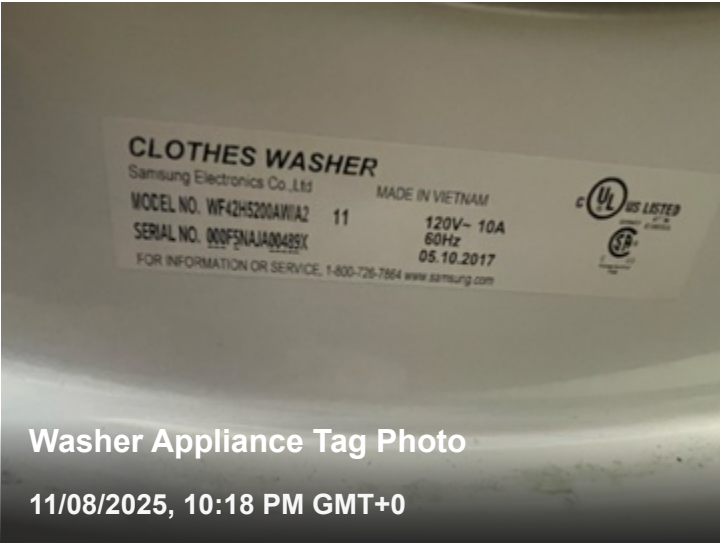
Washer Appliance Tag Photo

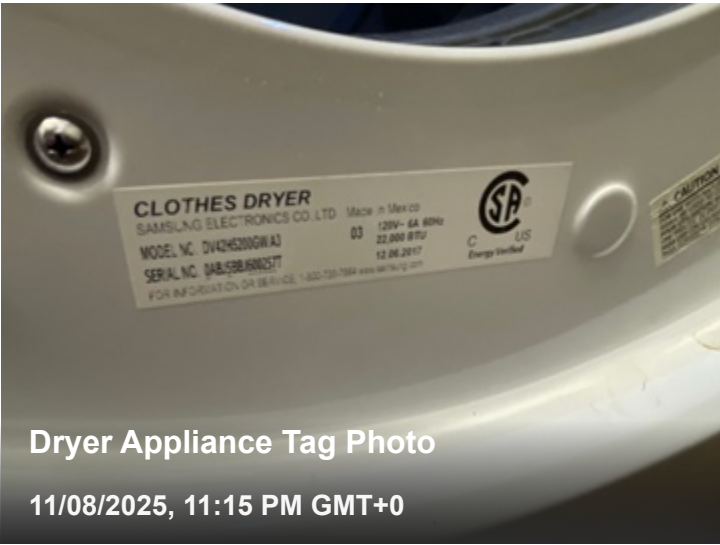
Dryer Appliance Tag Photo

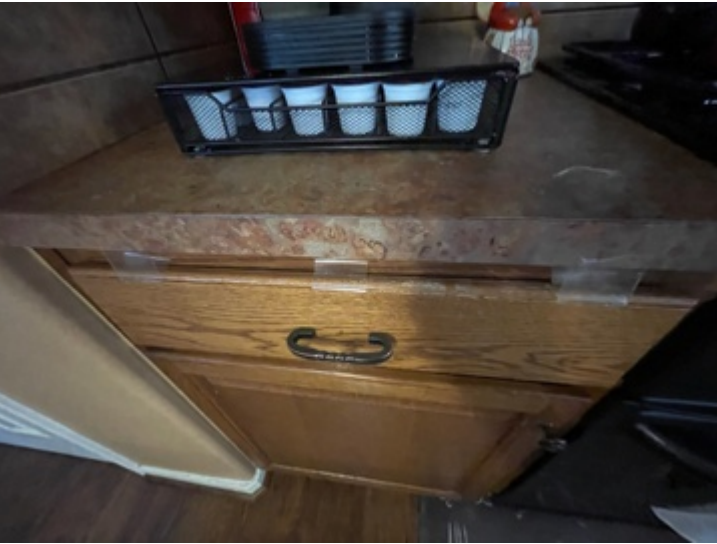
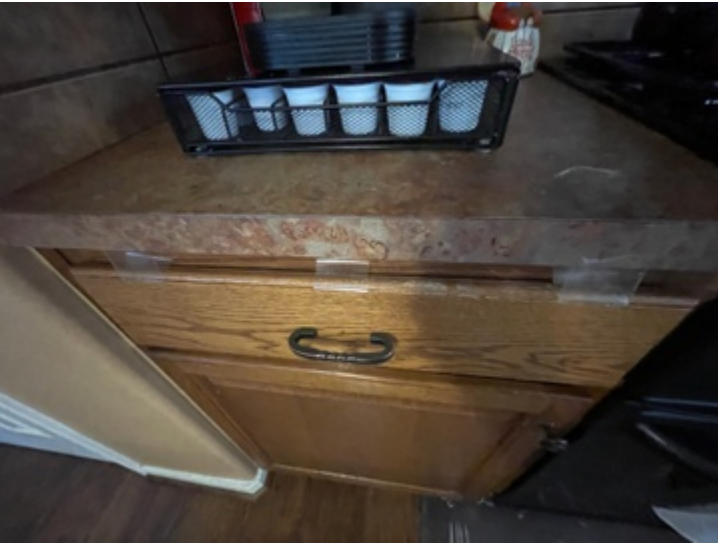
**Repair deficiency**

**Damaged / Missing Cabinet Door / Drawer**

The cabinet door / drawer is damaged / missing.

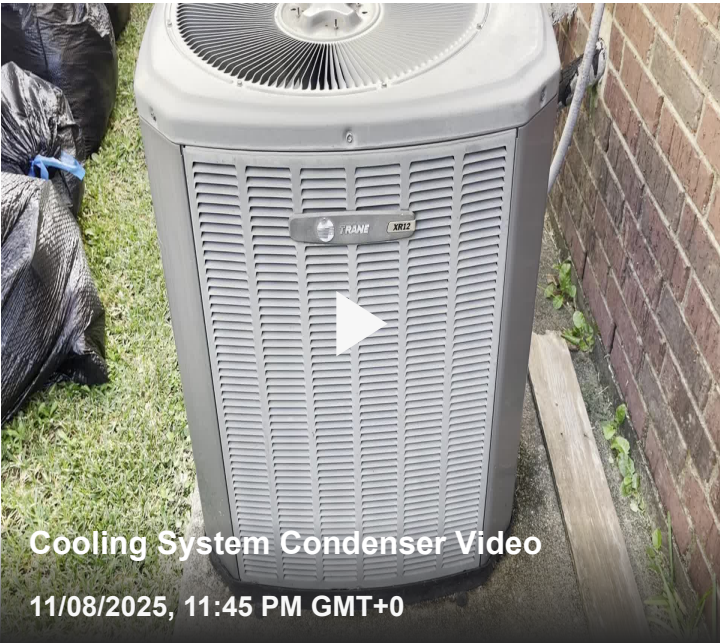
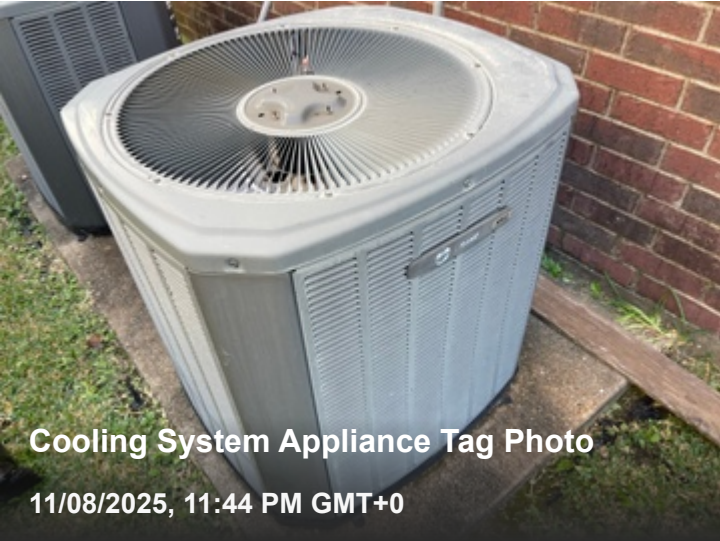
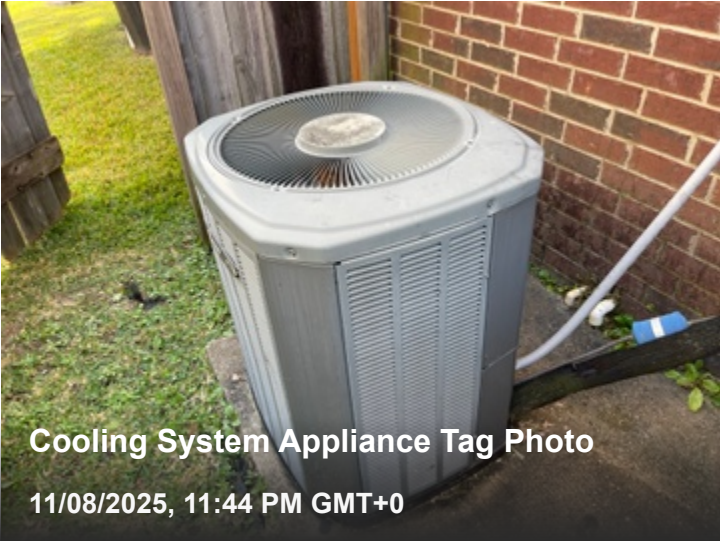
Air Conditioner not found

Unable to retrieve appliance data from the model / serial number photo.

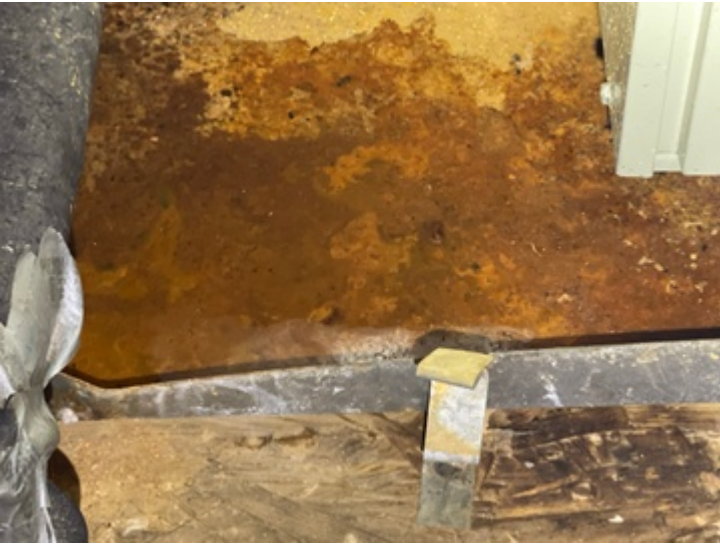
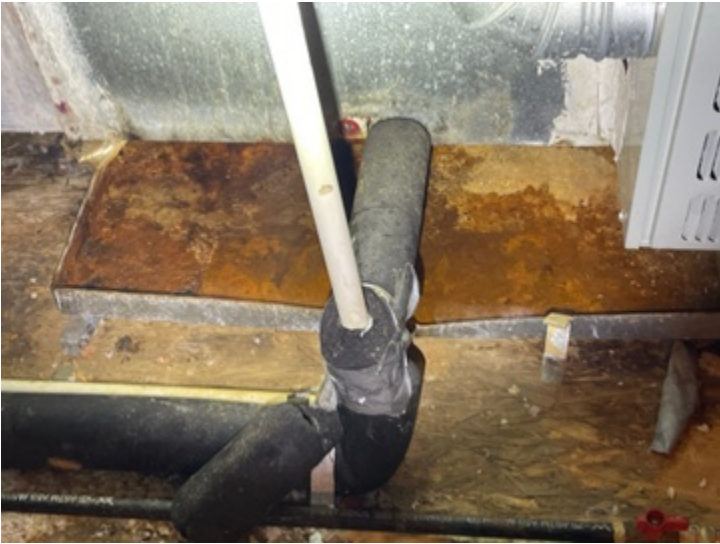
**Repair deficiency**

**Rusting or Damaged HVAC Drip Pan**

The drip pan below the air conditioning unit is rusting or damaged.

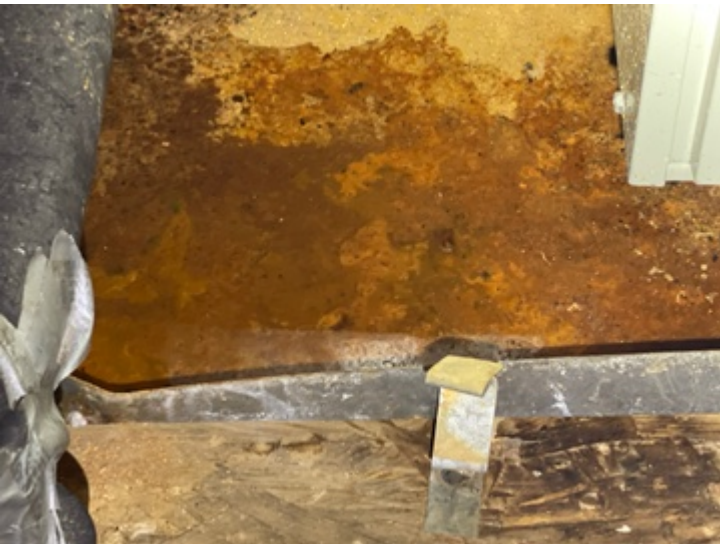
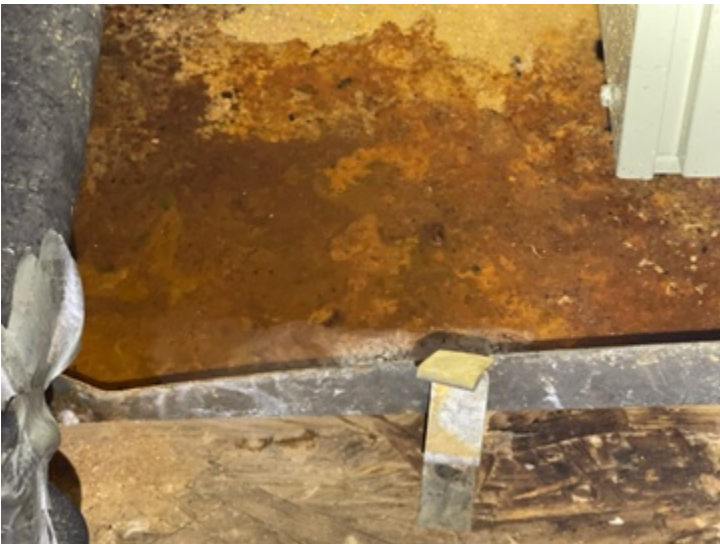
**Repair deficiency**

Standing water was noted in the drain pan.

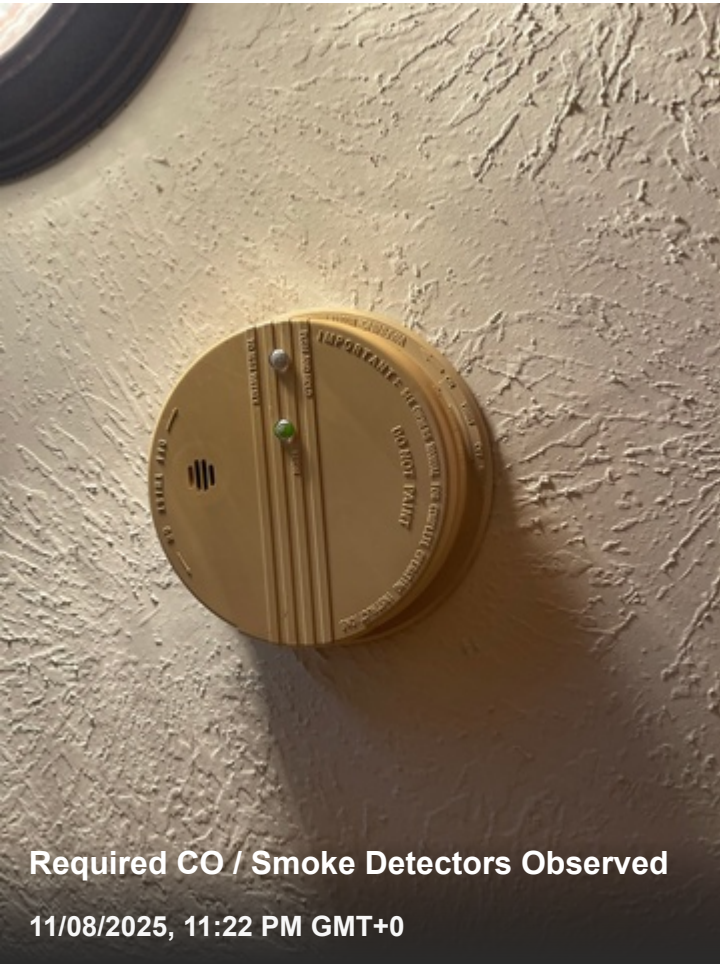
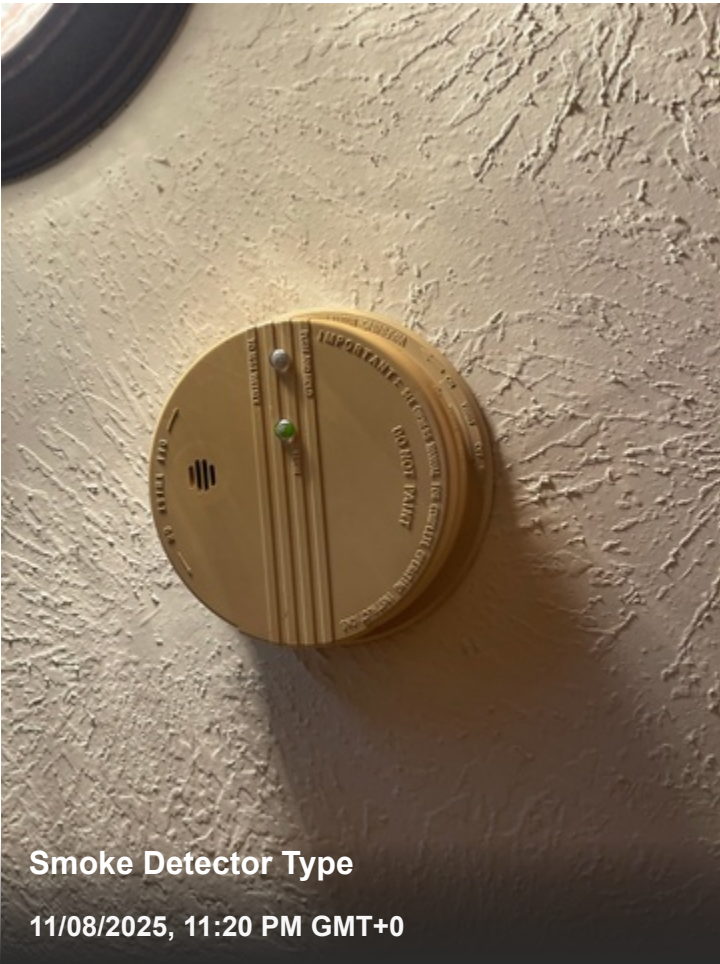
Safety deficiency

Missing Carbon Monoxide Detector(s)

One or more carbon monoxide detector(s) is missing or not installed.
