12325 Green Ridge Dr Willis, Texas 77318

Client	--
Reference id	a4xPd000003GAo5IAG
Type	Home Inspection and Floor Plan Report - 12325 Green Ridge Dr
Inspected by	HomeTeam Inspection Service - Northwest Houston
State license	Texas: TREC 22223
InterNACHI	Certified Professional Inspector (CPI): NACHI16110228
Other license	Texas Mold Assessment Consultant: MAC1506
Scheduled	December 5, 2025, 12:00 PM CST
Completed	December 5, 2025, 6:03 PM CST

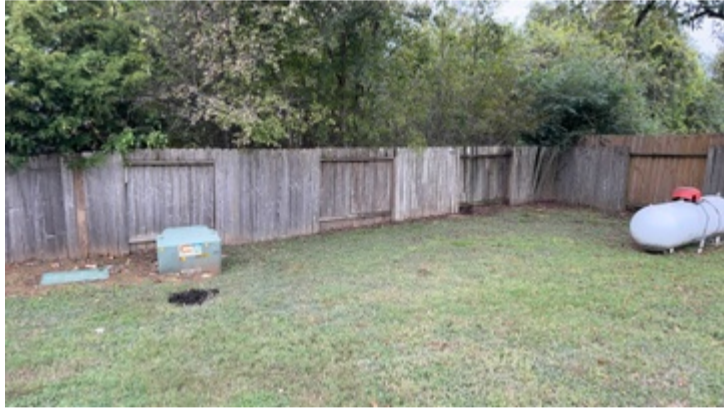
Damaged / Missing Fence Boards

One or more fence boards are missing or damaged.

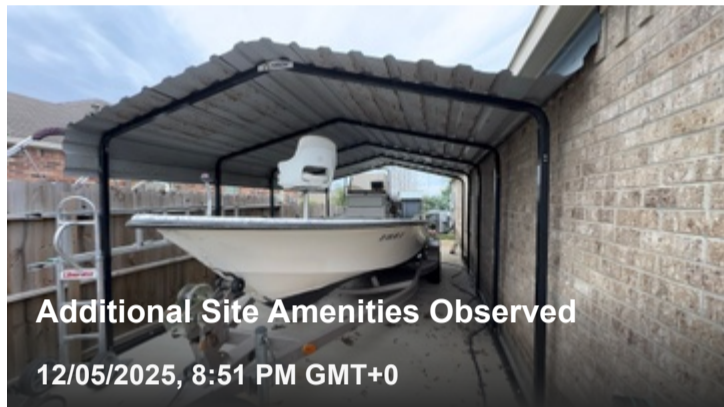
A carport and additional storage shed on the left side A carport and additional storage shed on the left side

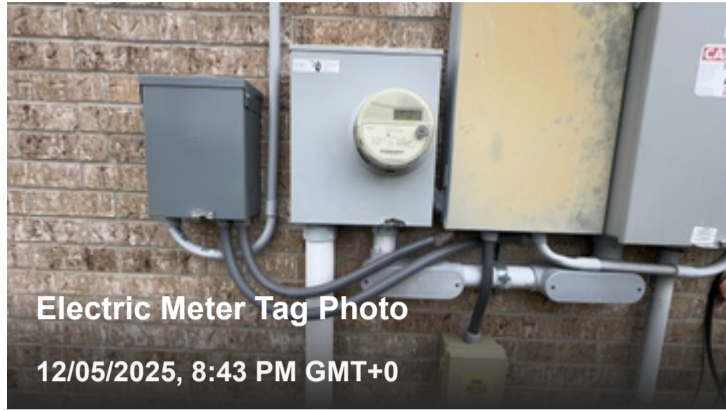
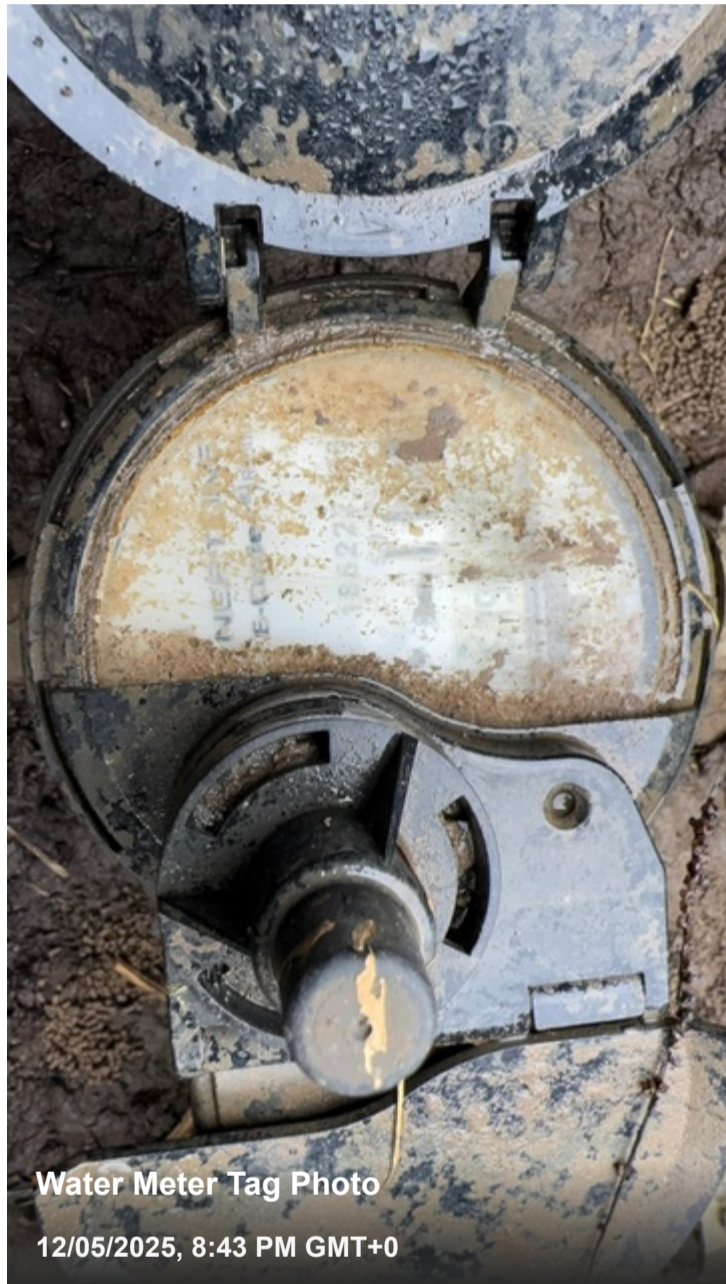
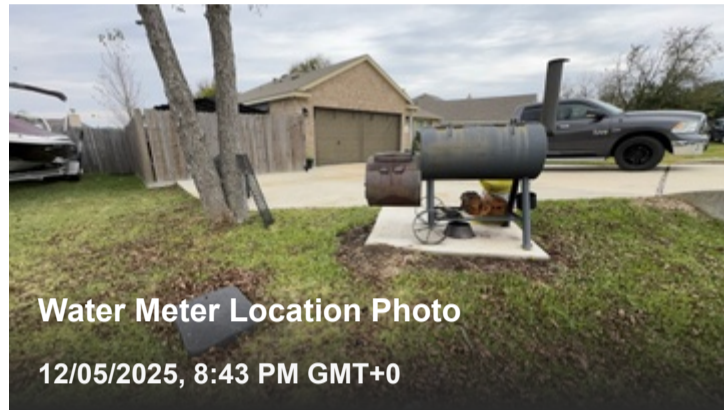
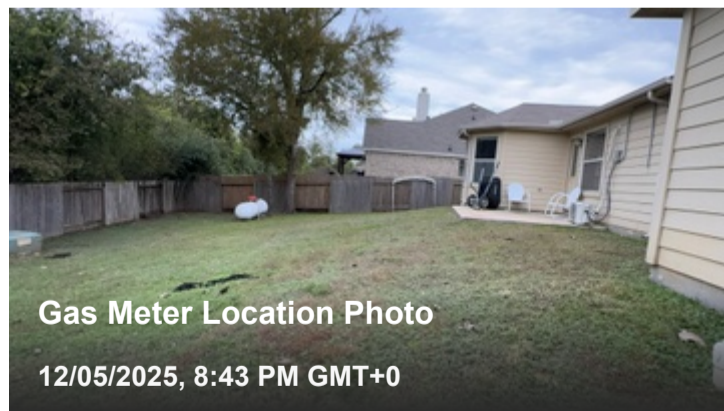
There is no gas meter only a propane tank in the backyard

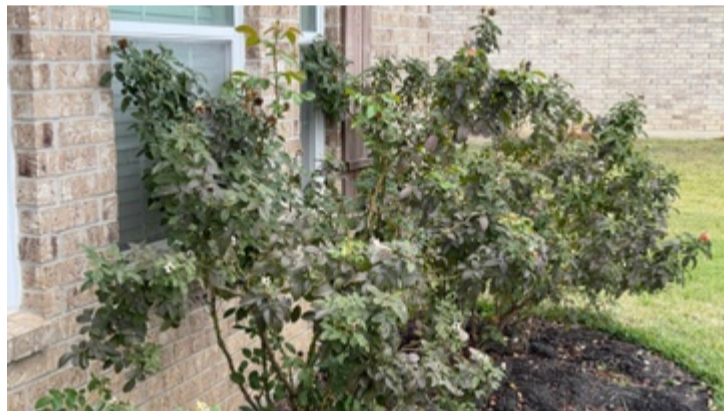
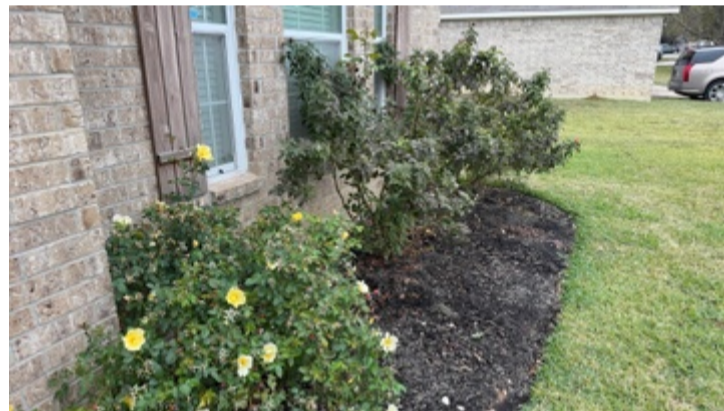
There is vegetation too close to the structure.

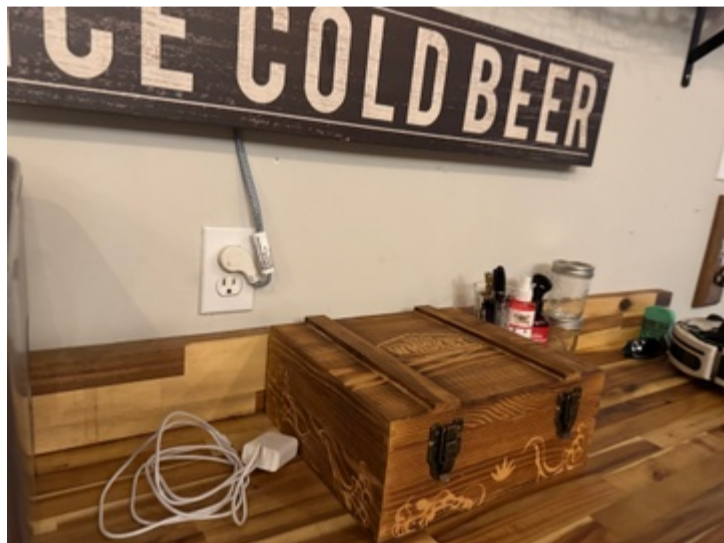
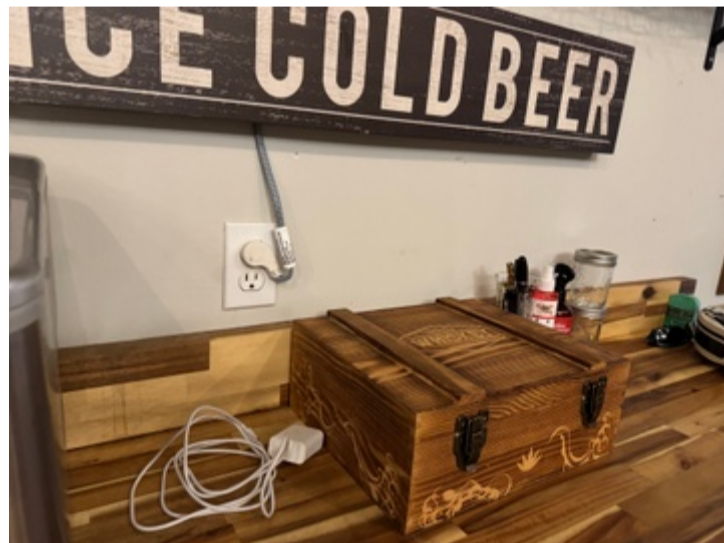
Attached Garage photos / videos

**Repair deficiency**

Missing GFCI

There is no GFCI (Ground-Fault Circuit Interrupter) protection.

Note

Some garage receptacles were not GFCI protected

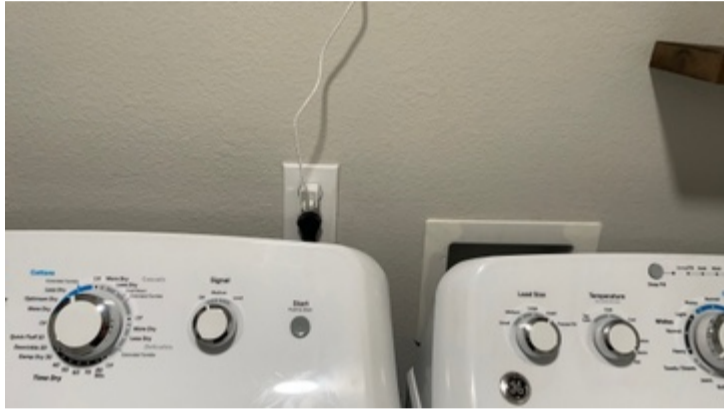
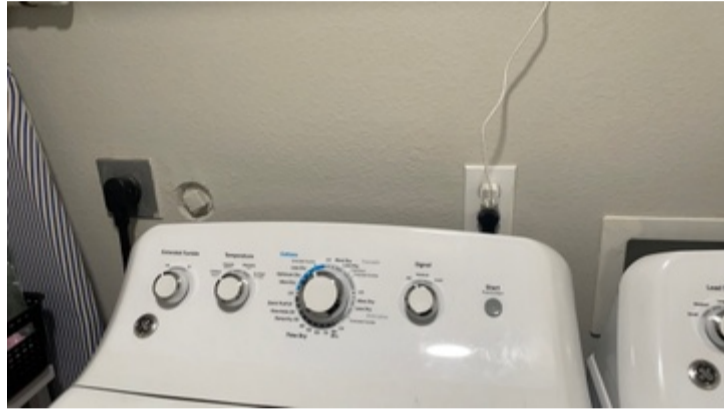
Missing GFCI

There is no GFCI (Ground-Fault Circuit Interrupter) protection.

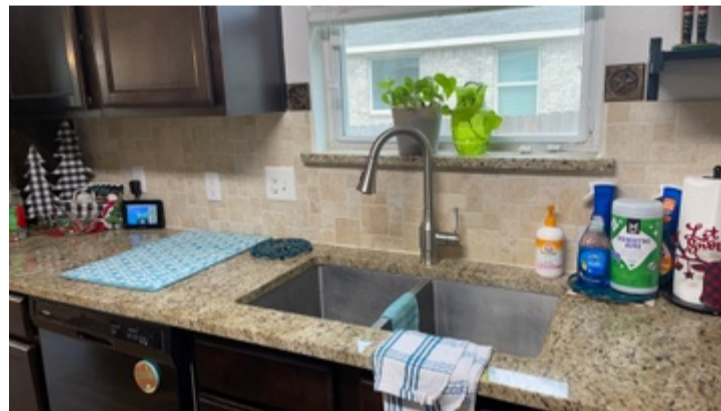
Kitchen General photos / videos

**Repair deficiency**

Missing GFCI

There is no GFCI (Ground-Fault Circuit Interrupter) protection.

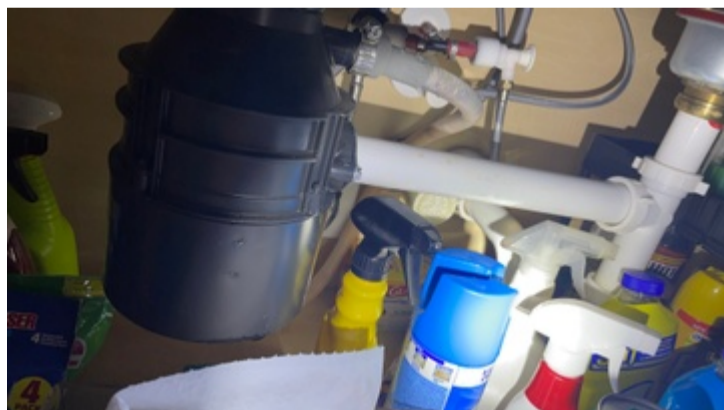
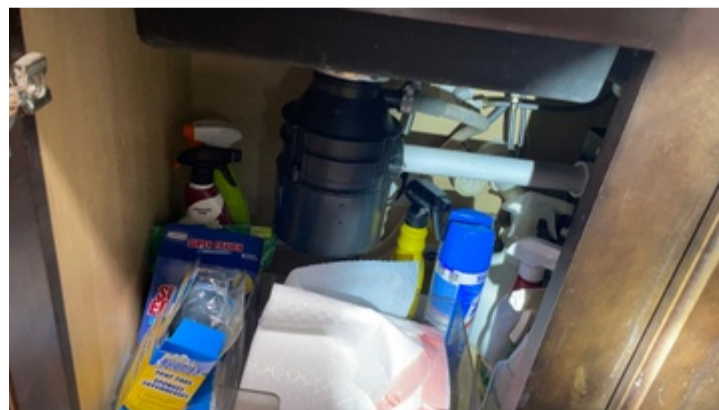
Dishwasher photos / videos

**Repair deficiency**

Missing Dishwasher High Loop

The dishwasher plumbing is missing a high loop.

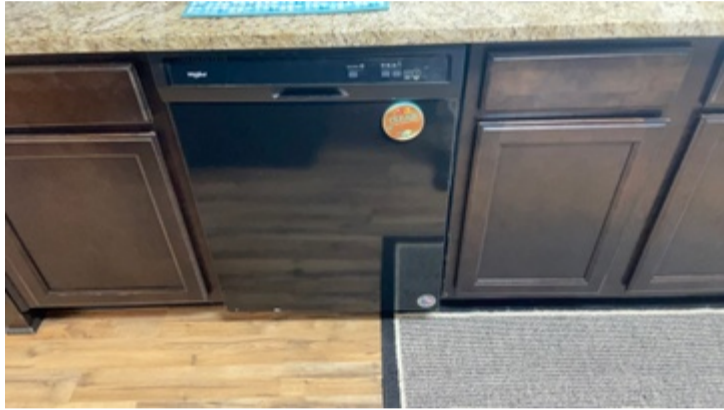
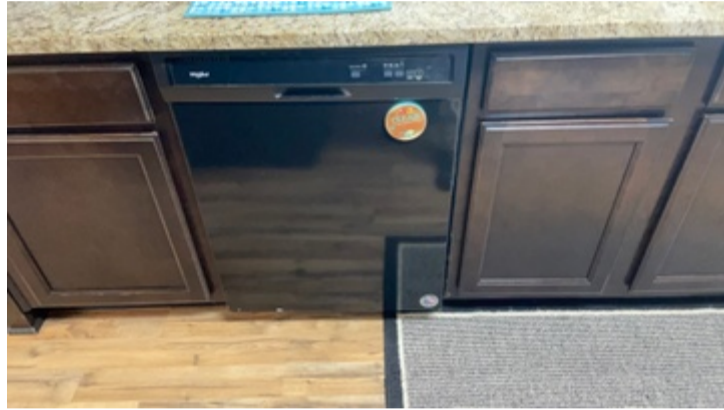
Dishwasher photos / videos

**Repair deficiency**

The dishwasher would not drain during the wash cycle. So water was standing in the bottom of the wash chamber when I left the inspection.

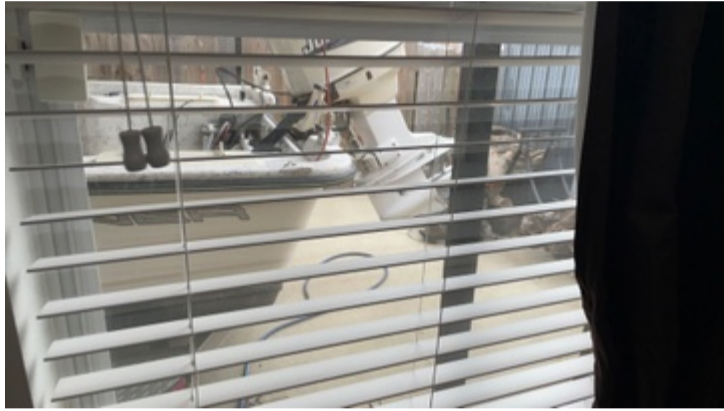
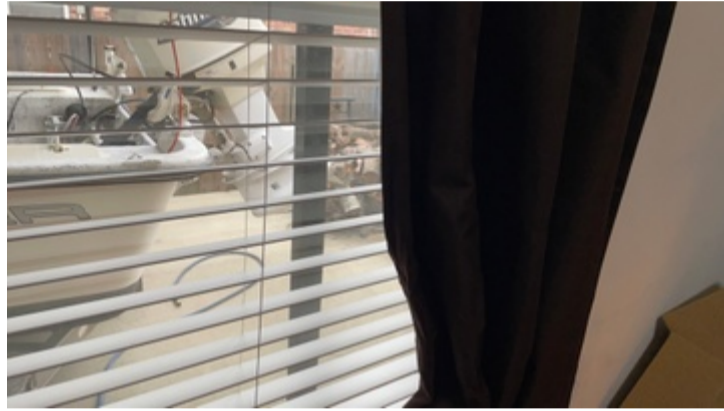
Missing Window Screen

One or more windows are missing a screen.

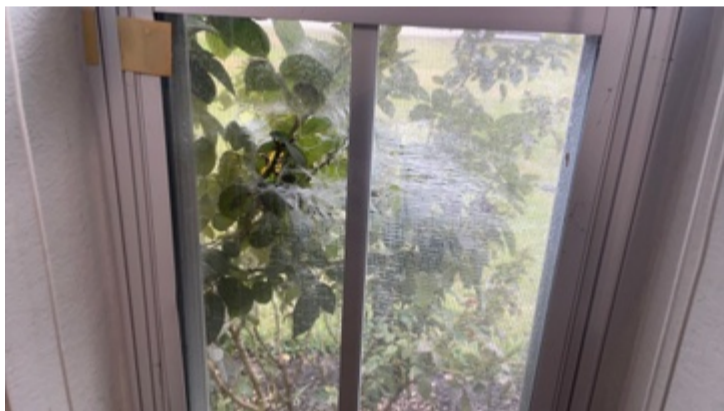
Damaged Screen

One or more window screens are damaged.

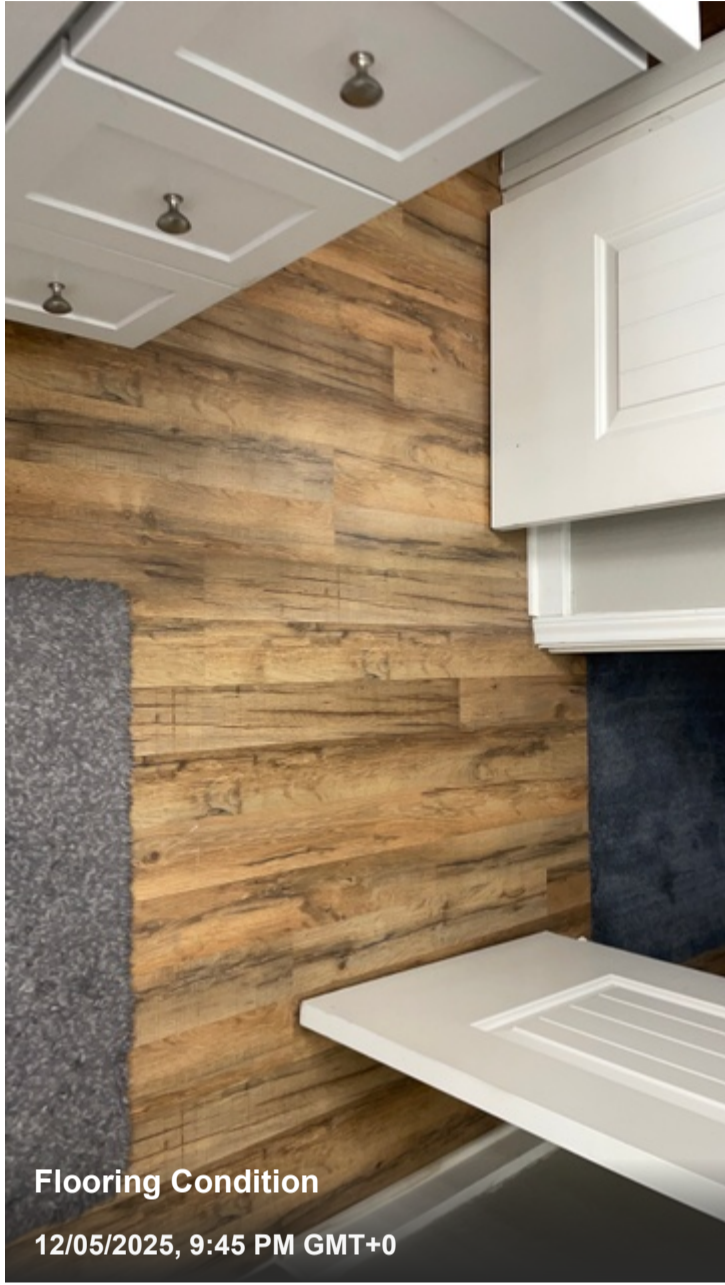
Flooring Condition
12/05/2025, 9:45 PM GMT+0

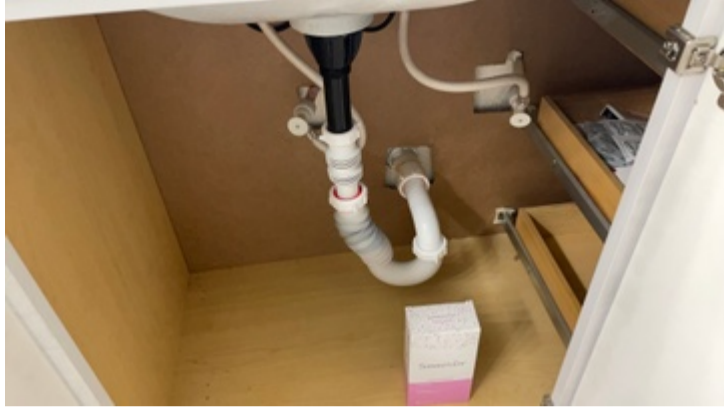
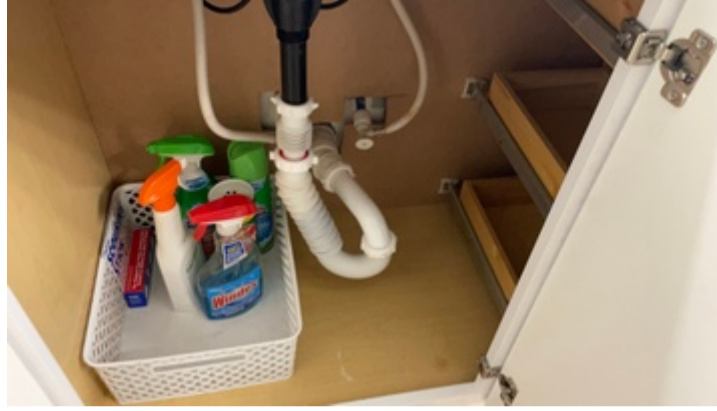
There is accordion drain material present.

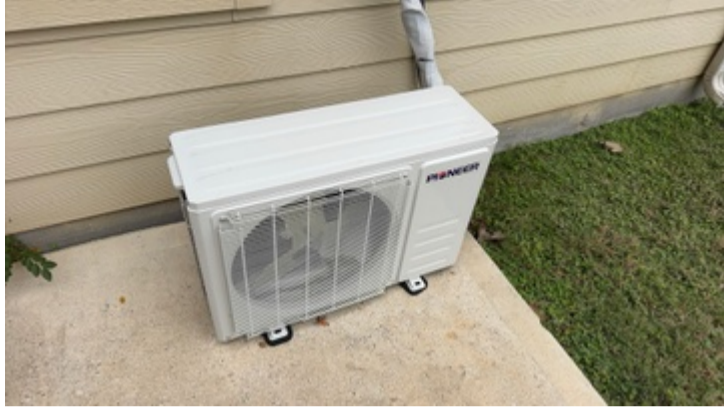
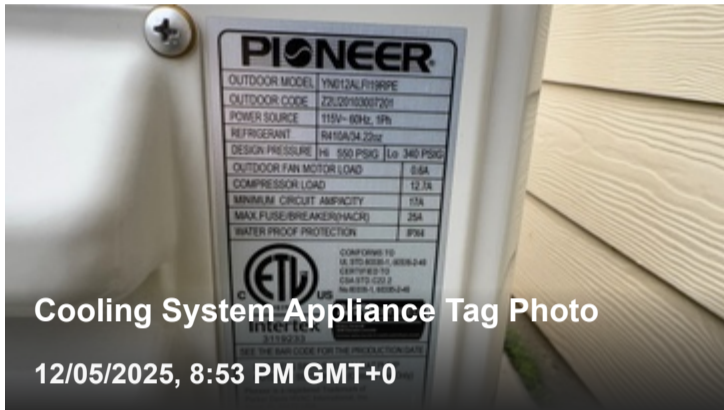
Cooling 2 photos / videos

Because the outside temperature was too cool to operate the air conditioner without the possibility of damaging the system, I did not operate the cooling system.

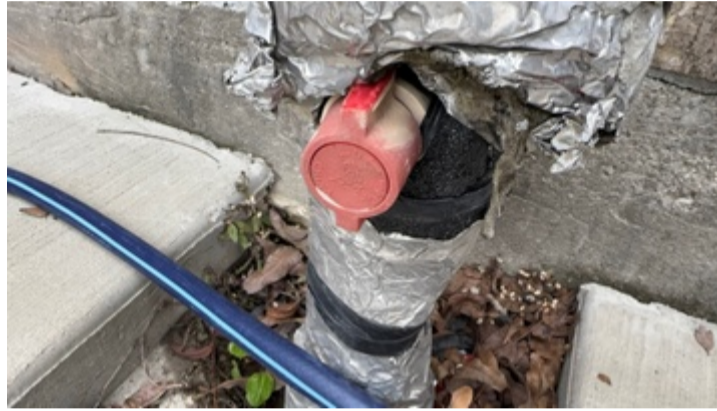
Main Water Supply photos / videos

Deteriorated / Damaged Water Valve

The valve is deteriorated / damaged.

No handles for the main water shut off valve

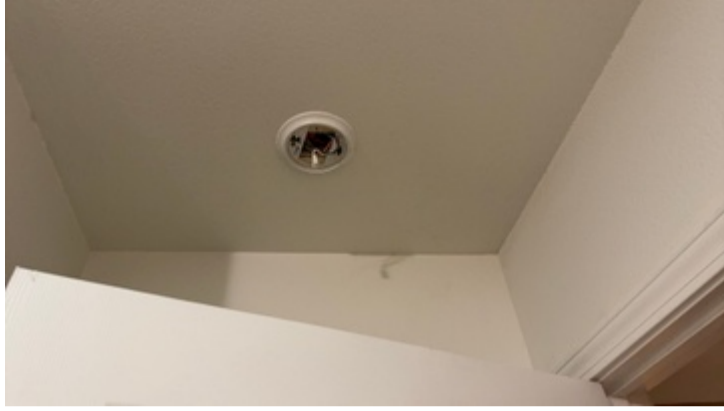
Smoke / Carbon Monoxide Detectors photos / videos

Missing Smoke Detector(s)

The amount of smoke detectors on the property does not meet the residential requirements.

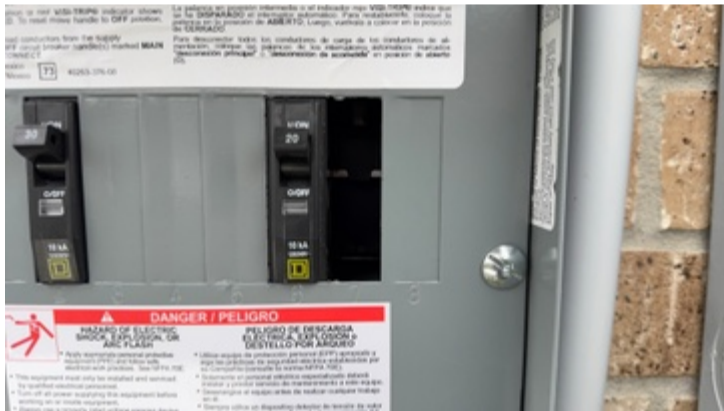
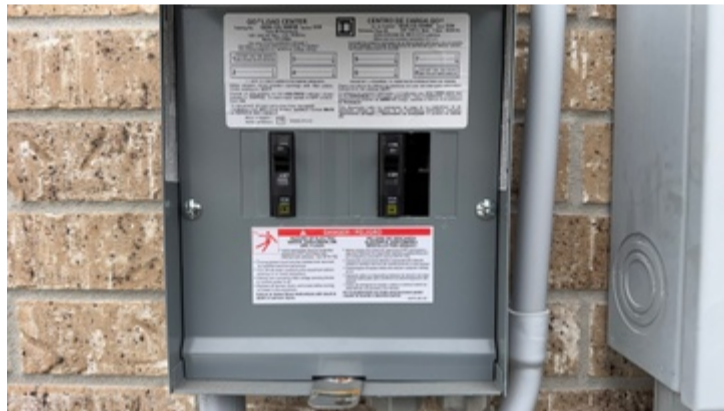
Missing Electrical Panel Knockouts

The electric panel knockouts are missing.

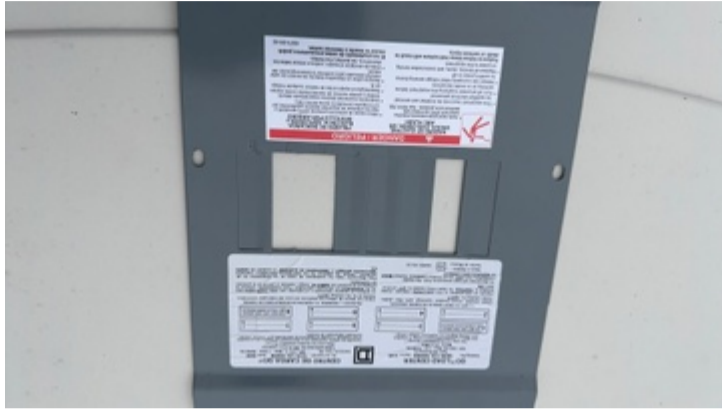
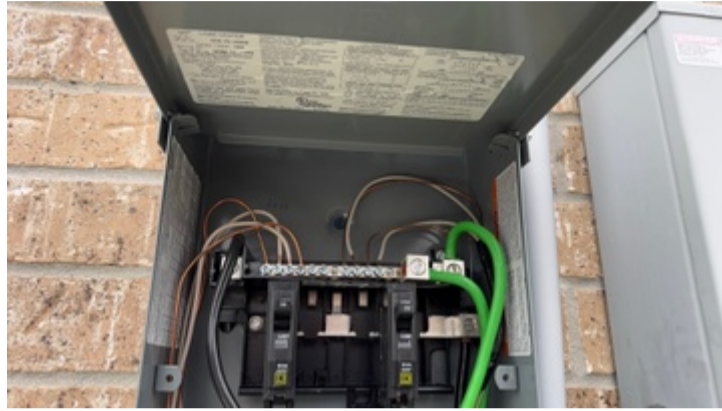
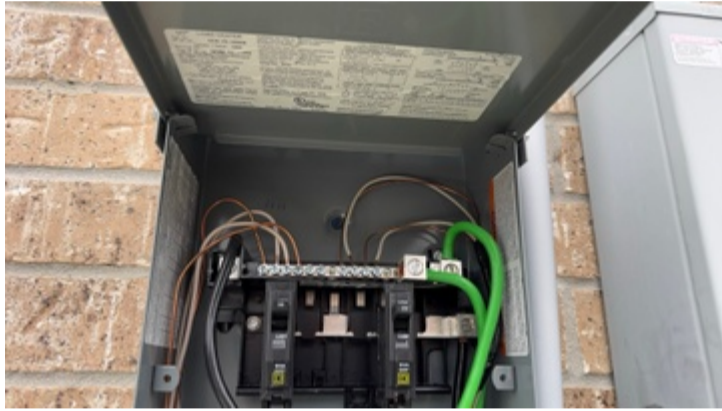
Missing Labels in Electrical Panel

The electrical panel is missing circuit labeling.
