# 15202 Sunlight Bay Ct

## Cypress, Texas 77429

| Type | Home Inspection and Floor Plan Report - 15202 Sunlight Bay Ct |
| Inspected by | Rio Bravo - Inspectify Pro - Houston |

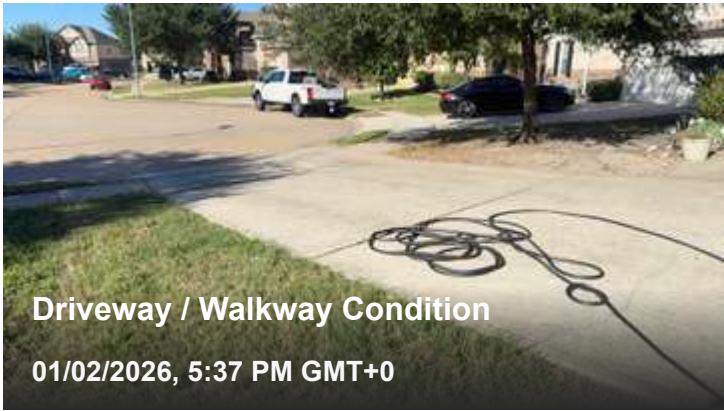
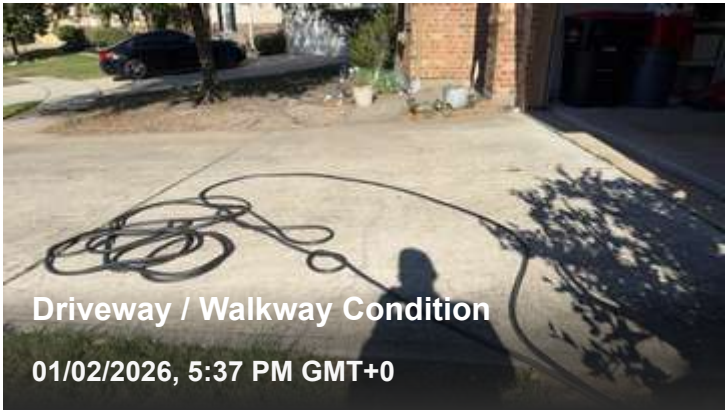
### Minor Cracks in the Driveway

The driveway has minor cosmetic cracks.

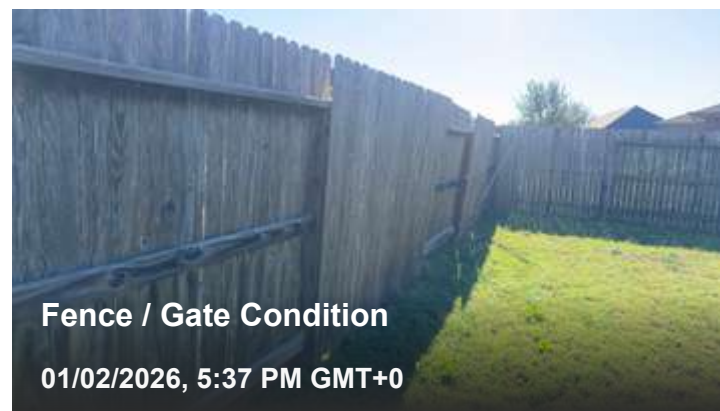
## Leaning Fence

The fence is leaning.

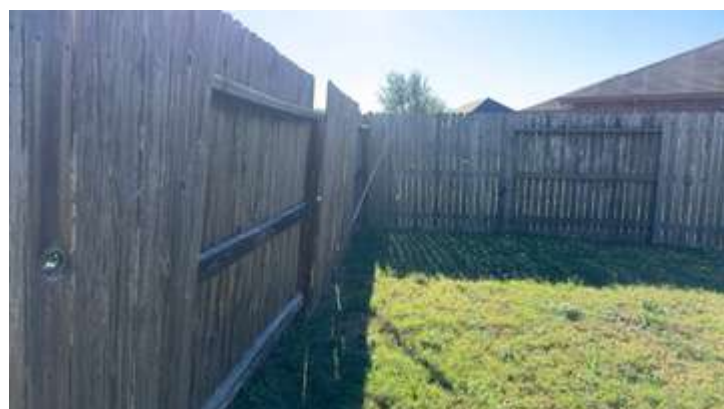
## Damaged / Missing Fence Boards

One or more fence boards are missing or damaged.

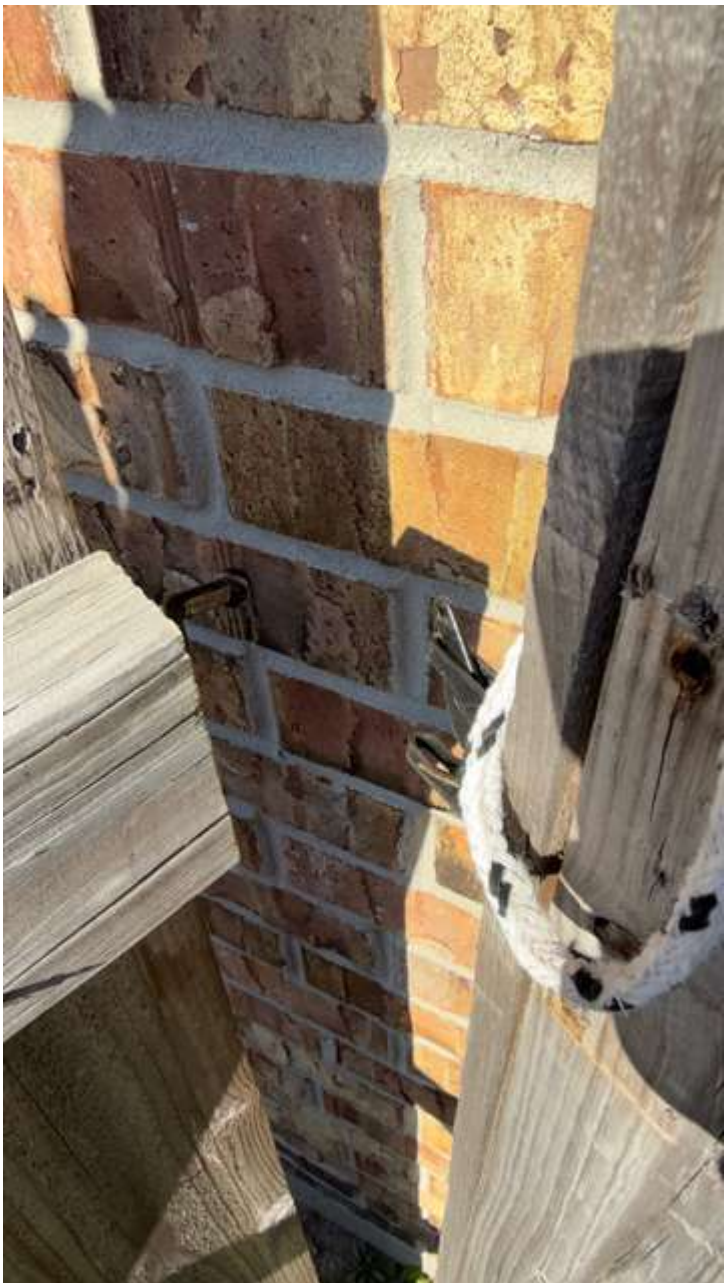
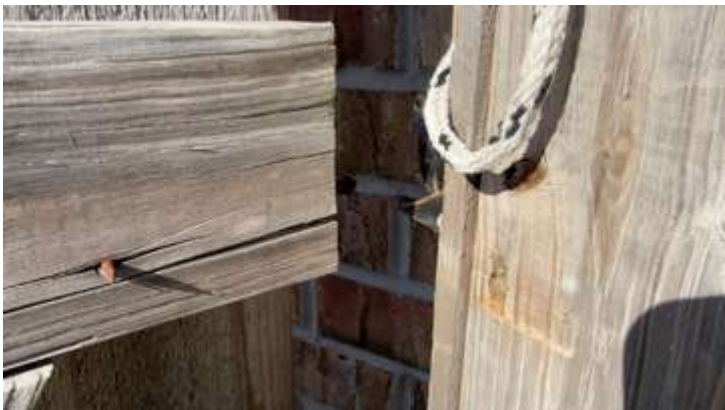
## Improperly Latching Gate

The gate does not latch.

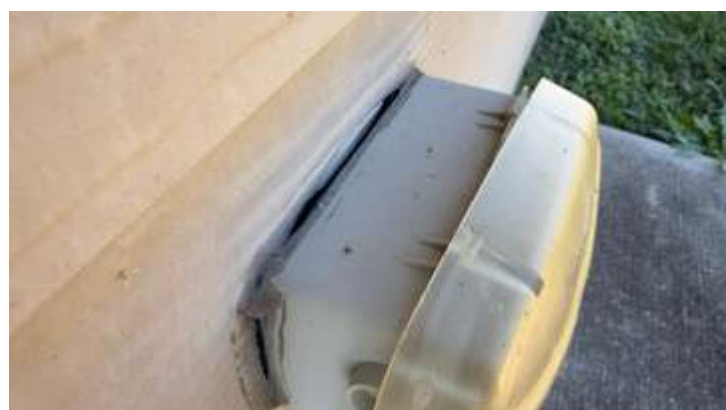
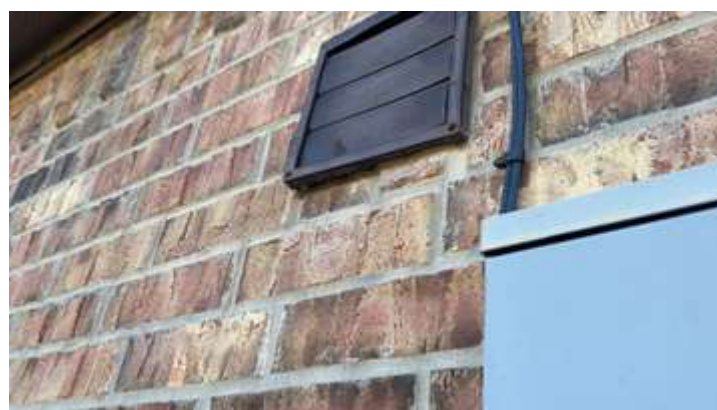
## Exterior Fixture Needs Caulking

There is no sealant around an exterior fixture.

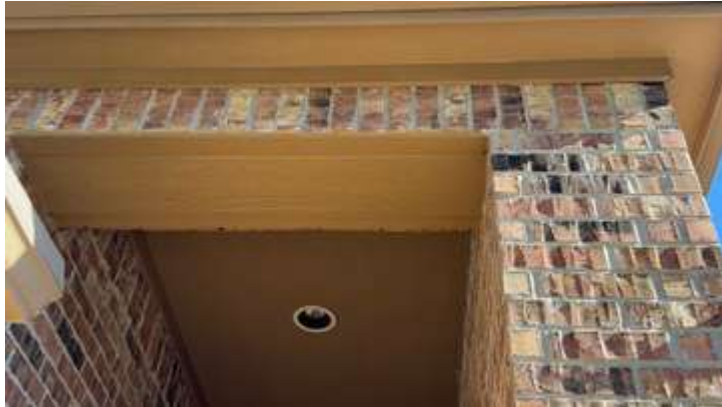
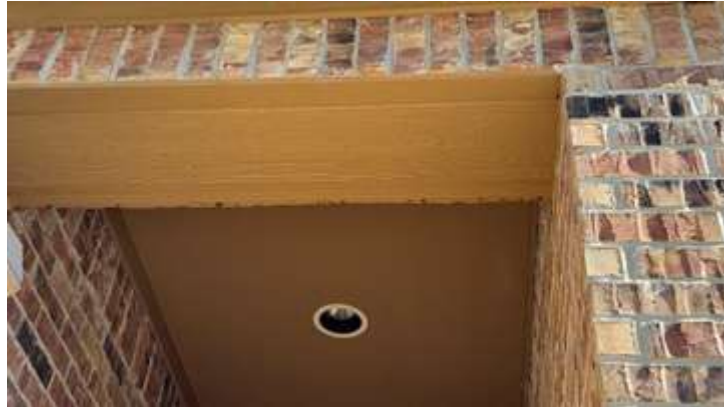
### Corroded Brick Lintel(s)

There are corroded brick lintels.

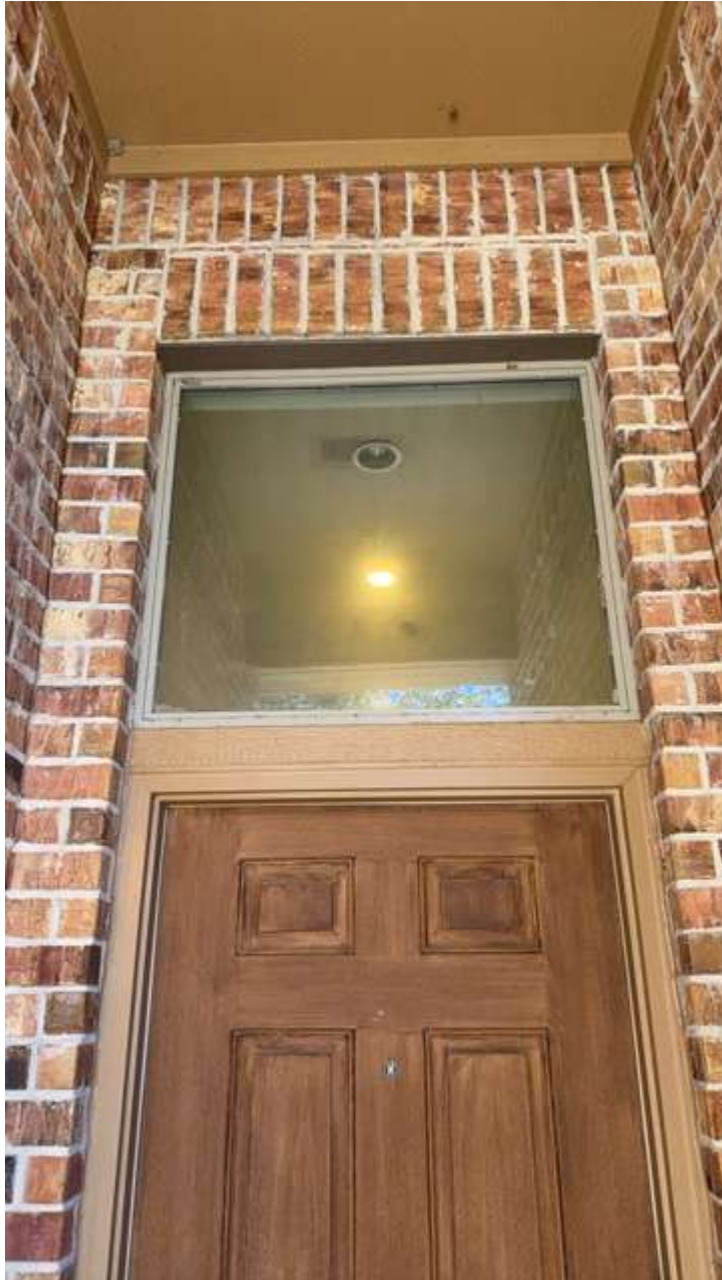
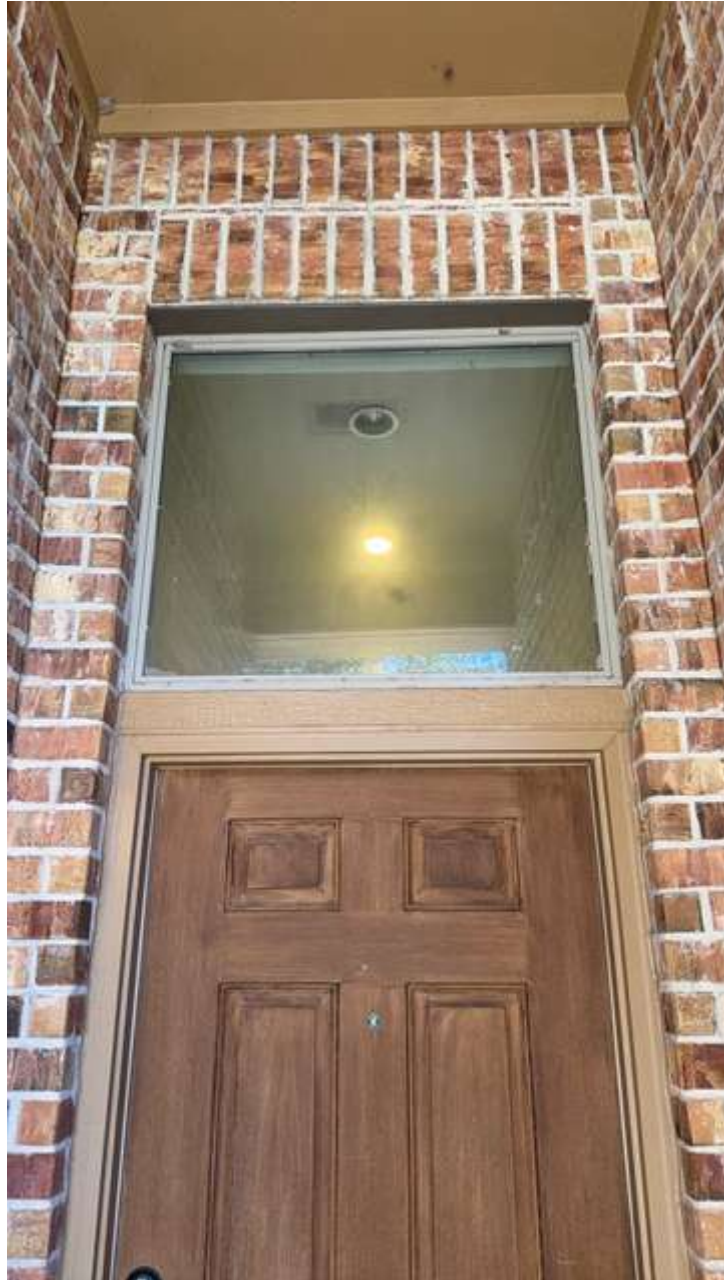
### Deteriorated / Failed Window Seal

One or more windows have condensation between the window panes.

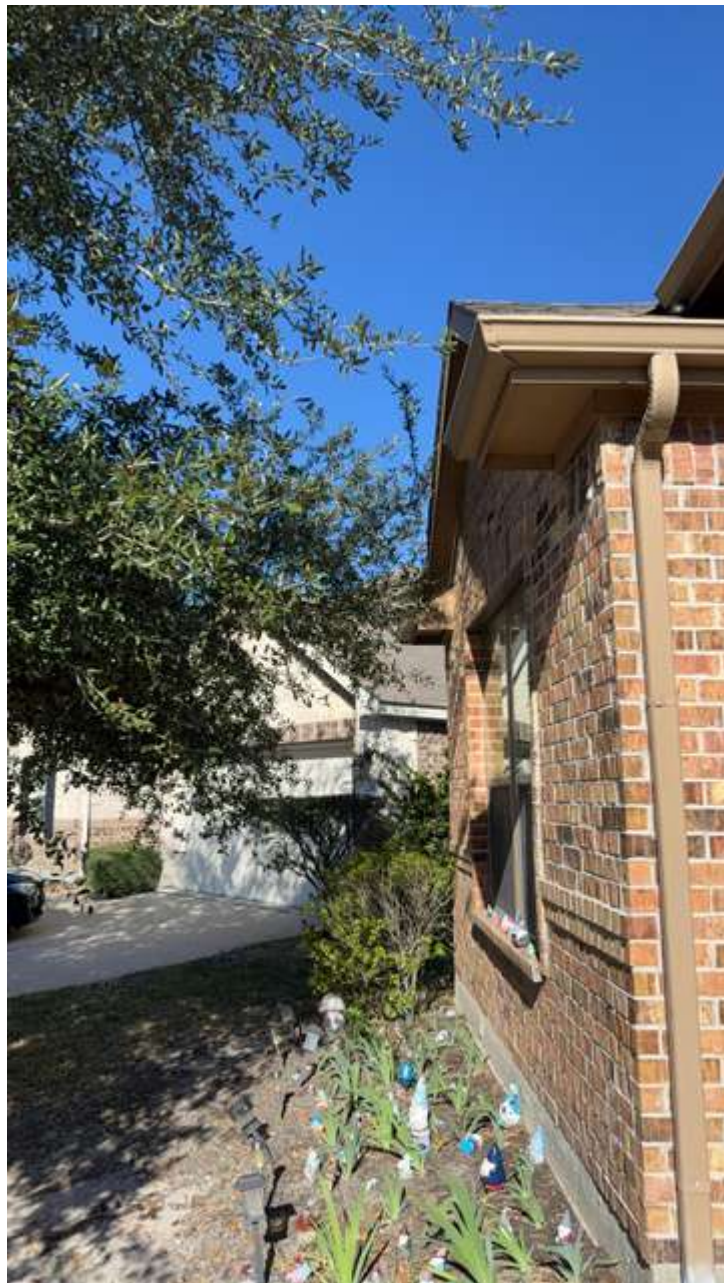
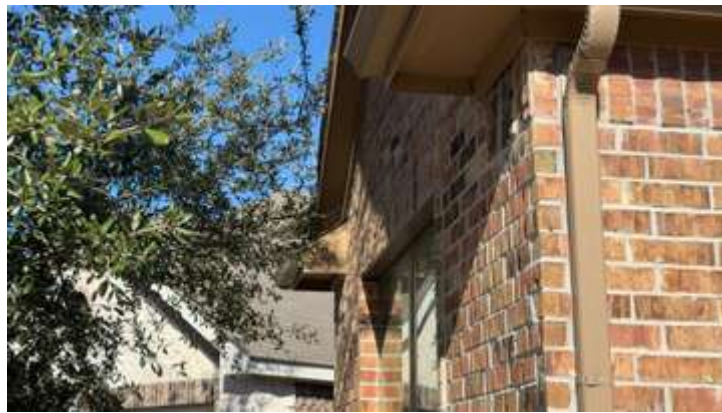
One or more tree branches(s) are overhanging the roof.

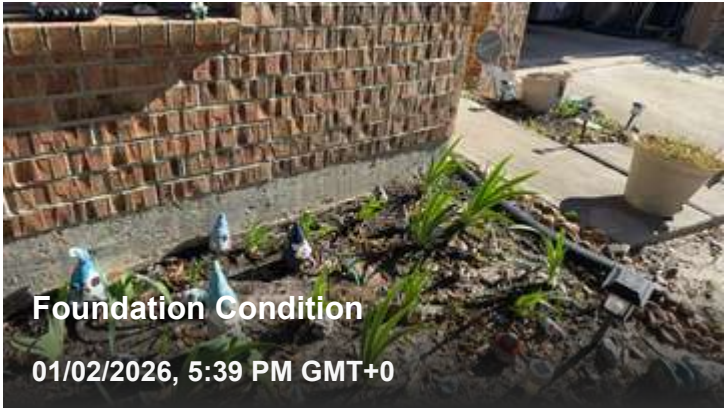
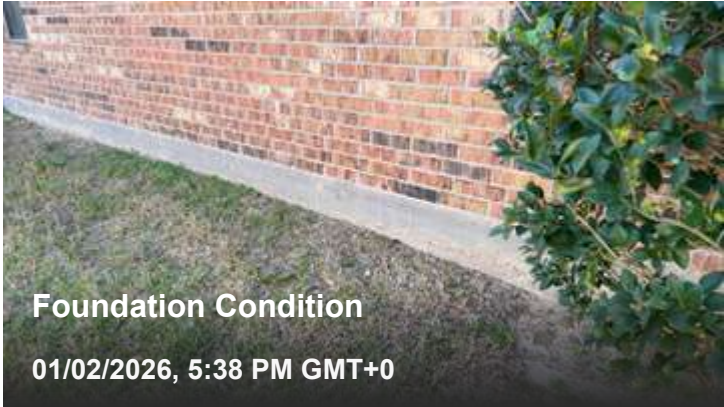
## Exposed Tendon Anchors

The cable ends are at risk of corrosion or failure.

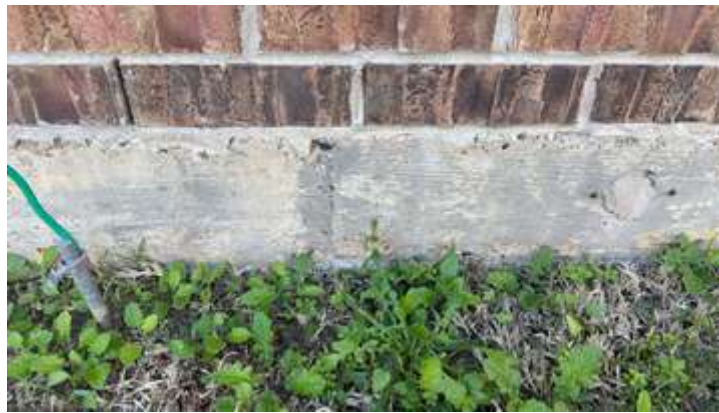
## Minor Foundation Cracks

One or more areas of the foundation have minor cracking.

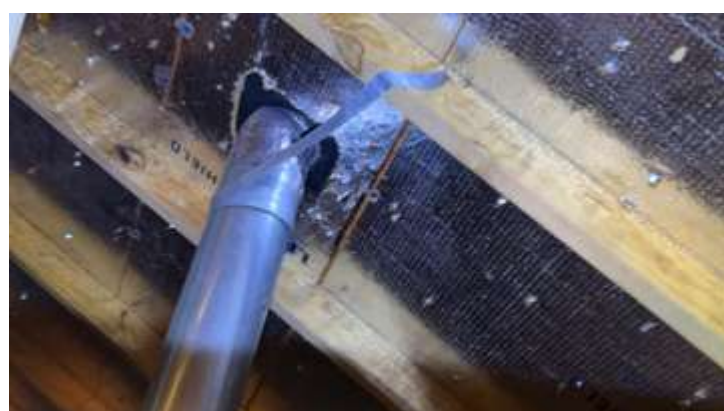
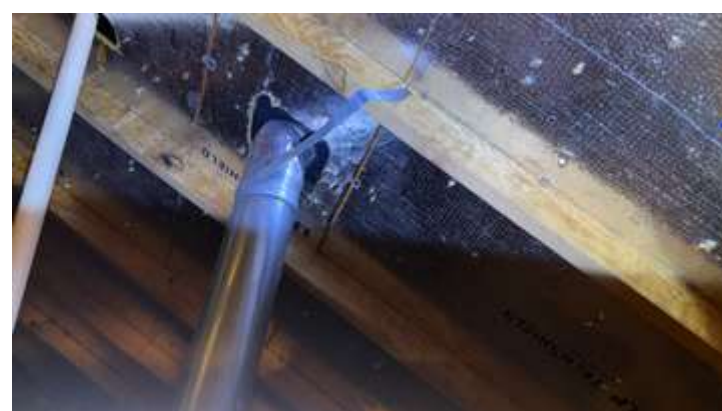
## Water Damage to Roof Deck

There are signs of water damage to the roof decking.

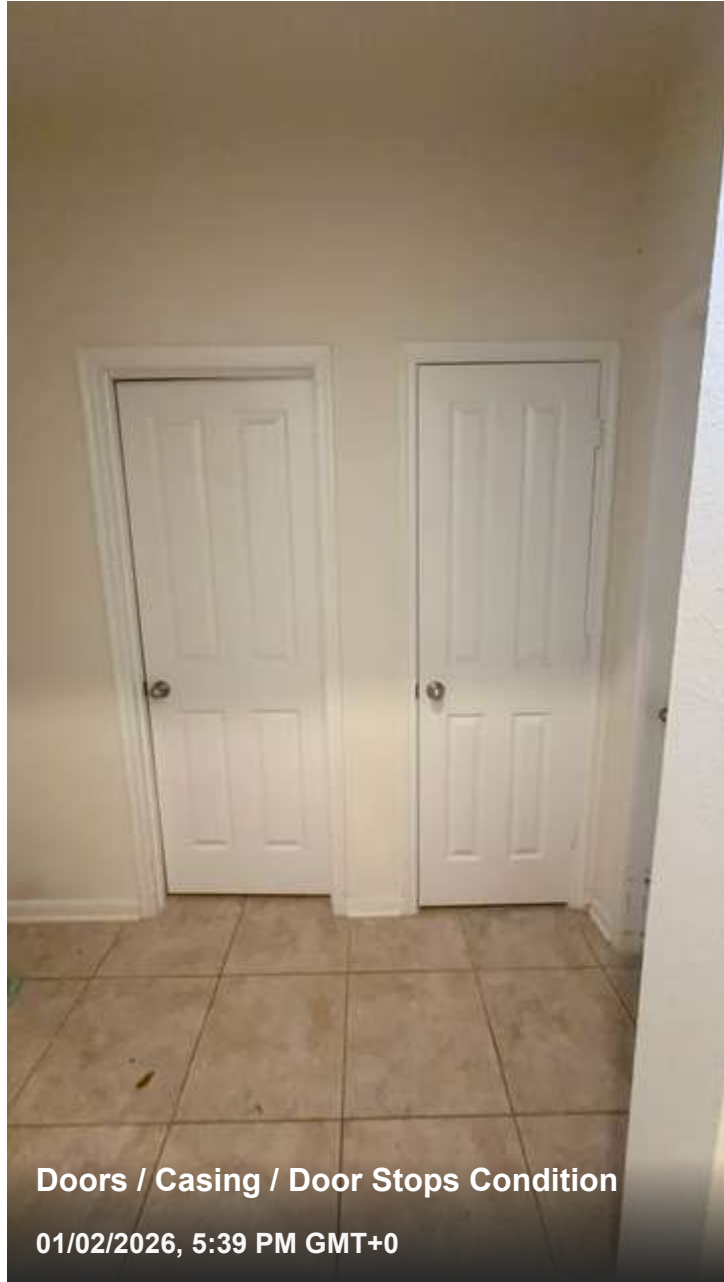
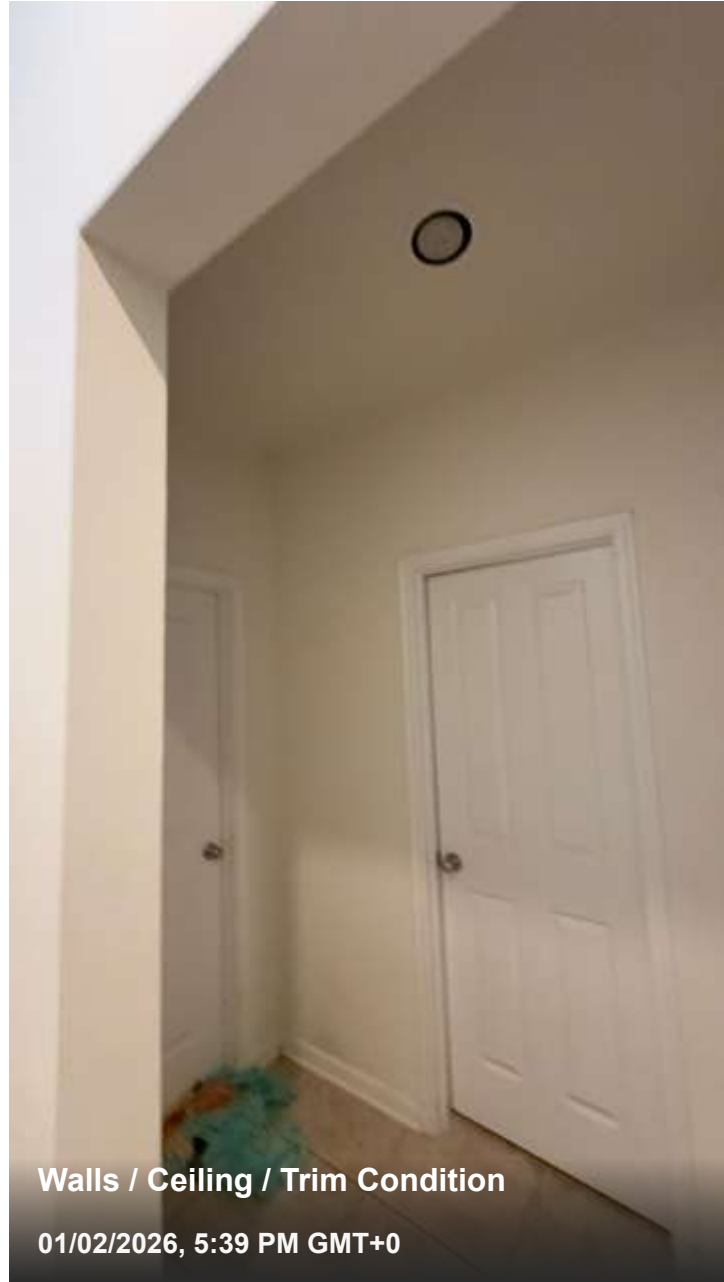
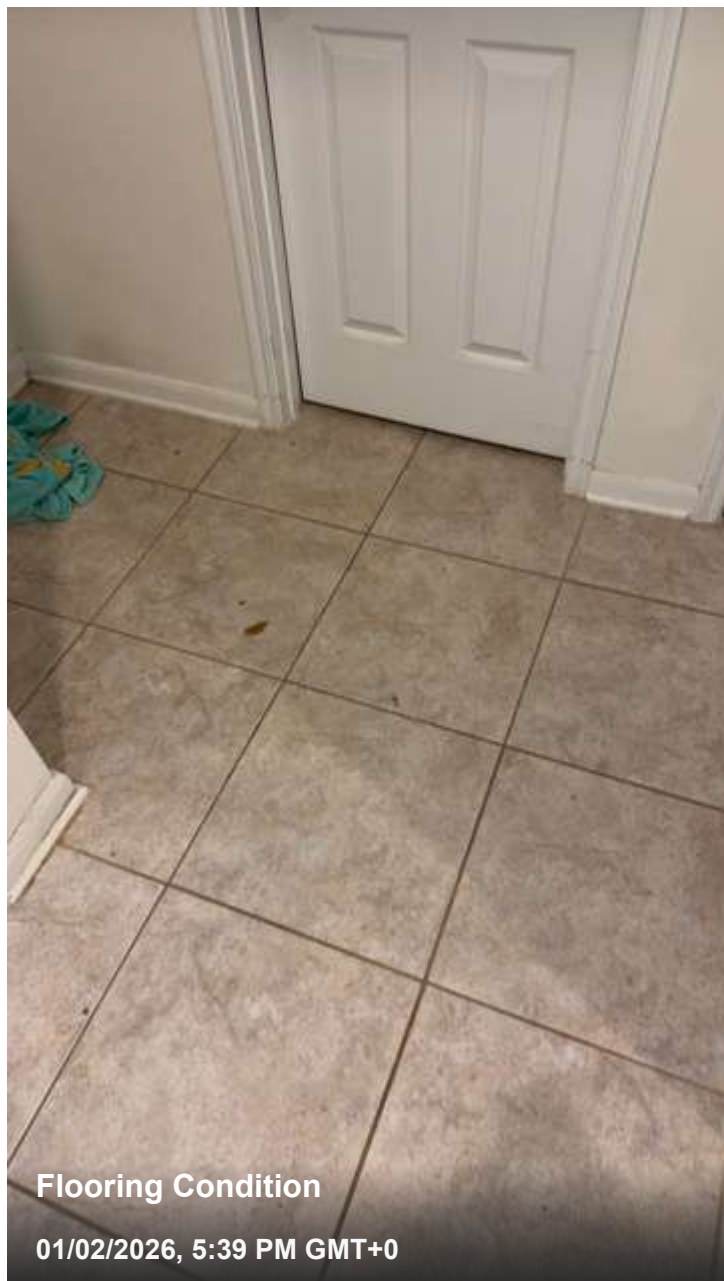
**Monitor deficiency****Inoperable or Missing Light Bulb**

One or more light bulbs have burnt out or are missing.

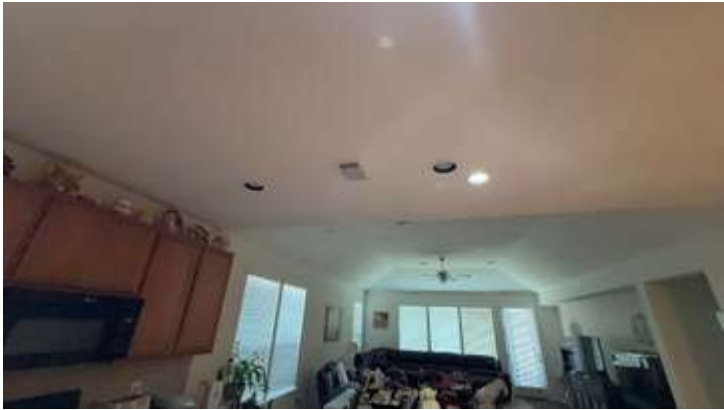
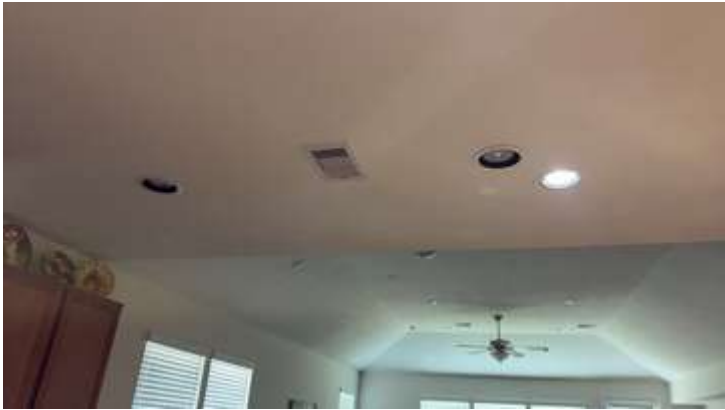
## Inoperable or Missing Light Bulb

One or more light bulbs have burnt out or are missing.

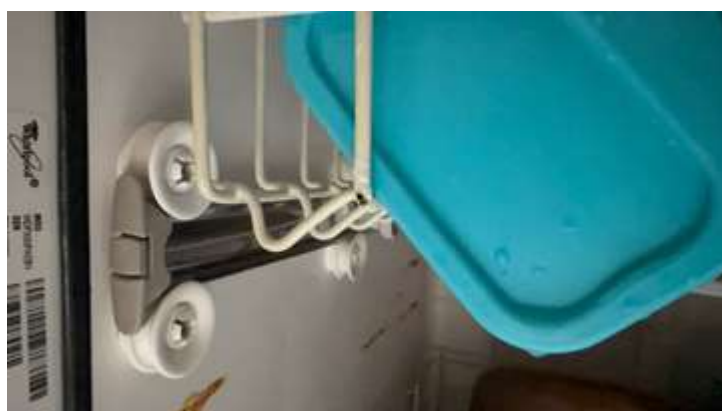
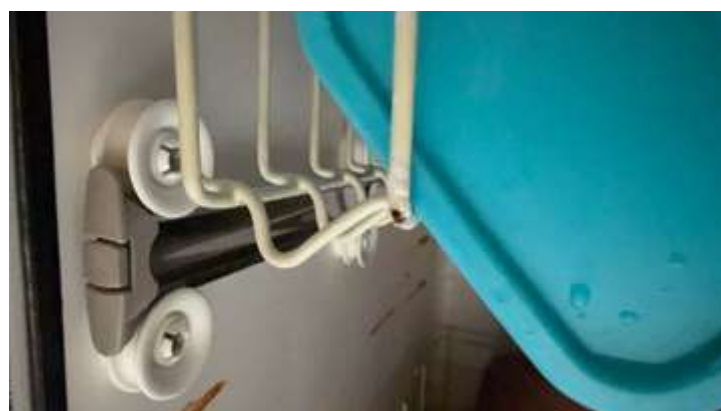
## Rusted / Damaged Dishwasher Racks

The dishwasher racks are rusted / damaged.

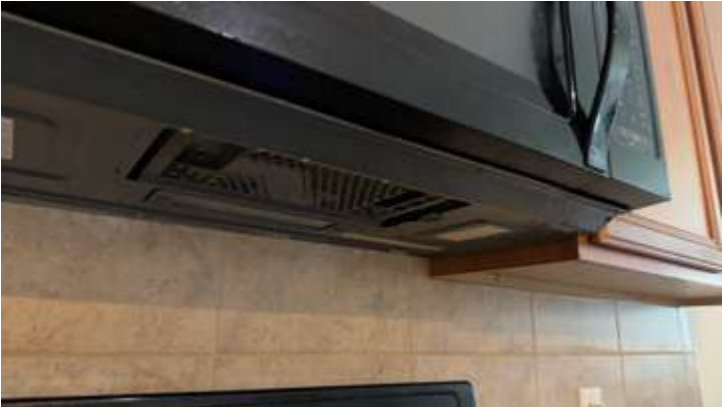
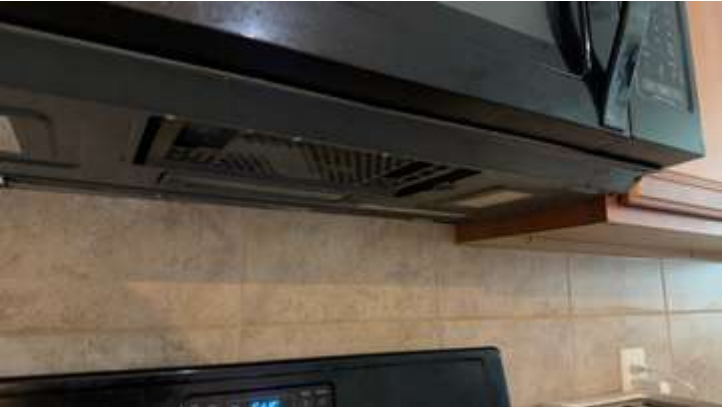
**Vent Hood Filters Missing**

The vent hood filters are missing.

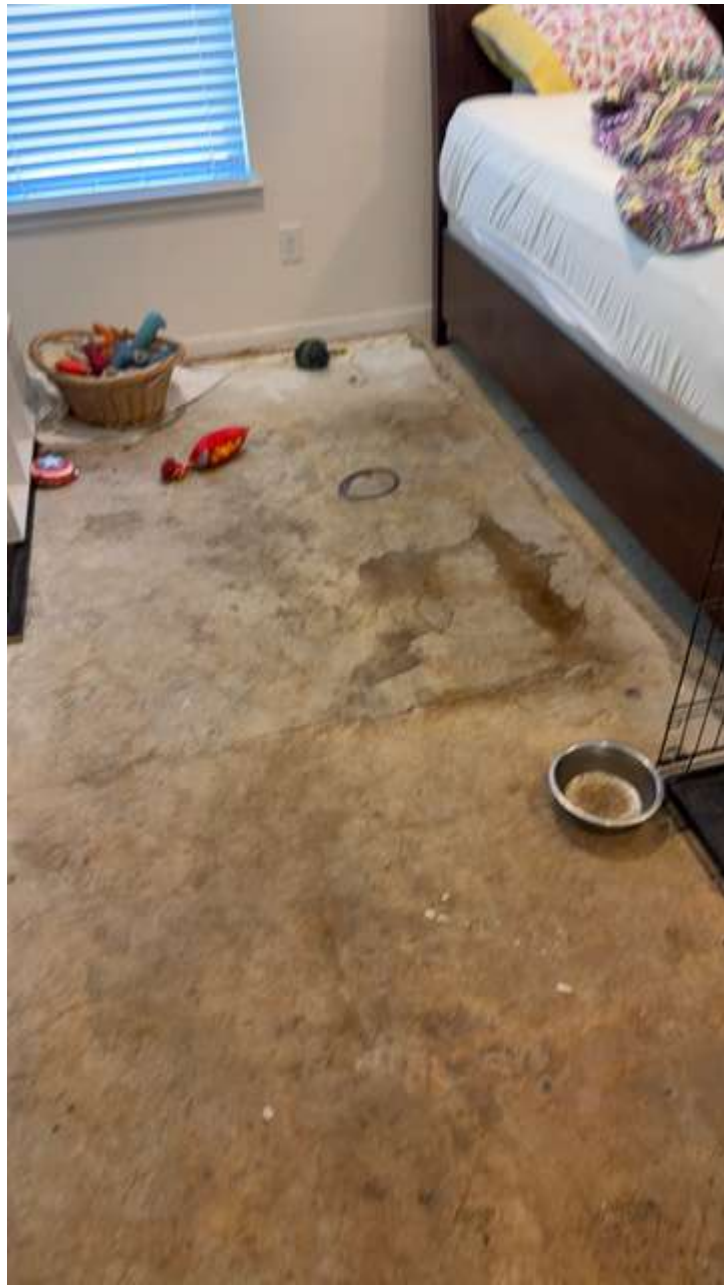
### Damaged or Torn Carpet

The carpet floor is damaged or torn in one or more areas.

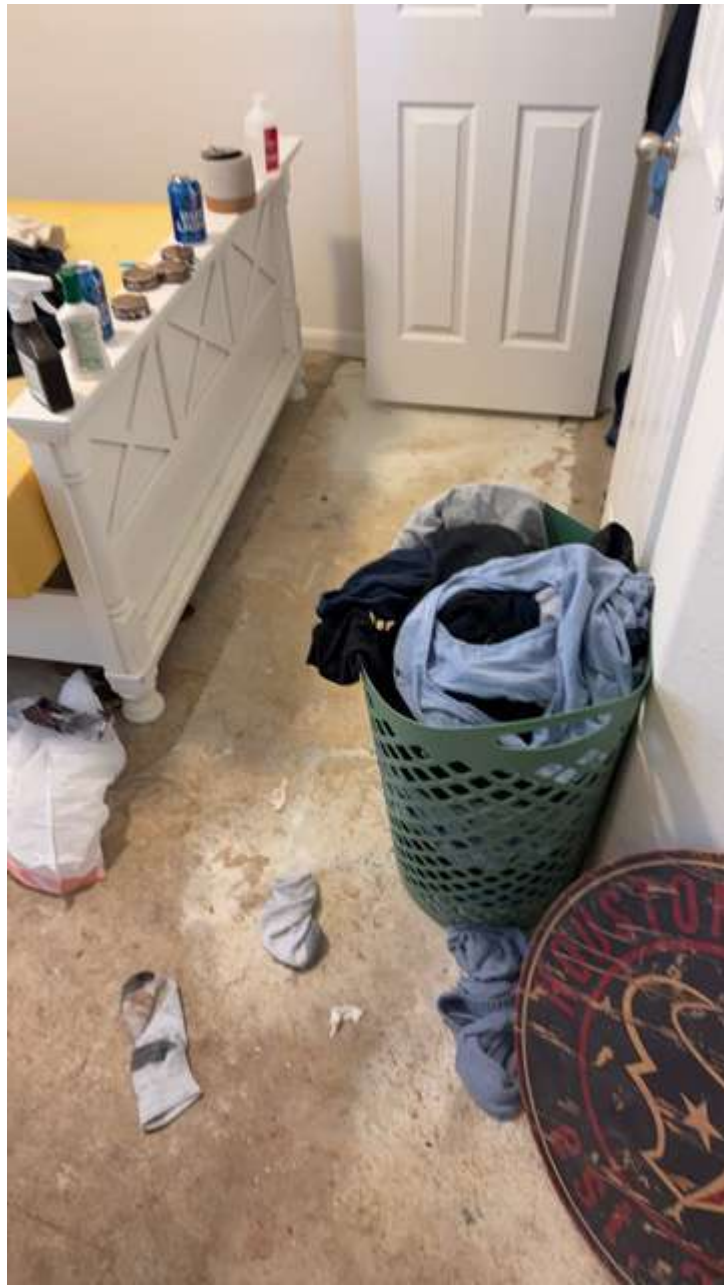
## Damaged or Torn Carpet

The carpet floor is damaged or torn in one or more areas.

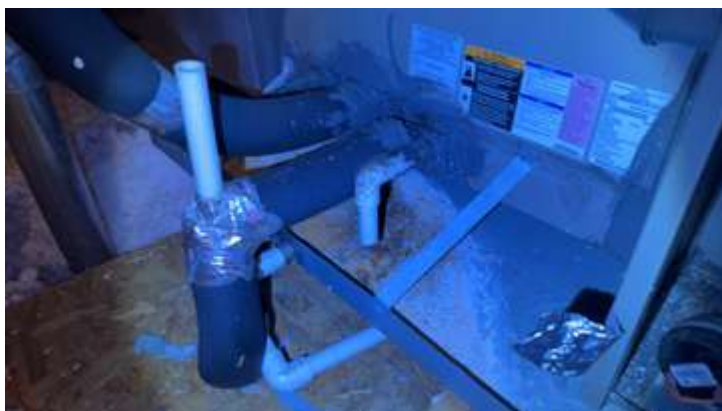
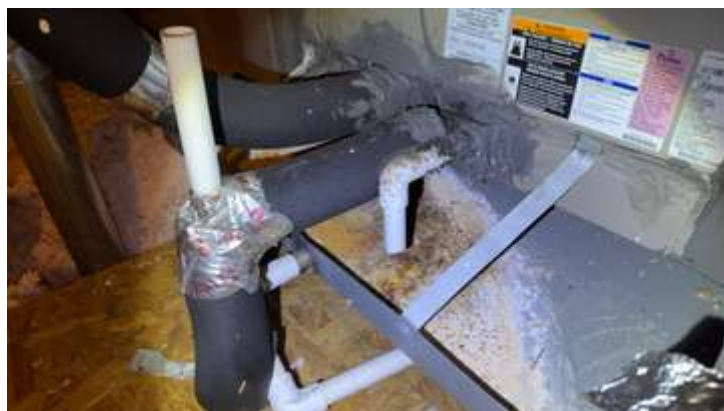
## Rusting or Damaged HVAC Drip Pan

The drip pan below the air conditioning unit is rusting or damaged.

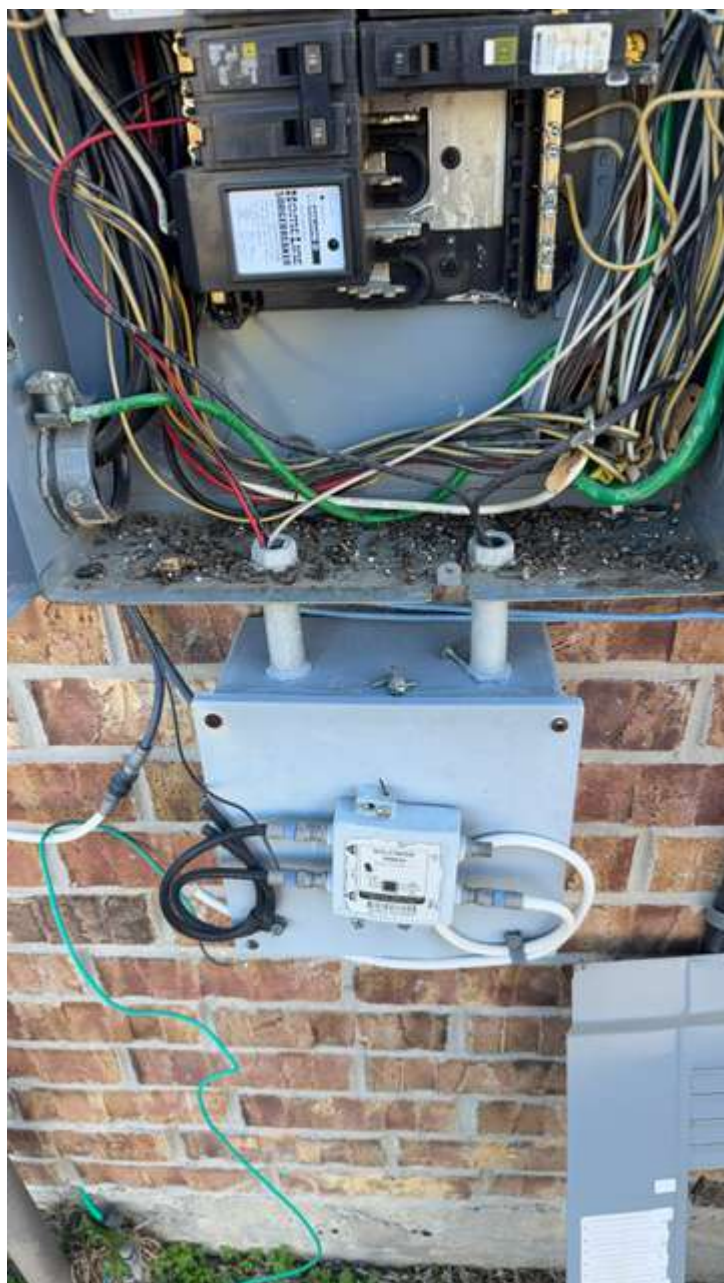
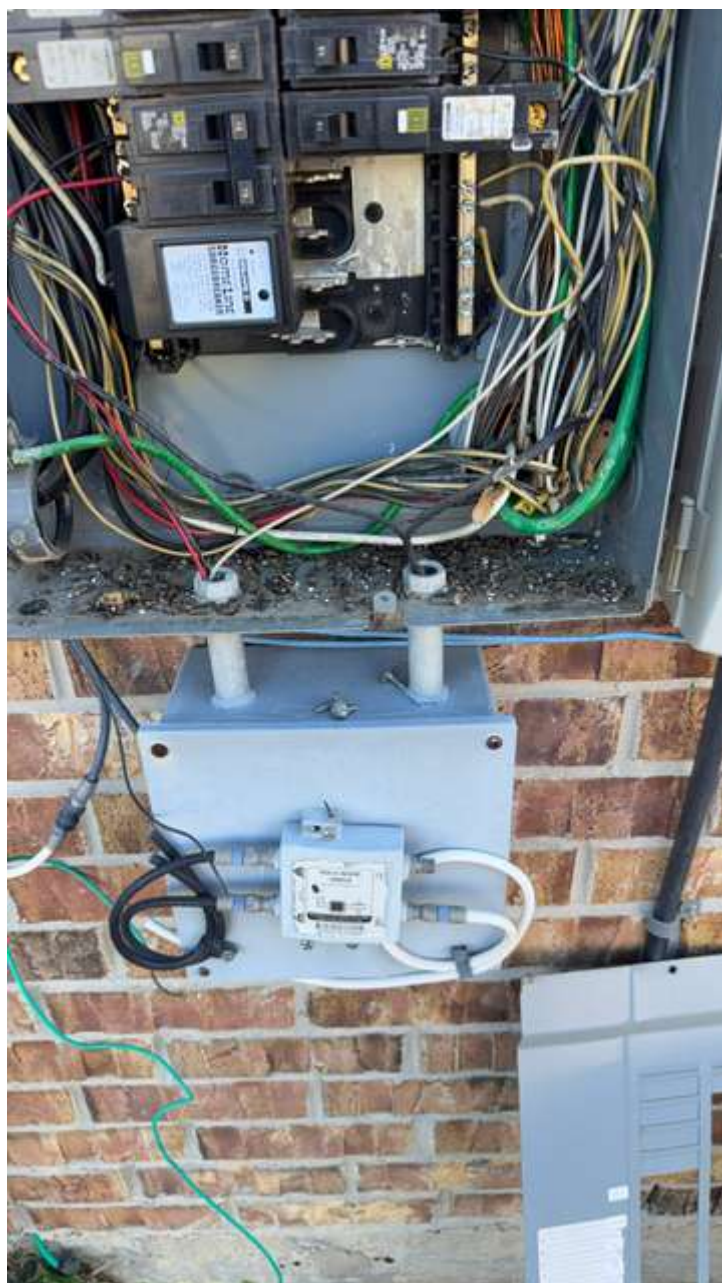
## Debris in Electrical Panel

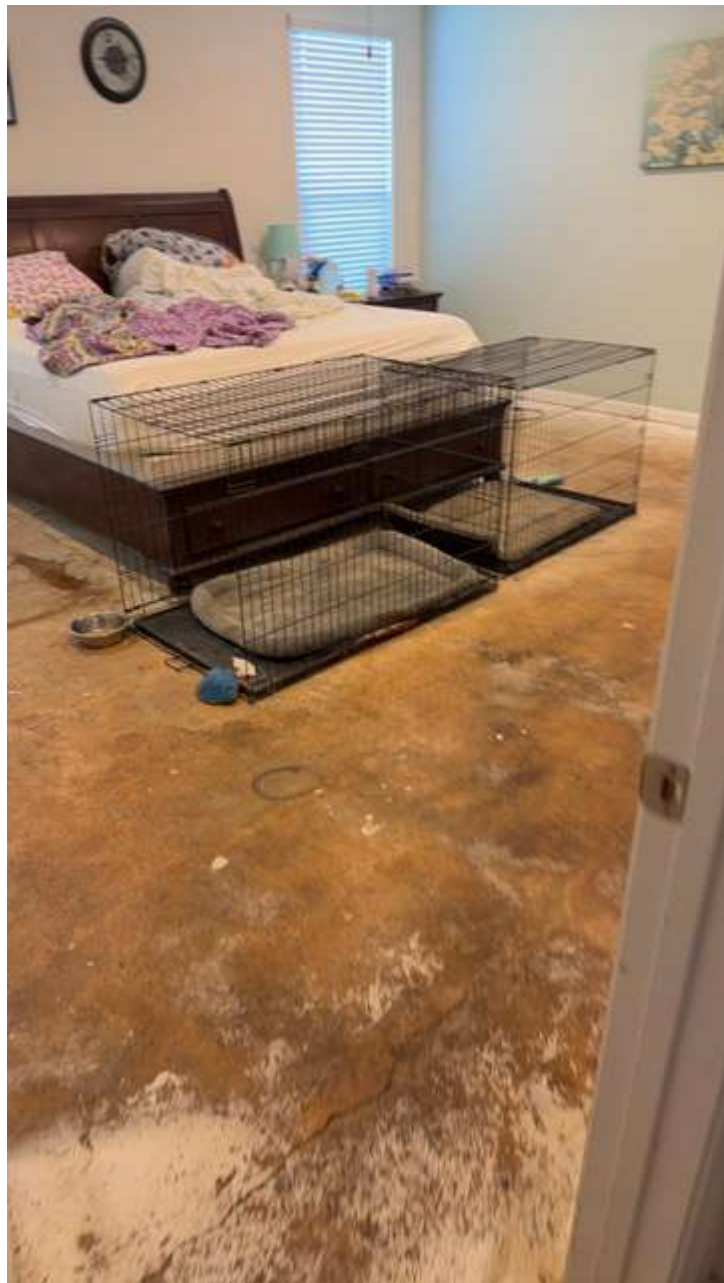
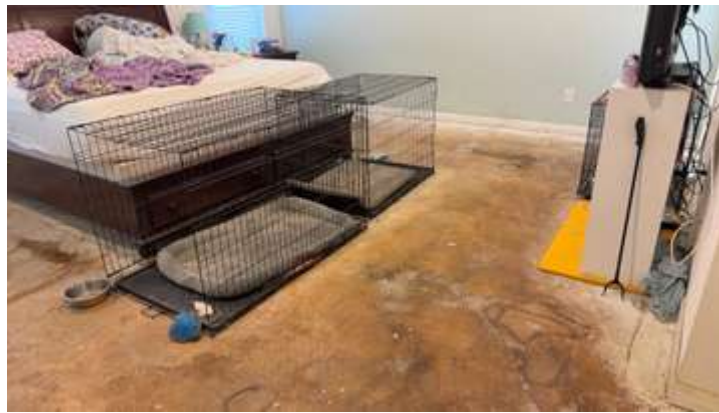
### Pet Odor Present

There is a pet odor on the property.

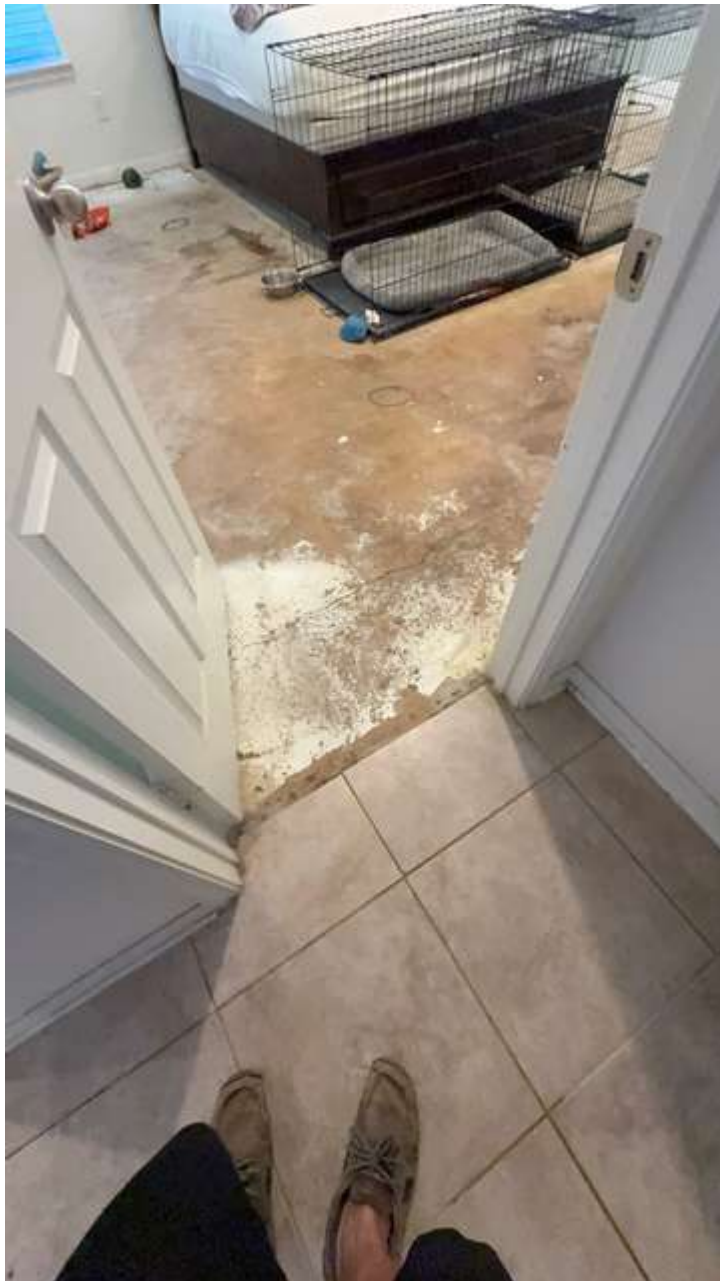
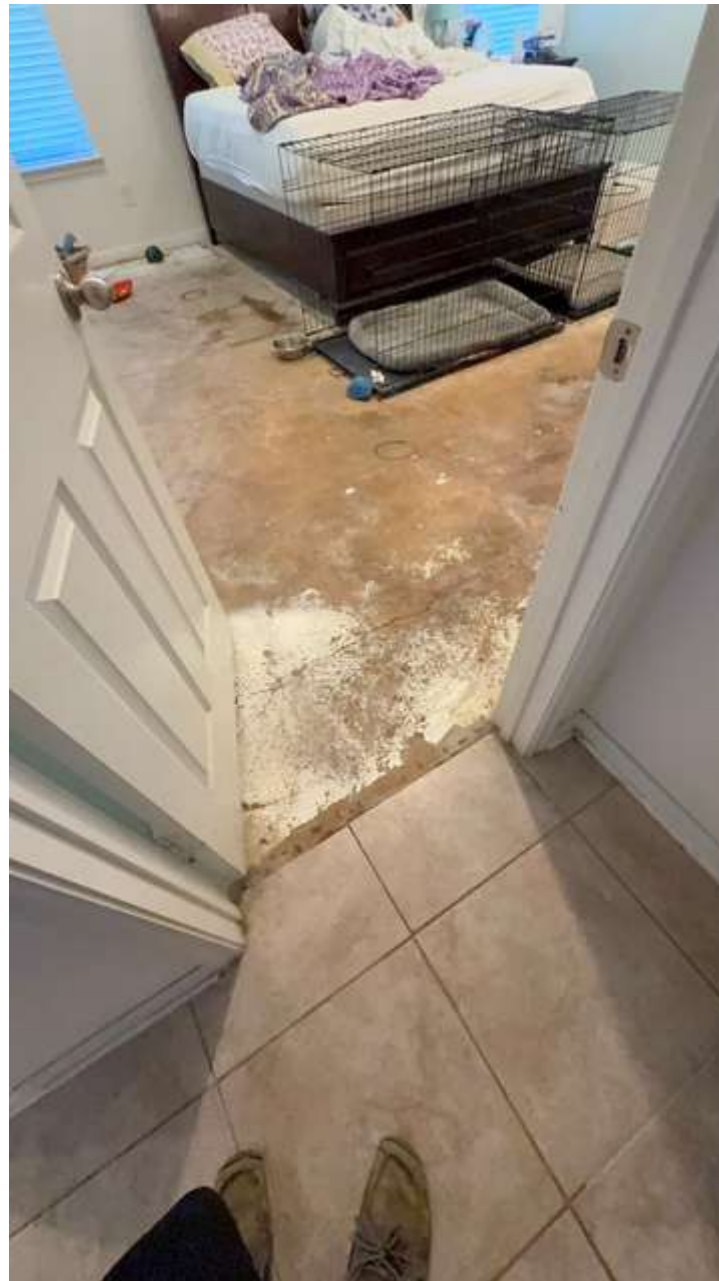
### Incompatible / Clashing Flooring Materials Observed

Yes
