28943 Enchanted Dr

Shenandoah, Texas 77381

Client	--
Reference id	a4xPd000003PxsnIAC
Type	Home Inspection and Floor Plan Report - 28943 Enchanted Dr
Inspected by	Rio Bravo - Inspectify Pro - Houston
State license	TREC 22388
InterNACHI	17031522
Scheduled	January 8, 2026, 11:00 AM CST
Completed	January 8, 2026, 1:19 PM CST

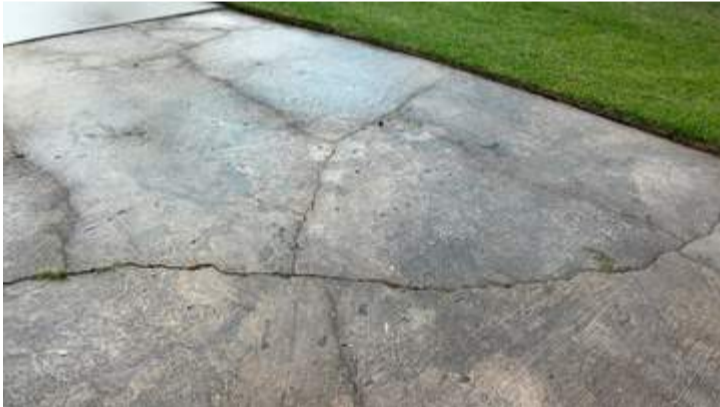
West

Significant Cracks in Driveway

There are one or more significant cracks in the driveway. Recommend repairs or replacing by a qualified professional.

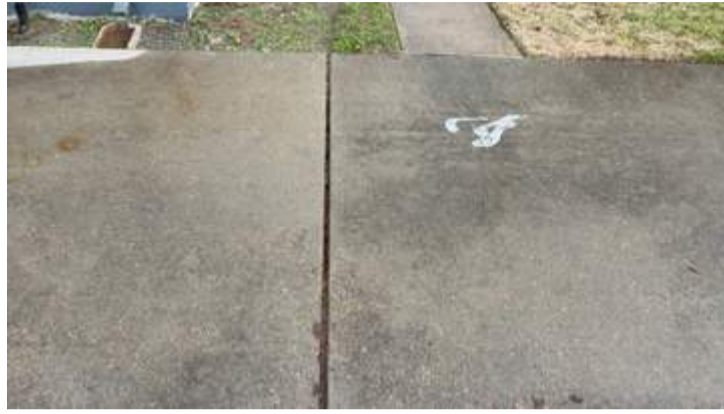
Missing / Deteriorated Expansion Joint Materials

Expansion joint materials are missing / deteriorated. Recommend repairs or replacing by a qualified professional.

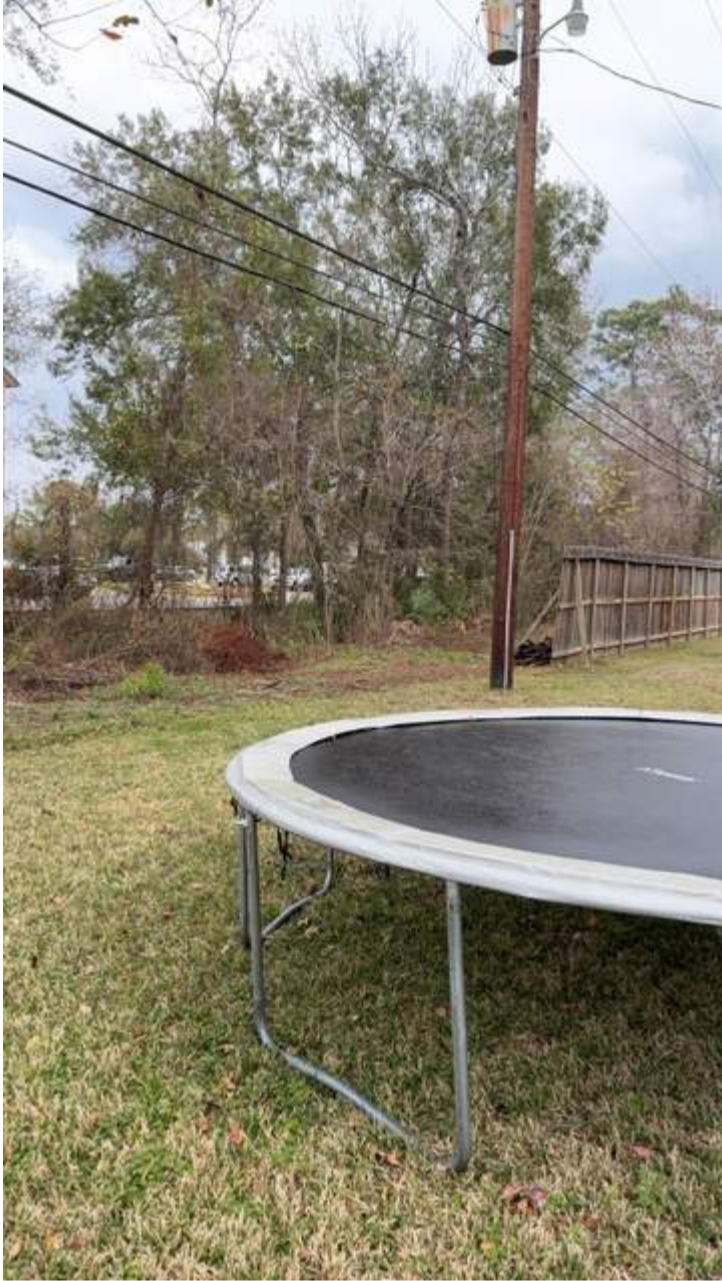
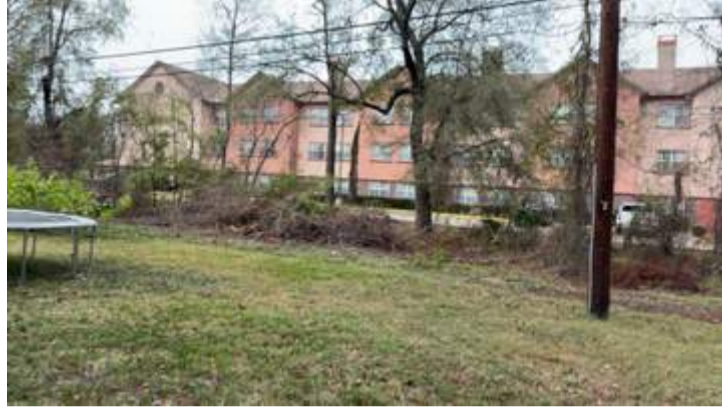
North

Damaged / Missing Fence Boards

One or more fence boards are missing or damaged.

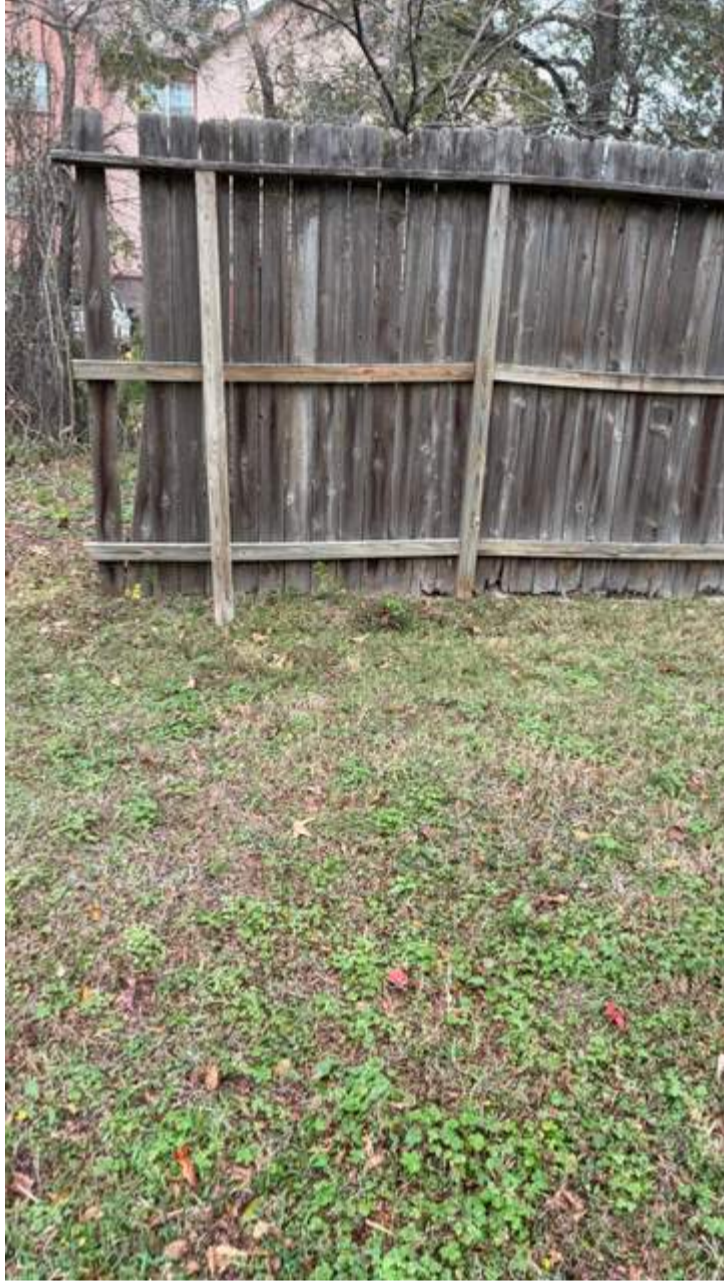
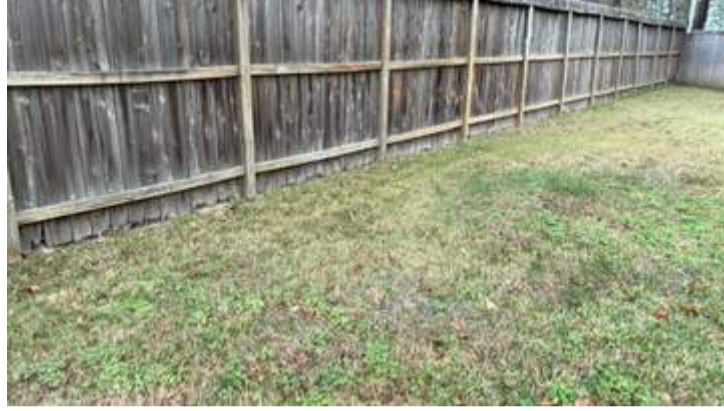
North

Large section of fence was missing

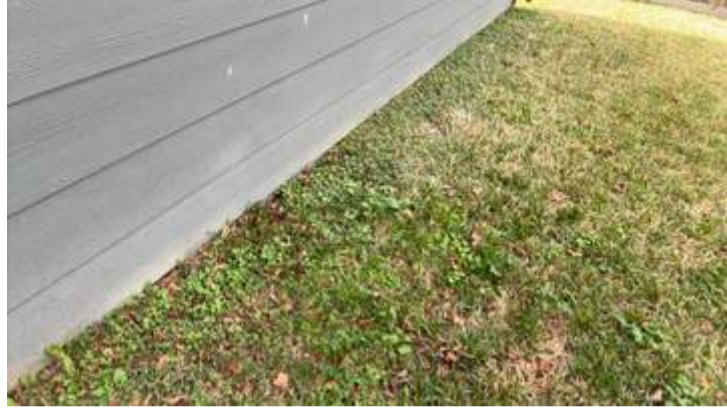
Garage

There are areas of high soil around the foundation.

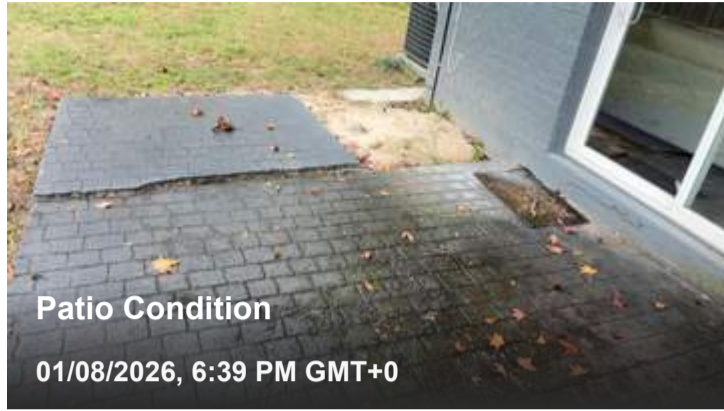
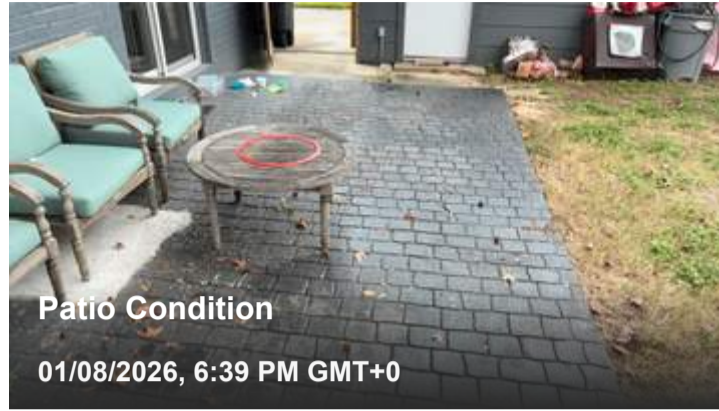
Major Cracks in Patio

There are major cracks observed in the patio. Recommend repairs or replacing by a qualified professional.

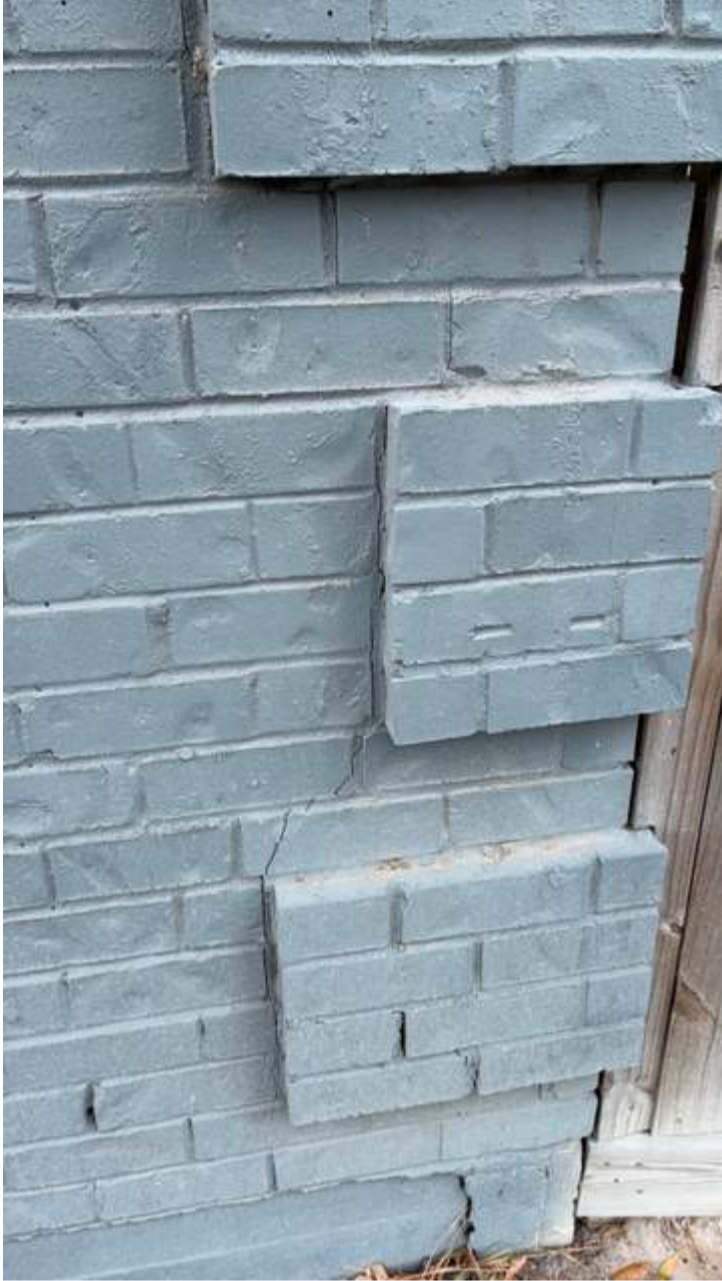
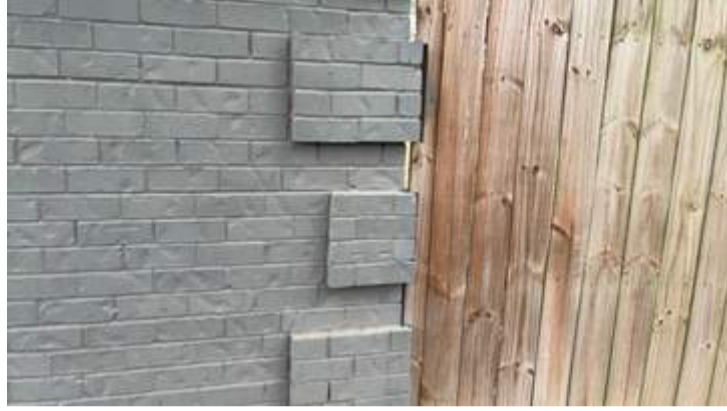
Southeast, West

Damaged Brick Mortar

The mortar is cracked / damaged in one or more areas.

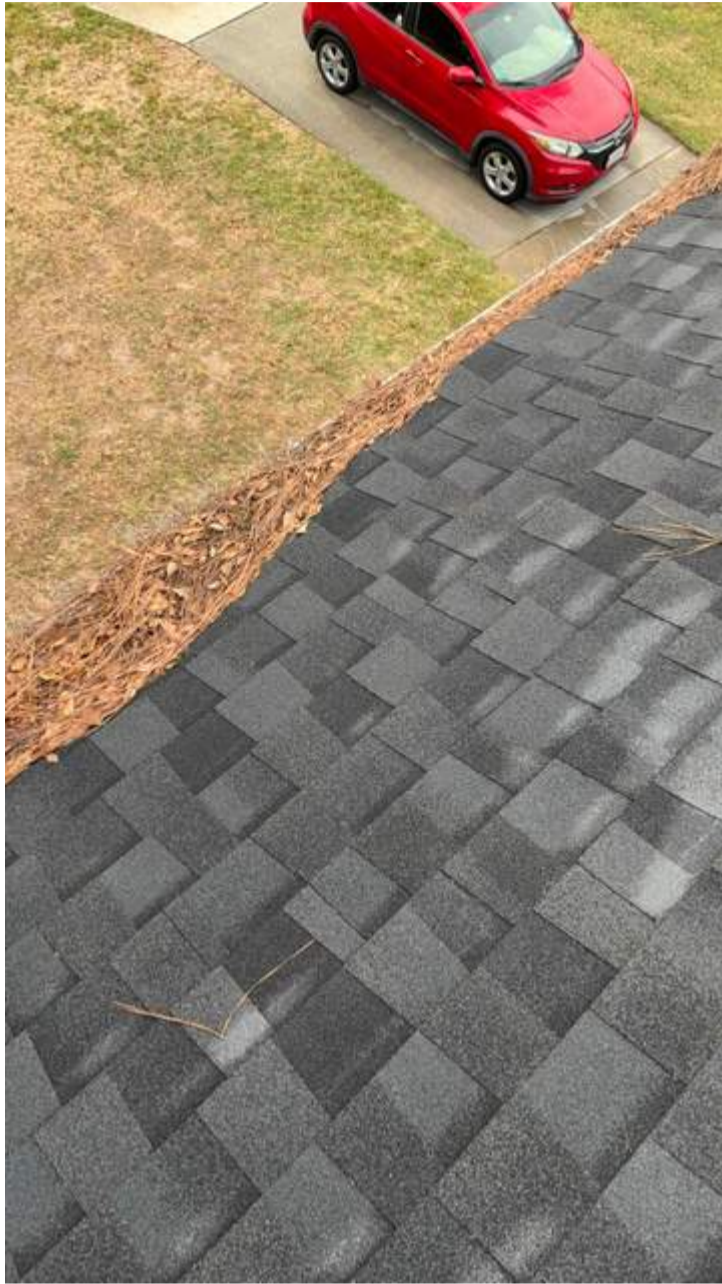
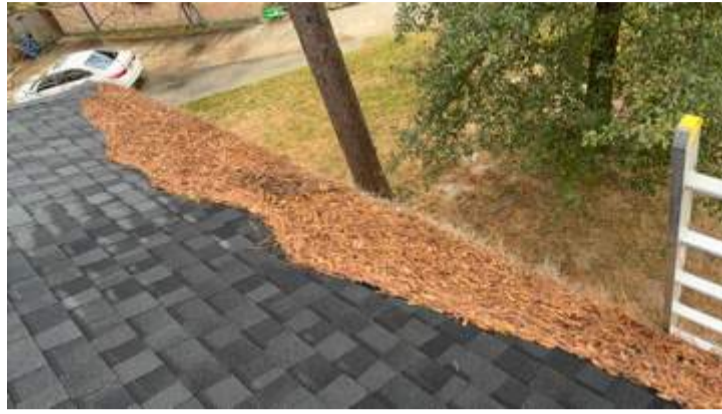
South

Debris in Gutters

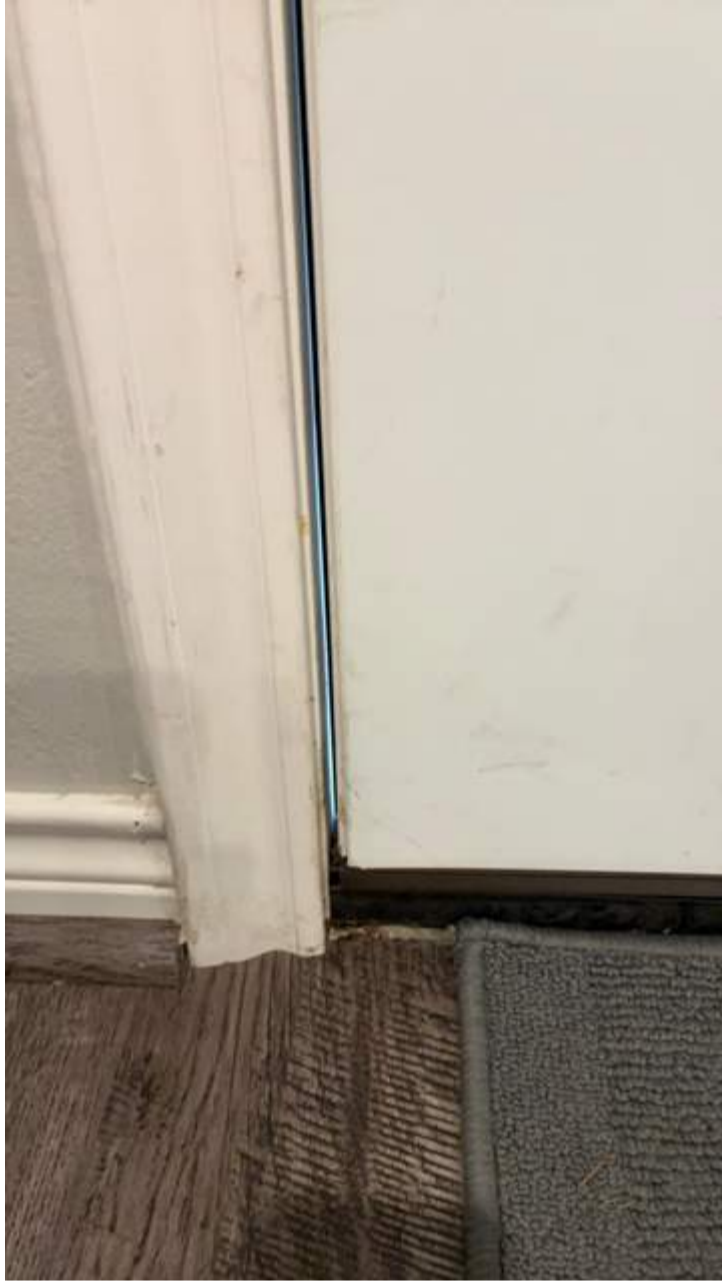
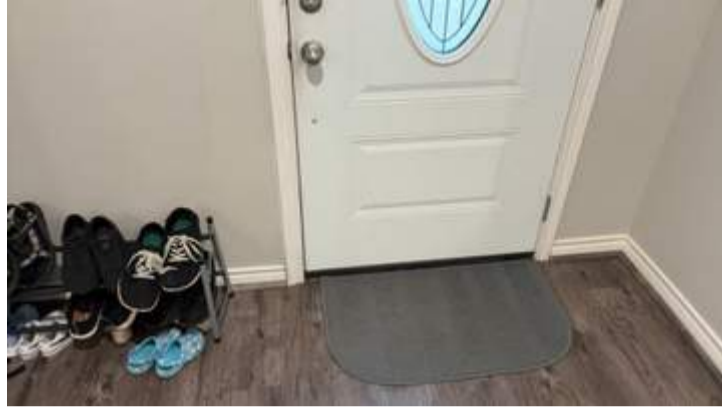
1st Floor, South

One or more gaps are observed on the exterior door.

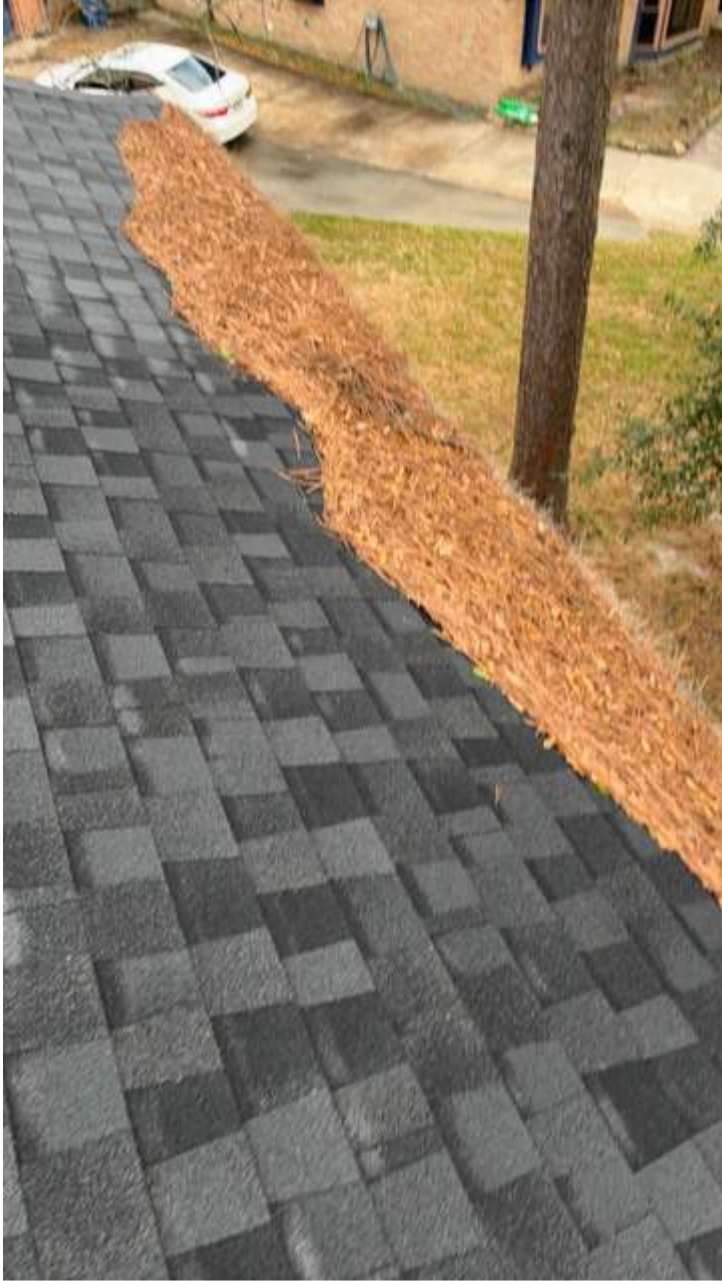
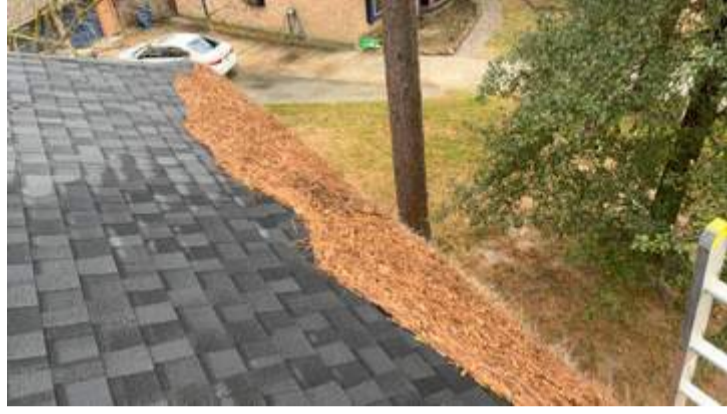
South

**Monitor deficiency****Debris on Roof**

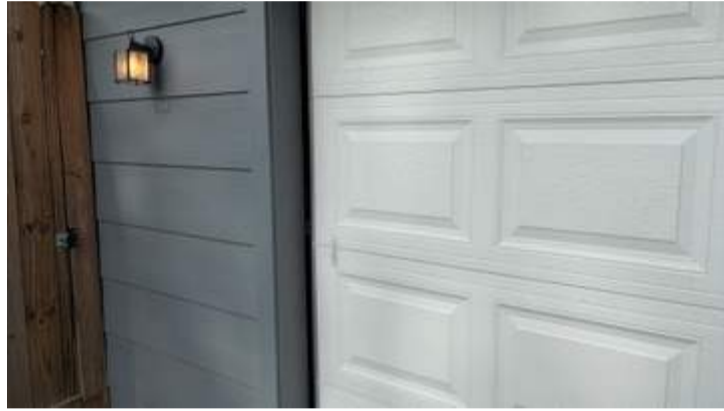
gaps were noted at both sides of garage door

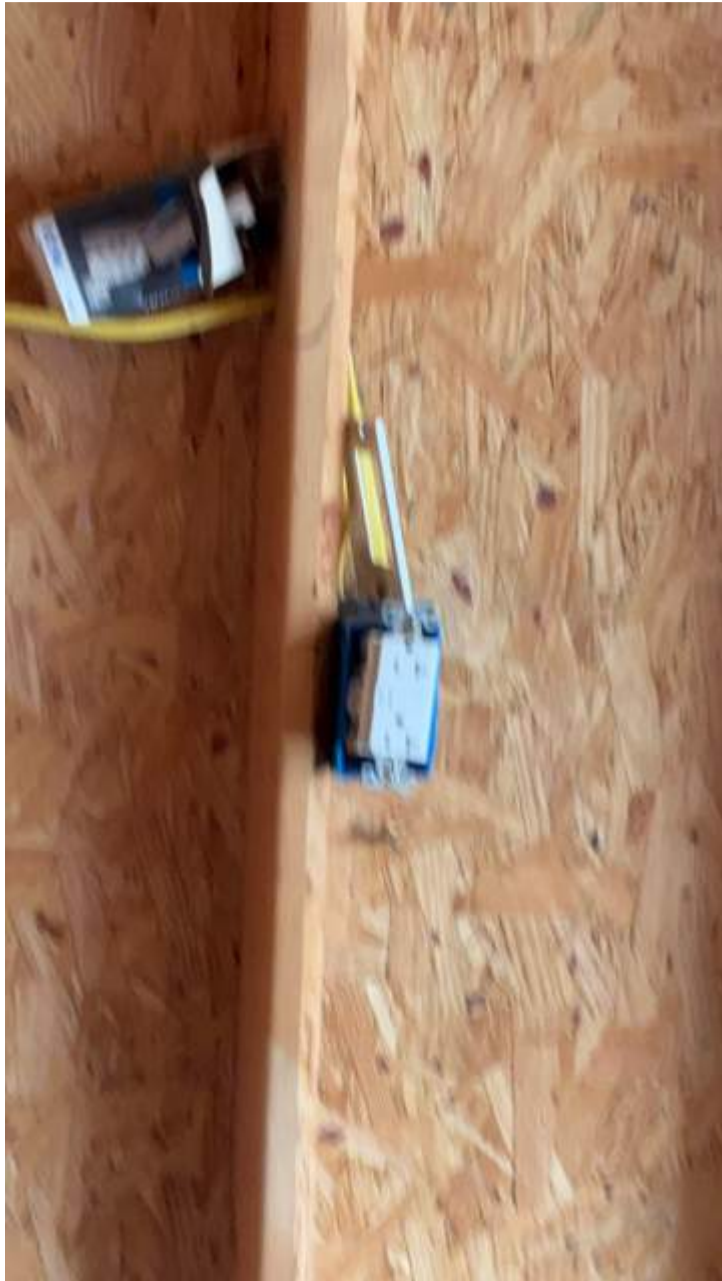
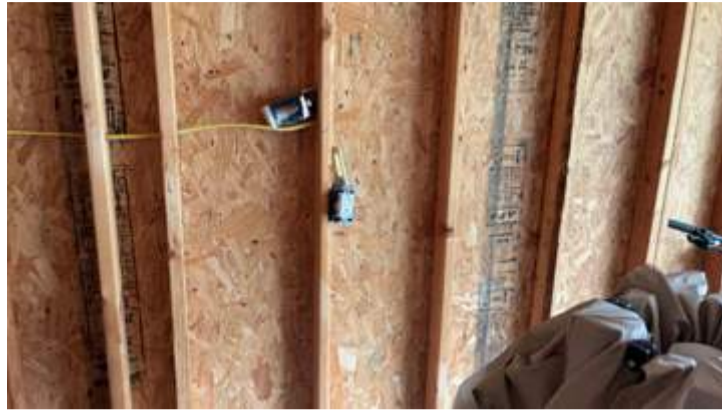
Garage

Loose Electrical Outlet

The electrical outlet is loose.

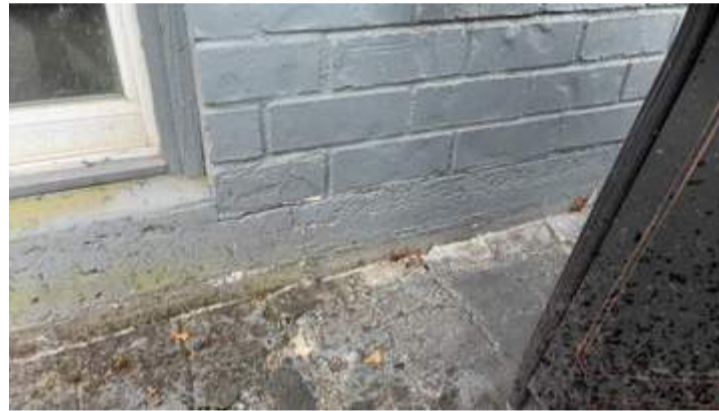
North

Minor Foundation Cracks

One or more areas of the foundation have minor cracking. Recommend further evaluation by a qualified professional.

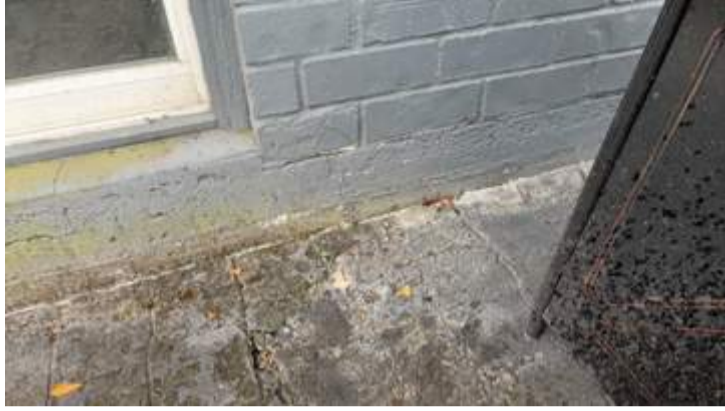
North

Minor Foundation Cracks

One or more areas of the foundation have minor cracking.

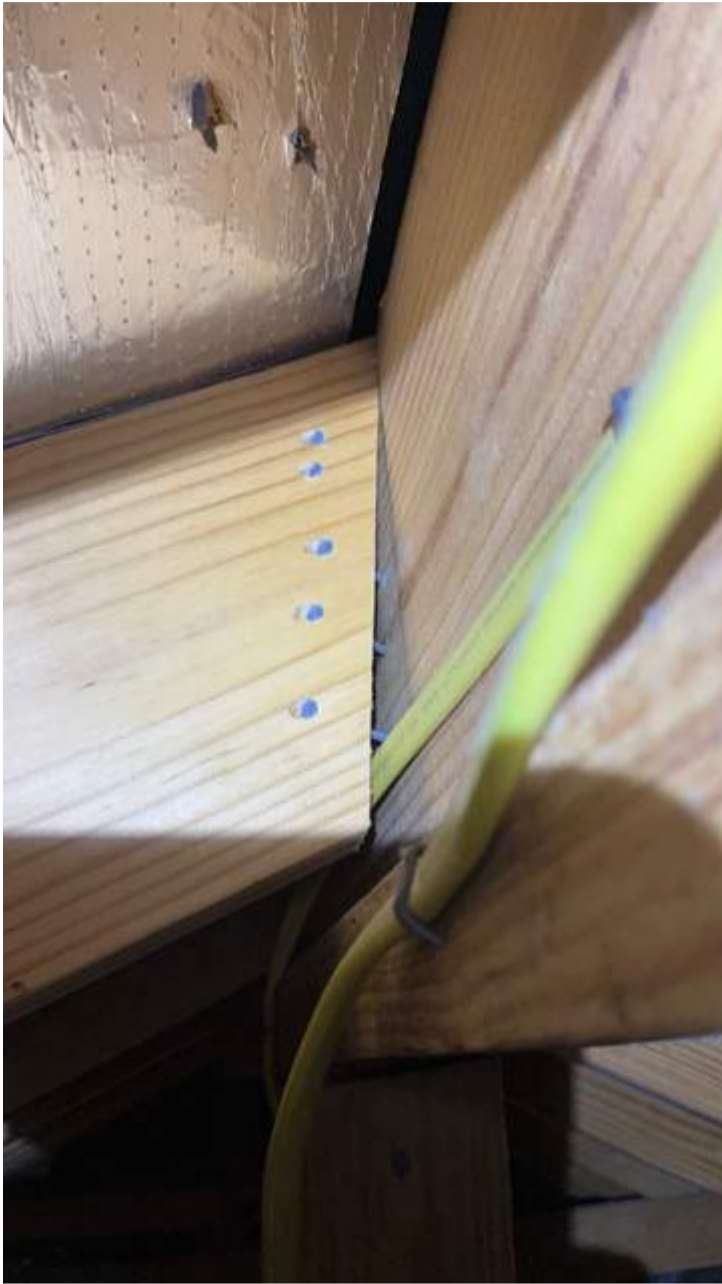
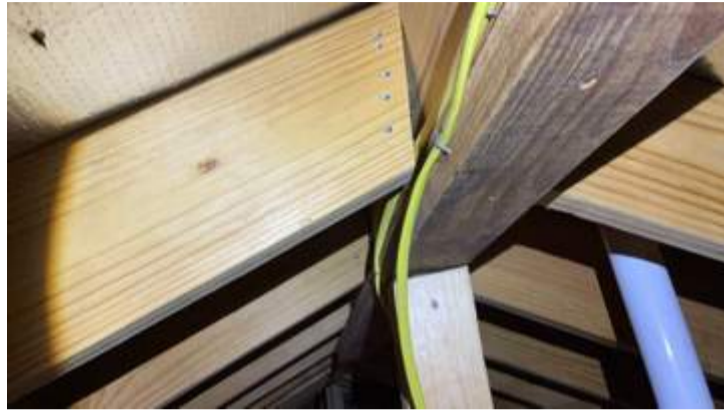
Attic

Rafter spread or gaps between rafter and ridge were noted at one or more rafters

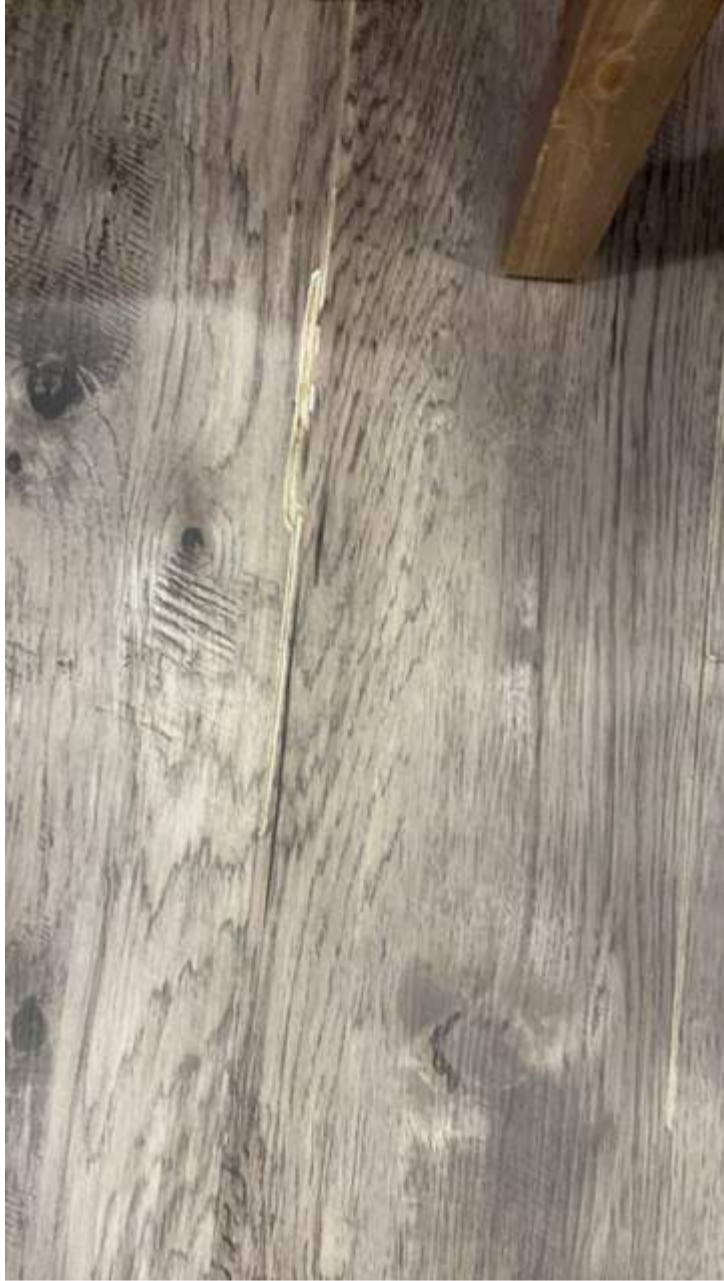
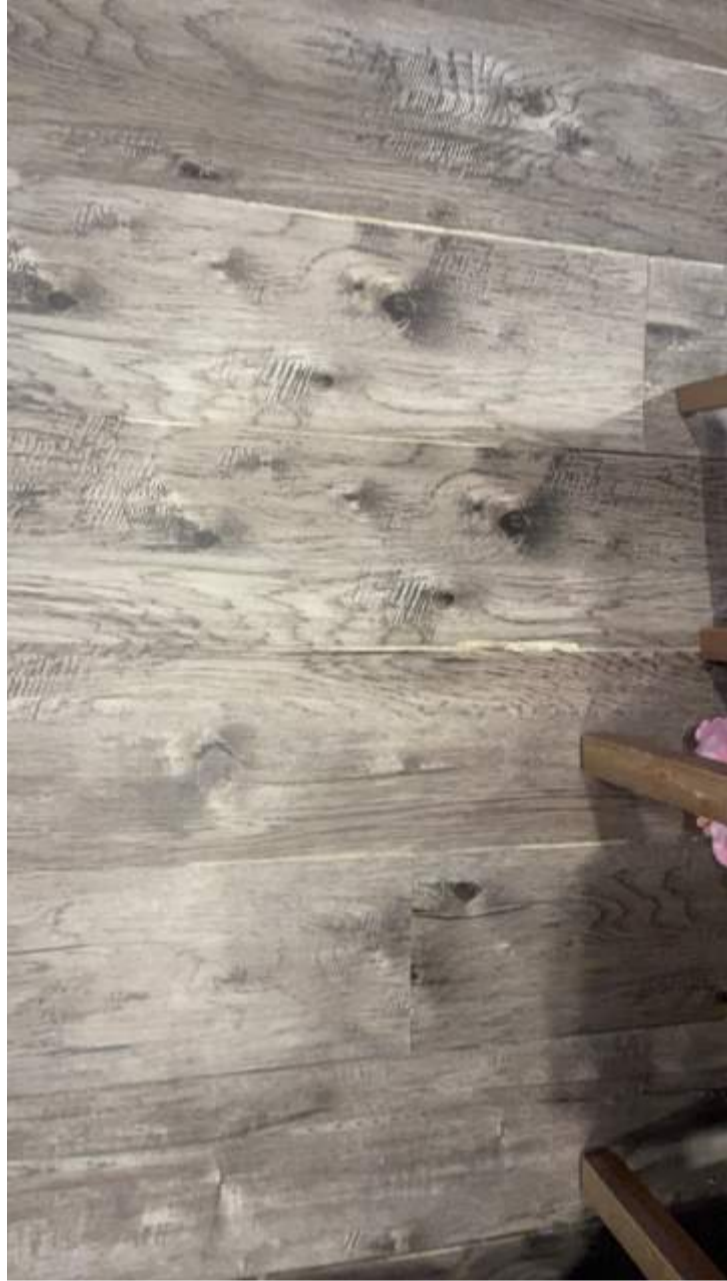
Living Room

Damaged Flooring

The floors are damaged. Recommend repairs or replacing by a qualified professional.

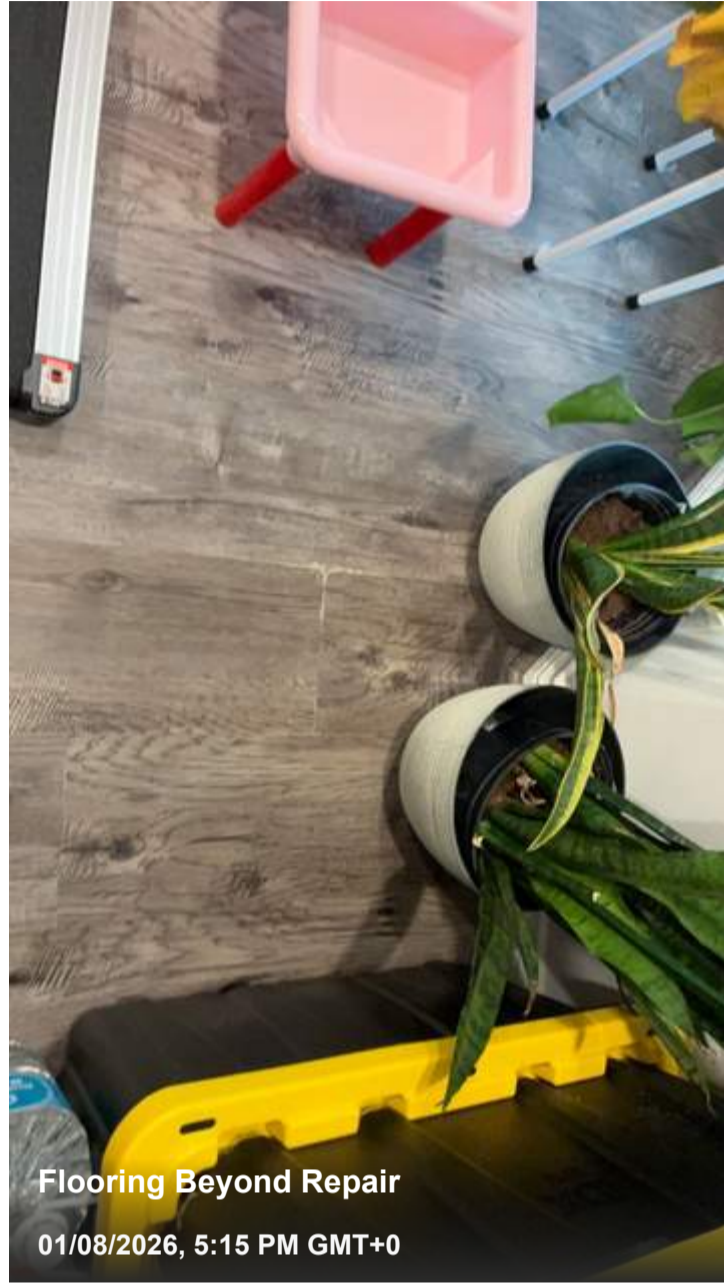
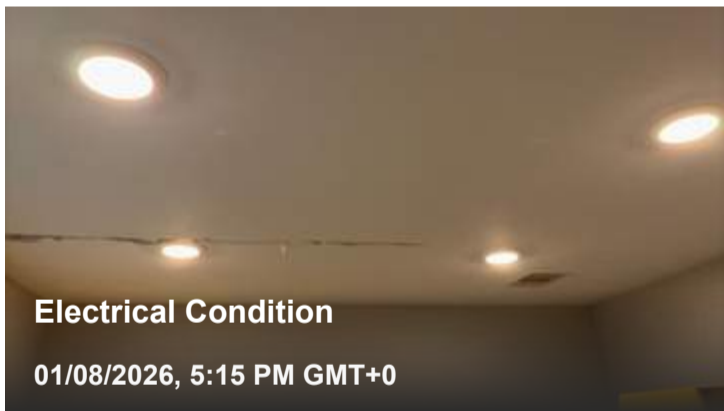
Damaged Flooring

The floors are damaged.

Flooring is also loose

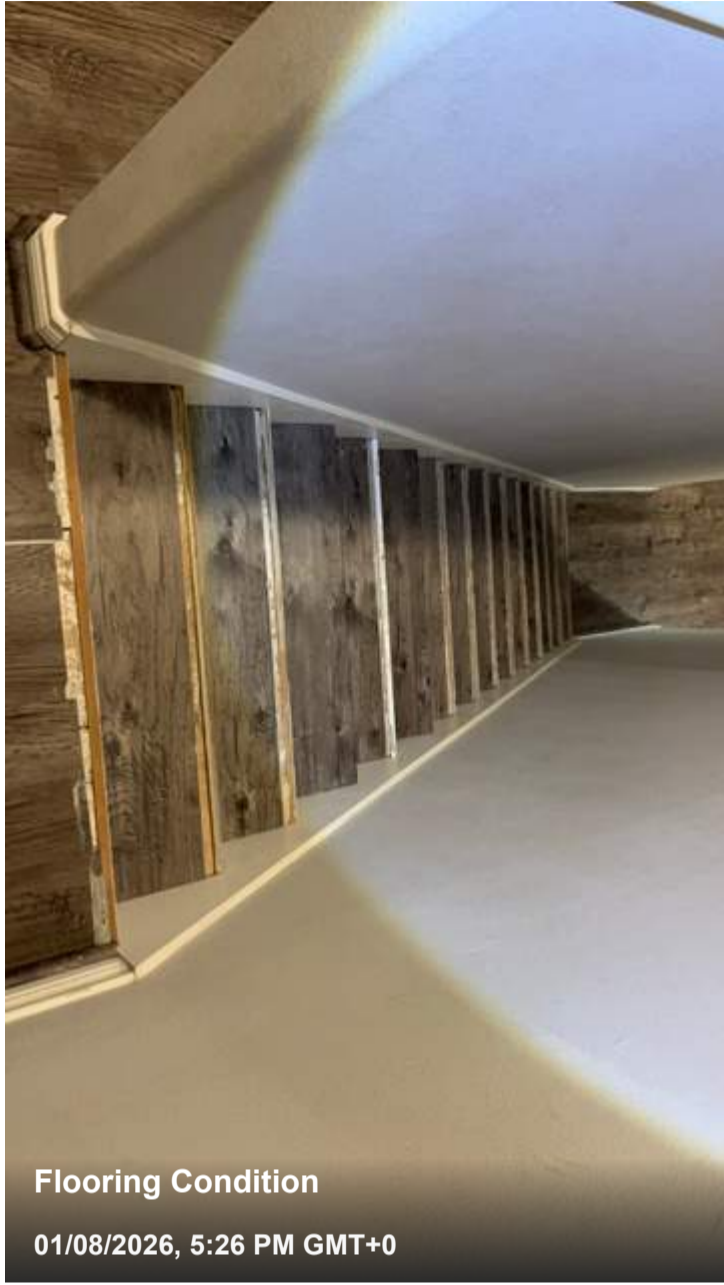
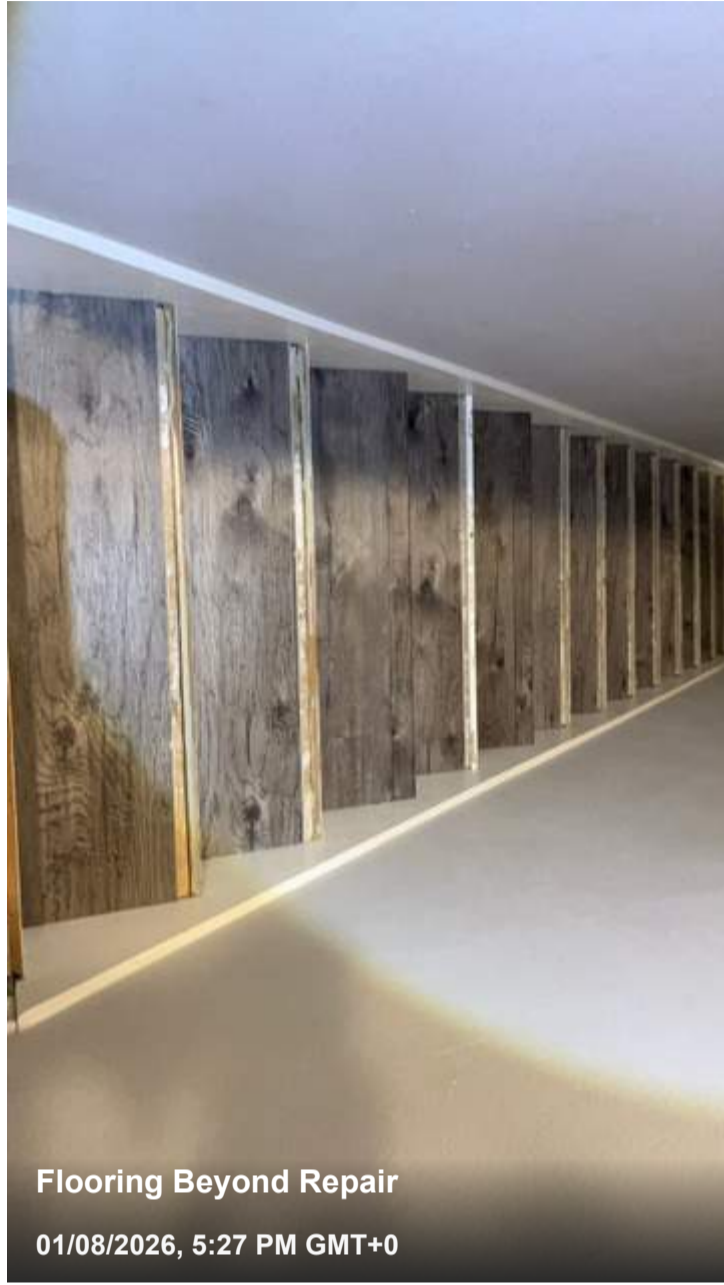
Missing Railing

There is no handrail for the staircase.

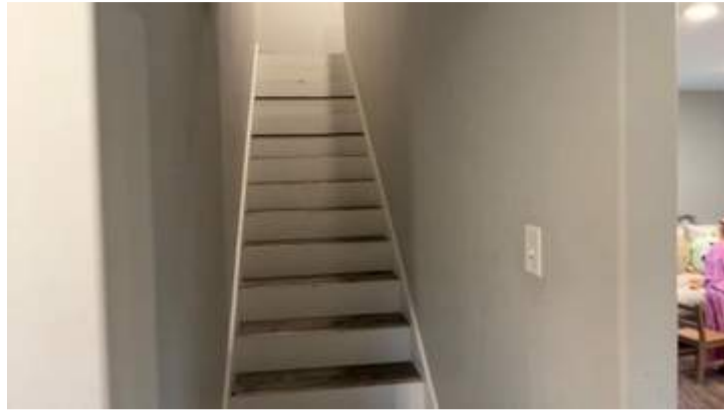
Damaged Flooring

The floors are damaged. Recommend repairs or replacing by a qualified professional.

Missing cover on nosing on all treads

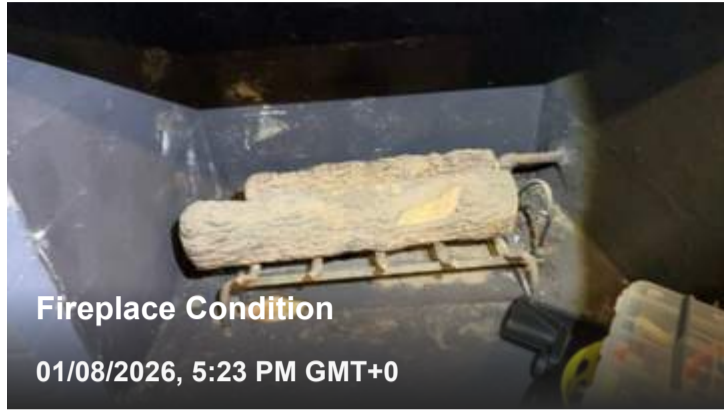
Missing Damper Clamp

The damper clamp is missing. Recommend repairs or replacing by a qualified professional.

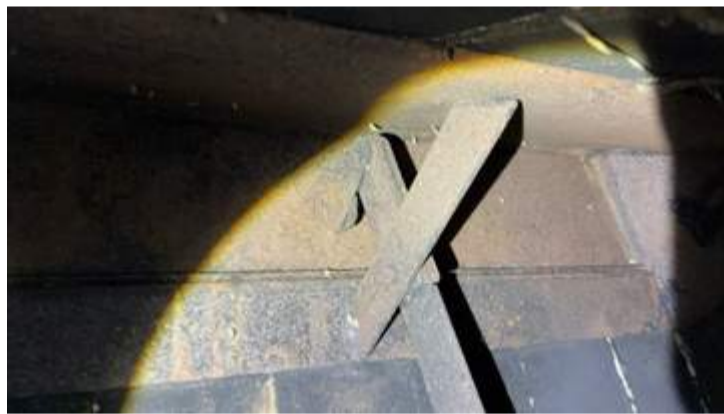
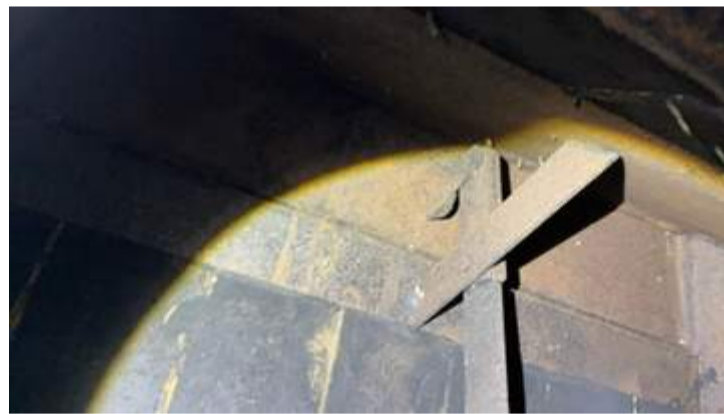
Damaged Brick Mortar

The mortar is cracked / damaged in one or more areas. Recommend repairs or replacing by a qualified professional.

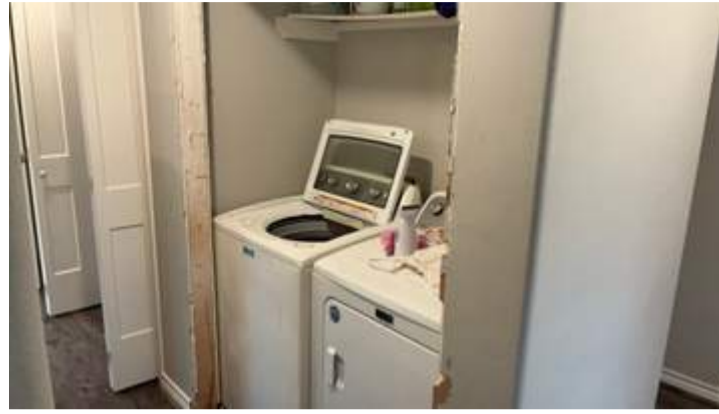
Damaged / Missing Interior Trim

The trim is damaged / missing in one or more spots.

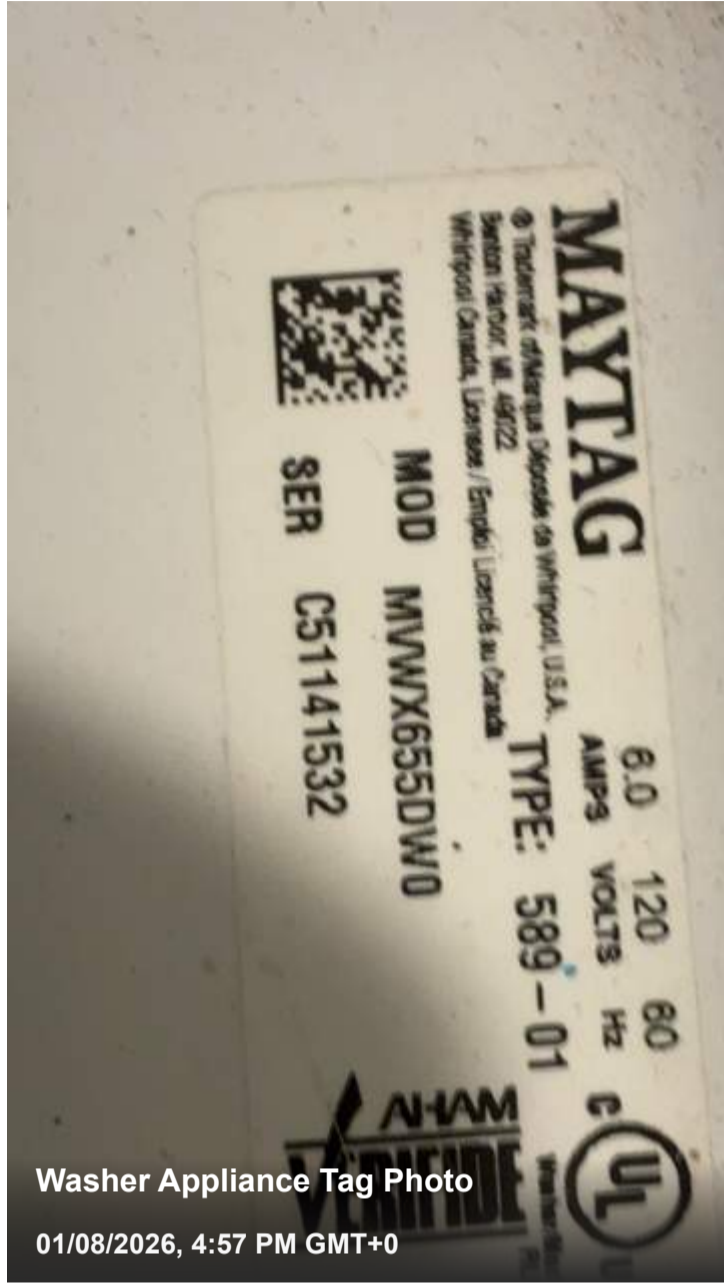
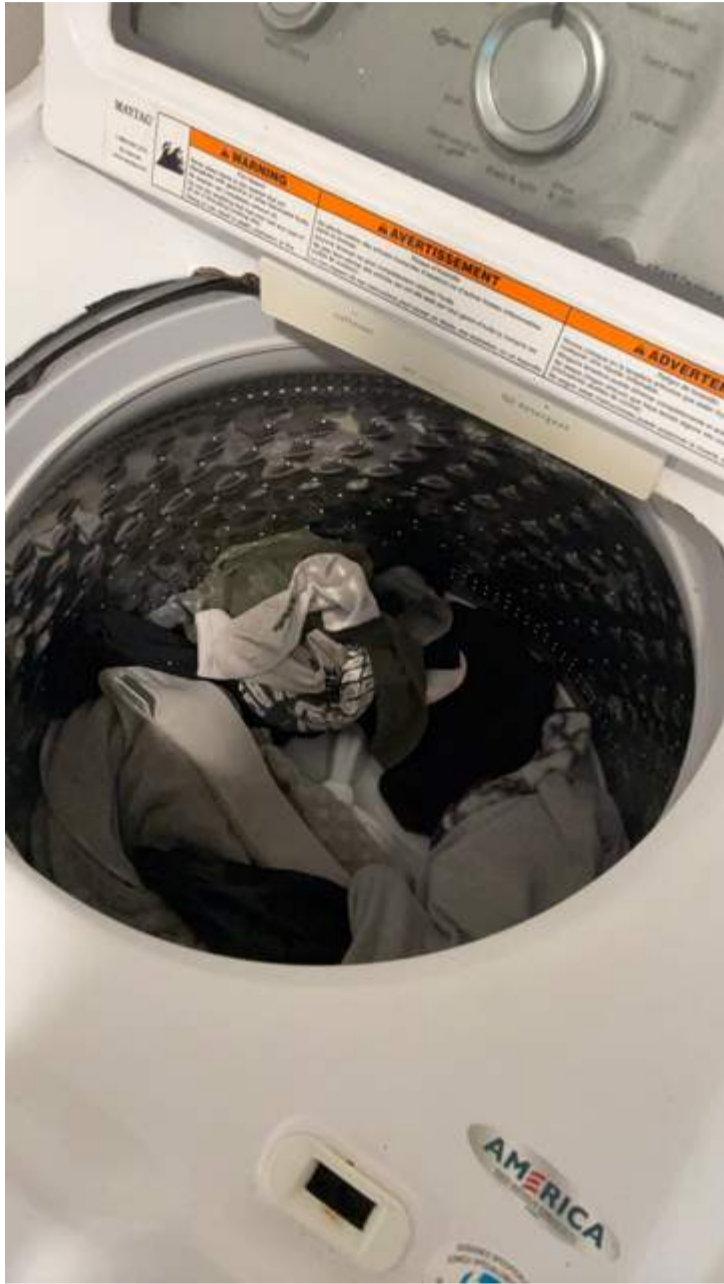
Washing machine was not operated due to personal items in washer

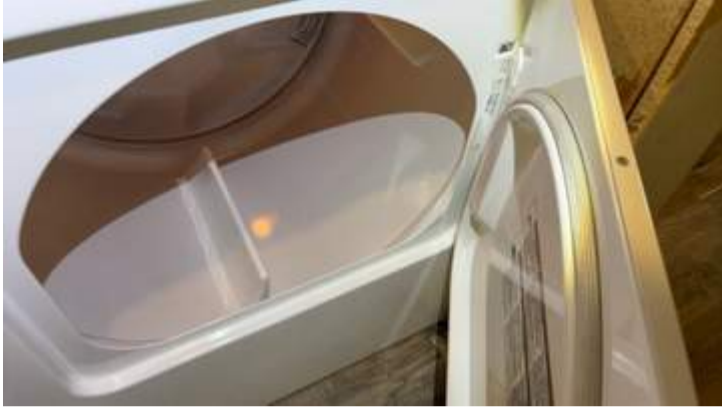
This inspector does not operate dryers without a load

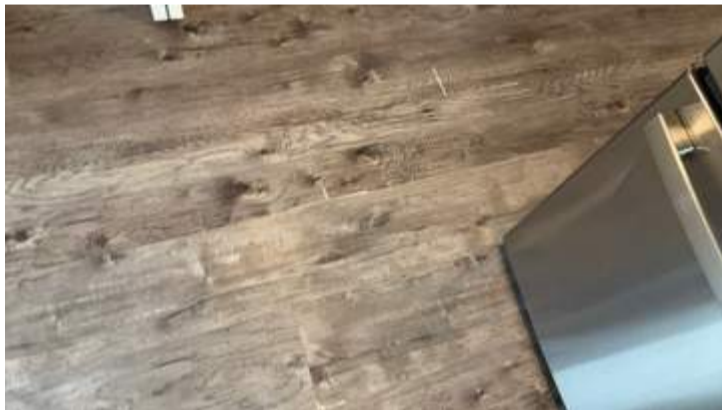
Damaged Flooring

The floors are damaged.

Flooring is loose and slightly damaged

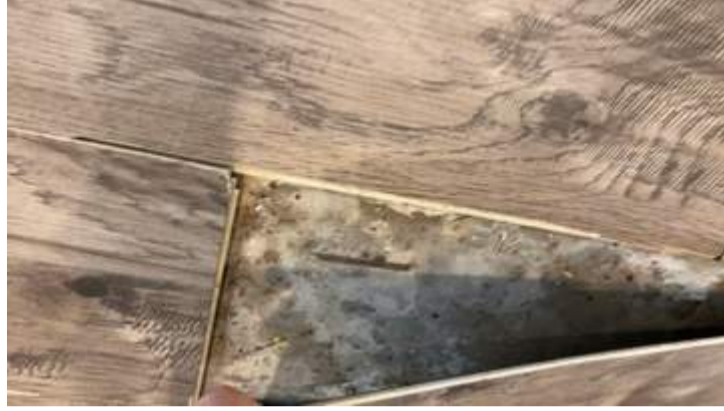
Missing Flooring Vapor Barrier

There is no vapor barrier beneath the flooring.

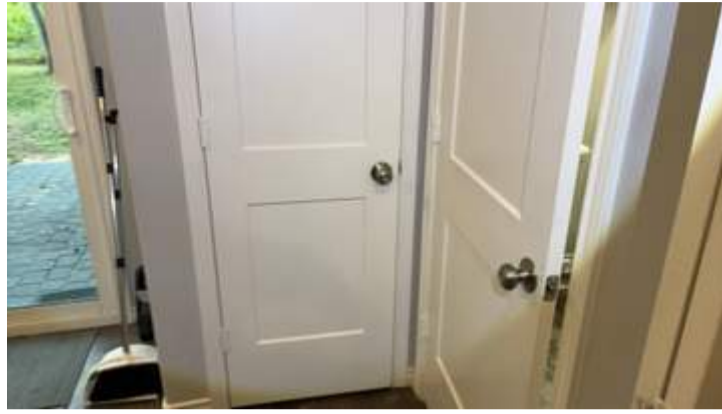
Also missing door stop
