28943 Enchanted Dr

Shenandoah, Texas 77381

Client	--
Reference id	a4xPd000003PxsnIAC
Type	Home Inspection and Floor Plan Report - 28943 Enchanted Dr
Inspected by	Rio Bravo - Inspectify Pro - Houston
State license	TREC 22388
InterNACHI	17031522
Scheduled	January 8, 2026, 11:00 AM CST
Completed	January 8, 2026, 1:19 PM CST

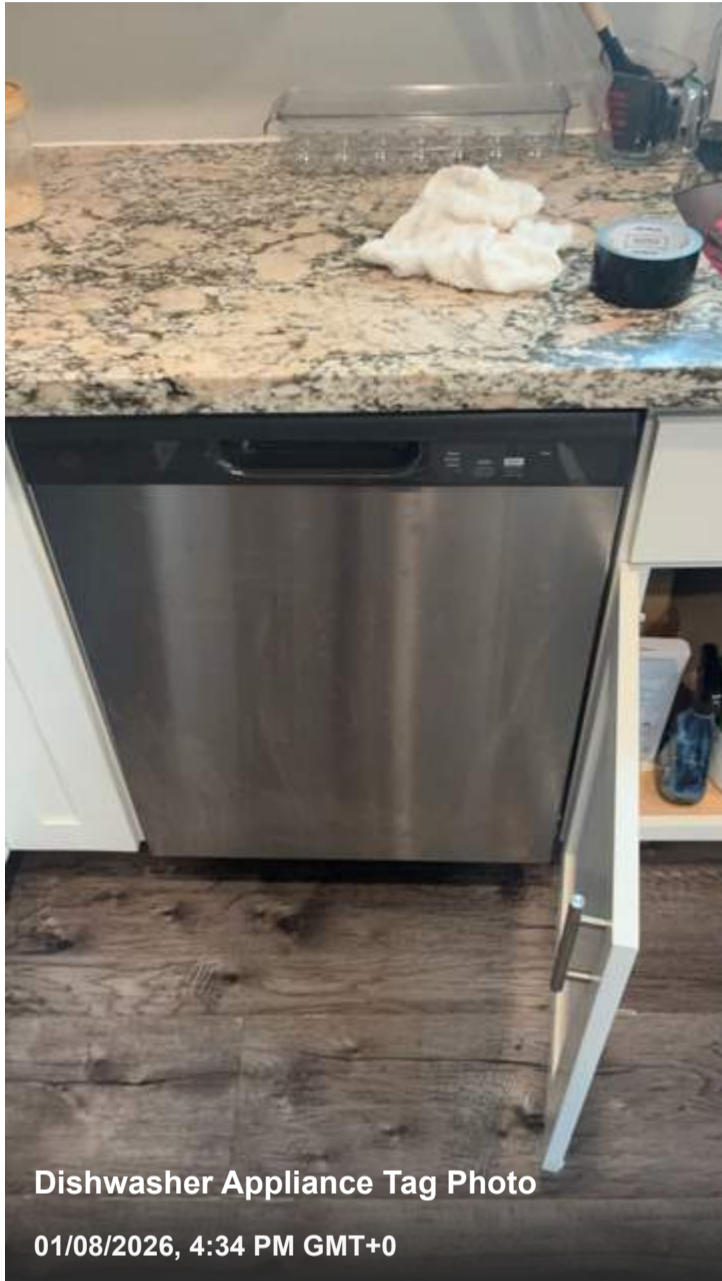
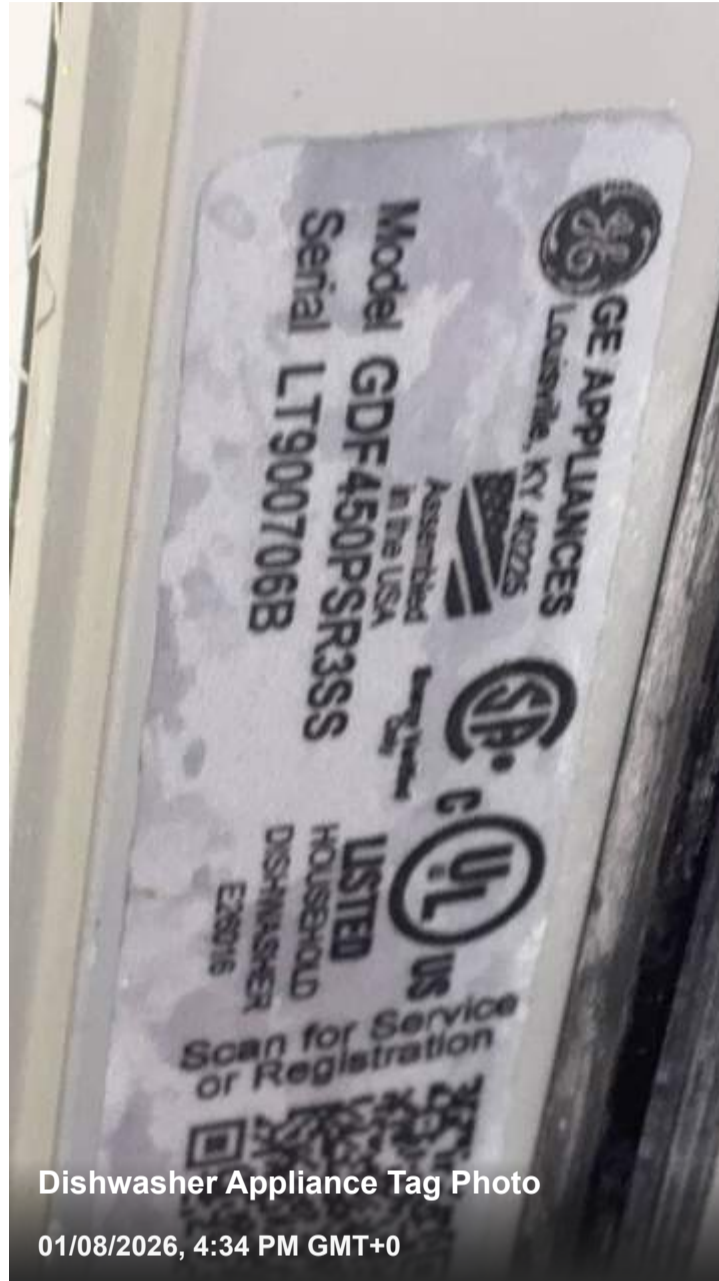
**Limitation**

I was unable to operate the dishwasher at the time of the inspection.

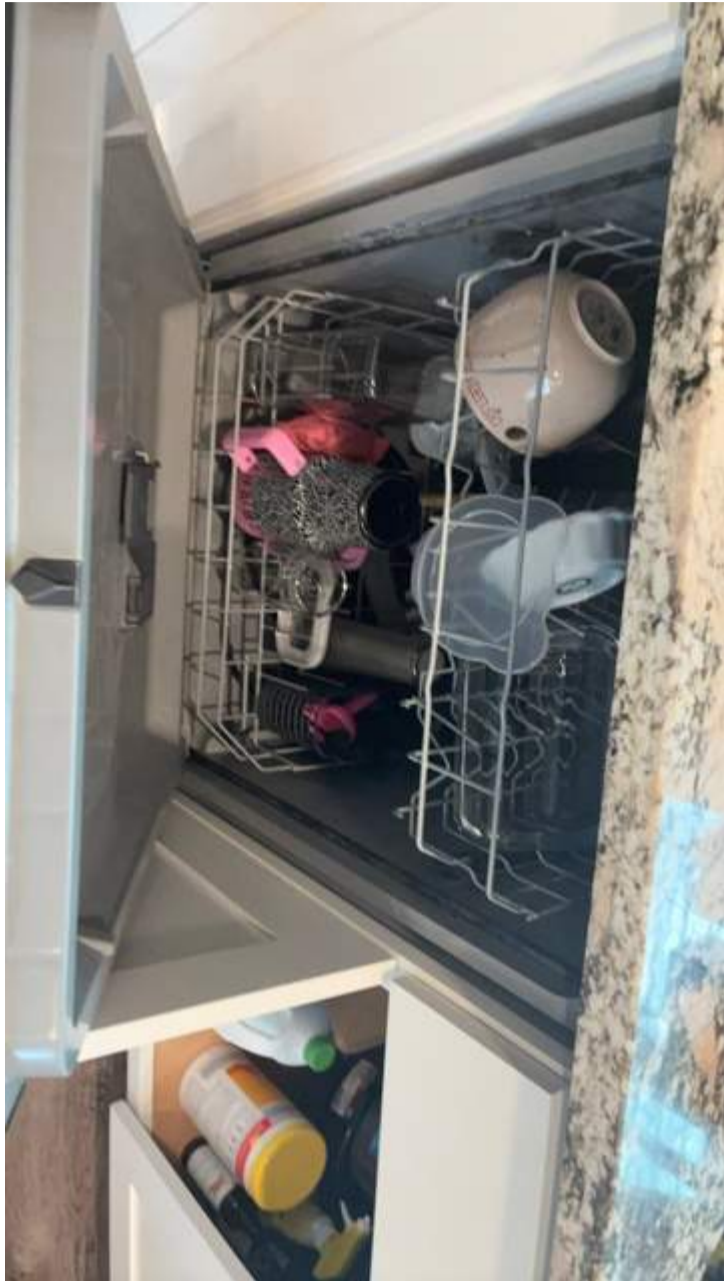
Note

Personal items in dishwasher

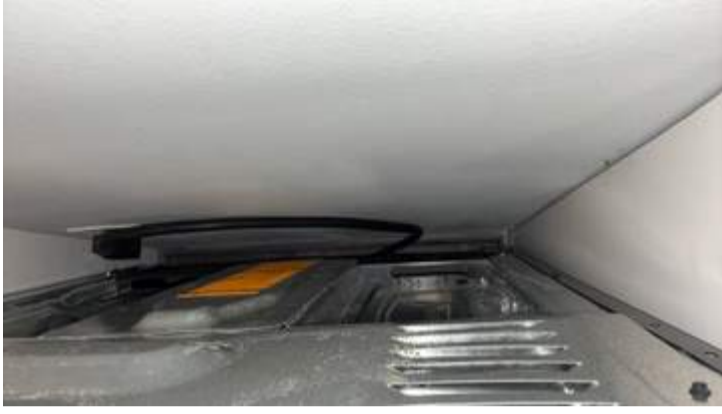
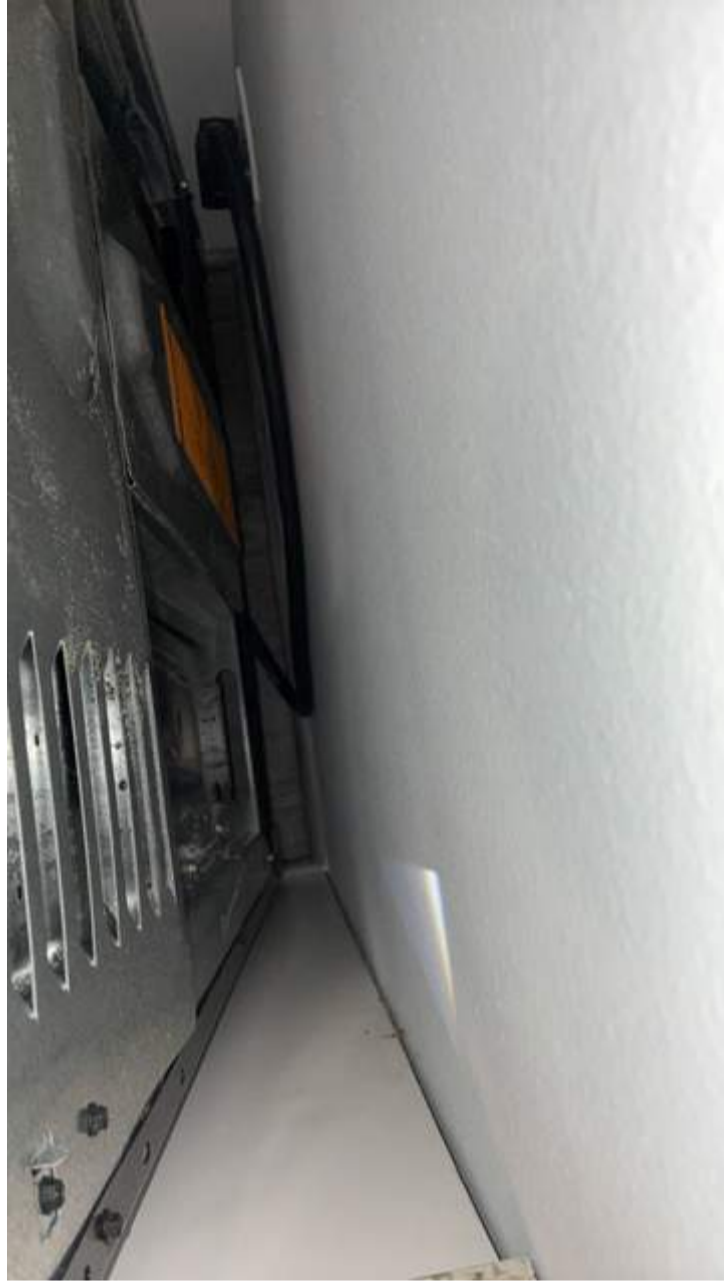
**Safety deficiency**

Missing Range Anti-tip Bracket

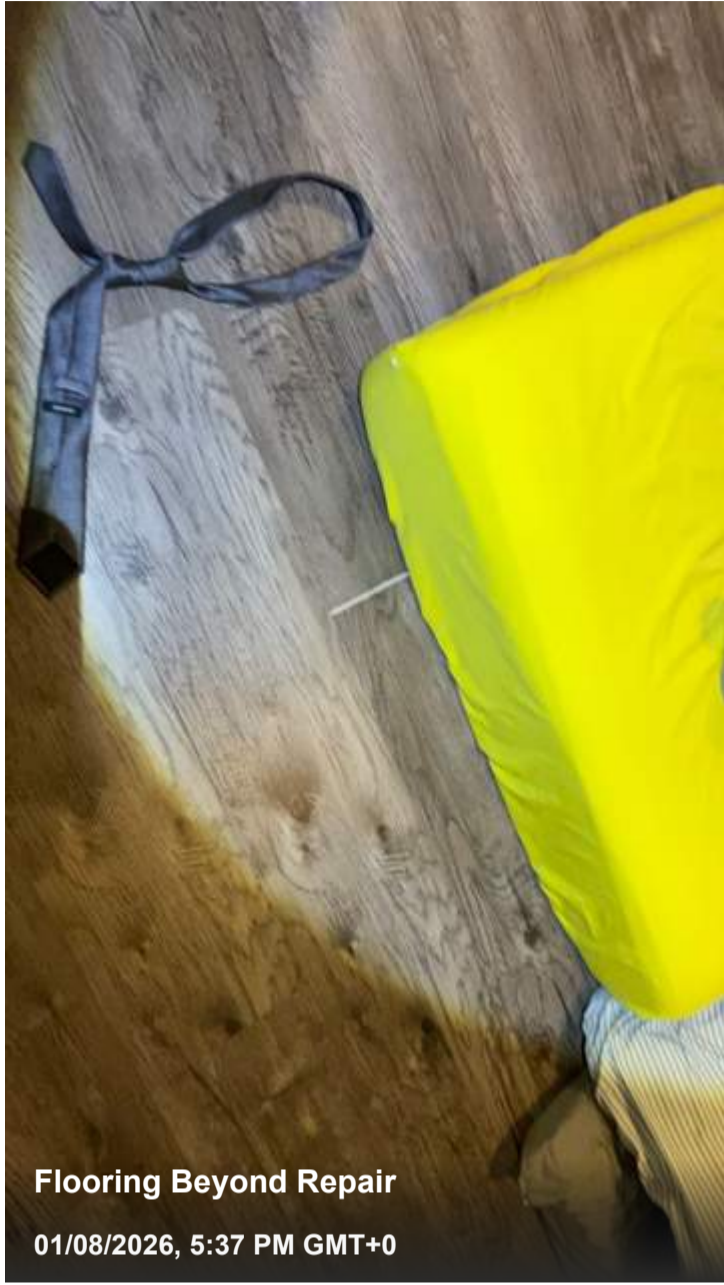
**Repair deficiency**

One or more gaps are present in the flooring. Recommend repairs or replacing by a qualified professional.

Flooring was also loose in some OBJ areas

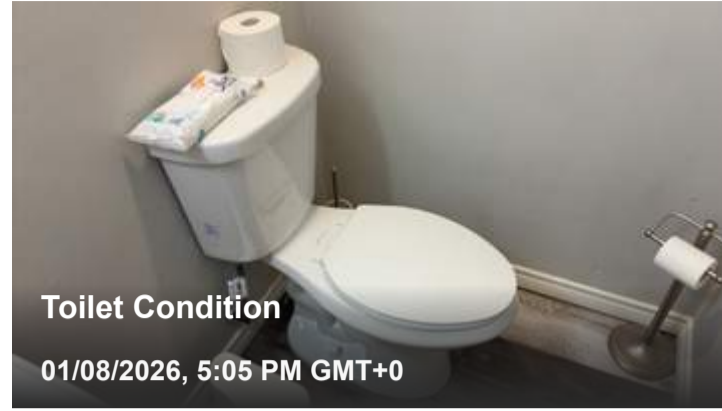
**Repair deficiency**

Missing flooring

Flooring was missing in one more areas Recommend further evaluation by a qualified professional.

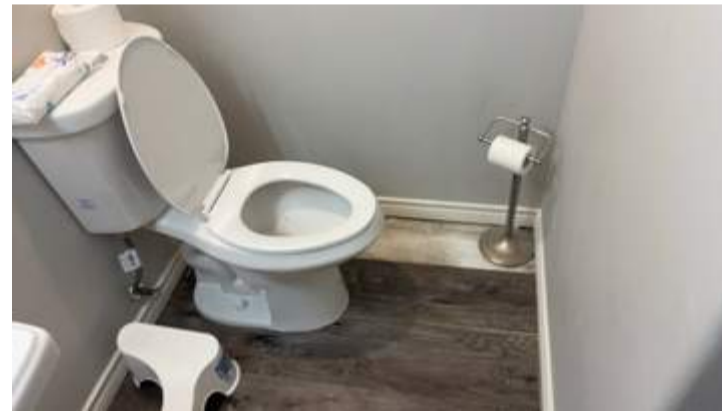
1st Floor, Bathroom

Note

Flooring was also loose

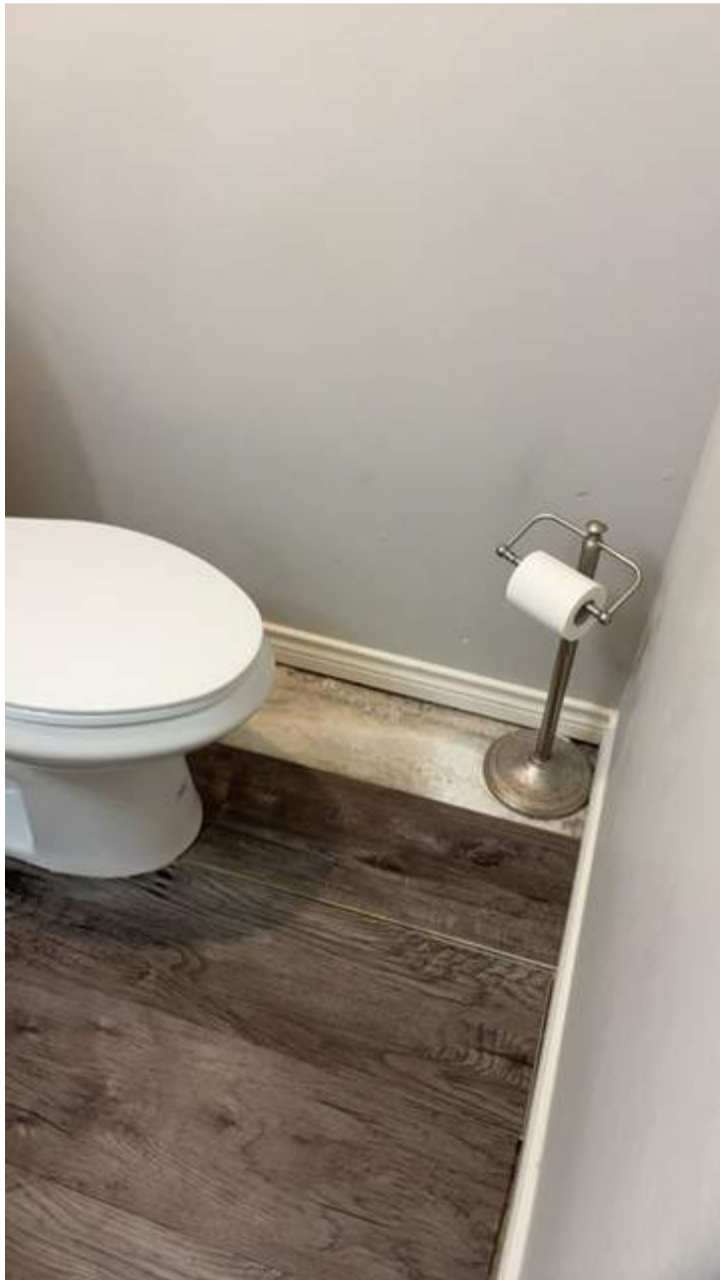
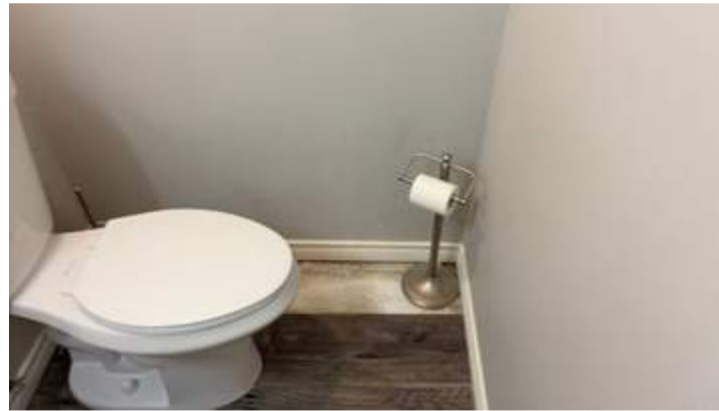
1st Floor, Bathroom

**Repair deficiency**

Missing Flooring Vapor Barrier

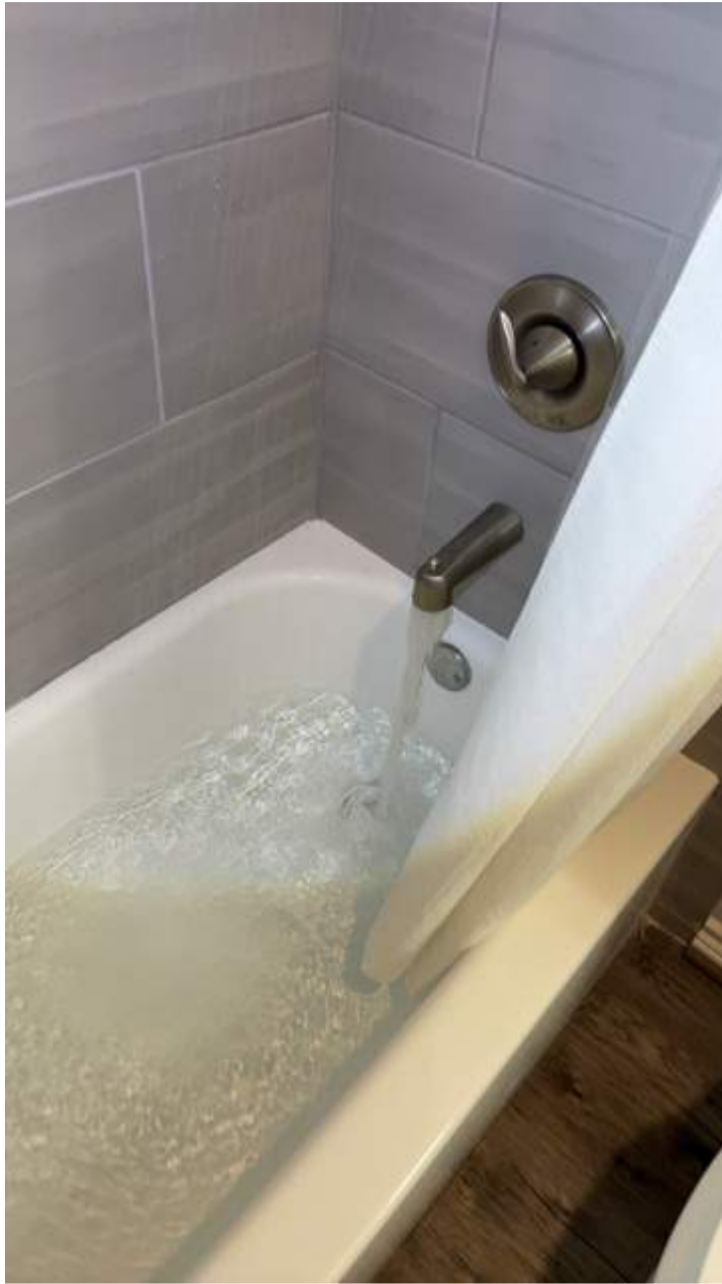
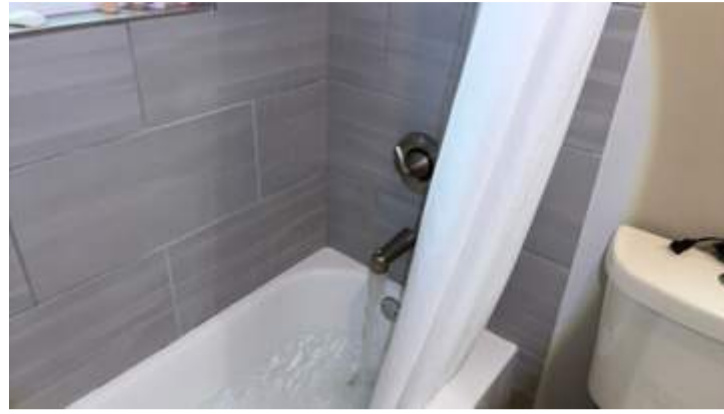
Bathroom, 2nd Floor

Water comes out of showerhead, even when the water is open on faucet

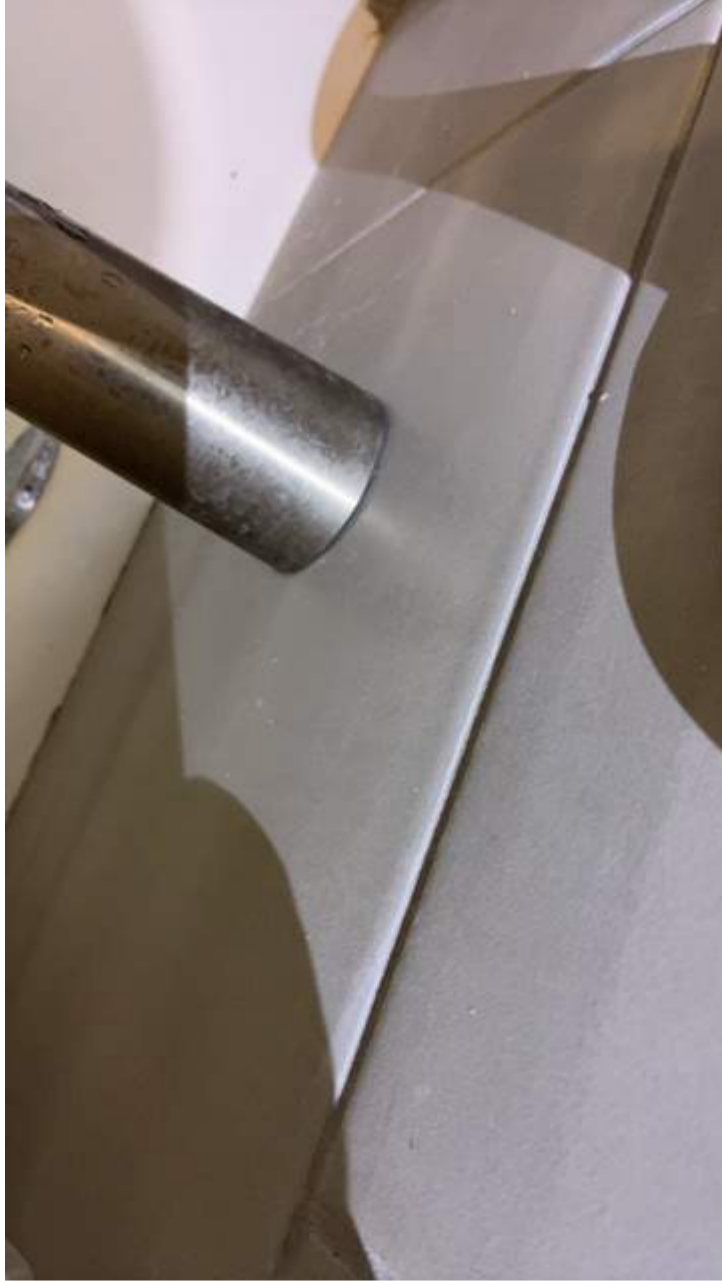
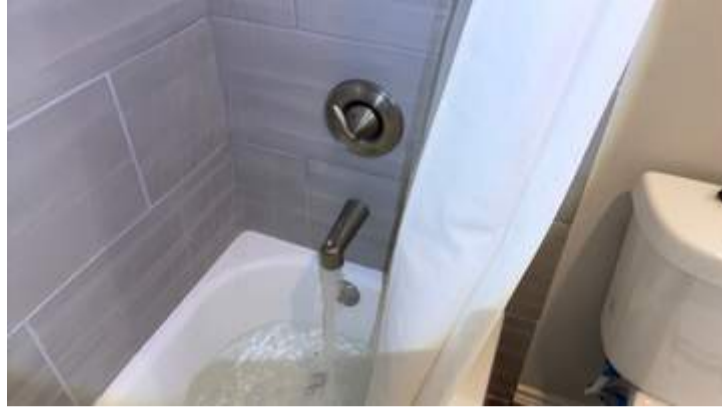
2nd Floor, Bathroom

Inadequate Bathroom Caulking

The caulking between the shower enclosure / tub / floor / wall is inadequate or damaged.

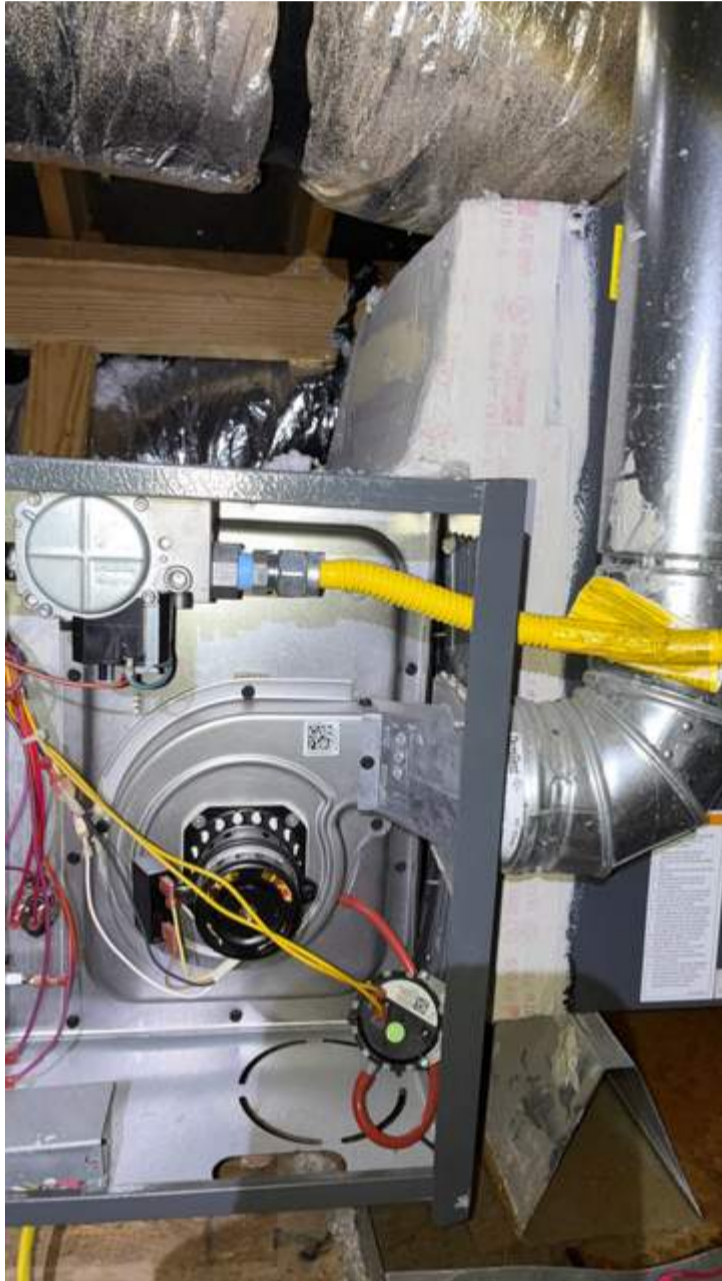
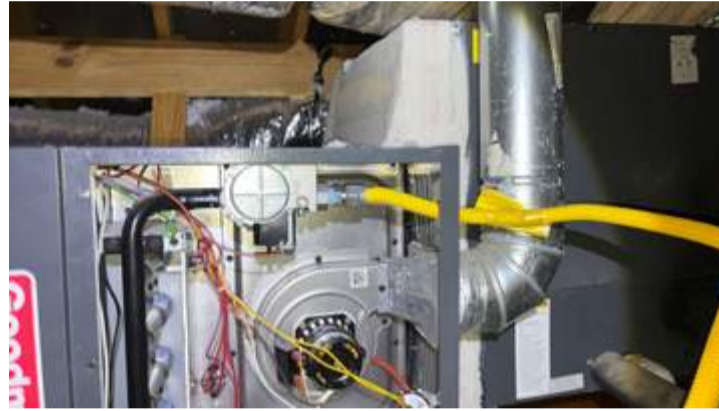
The gas flex line was entering the furnace cabinet

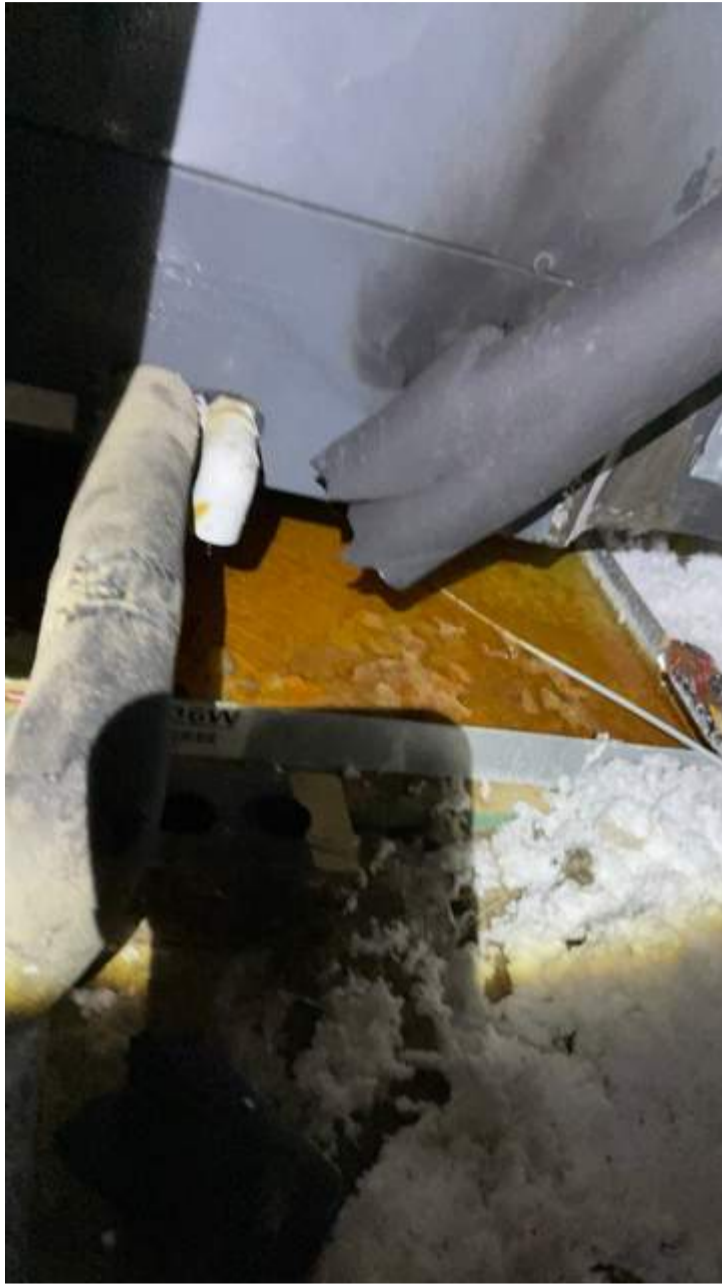
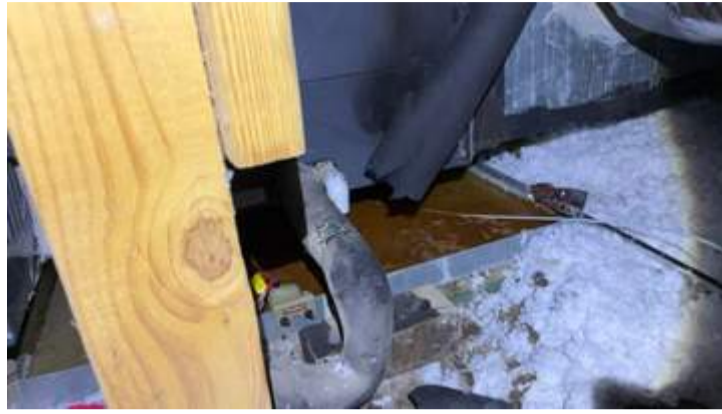
Attic

Standing Water in Drain Pan

Standing water was noted in the drain pan. Recommend repairs or replacing by a qualified professional.

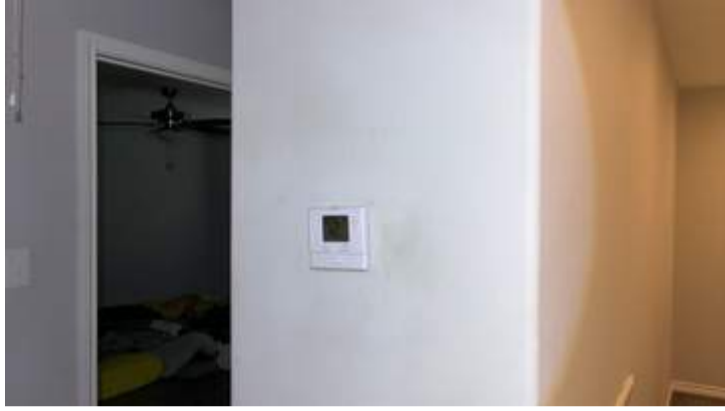
Loose Thermostat

The thermostat is loose.

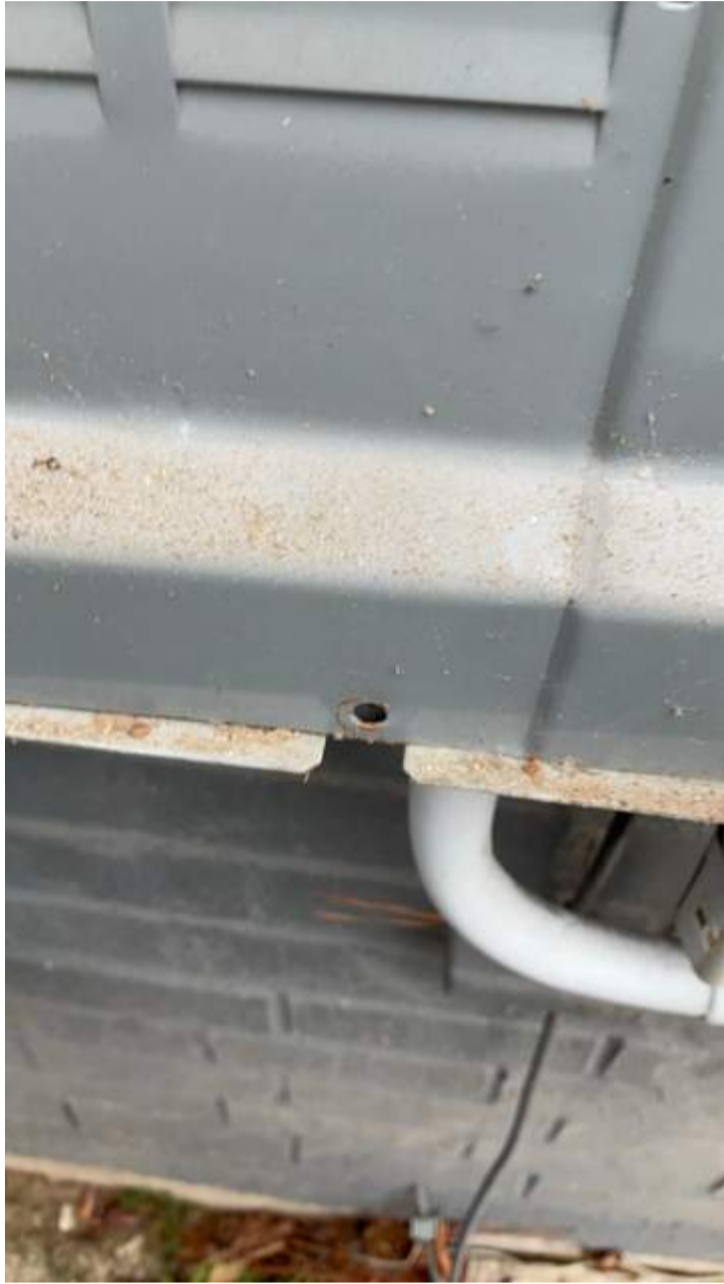
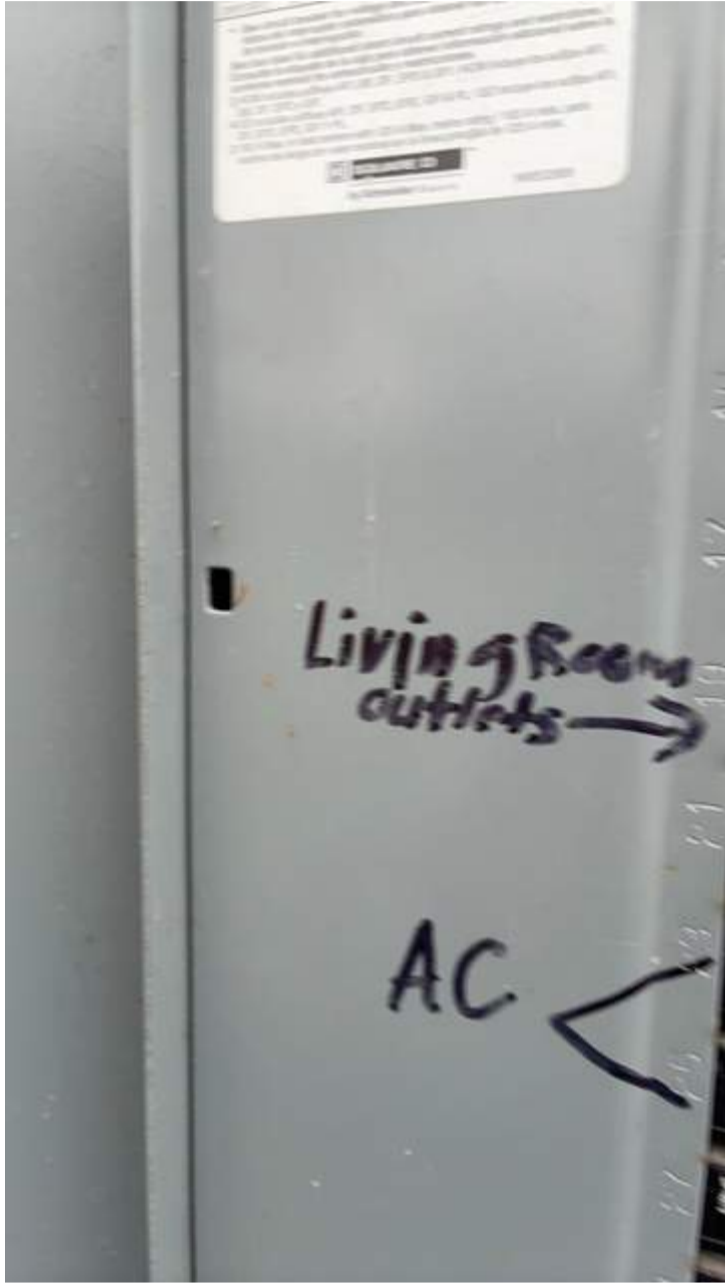
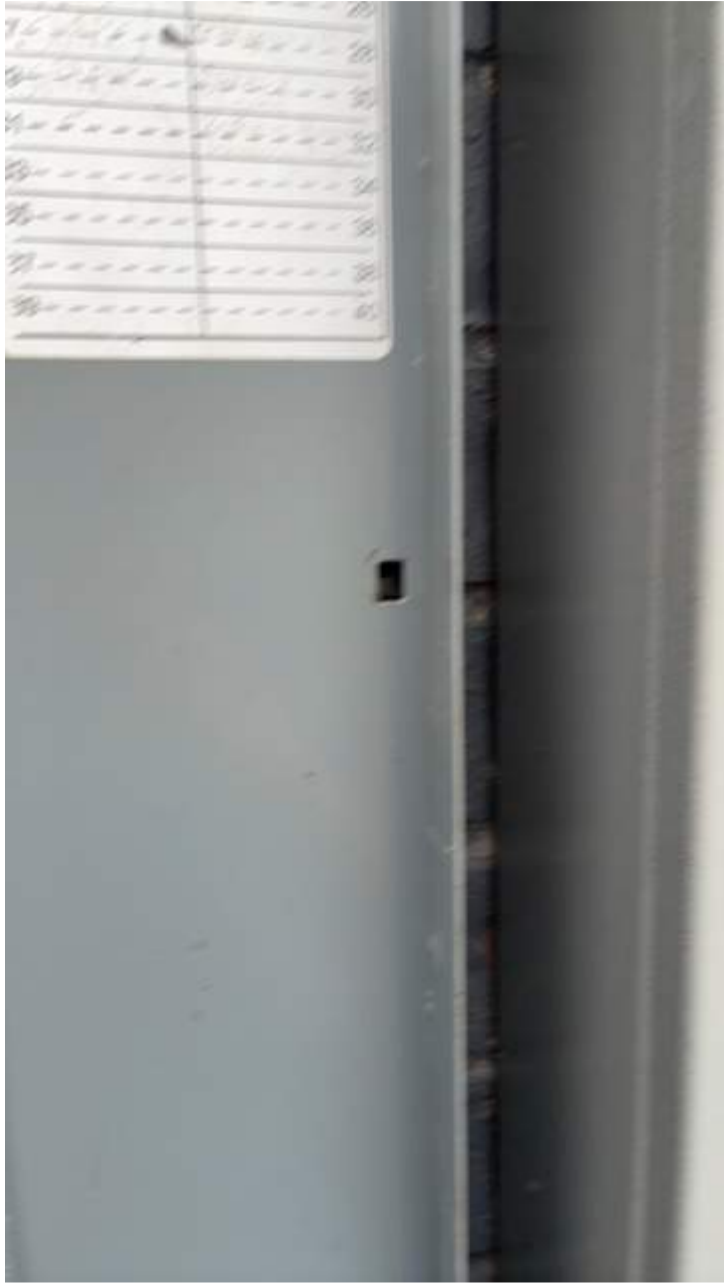
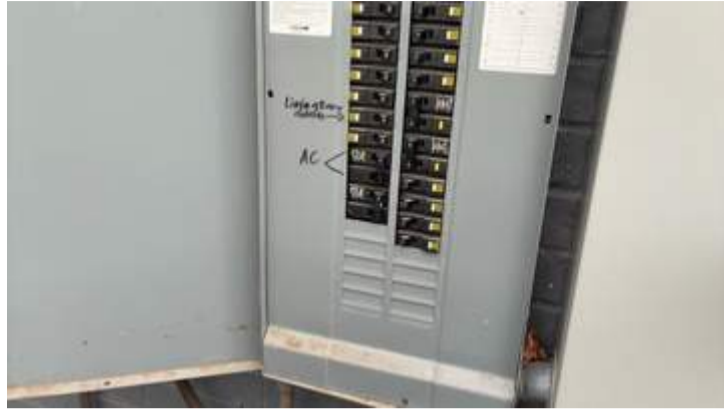
Missing / Incorrect Screws for Electrical Panel

There are missing / incorrect screws.

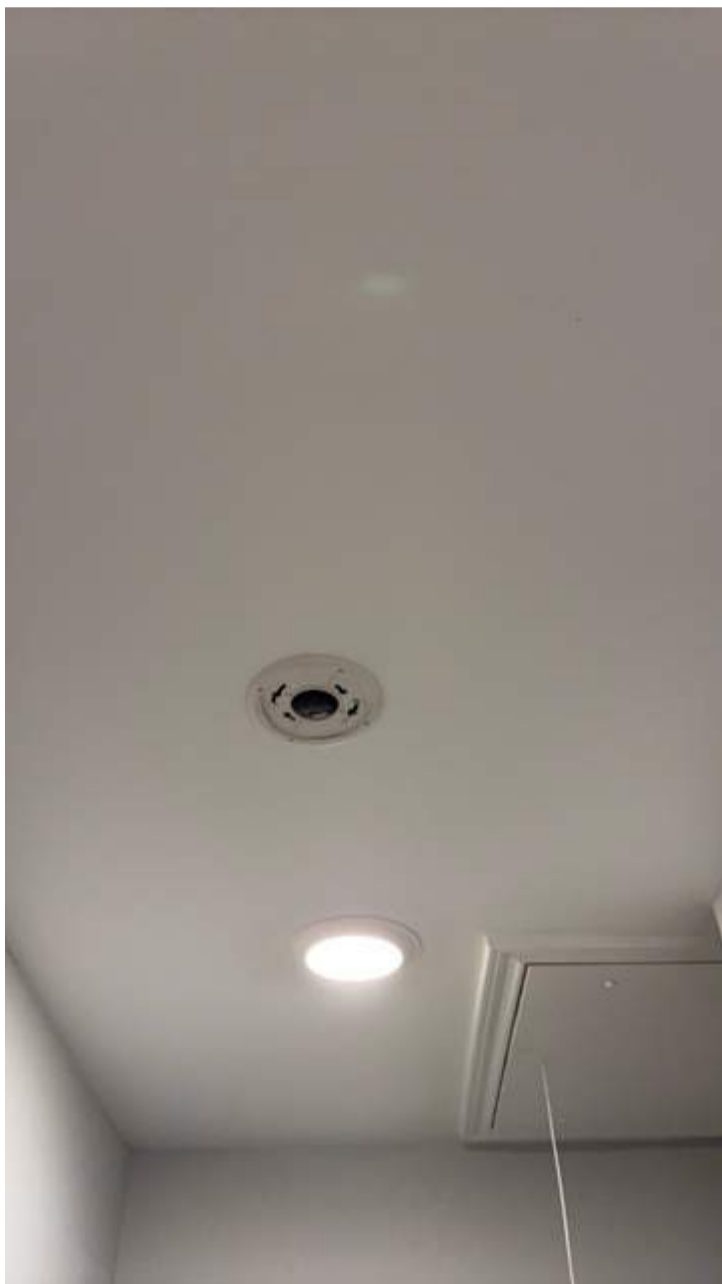
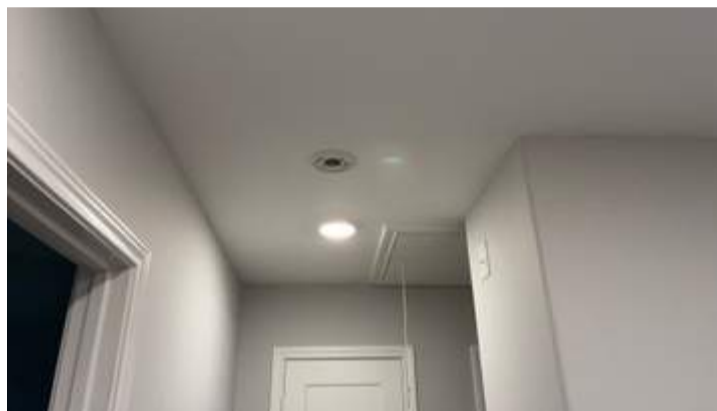
2nd Floor

Safety deficiency

Missing Carbon Monoxide Detector(s)

One or more carbon monoxide detector(s) is missing or not installed. Recommend repairs or replacing by a qualified professional.
