# 16870 Blackberry Lily Ln Conroe, Texas 77385

Client	--
Reference id	<b>a4xPd000003NoOziAK</b>
Type	<b>Home Inspection and Floor Plan Report - 16870 Blackberry Lily Ln</b>
Inspected by	<b>HomeTeam Inspection Service - North Houston</b>
State license	<b>TREC 20811</b>
Scheduled	<b>December 24, 2025, 9:00 AM CST</b>
Completed	<b>December 24, 2025, 3:38 PM CST</b>

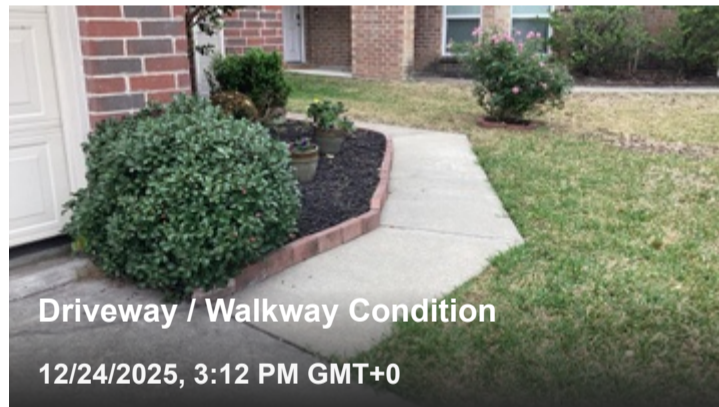
### Minor Cracks in the Driveway

The driveway has minor cosmetic cracks.

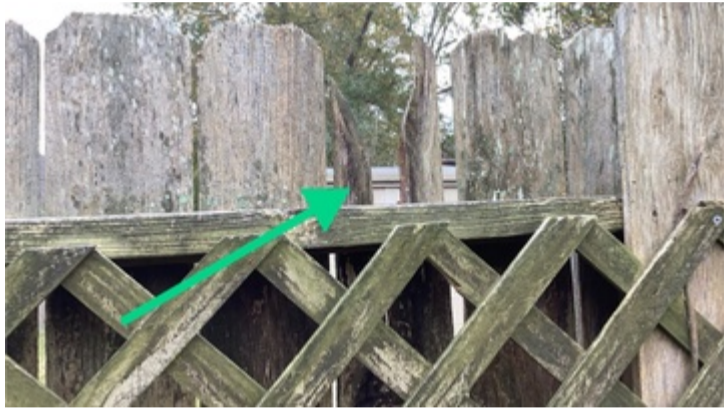
## Damaged / Missing Fence Boards

One or more fence boards are missing or damaged.

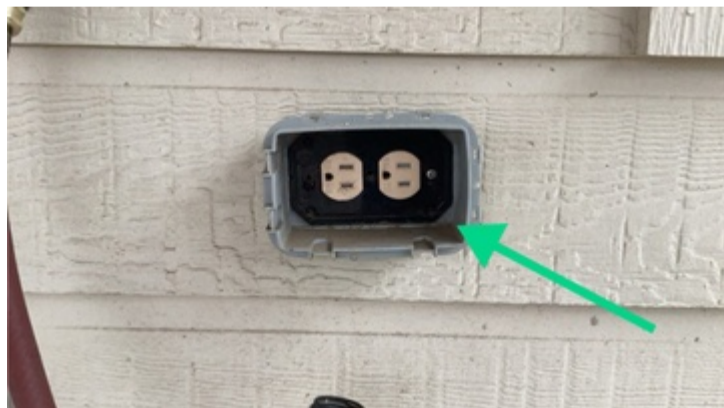
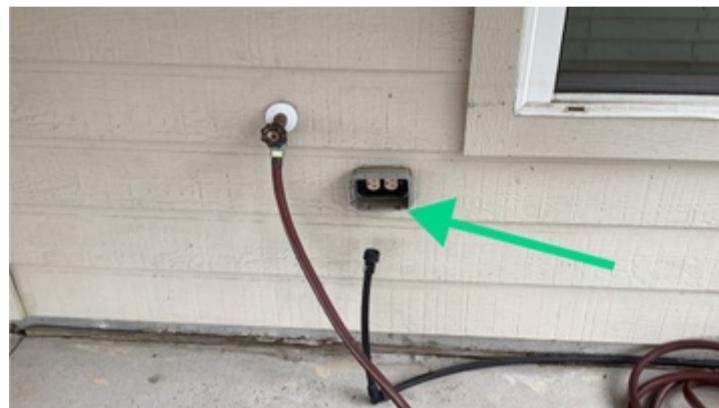
### Missing GFCI

There is no GFCI (Ground-Fault Circuit Interrupter) protection.

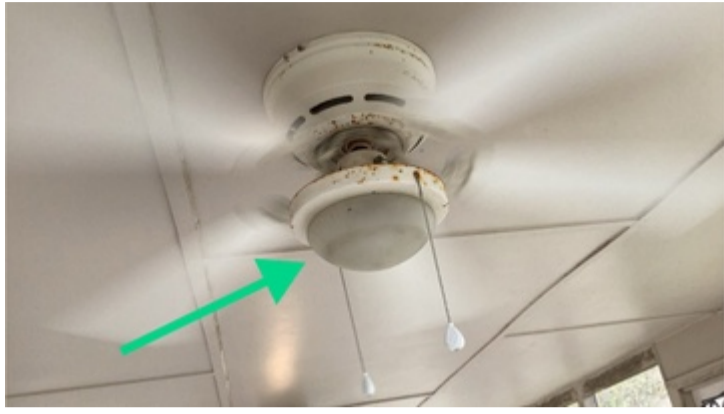
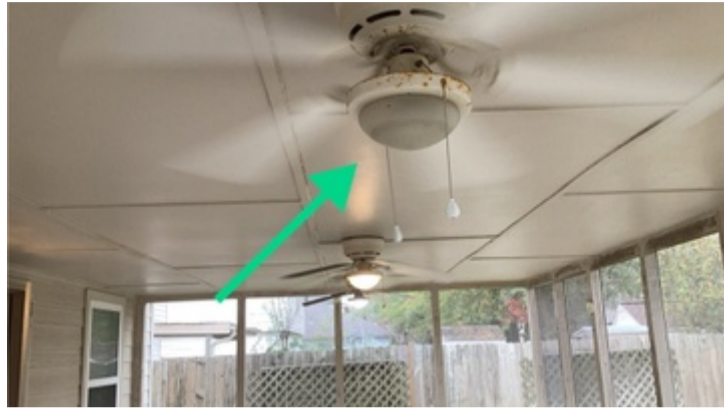
The exterior light is not turning on.

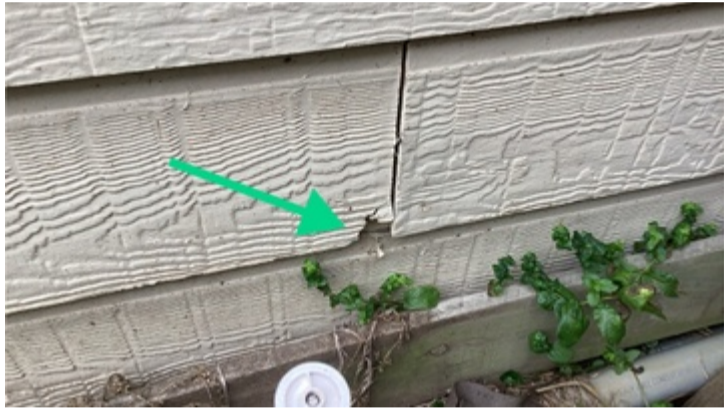
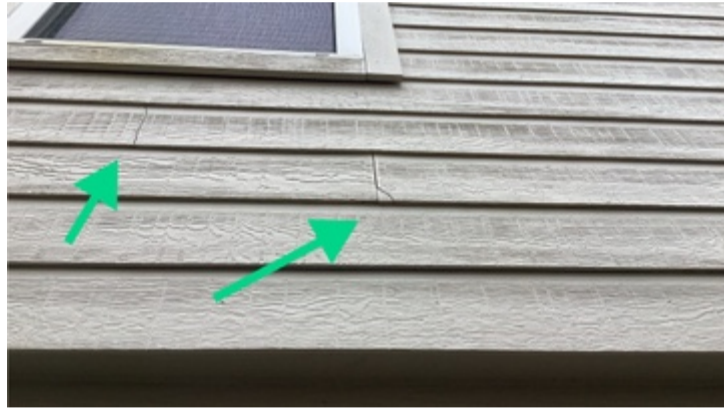
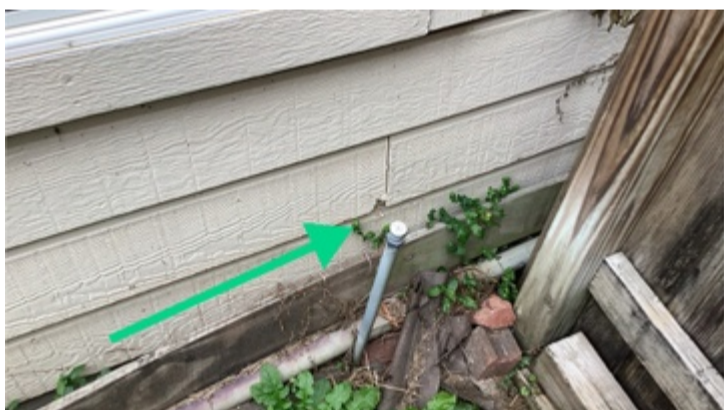
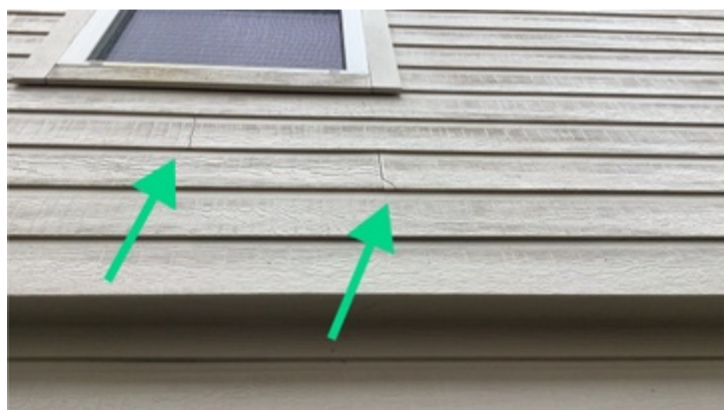
### Damaged Siding

One or more areas of the siding is damaged.

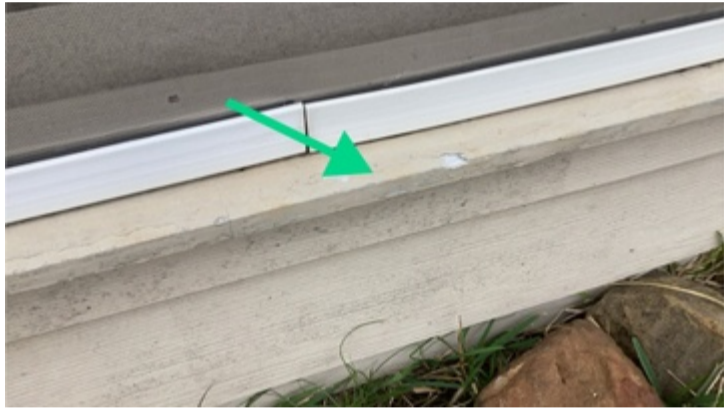
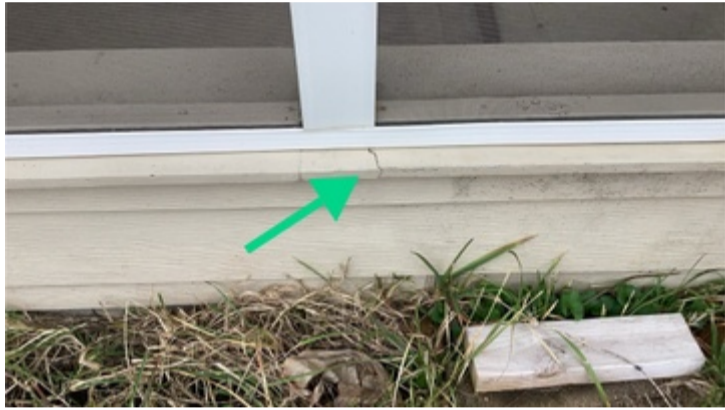
### Damaged Trim

There are signs of damage to the trim.

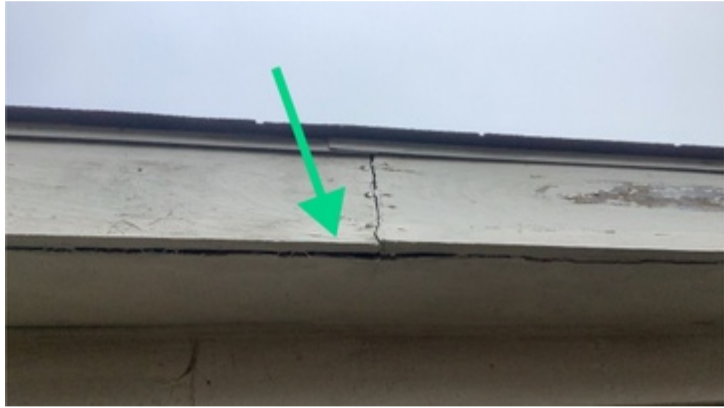
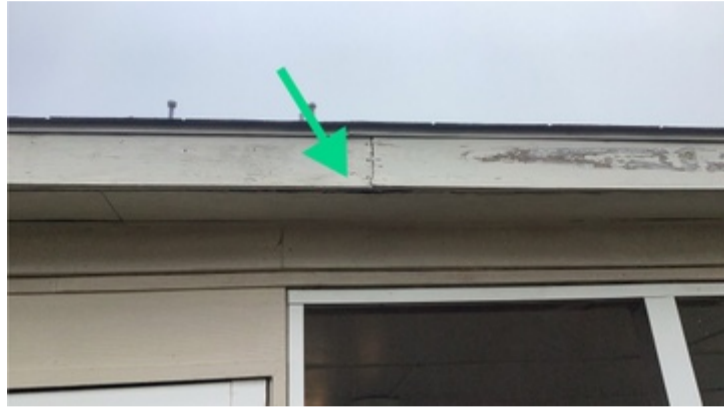
**Rotted Fascia**

One or more sections of the fascia are rotted.

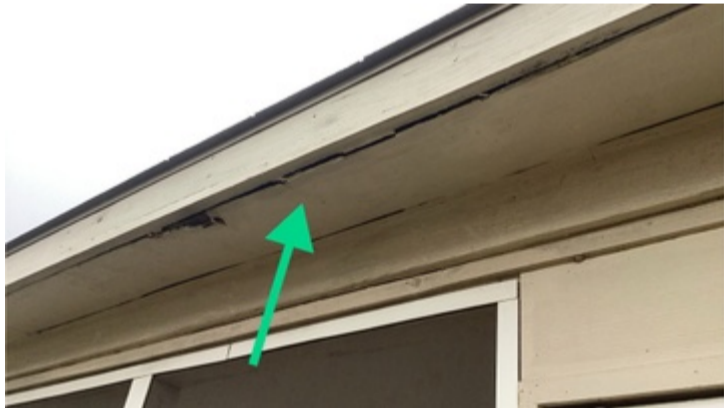
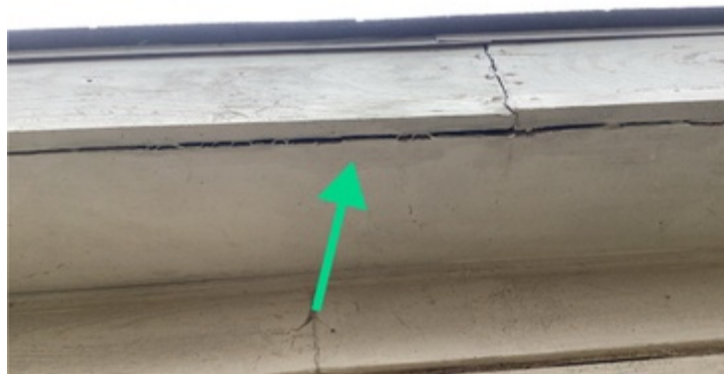
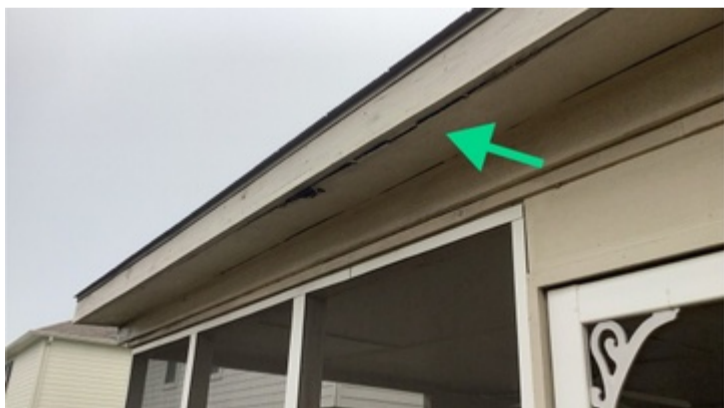
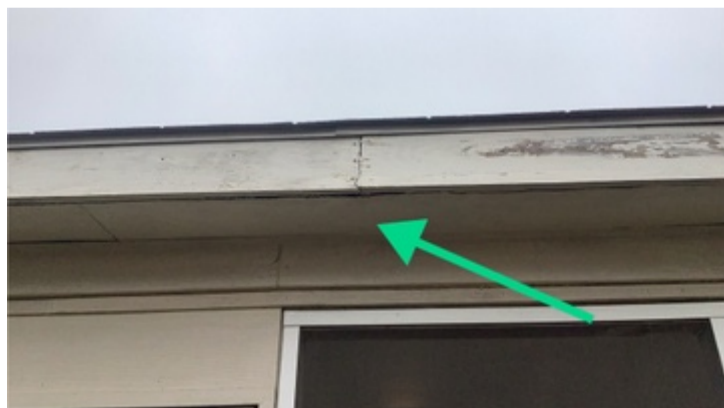
**Loose Soffit**

The soffit was loose.

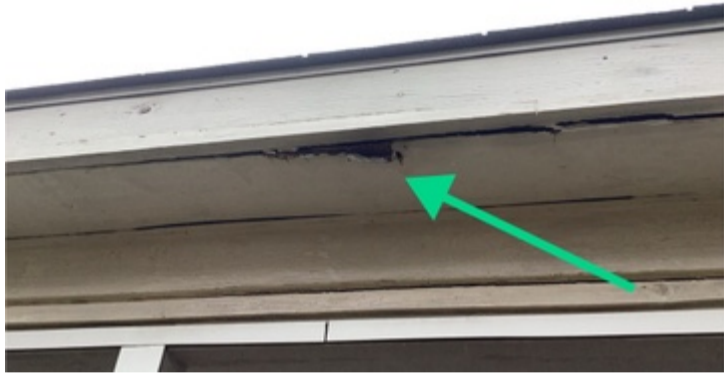
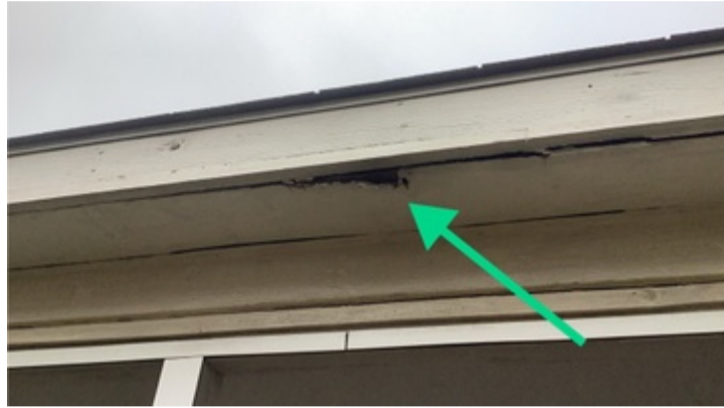
## Damaged Soffit

There are signs of damage or deterioration on the soffit.

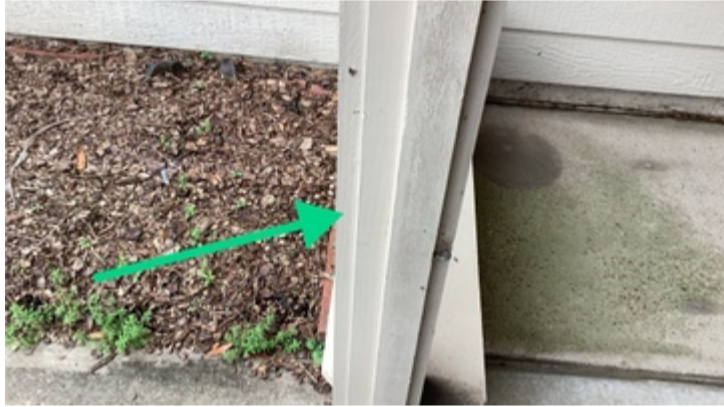
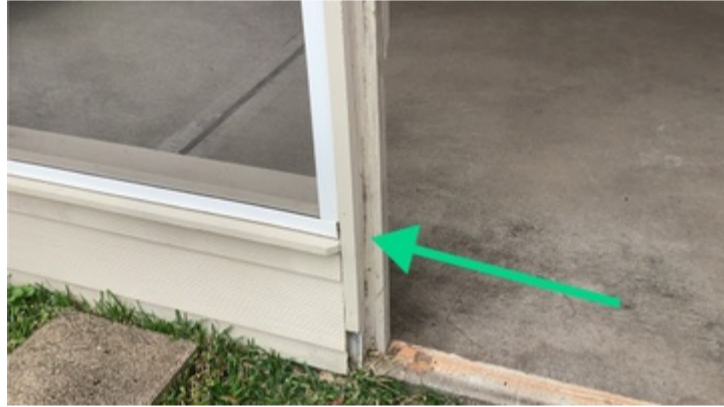
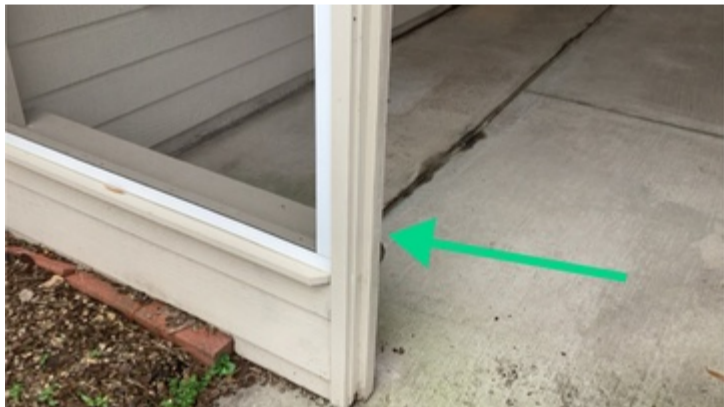
### Damaged or Missing Weatherstripping

The weatherstripping is damaged or missing.

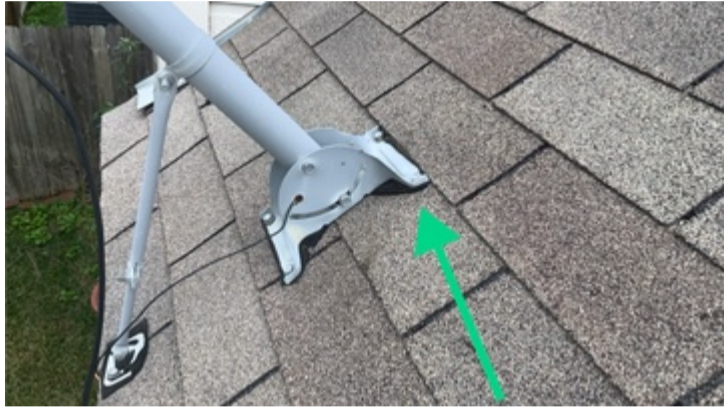
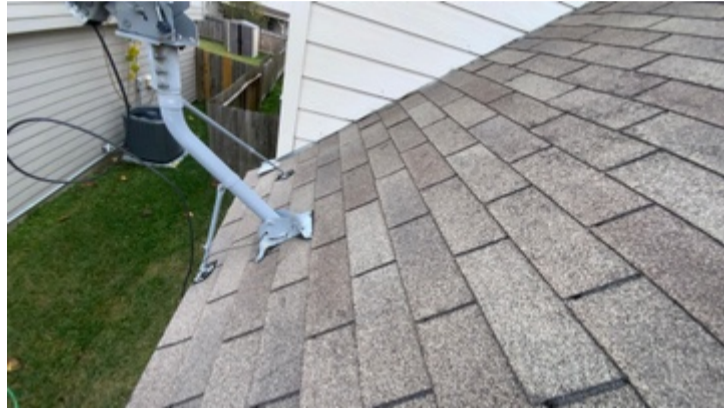
Satellite dish brackets installed over roof covering materials.

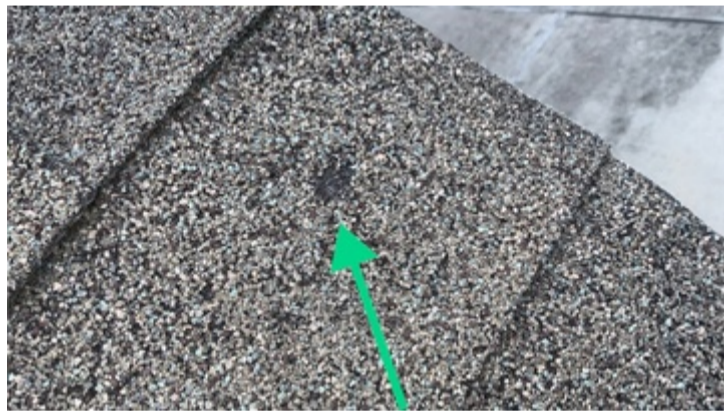
### Damaged Shingles

One or more shingles are cracked or torn.

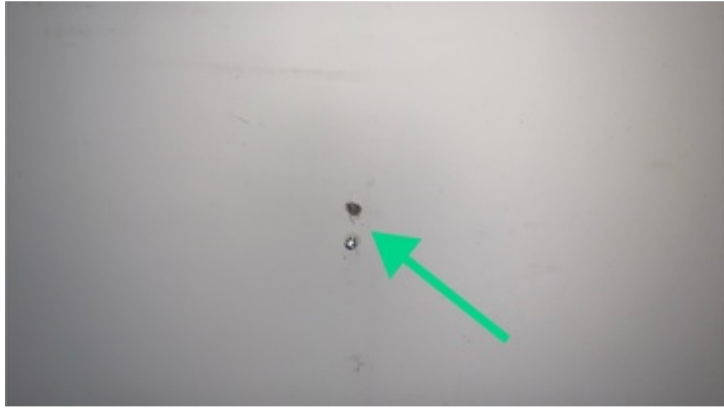
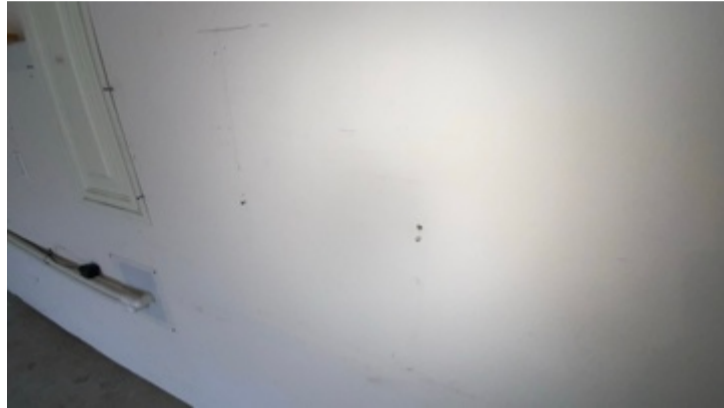
### Damaged Interior Walls or Ceilings

Holes or damage are present on the interior walls / ceilings.

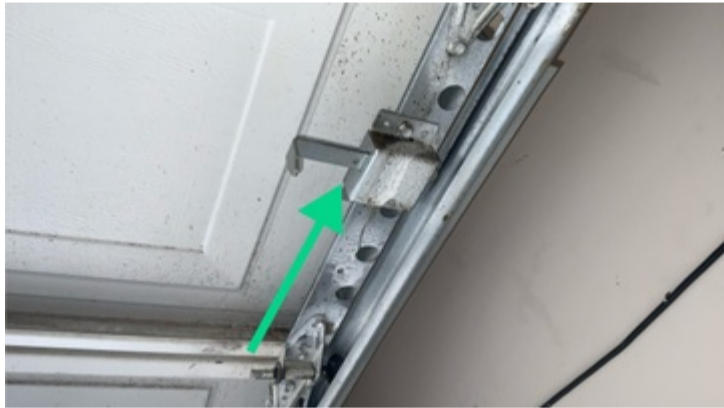
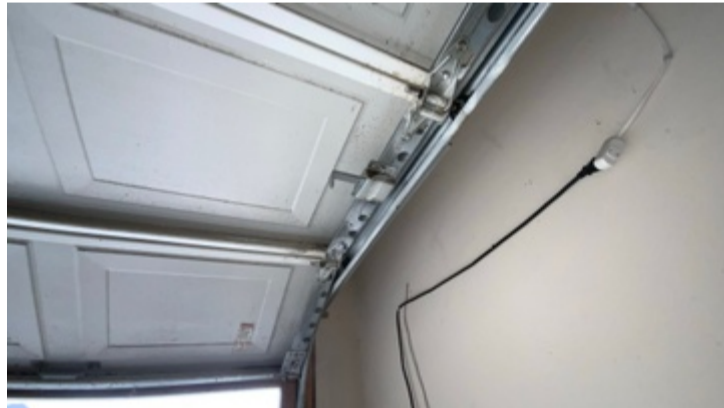
The garage door manual lock was not disabled.

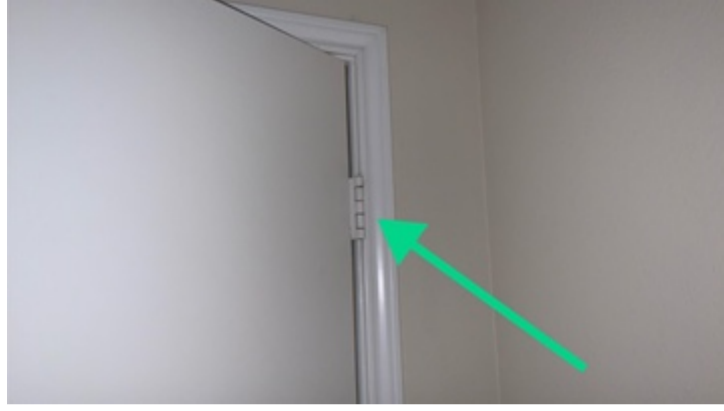
### Missing / Inoperable Self-Closing Door Hinges

The self-closing door hinges are missing / inoperable.

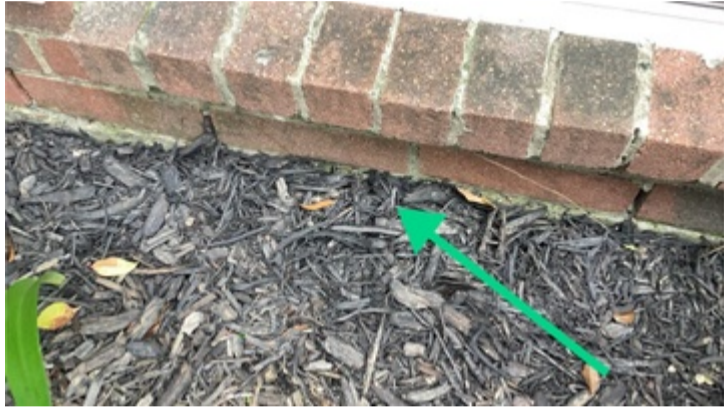
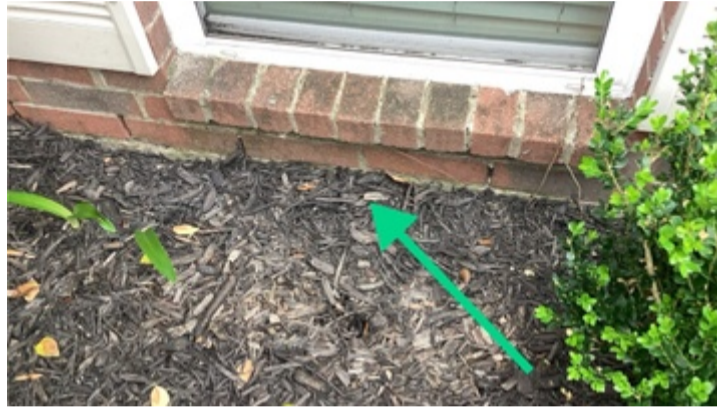
There are areas of high soil around the foundation.

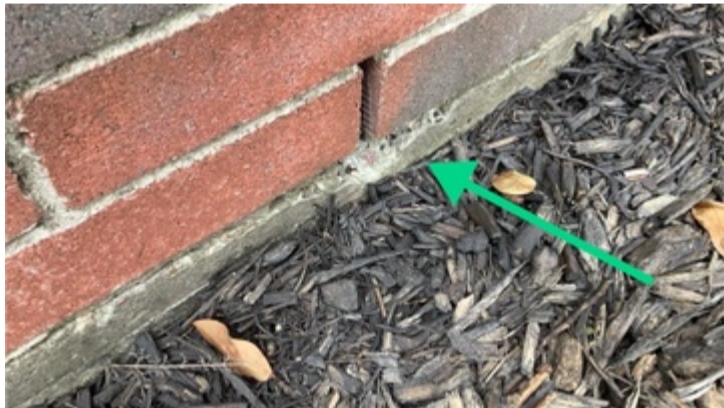
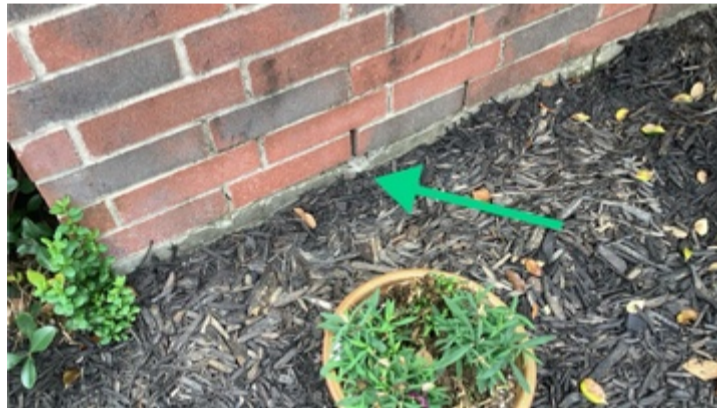
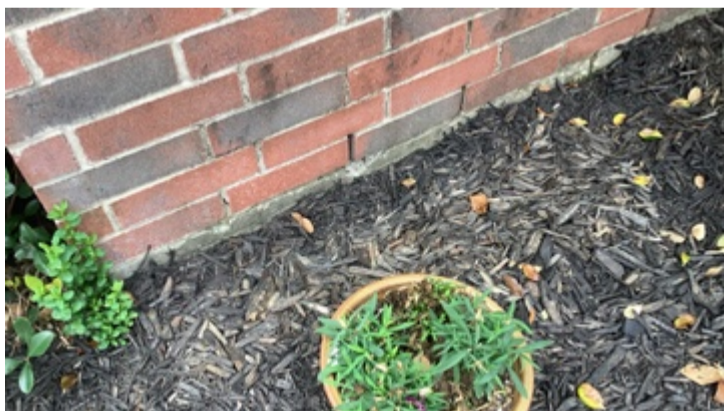
### Minor Foundation Cracks

One or more areas of the foundation have minor cracking.

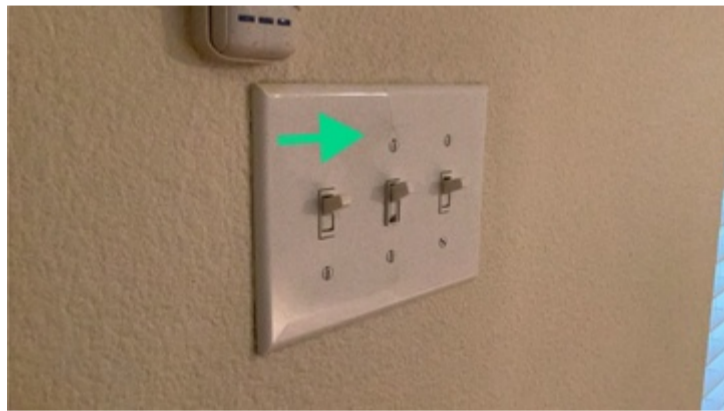
### Damaged Cover Plates

One or more switch / outlet / receptacle cover plates are damaged.

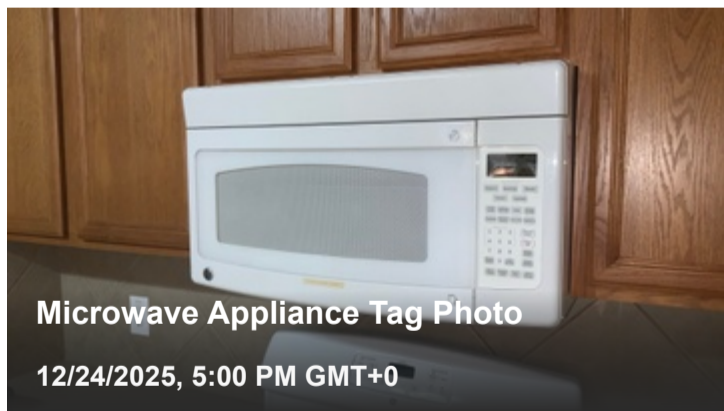
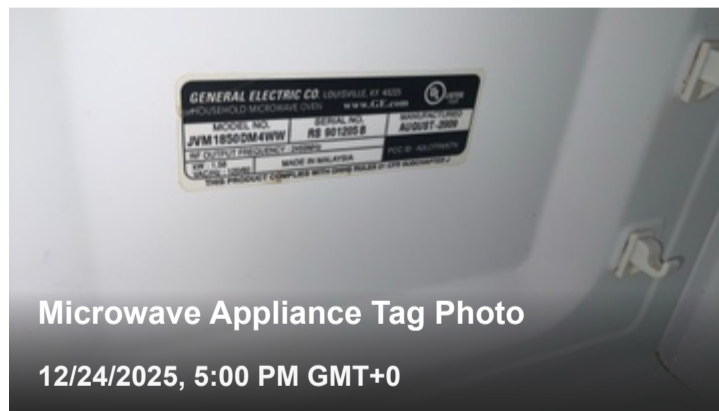
Repair deficiency

### Loose or Broken Microwave Handle

The microwave handle is loose or broken.

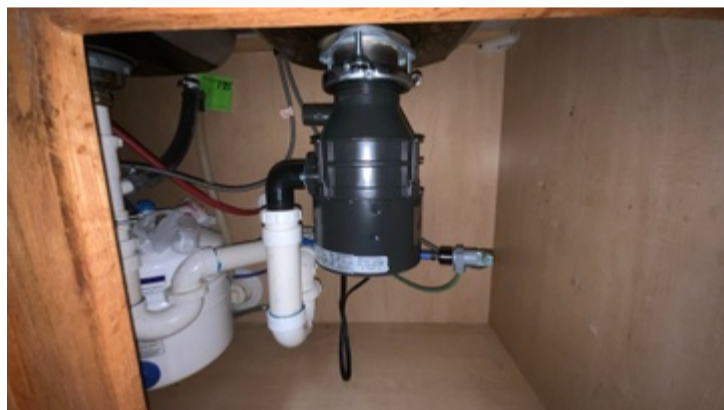
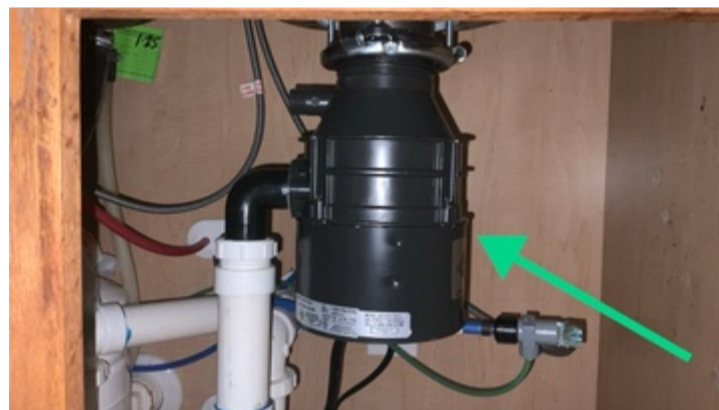
**Repair deficiency**

The garbage disposal is inoperable.

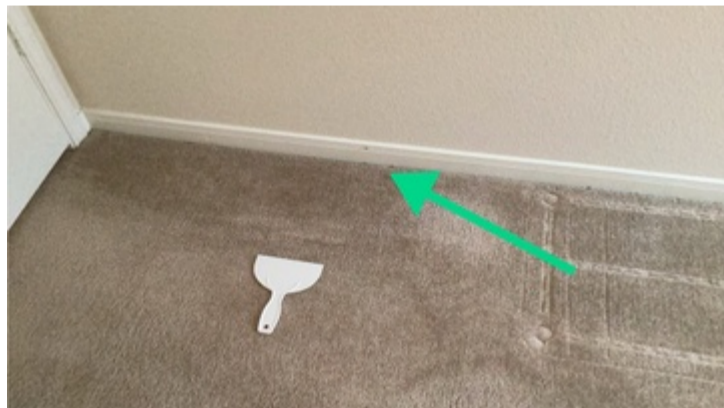
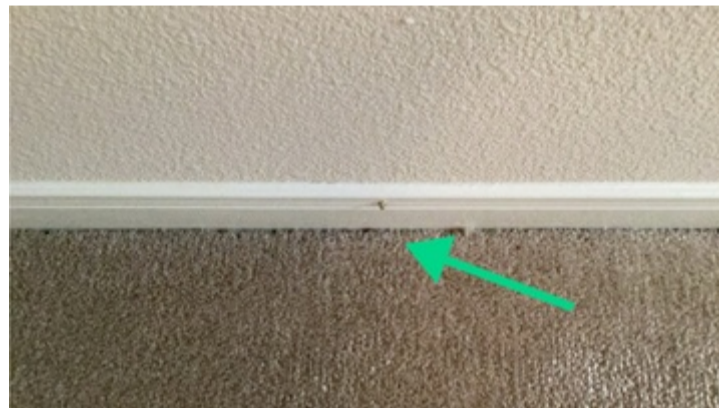
**Repair deficiency**

### Missing / Damaged Door Stop(s)

Door stops are missing or damaged for an interior door.

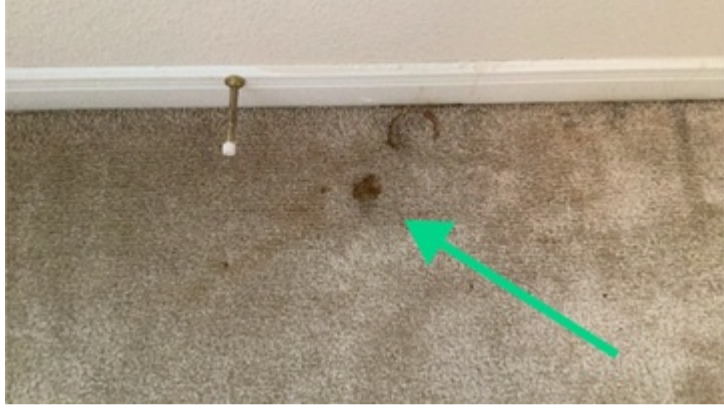
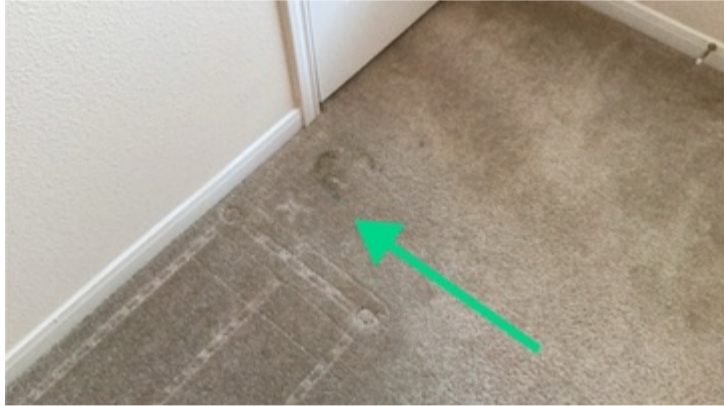
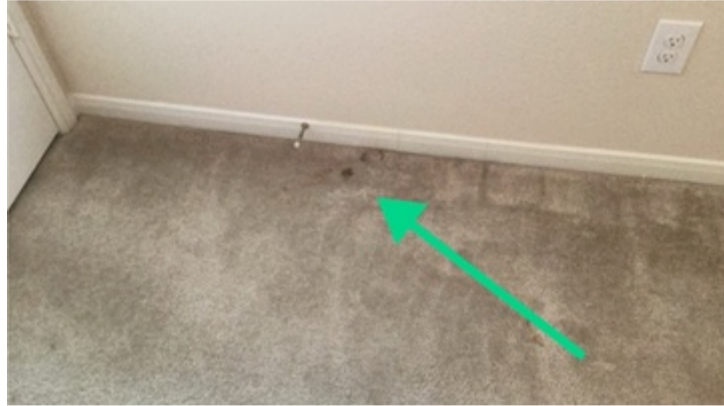
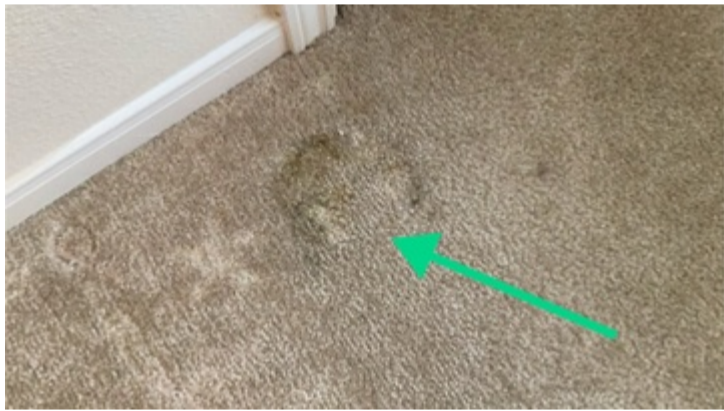
**Monitor deficiency**

### Stained Carpet

The carpet has areas of staining or discoloration.

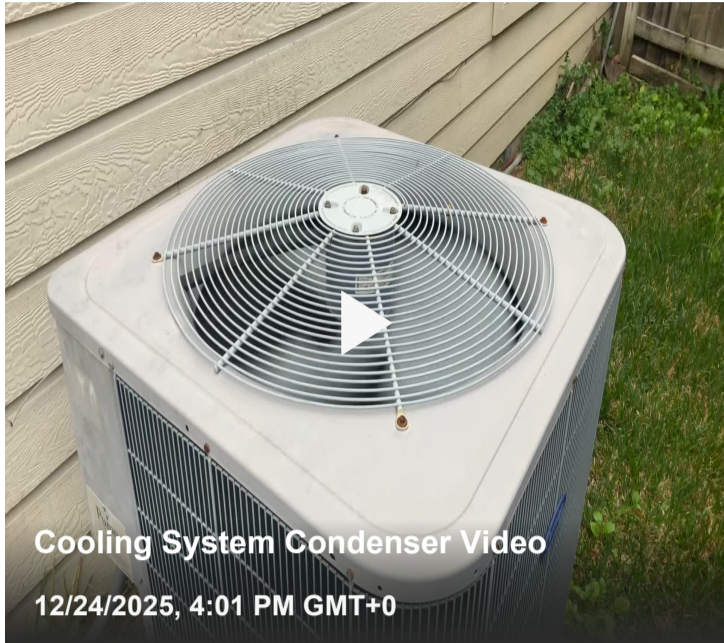
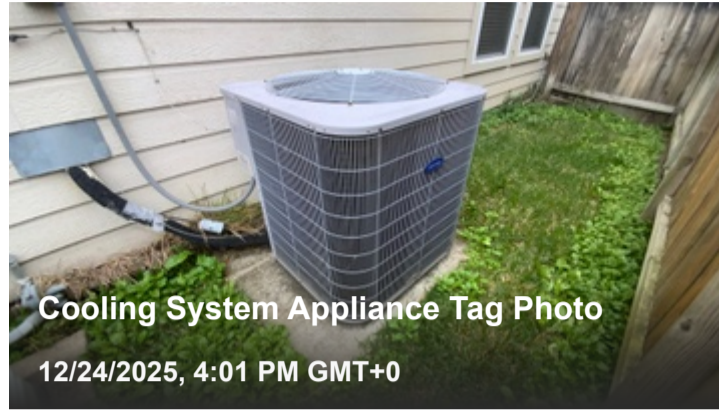
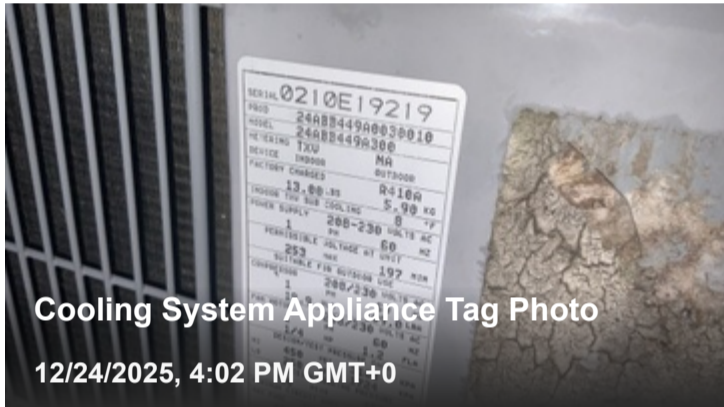
## Missing or Damaged HVAC Line Insulation

The refrigerant line insulation is missing or damaged.

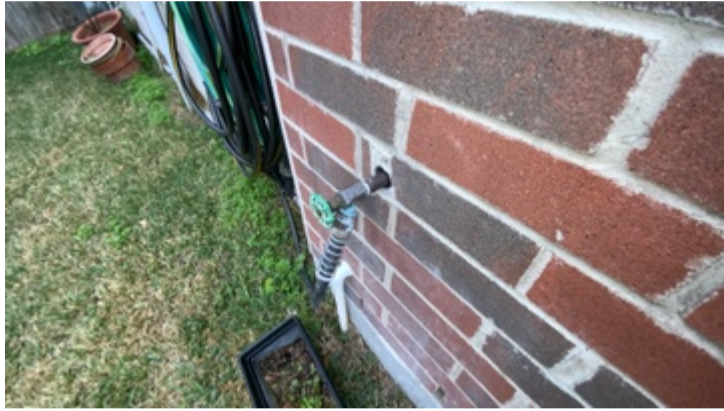
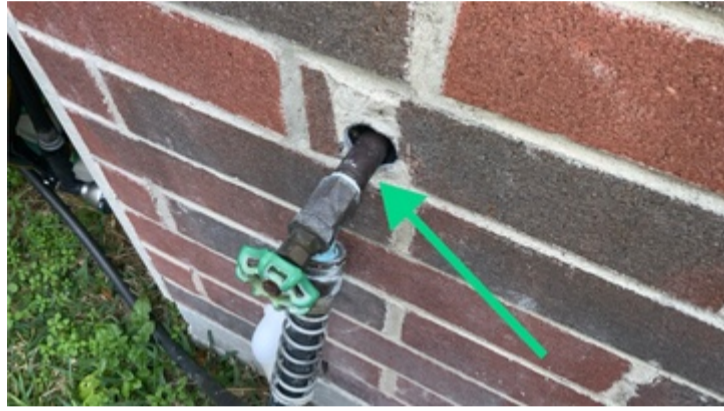
**Repair deficiency**

The water lines are uninsulated.

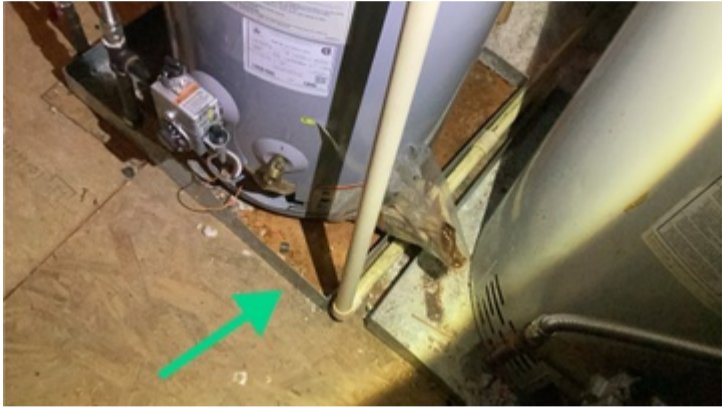
Monitor deficiency

### Rusted water heaters drip pans

Rust in the water heaters drip pans

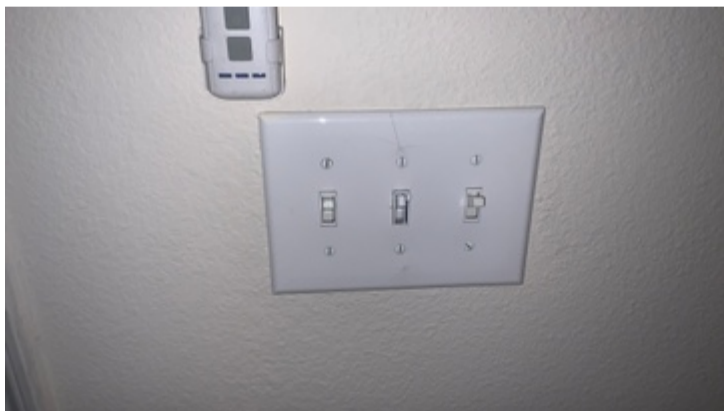
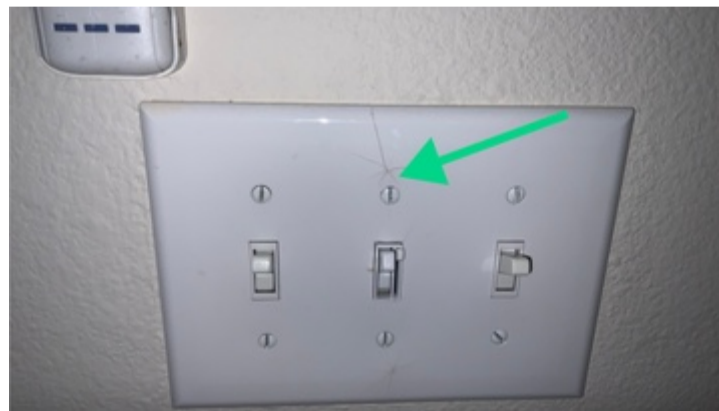
**Safety deficiency**

### Damaged Cover Plates

One or more switch / outlet / receptacle cover plates are damaged.
