Lone Star Stucco, LLC

Moisture Assessment Report

2314 Hudly St B

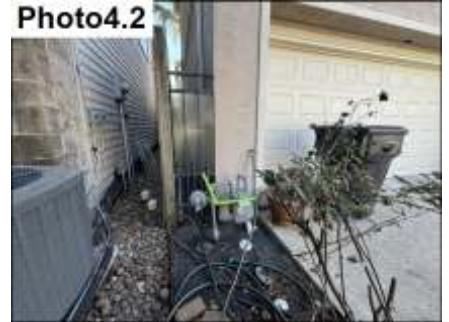
Photo4.2

Proper Grade Termination with Plaster Stop / Positive Detail

- Stucco appears to be typically detailed at grade for the time of this construction. The inspector suggests that this is a positive detail and recommends no modification at this time but to always keep soil away from the structure. Please refer to photos #4.2, #4.3, #4.4, #4.5 and #4.6 for more detail.

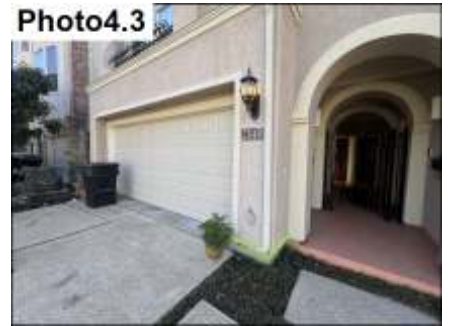
Photo4.3

Proper Grade Termination with Plaster Stop / Positive Detail

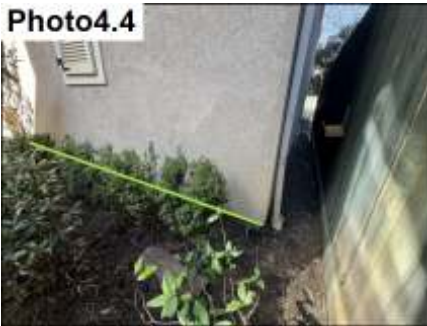
Photo4.4

Proper Grade Termination with Plaster Stop / Positive Detail

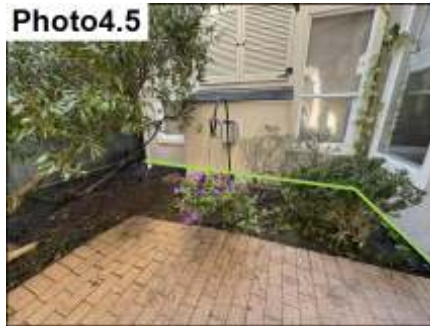
Photo4.5

Proper Grade Termination with Plaster Stop / Positive Detail

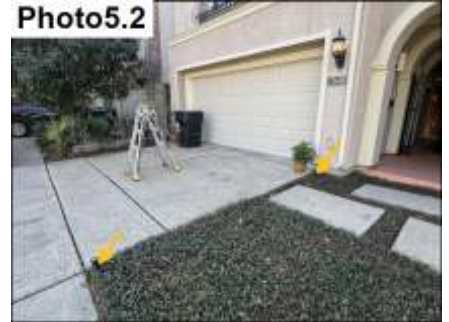
Photo5.2

Sprinklers / Redirect as Needed

- Sprinklers have been noted on this home. The inspector suggests to always redirect sprinkler heads away from the system and windows as needed in an effort to prevent moisture intrusion. Please refer to photos #5.2, #5.3, #5.4, #5.5 and #5.6 for more detail.

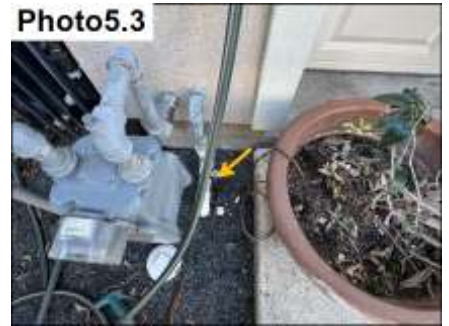
Photo5.3

Sprinklers / Redirect as Needed

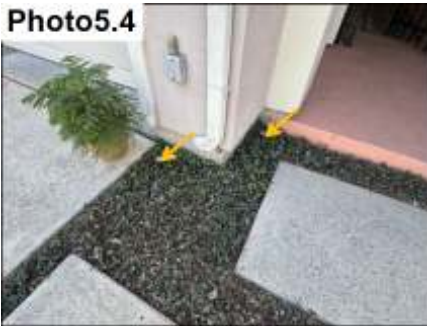
Photo5.4

Sprinklers / Redirect as Needed

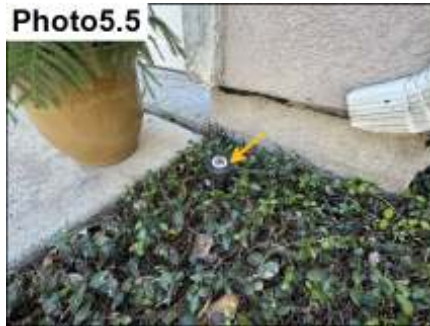
Photo5.5

Sprinklers / Redirect as Needed

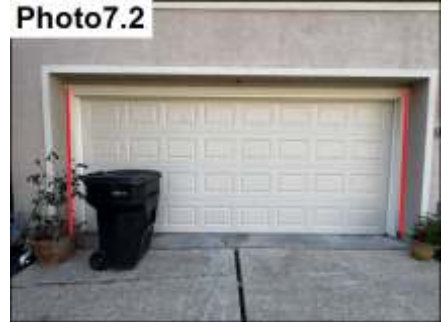
Photo7.2

Garage Door Trim Sealant / Seal

Grid Location	Item Description	Moisture Readings	Substrate Condition	Observations
Red Lines	Garage Doors			The garage door trim sealants are aged at this location. The inspector suggests to have a qualified waterproofing contractor seal this area with a low modulus sealant in an effort to prevent moisture intrusion. These types of sealants are of high quality and compatible with stucco and other termination points. Please refer to photos #7.2, #7.3, #7.4, #7.5 and #7.6 for more detail.

- The garage door trim sealants are aged at this location. The inspector suggests to have a qualified waterproofing contractor seal this area with a low modulus sealant in an effort to prevent moisture intrusion. These types of sealants are of high quality and compatible with stucco and other termination points. Please refer to photos #7.2, #7.3, #7.4, #7.5 and #7.6 for more detail.

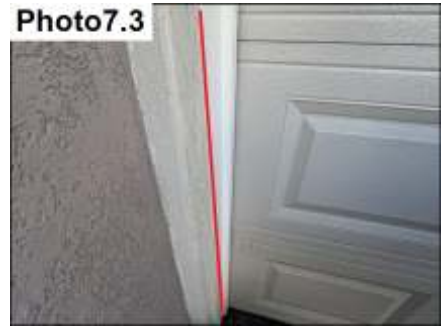
Photo7.3

Garage Door Trim Sealant / Seal

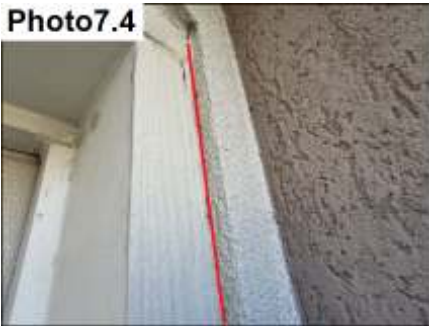
Photo7.4

Garage Door Trim Sealant / Seal

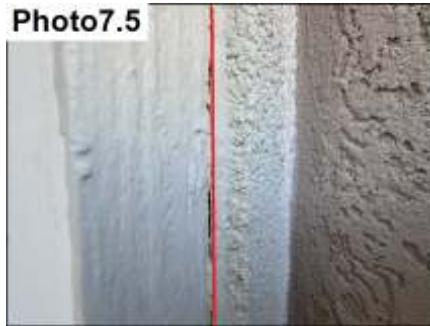
Photo7.5

Garage Door Trim Sealant / Seal

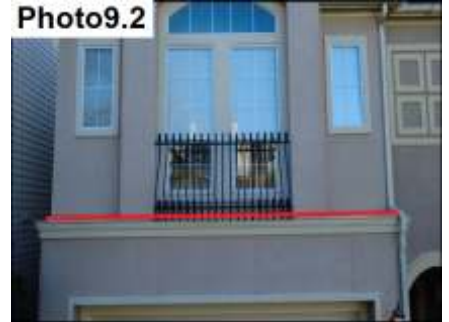
Photo9.2

- The metal cap sealants are aged or separated at this location allowing excess moisture into the system below. The inspector suggests to have a qualified waterproofing contractor further assess and seal this area with a low modulus sealant in an effort to prevent moisture intrusion. These types of sealants are of high quality and compatible with stucco and other termination points. Please refer to photos #9.2, #9.3, #9.4, #9.5 and #9.6 for more detail.

Metal Cap Termination / Seal

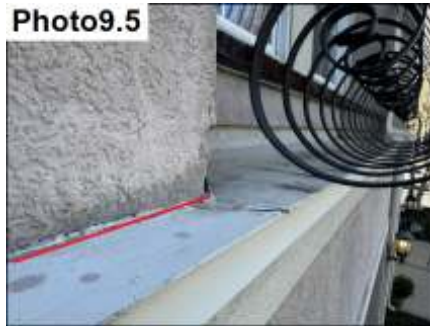
Photo9.5

Metal Cap Termination / Seal

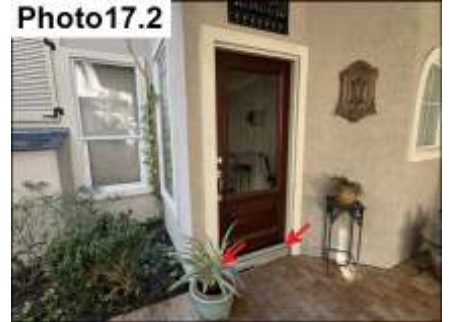
Photo17.2

Door Trim and Miter Sealant / Seal

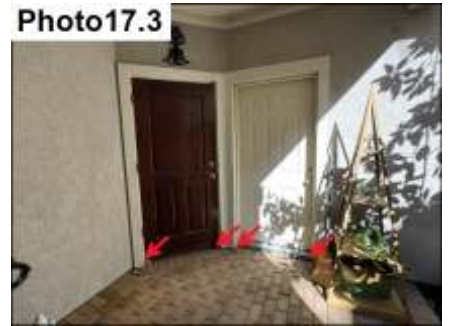
Photo17.3

Door Trim and Miter Sealant / Seal

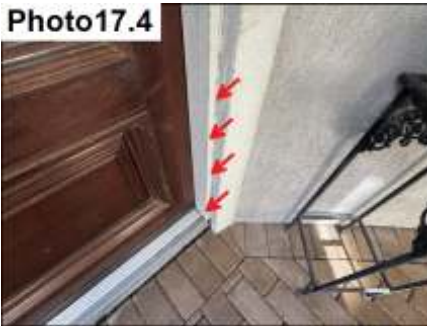
Photo17.5

Door Trim and Miter Sealant / Seal

Grid Location	Item Description	Moisture Readings	Substrate Condition	Observations
Red Arrows	Doors			The door trim and miter sealants are separated or aged at this location. The inspector suggests to have a qualified waterproofing contractor seal this area with a low modulus sealant in an effort to prevent moisture intrusion. These types of sealants are of high quality and compatible with stucco and other termination points. Please refer to photos #17.2, #17.3, #17.4, #17.5 and #17.6 for more detail.

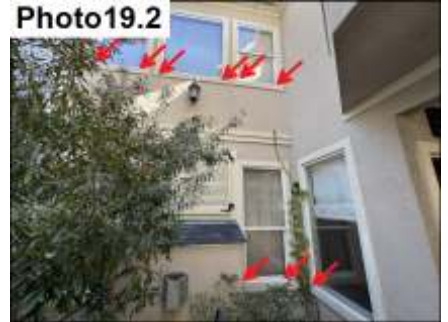
Photo19.3

Window Sealants / Seal

Grid Location	Item Description	Moisture Readings	Substrate Condition	Observations
Red Arrows	Windows			The window sealants are aged or separated. The inspector suggests to have a qualified waterproofing contractor further assess and seal this area with a low modulus sealant in an effort to prevent moisture intrusion. These types of sealants are of high quality and compatible with stucco and other termination points. Please refer to photos #19.2, #19.3, #19.4, #19.5 and #19.6 for more detail.

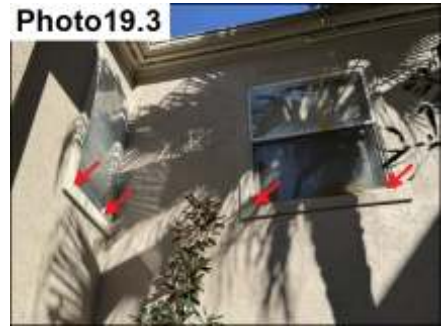
Photo19.4

Window Sealants / Seal

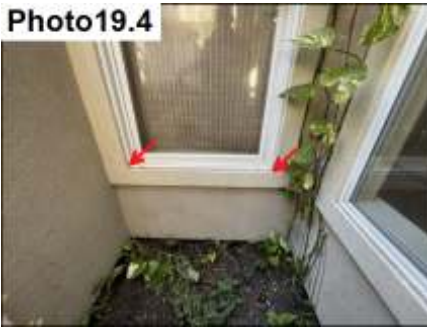
Photo19.5

Window Sealants / Seal

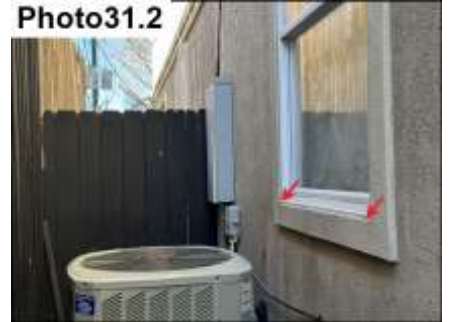
Photo31.2

Window Sealants / Seal

Grid Location	Item Description	Moisture Readings	Substrate Condition	Observations
Red Arrows	Windows			The window sealants are aged. The inspector suggests to have a qualified waterproofing contractor further assess and seal this area with a low modulus sealant in an effort to prevent moisture intrusion. These types of sealants are of high quality and compatible with stucco and other termination points. Please refer to photos #31.2, #31.3, #31.4, #31.5 and #31.6 for more detail.

- The window sealants are aged. The inspector suggests to have a qualified waterproofing contractor further assess and seal this area with a low modulus sealant in an effort to prevent moisture intrusion. These types of sealants are of high quality and compatible with stucco and other termination points. Please refer to photos #31.2, #31.3, #31.4, #31.5 and #31.6 for more detail.

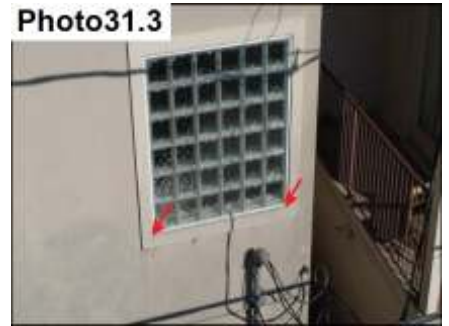
Photo31.3

Window Sealants / Seal

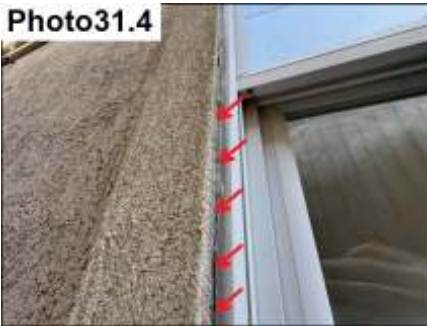
Photo31.4

Window Sealants / Seal

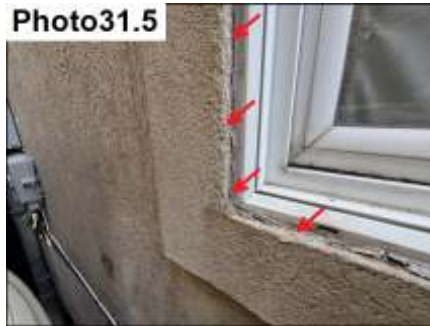
Photo31.5

Window Sealants / Seal
