2911 Royal Oaks Grv

Client	--
Reference id	a4xPd000003XGcDIAW
Type	Home Inspection and Floor Plan Report - 2911 Royal Oaks Grv
Inspected by	Rio Bravo - Inspectify Pro - Houston
State license	TREC 22388
InterNACHI	17031522
Scheduled	January 29, 2026, 12:45 PM CST
Completed	January 29, 2026, 5:34 PM CST

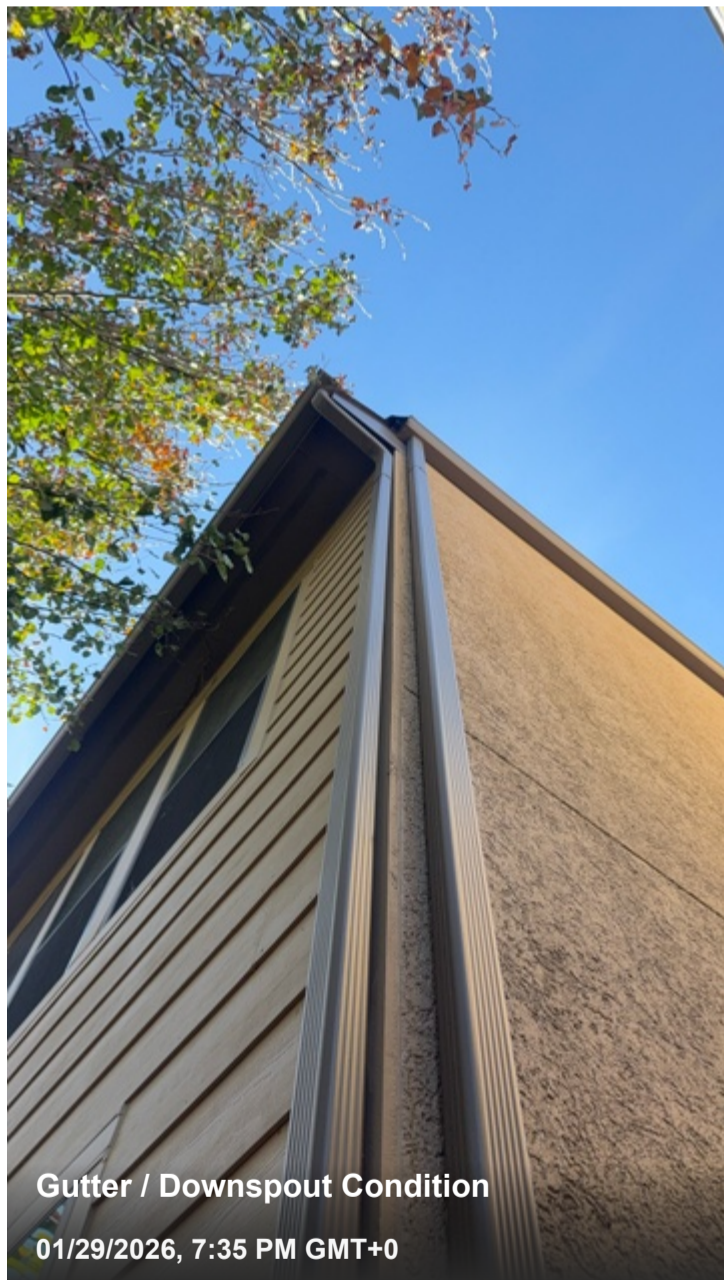
One or more downspouts / downspout extensions drain too close to the property's foundation.

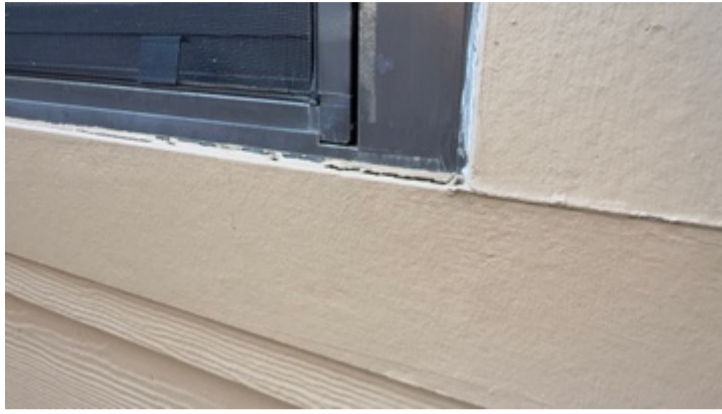
One or more windows need caulking.

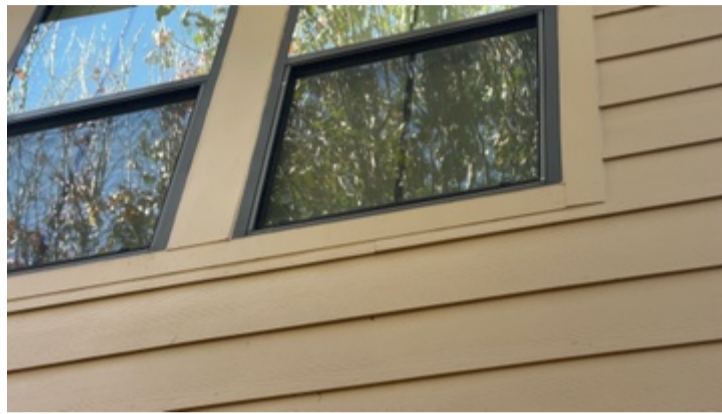
Damaged Screen

One or more window screens are damaged.

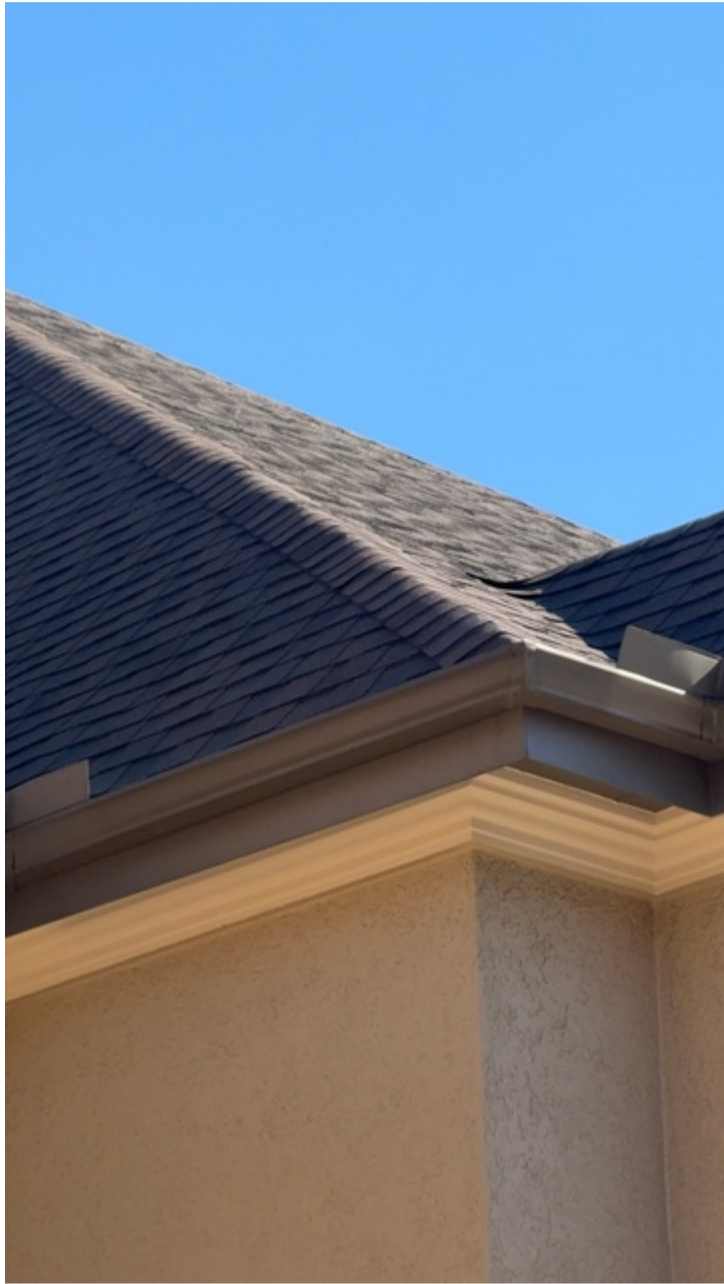
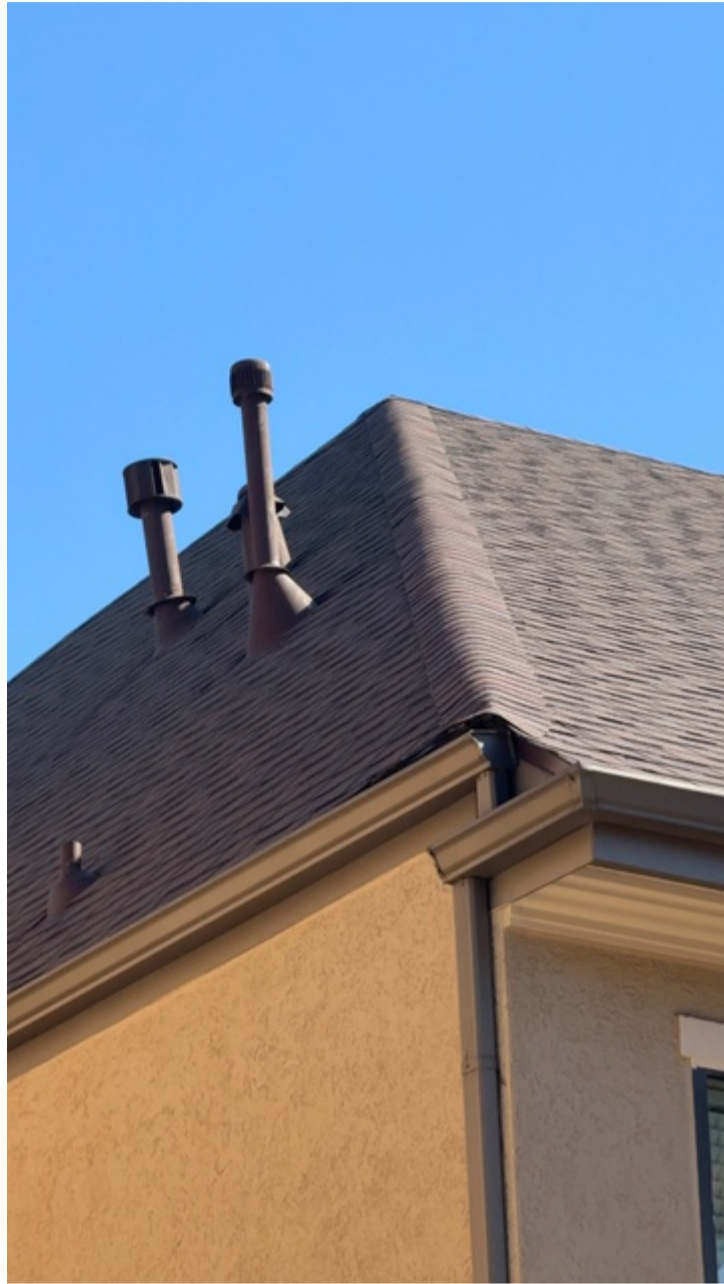
There is granular loss on one or more areas of the roof.

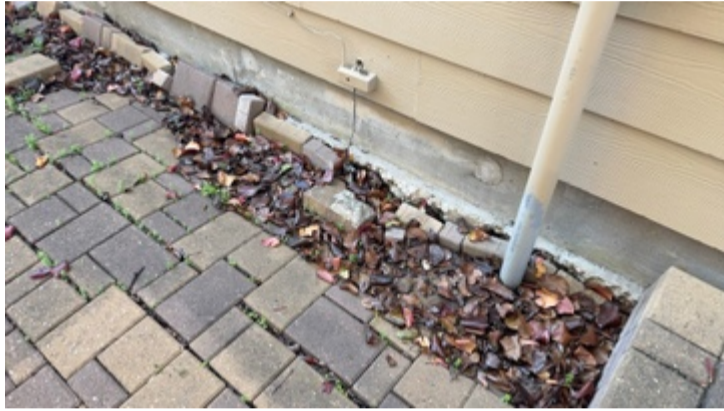
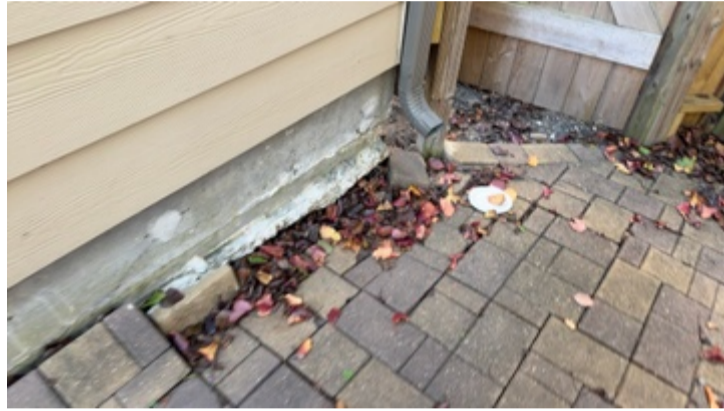
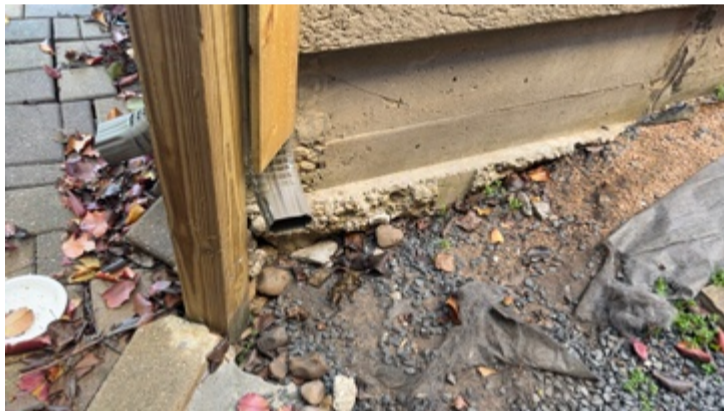
Eroding / ponding soil is present on one or more areas of the property.

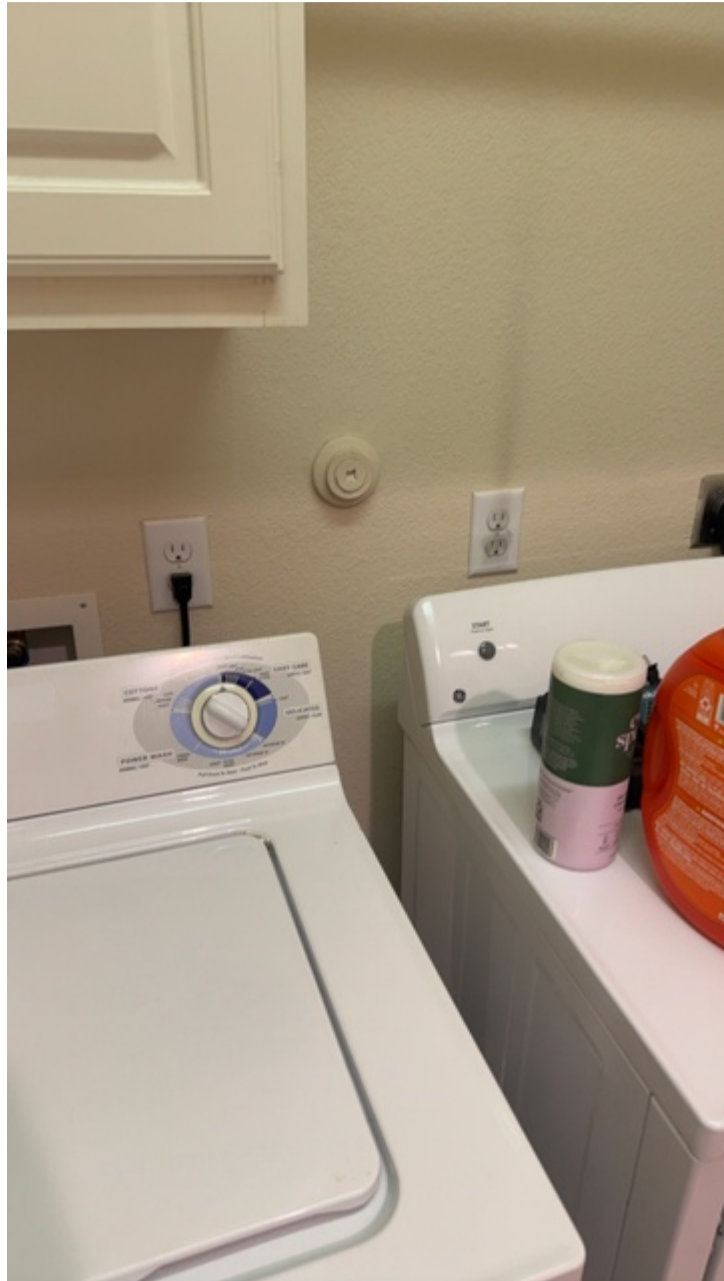
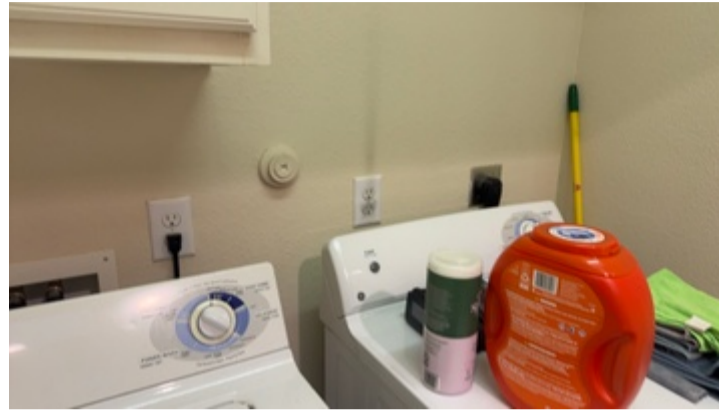
Laundry Area photos / videos

**Repair deficiency**

Missing GFCI

There is no GFCI (Ground-Fault Circuit Interrupter) protection.

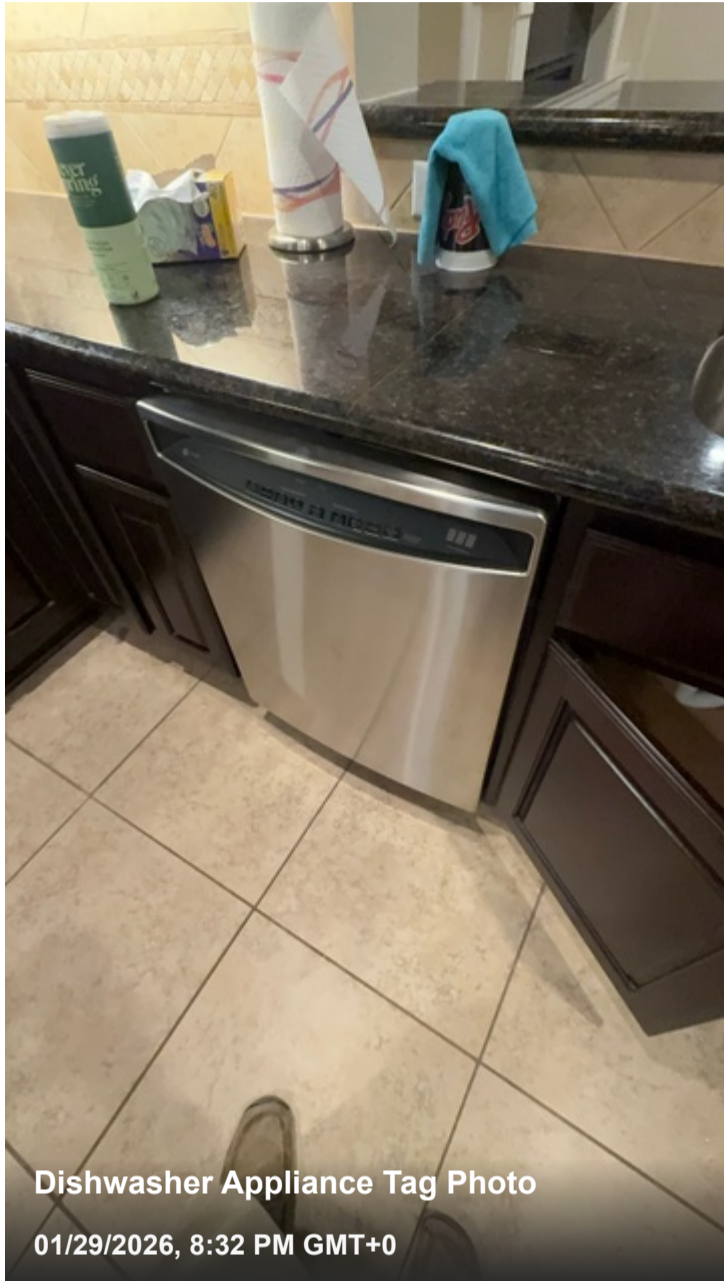
Functional With Cosmetic Defects

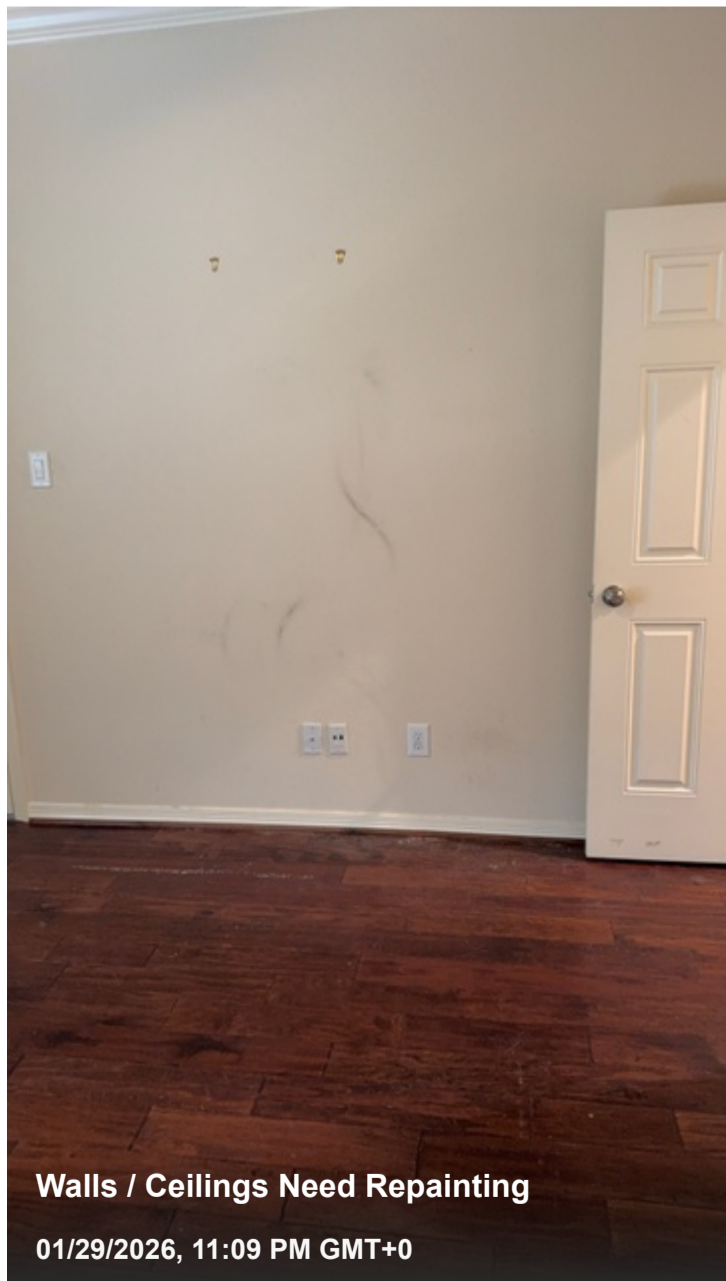
Walls / Ceilings Need Repainting
01/29/2026, 11:08 PM GMT+0

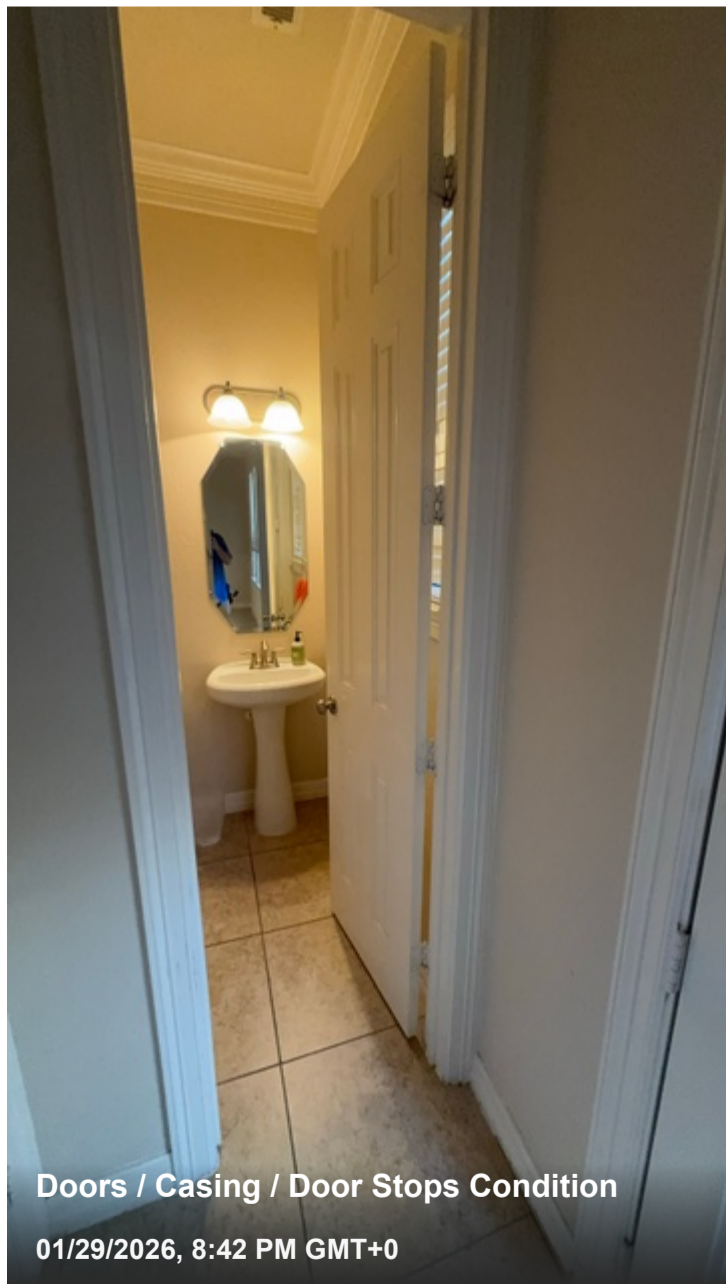
Doors / Casing / Door Stops Condition
01/29/2026, 8:42 PM GMT+0

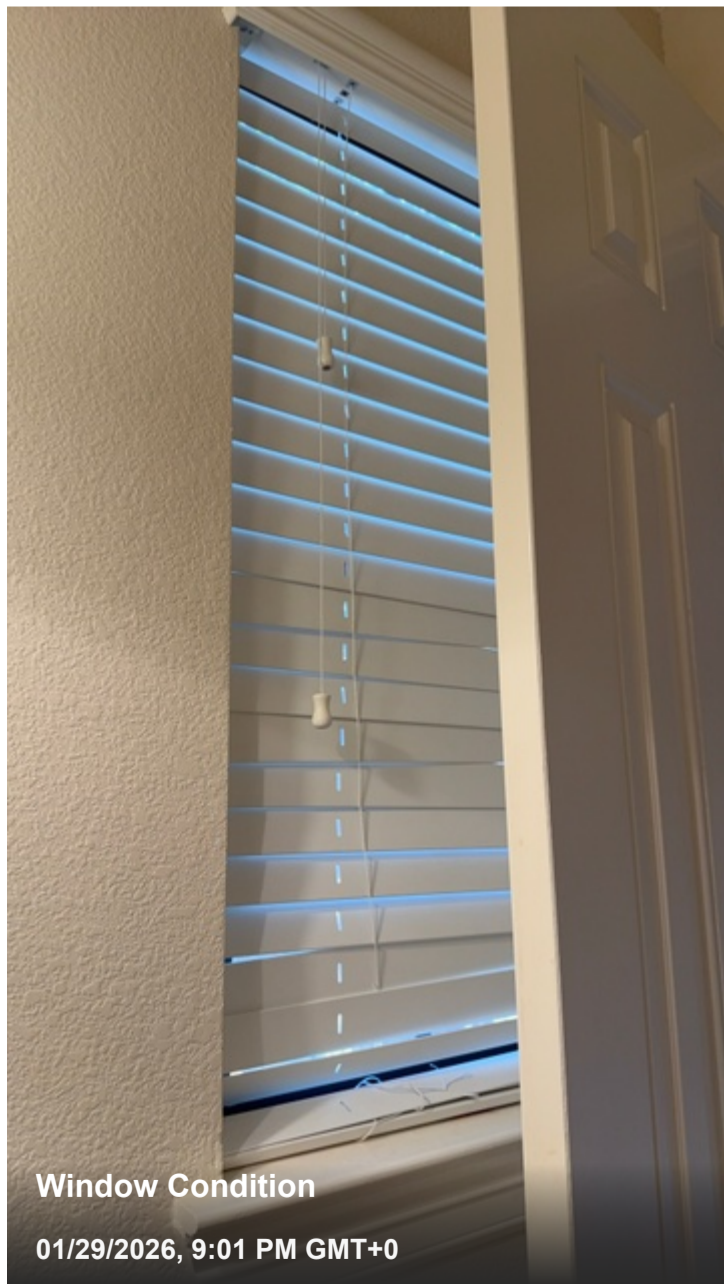
Window Condition
01/29/2026, 9:01 PM GMT+0

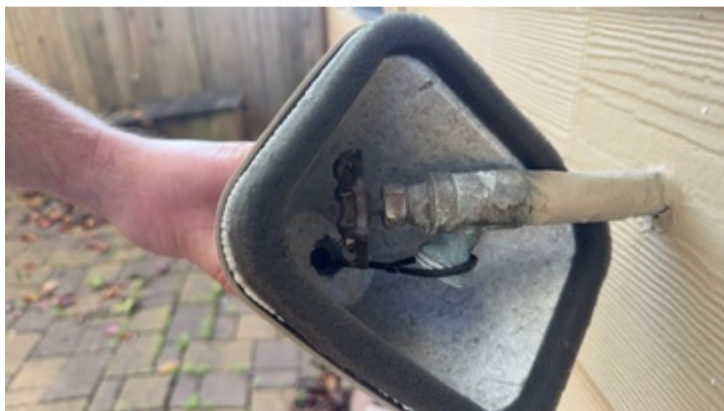
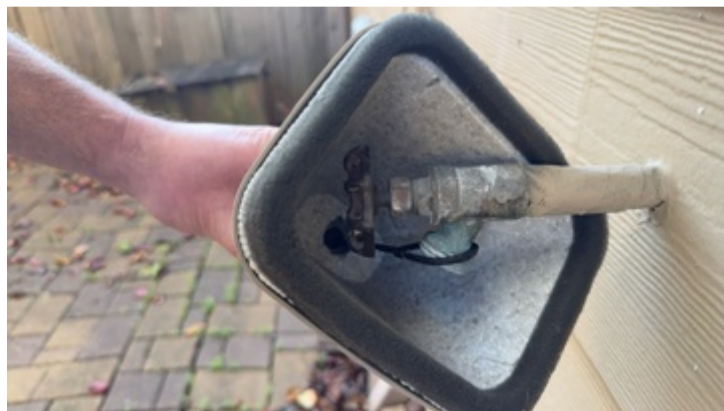
**Repair deficiency**

Missing Anti-Siphon Valve

There is no anti-siphon device present. Recommend further evaluation by a qualified professional.

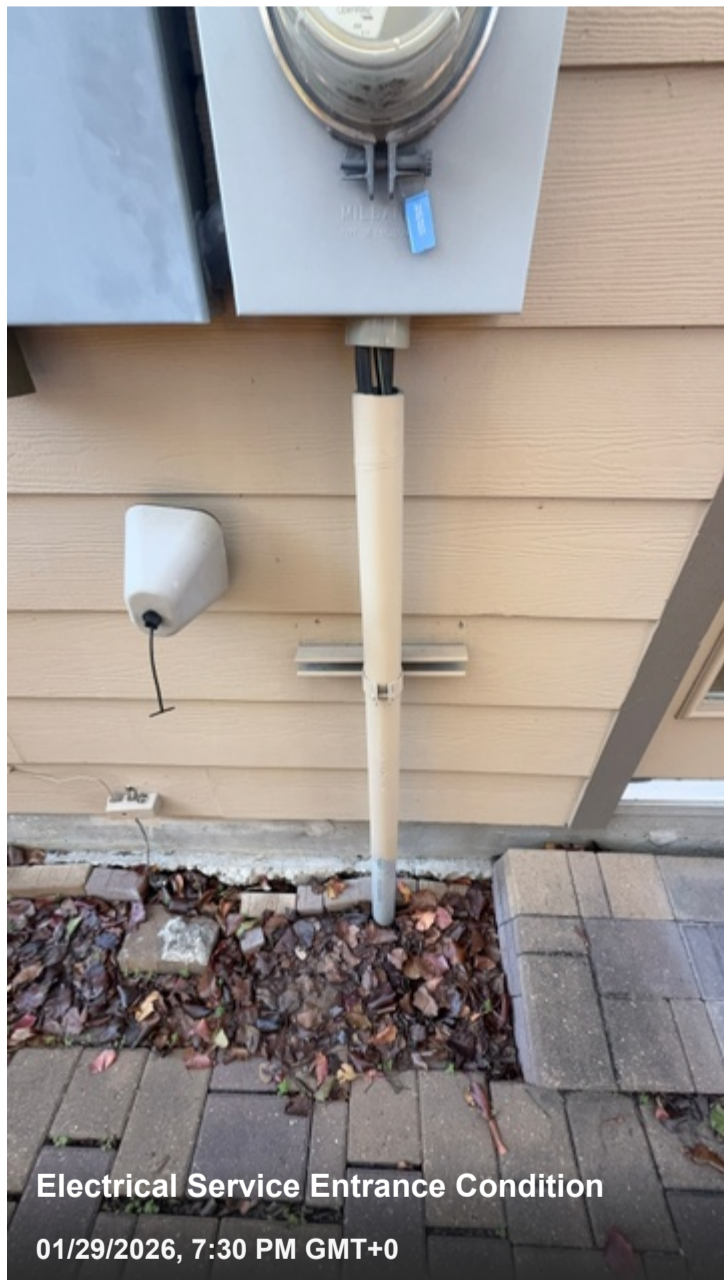
🔧 Repair deficiency

Disconnected or Damaged Conduit

The conduit is disconnected or damaged.

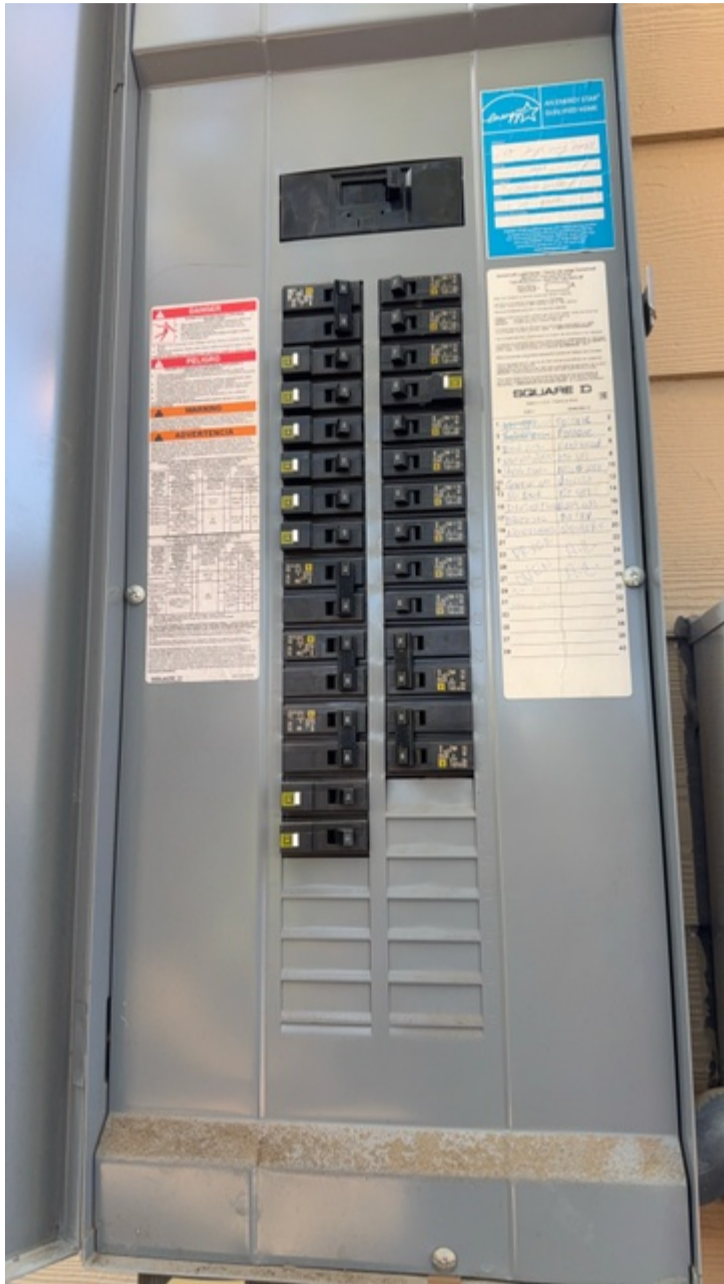
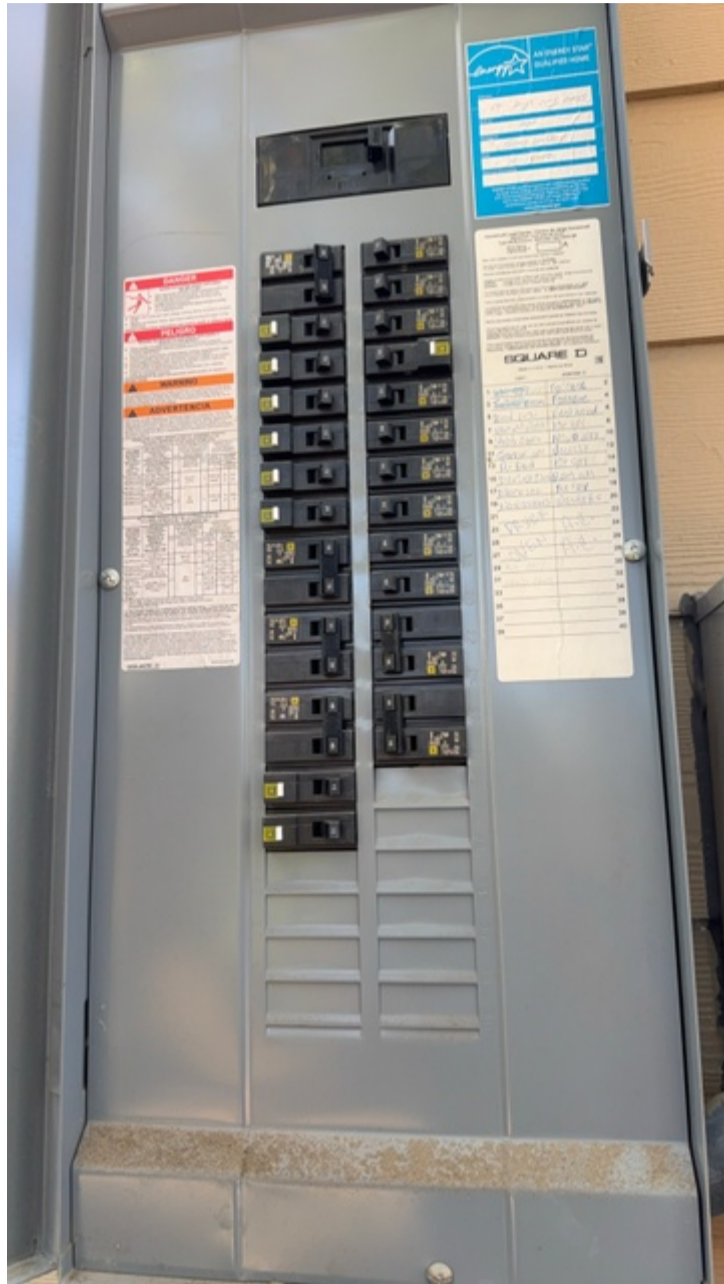
**Repair deficiency**

Missing AFCI Breaker

A required Arc-Fault Circuit Interrupter is missing.
