RCI PROFESSIONAL INSPECTIONS

RESIDENTIAL INSPECTION

17707 Champion Forest Dr
Spring, TX 77379

PROPERTY INSPECTION REPORT FORM

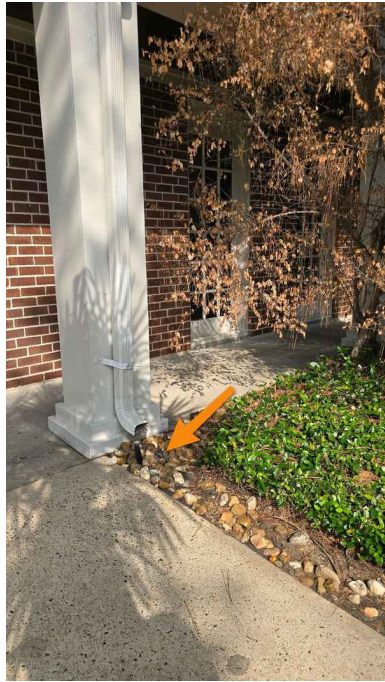
5: Damaged gutter

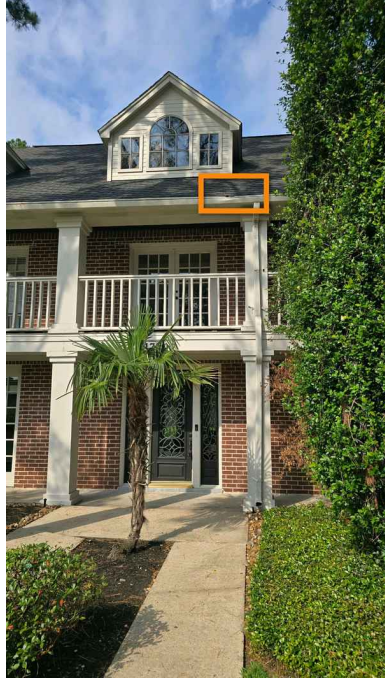
6: Loose gutter

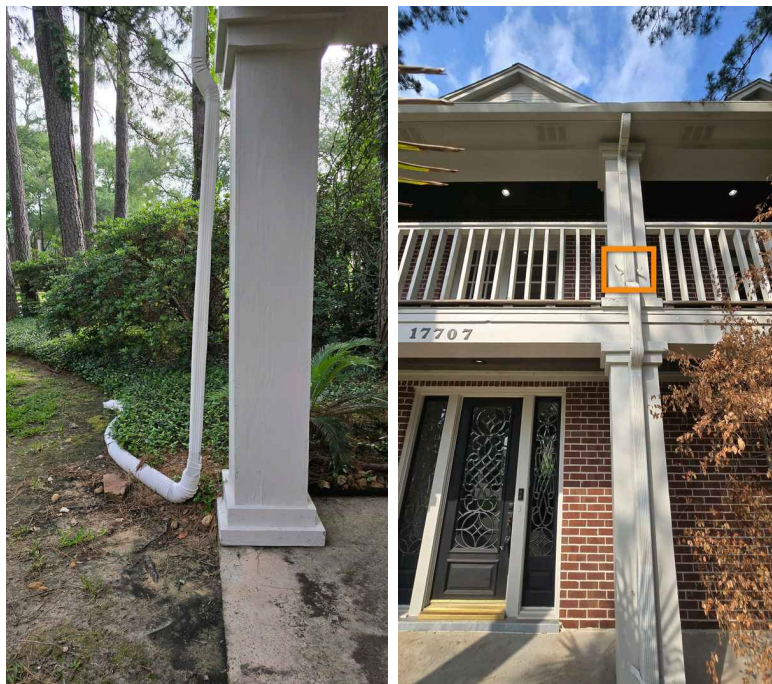
7: Improper gutter slope

Gutters should have a slope of half inch for every 10 feet to a downspout. Repairs are needed to prevent gutter leakage and ensure proper drainage.

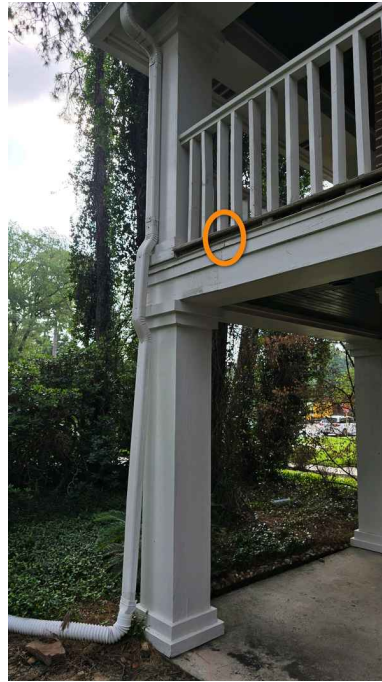
3: Lifted flashing

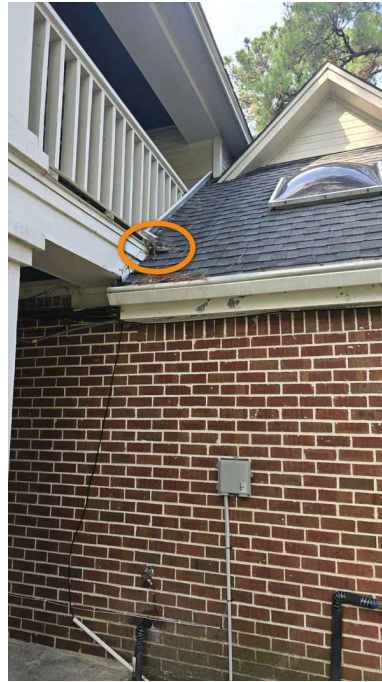
4: Damaged skylight

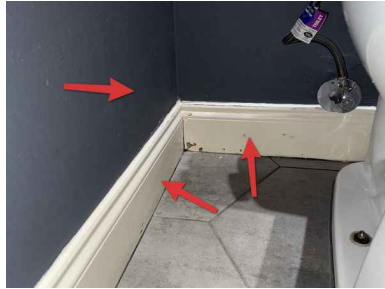
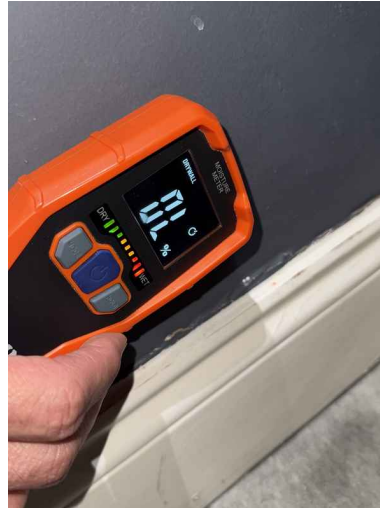
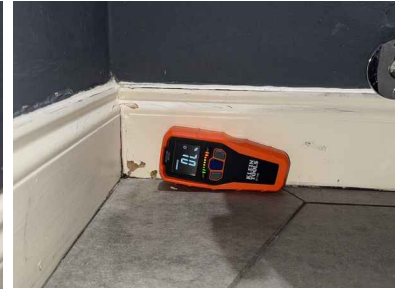
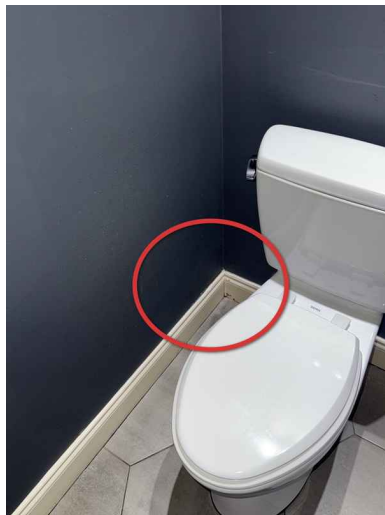
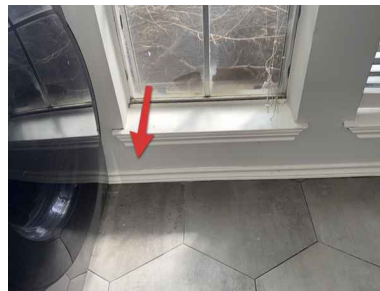
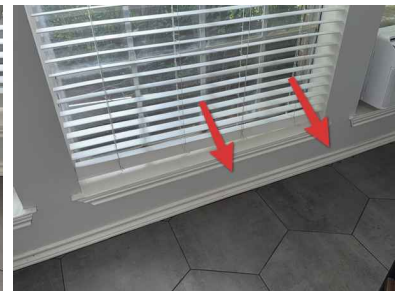
Moisture meter readings were taken, and areas indicate elevated moisture measurements. This should be further investigated and repaired.

Recommendation: Contact a qualified professional.

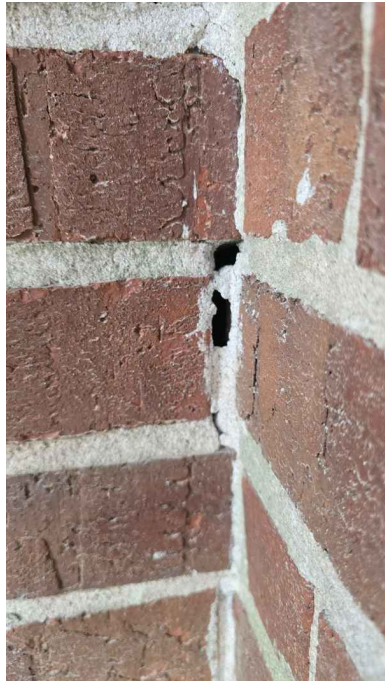
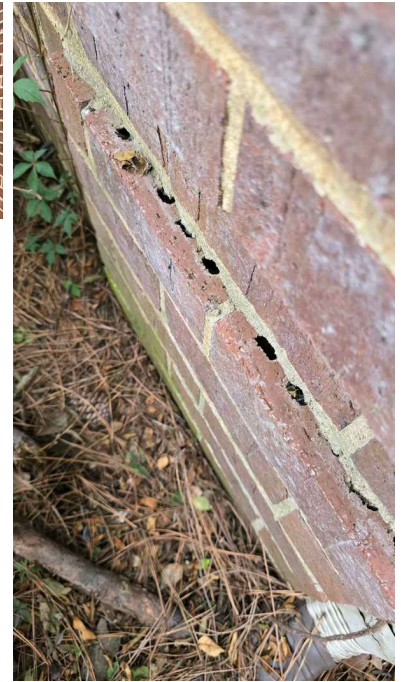
8: Caulking repairs at wall penetrations

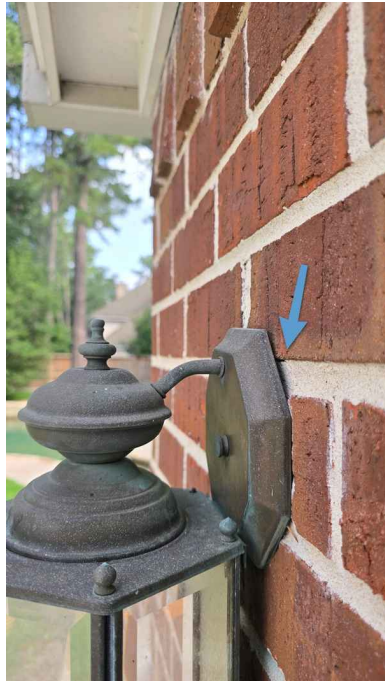
9: Caulking repairs at siding

Seal siding/trim at separations or where missing.

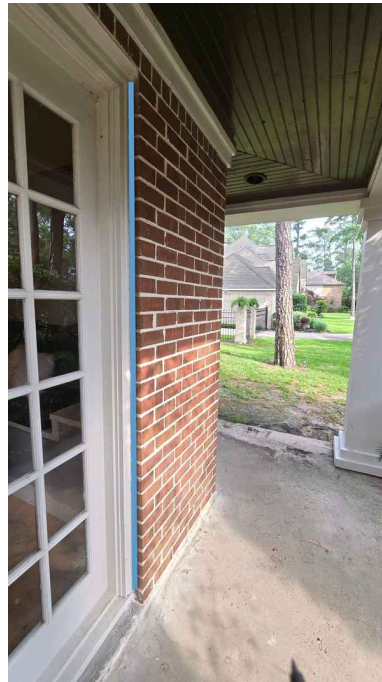
10: Painting repairs needed

Siding needs to be painted where exposed to prevent deterioration.

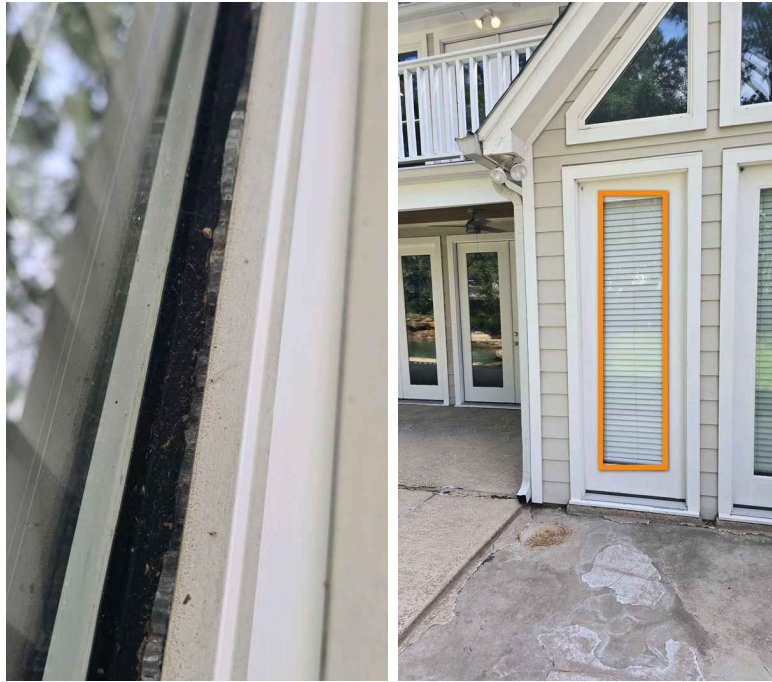
4: Binding door

Breakfast Area Exterior, Rear Exterior, Living Room, Balcony, Front Left Bedroom, 2nd Level Left Bathroom

Adjust and/or repair door to align and not bind.

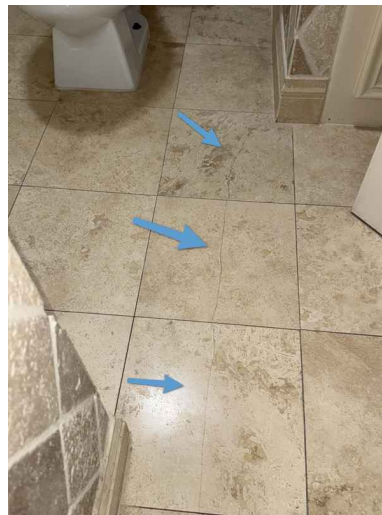
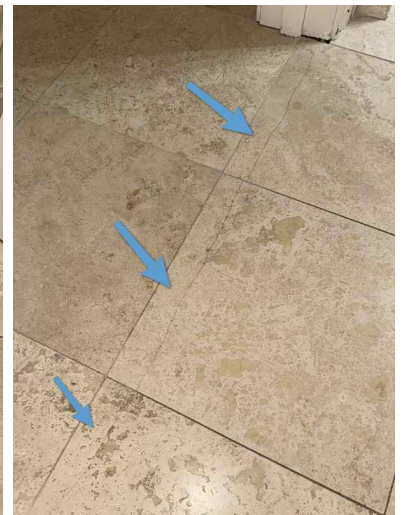
2: Damaged tiles

Broken/cracked tiles were observed.

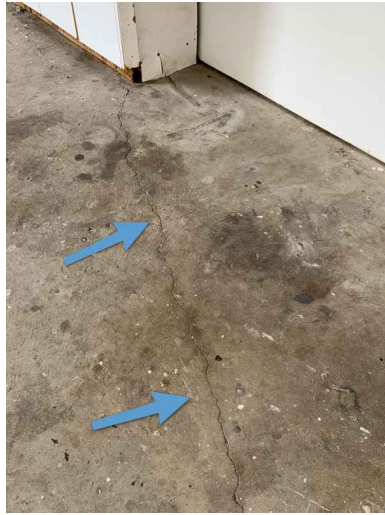
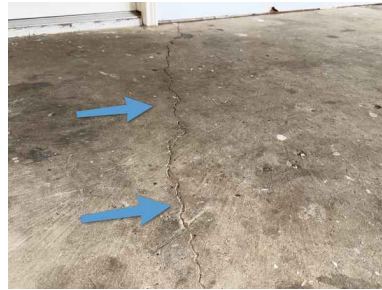
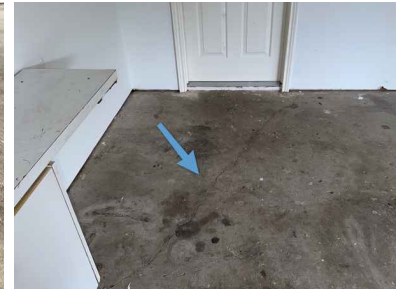
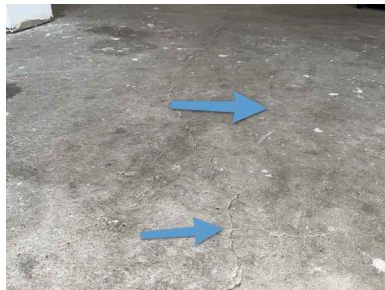
3: Garage floor cracking

Some cracking of the garage concrete floor was observed. This is can be caused from normal settlement and should be monitored for any further movement.

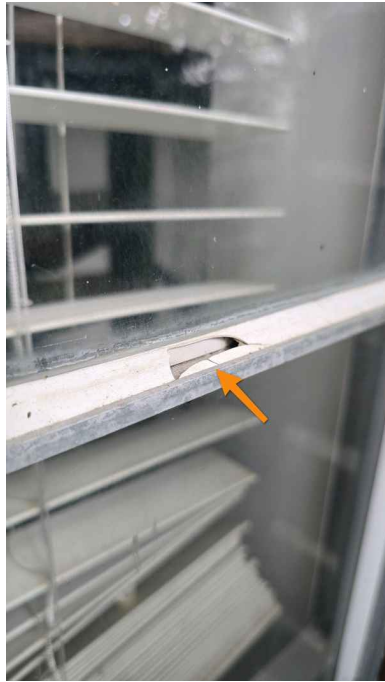
4: Broken glass pane

Broken glass window pane is in need of replacement.

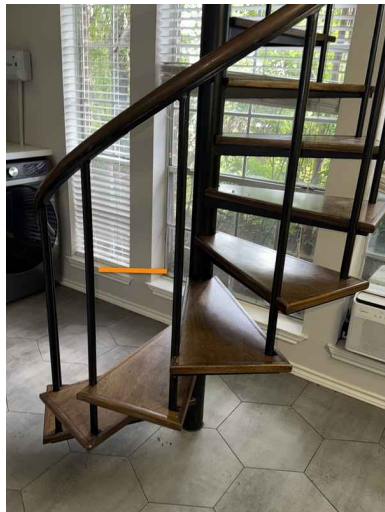
1: Railing openings greater than 4"

Client should be aware that the distance between guard railing balusters is greater than 4", as currently allowed for child safety.

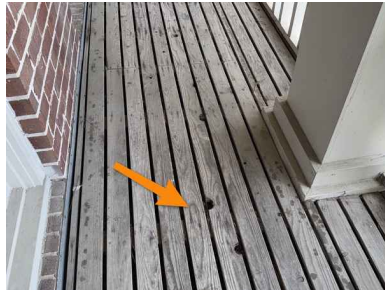
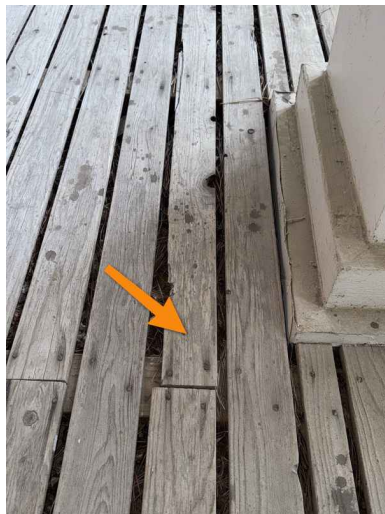
1: Loose step board

Any loose step boards should be repaired for safety.

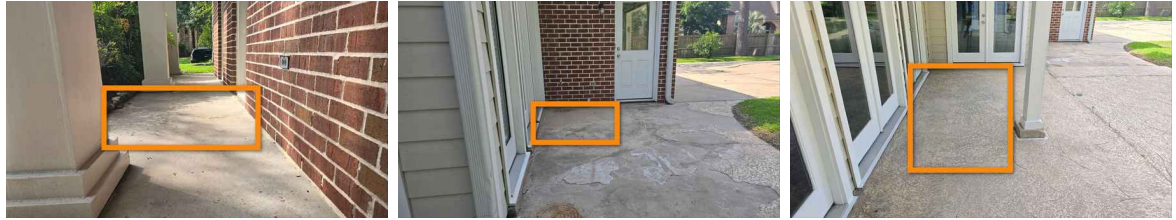
2: Improper slope

The required slope for concrete flatwork is a minimum of 1/4" per foot, away from the structure.

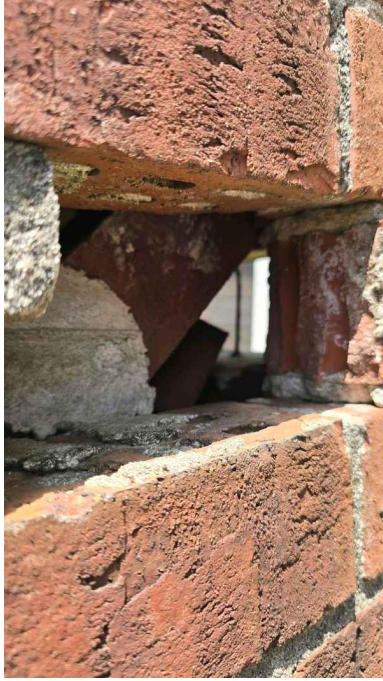
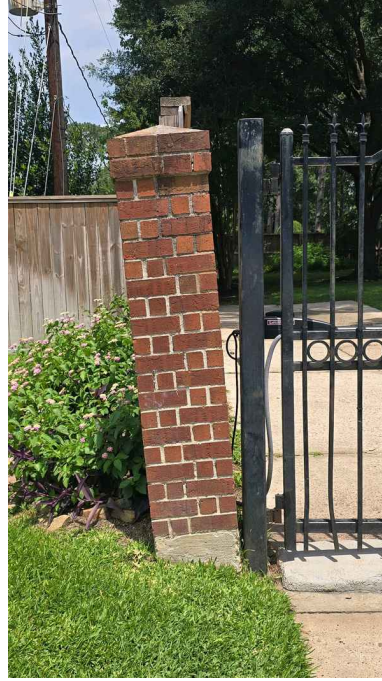
Portion of the driveway gate enclosure is leaning and missing bricks. Repairs are needed for stability.

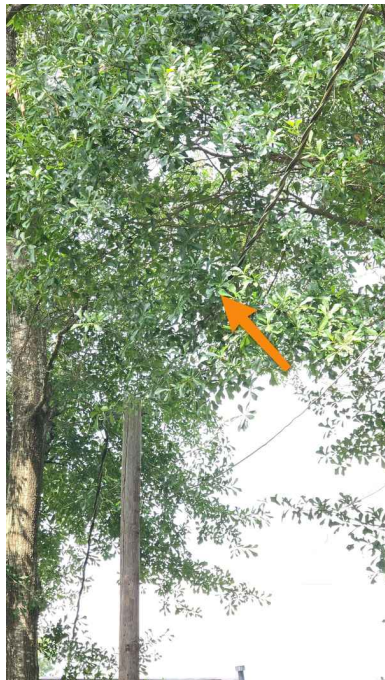
1: Tree limbs at service wires

Tree limbs in contact with the service lines and needs to be trimmed back.

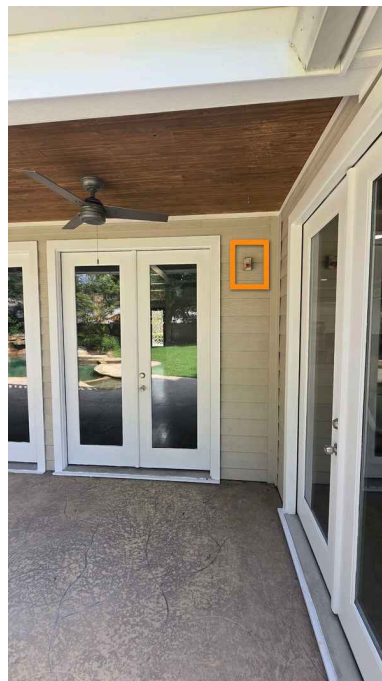
Receptacle outlet was not operable and in need of repair/replacement.

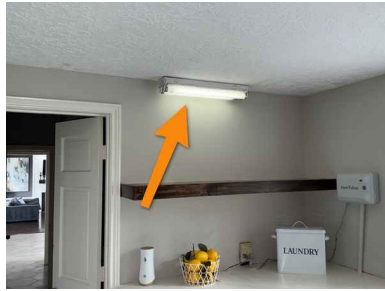
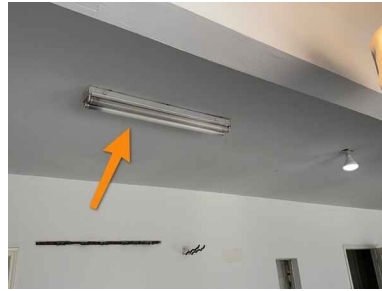
Possible cause could be a loose connection at the fixture. This should be further investigated and repaired.

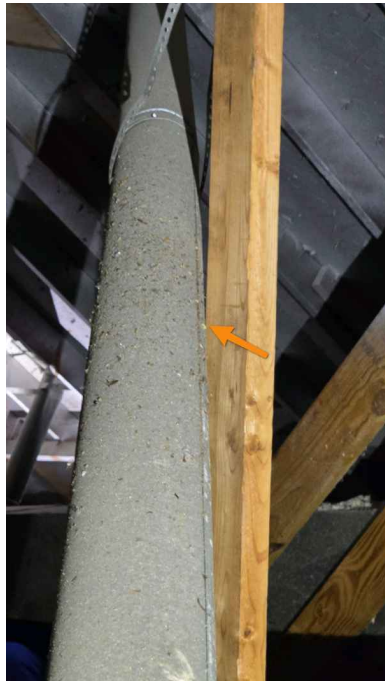
2: Improper exhaust clearance

Heater exhaust flues should have clearance of a minimum of 1" to all building material for fire safety, per manufacturers specifications.

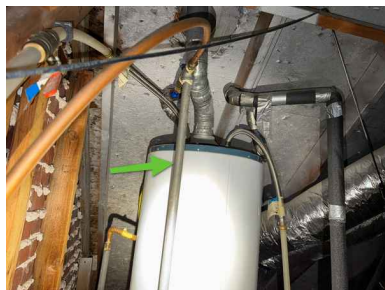
Galvanized Piping Note:

Some or all of the water distribution pipes were observed galvanized steel. These pipes are outdated and subject to corrosion which will eventually result in restricted flow and leakage and will need to be replaced.

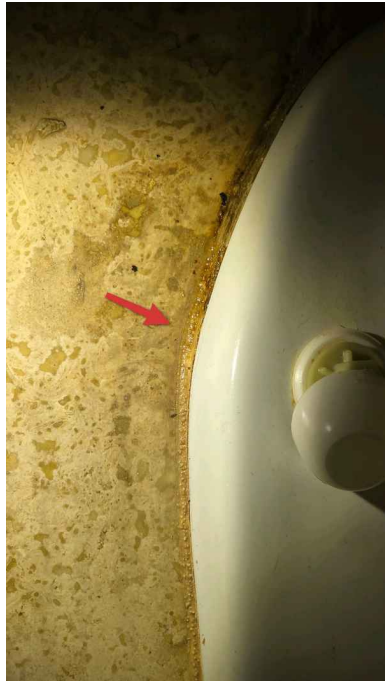
2: Loose fixture

Loose fixture needs to be better secured at the countertop.

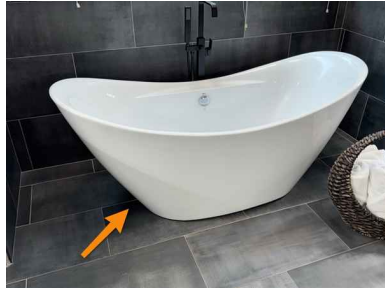
6: Loose tub

The freestanding bathtub is not properly secured to the floor. This lack of stability could lead to safety hazards and improper drainage. Repairs are needed.

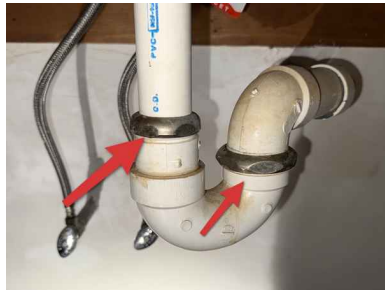
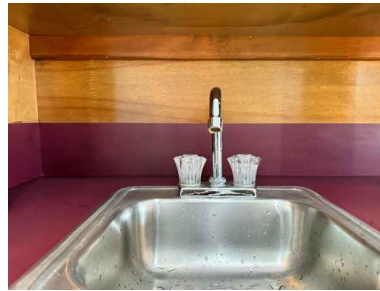
1: Drain line leak

Leakage was observed at drain line. Repairs are needed.

Recommendation: Contact a qualified plumbing contractor.

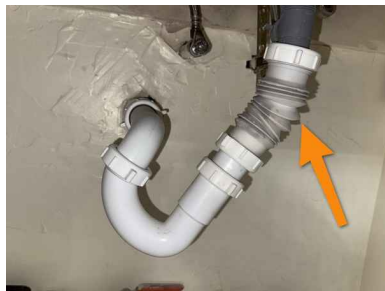
2: Improper flex drain line

Flex drain lines are not allowed by plumbing code. All drain lines should be smooth interior to not reduce water flow or trap debris.

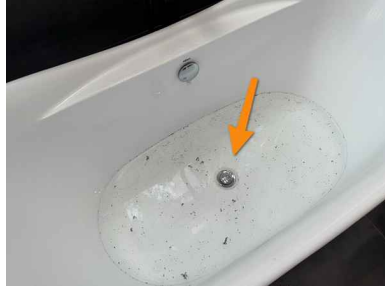
Slow drain was observed and repairs are needed for proper drainage.

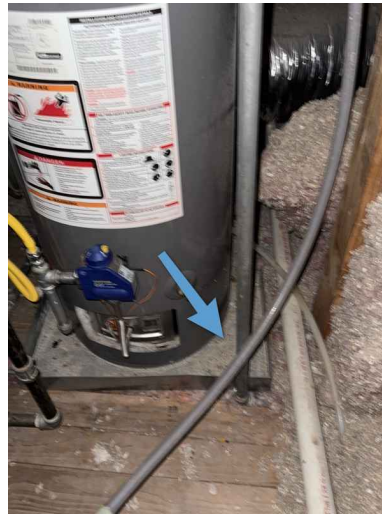
2: Debris at drain pan

All debris should be removed from emergency drain pan to prevent possible clogs at drain line.

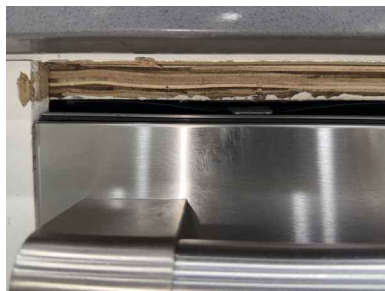
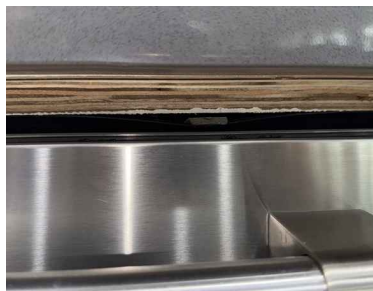
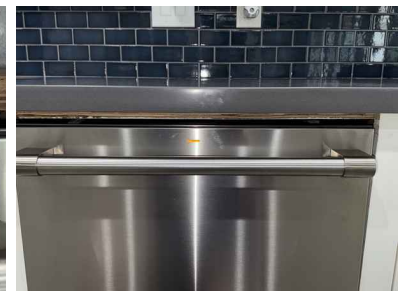
2: Unit not secured

Unit is not anchored/mounted in cabinet and needs to be secured to prevent possible leaks.

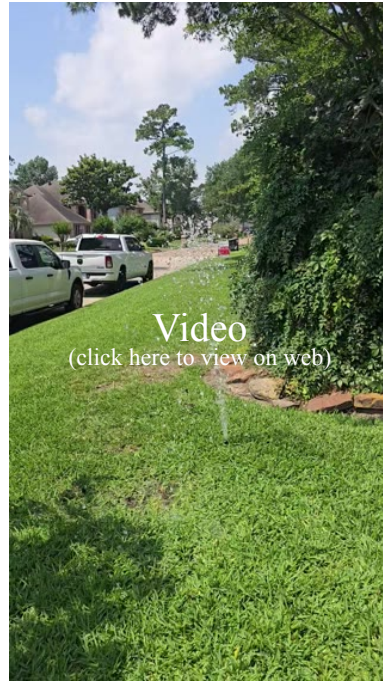
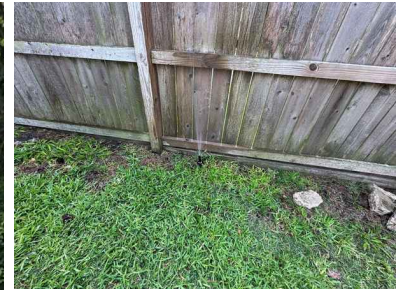
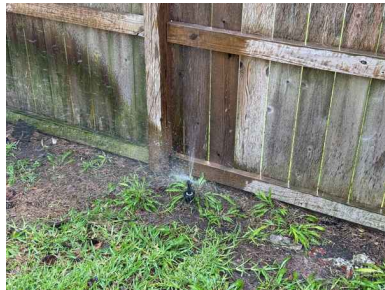
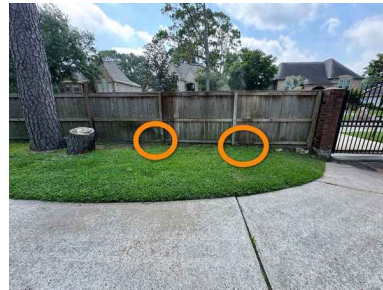
1: Damaged head(s)

Damaged sprinkler head is in need of replacement.
