RESIDENTIAL INSPECTION

17707 Champion Forest Dr
Spring, TX 77379

PROPERTY INSPECTION REPORT FORM

Will Washington <i>Name of Client</i>	05/15/2025 9:00 am <i>Date of Inspection</i>
17707 Champion Forest Dr, Spring, TX 77379 <i>Address of Inspected Property</i>	
Tyler Roberts, Andrew Gordon <i>Name of Inspector</i>	TREC #24422, TREC #26487 <i>TREC License #</i>
Leslie Brush # <i>Name of Sponsor (if applicable)</i>	21684 <i>TREC License #</i>

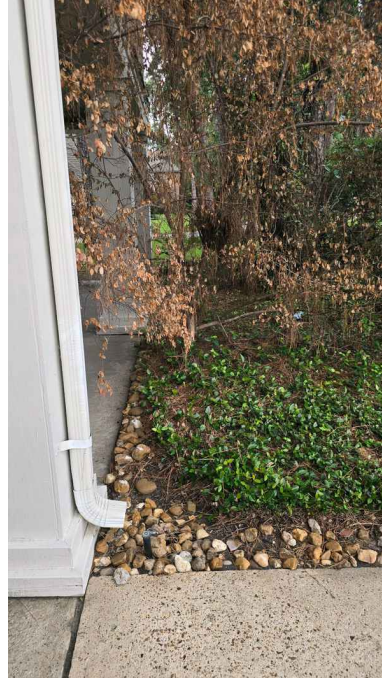
3: High soil/grade levels

🚩Concern

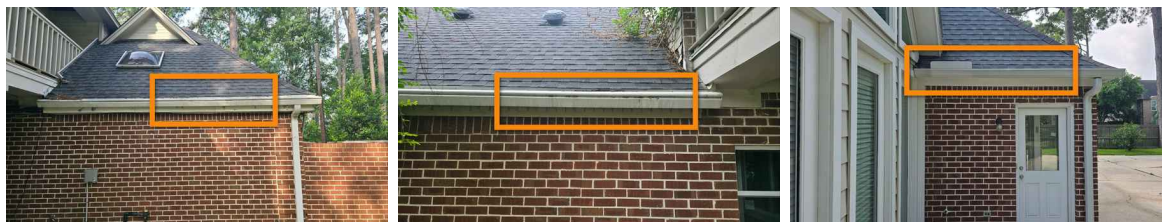
Front Right, Front, Rear

Gutters should have a slope of half inch for every 10 feet to a downspout. Repairs are needed to prevent gutter leakage and ensure proper drainage.

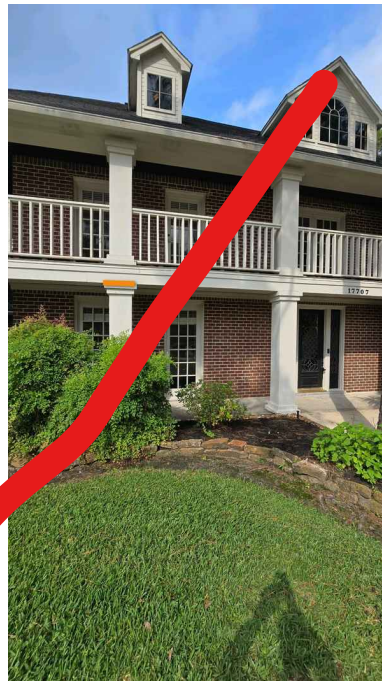
2: Wood Deterioration

⚠️ Concern

Front, Rear

All damaged areas should be repaired, as needed.

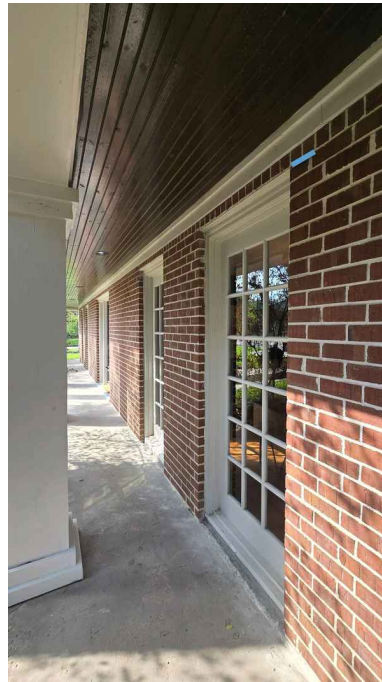
Front

Exposed lintel (supports for the masonry) should be sealed/patched over to prevent corrosion.

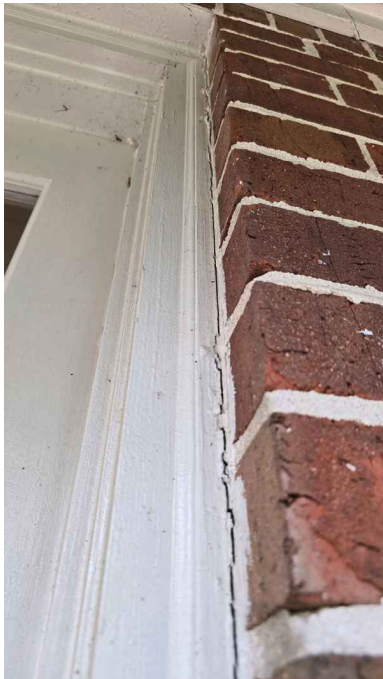
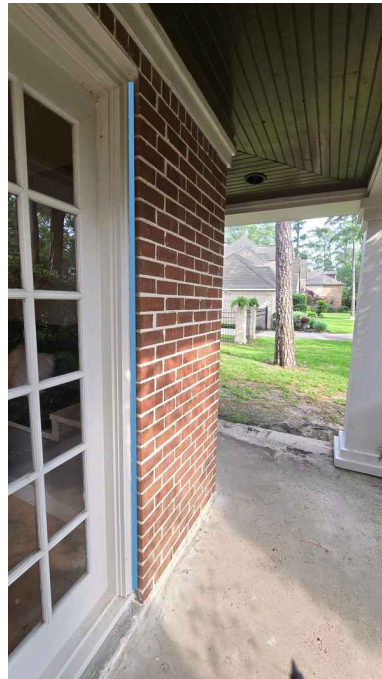
9: Caulking repairs at siding

Low Level

Front

Seal siding/trim at separations or where missing.

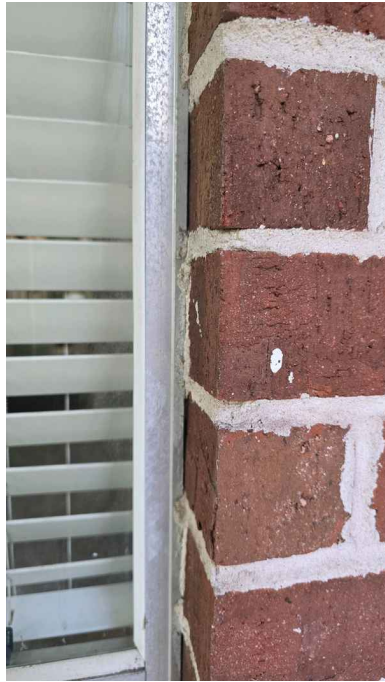
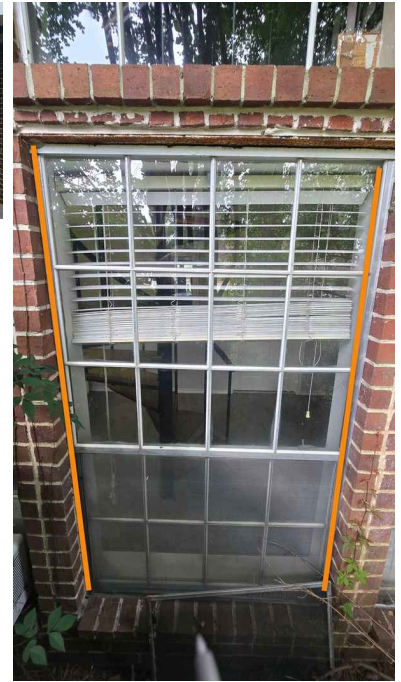
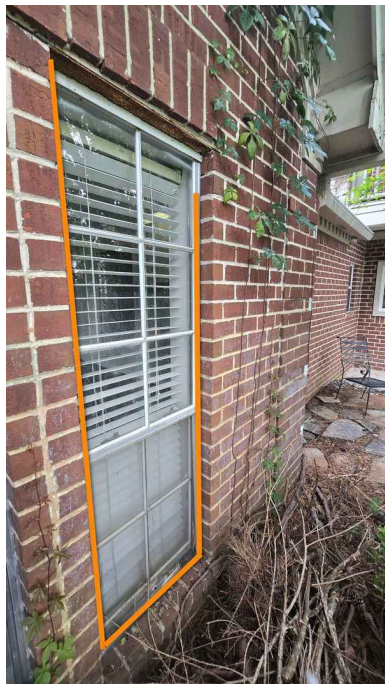
2: Discoloration/fogging between panes

This occurs when the seal between the glass panes is broken or when the desiccant inside the window is saturated. With double pane windows, the insulating air space in between the glass panels maintains consistent temperature and reduces heat lost.

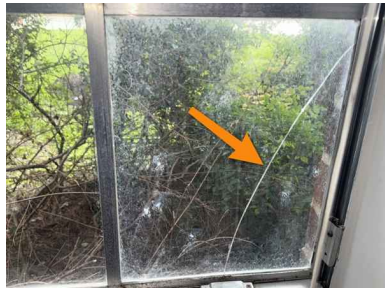
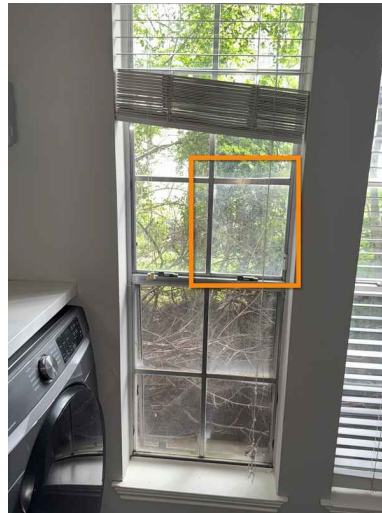
5: Broken spring balance(s)

A broken spring balance can cause a window to not operate smoothly and/or to not hold an open position. Repairs are needed.

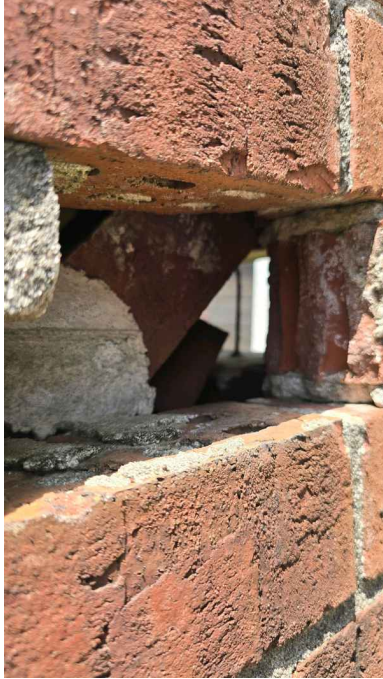
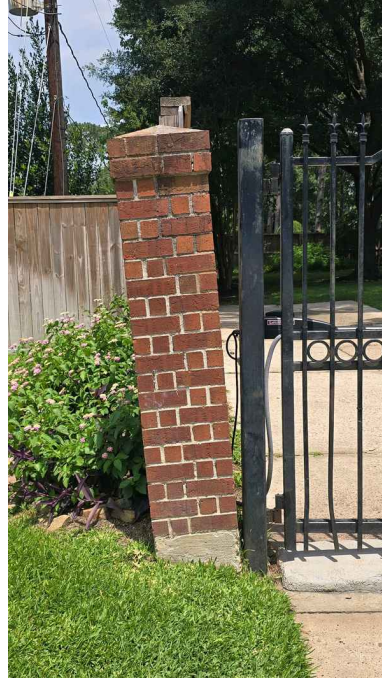
Portion of the driveway gate enclosure is leaning and missing bricks. Repairs are needed for stability.

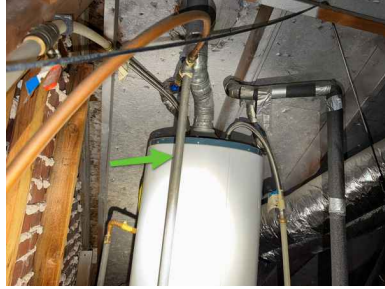
Galvanized Piping Note:

Some or all of the water distribution pipes were observed galvanized steel. These pipes are outdated and subject to corrosion which will eventually result in restricted flow and leakage and will need to be replaced.

All plumbing repairs listed in report or otherwise noted during estimate of repairs should be made by a qualified licensed plumbing contractor, as per code and safety.

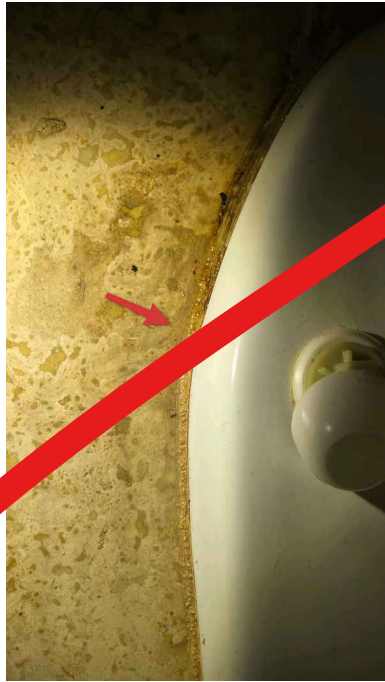
2: Loose fixture

Loose fixture needs to be better secured at the countertop.

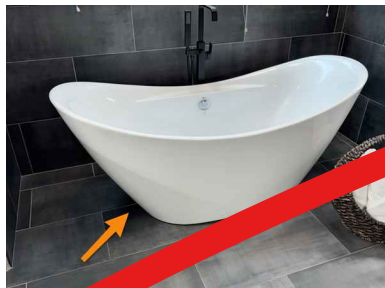
6: Loose tub

The freestanding bathtub is not properly secured to the floor. This lack of stability could lead to safety hazards and improper drainage. Repairs are needed.

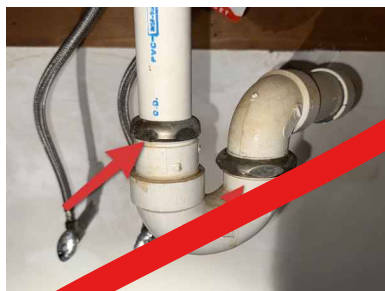
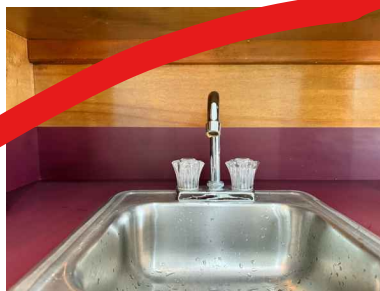
1: Drain line leak

Leakage was observed at drain line. Repairs are needed.

Recommendation: Contact a qualified plumbing contractor.

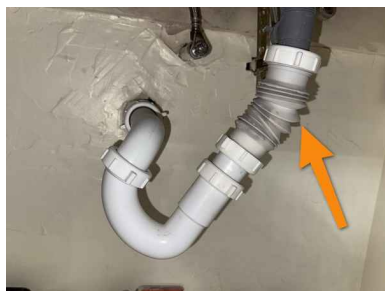
2: Improper flex drain line

Flex drain lines are not allowed by plumbing code. All drain lines should be smooth interior to not reduce water flow or trap debris.

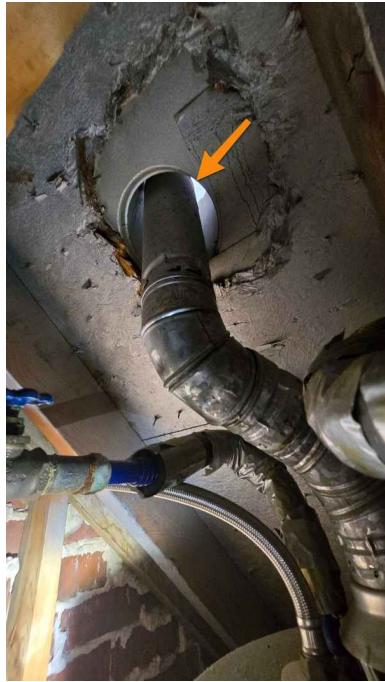
2: Debris at drain pan

All debris should be removed from emergency drain pan to prevent possible clogs at drain line.

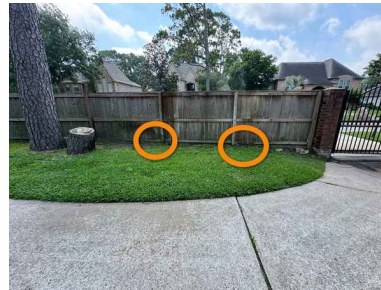
2: Low water spray

Low water spray was observed at sprinkler head. Repairs are needed.
