Home Inspection - TREC

Inspection Completed for: Graebel Companies - CO
(770) 325-4790
16346 Airport Circle
Aurora, CO 80011
APROA649919

Transferee / Property Information: Mingzhe Yu
3923 Birch Vale Ln
Sugar Land, TX 77479

PROPERTY INSPECTION REPORT FORM

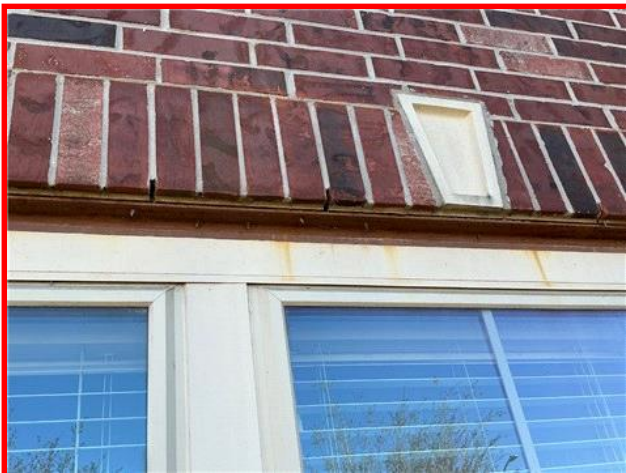
Rusted Lintel

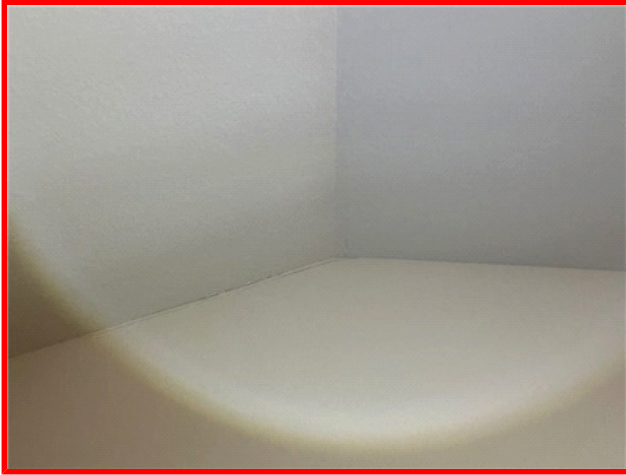
Separation in Upstairs Game Room

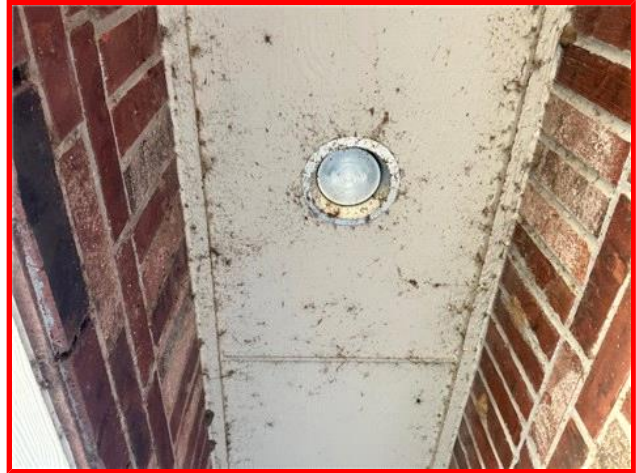
Light Did Not Illuminate by Garage
