2713 Druid Street

Houston, Texas 77091

Client	--
Reference id	a4xPd000001zEwjIAE
Type	Home Inspection and Floor Plan Report - 2713 Druid Street
Inspected by	Rio Bravo - Inspectify Pro - Houston
State license	TREC 22388
InterNACHI	17031522
Scheduled	April 17, 2025, 5:00 PM
Completed	April 17, 2025, 5:39 PM

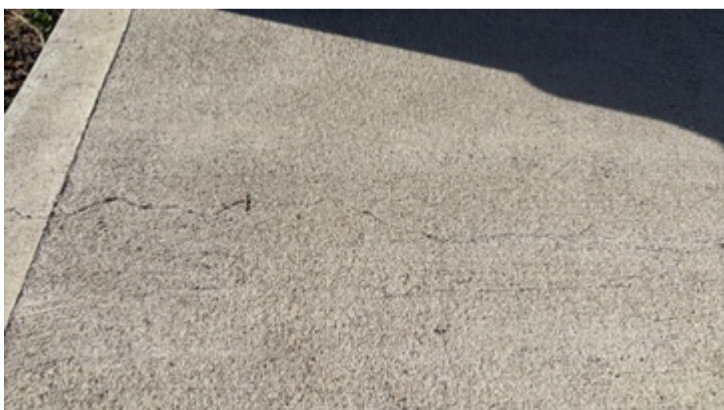
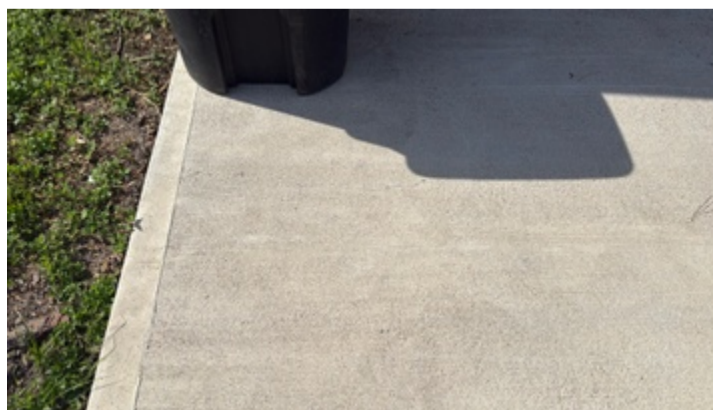
🔍 Monitor deficiency

Minor Cracks in the Driveway

The driveway has minor cosmetic cracks.

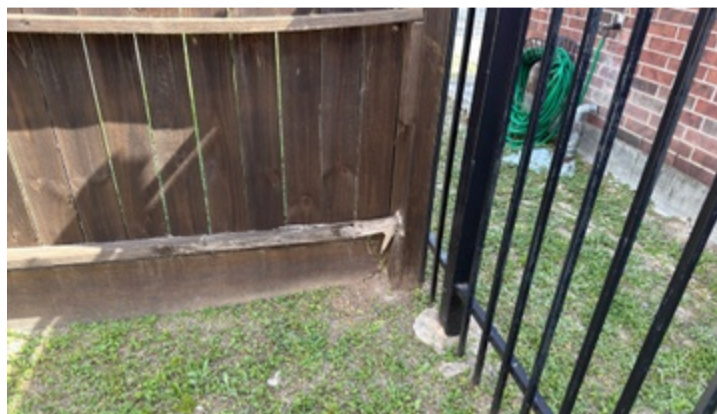
🔧 Repair deficiency

Damaged / Missing Fence Boards

One or more fence boards are missing or damaged.

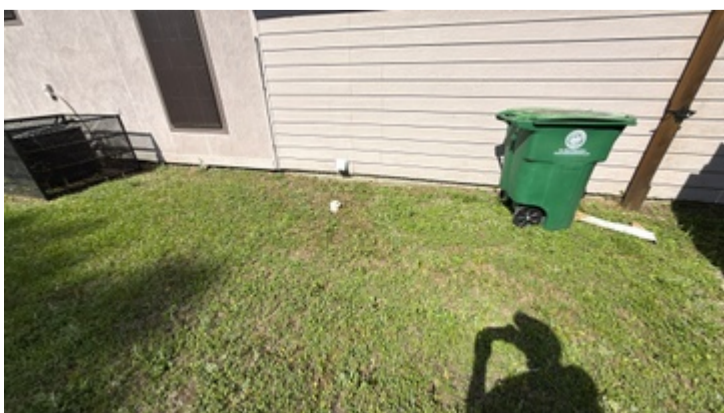
**Repair deficiency**

Eroding / ponding soil is present on one or more areas of the property.

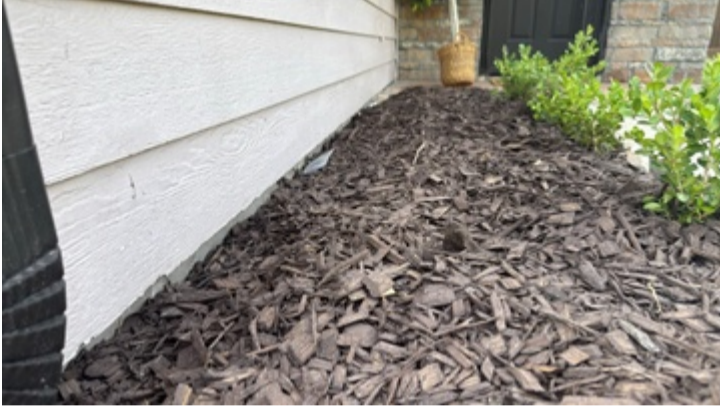
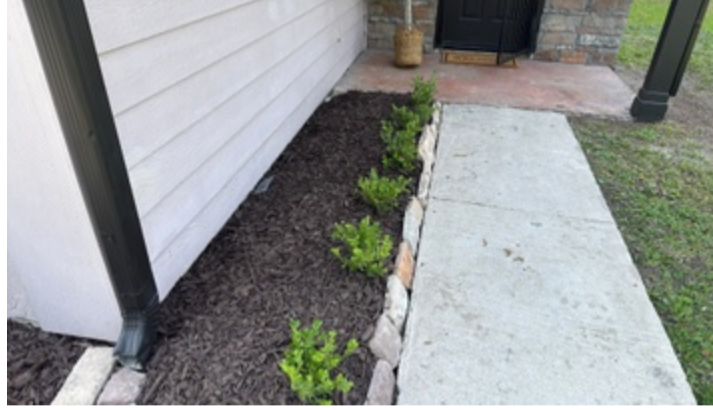
**Repair deficiency**

There are areas of high soil around the foundation.

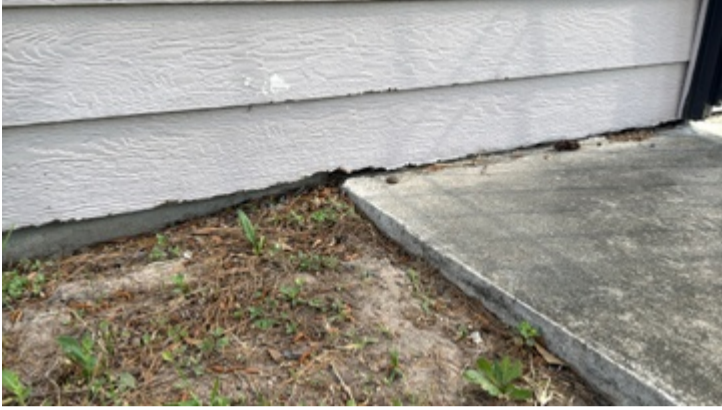
Damaged Siding

One or more areas of the siding is damaged.

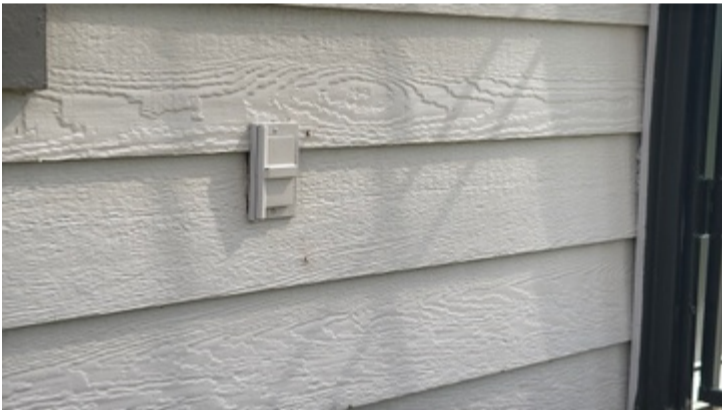
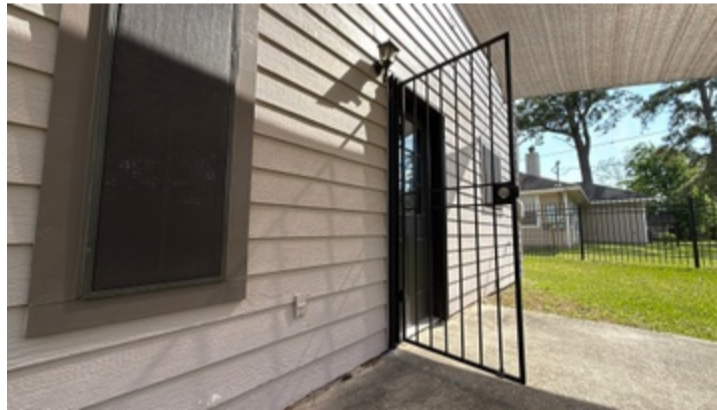
Missing Exterior Caulk

One or more exterior areas need caulking.

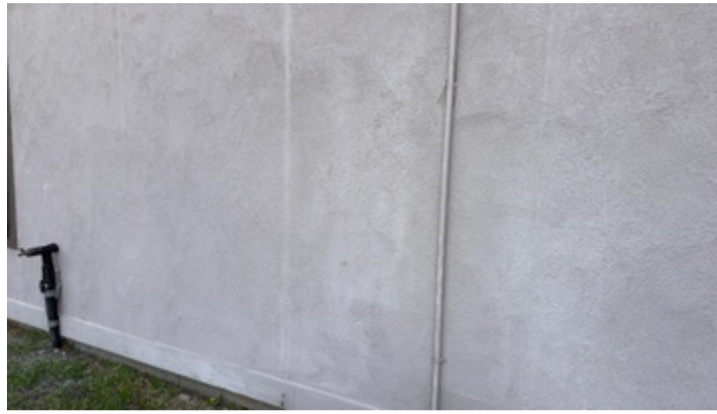
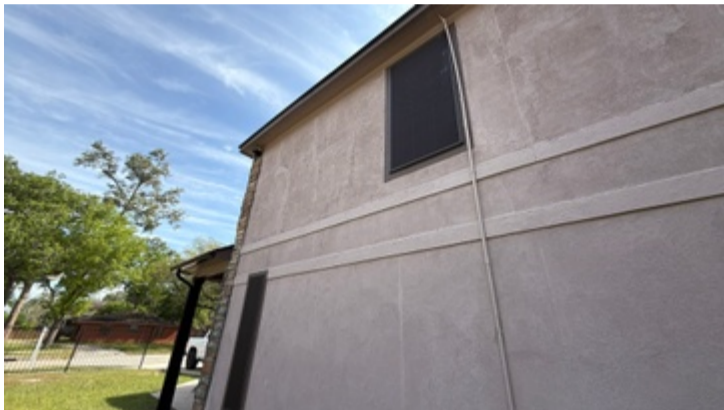
Cracked / Damaged Stucco

The exterior stucco is showing signs of cracking or damage.

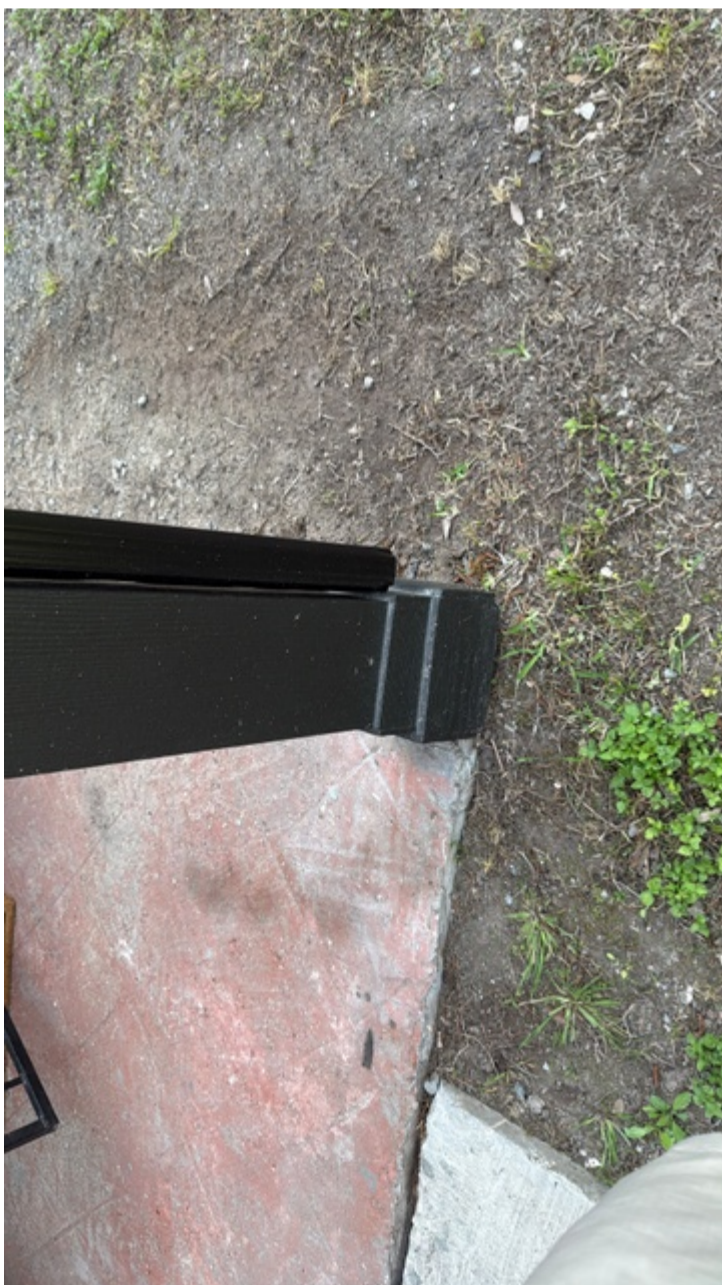
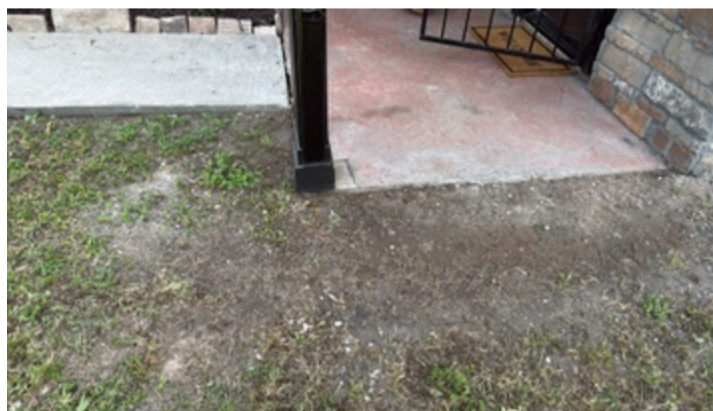
Missing Downspout Splash Blocks

There are no splash blocks for the downspouts.

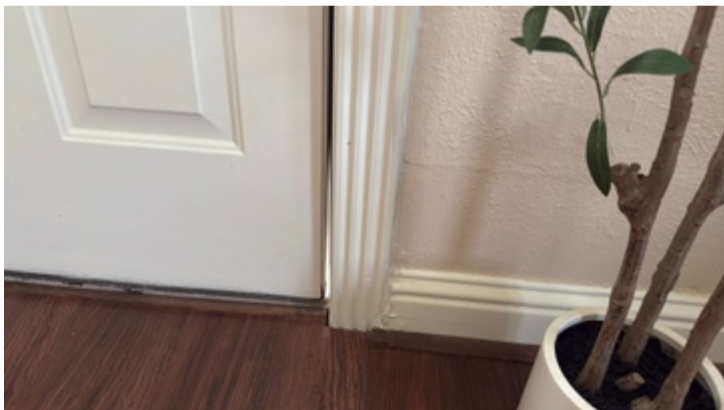
Damaged or Missing Weatherstripping

The weatherstripping is damaged or missing.

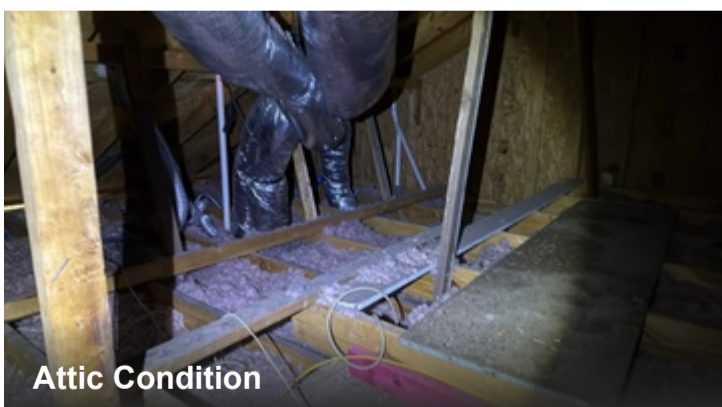
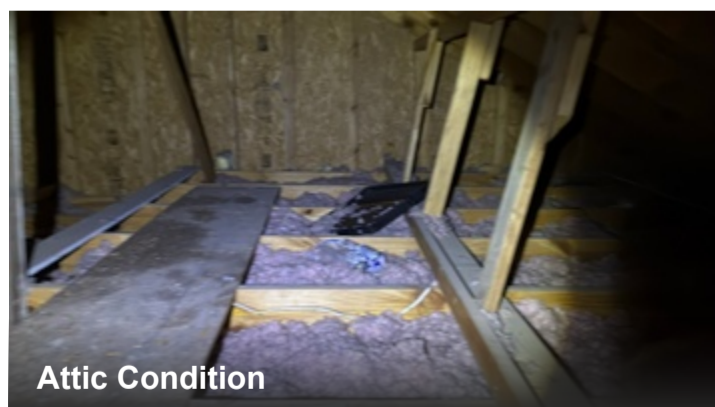
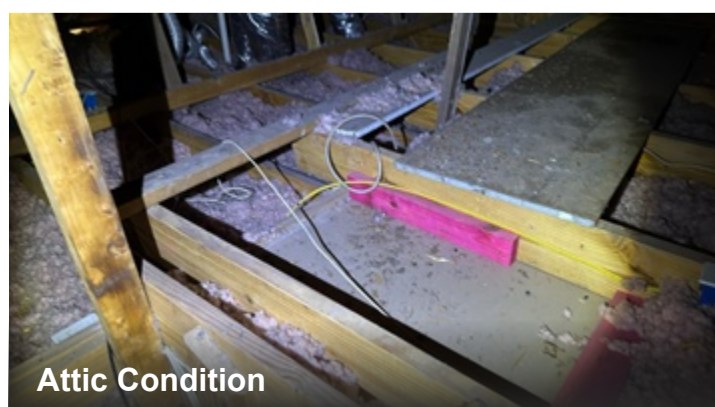
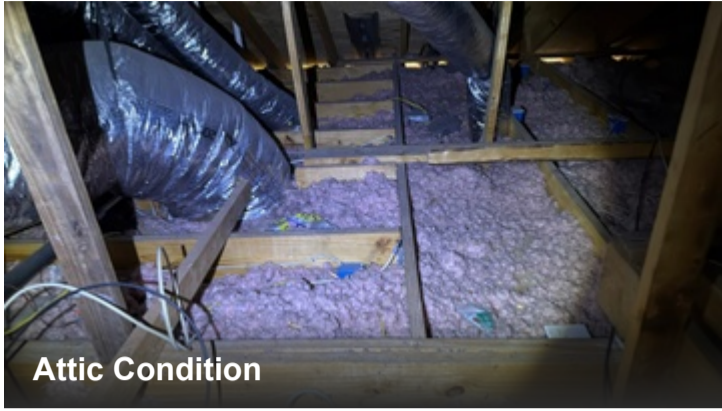
Attic photos / videos

Attic Condition

Fair (Some Repairs)

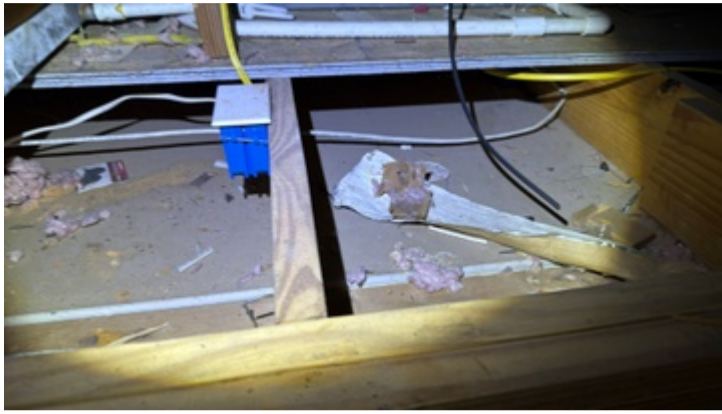
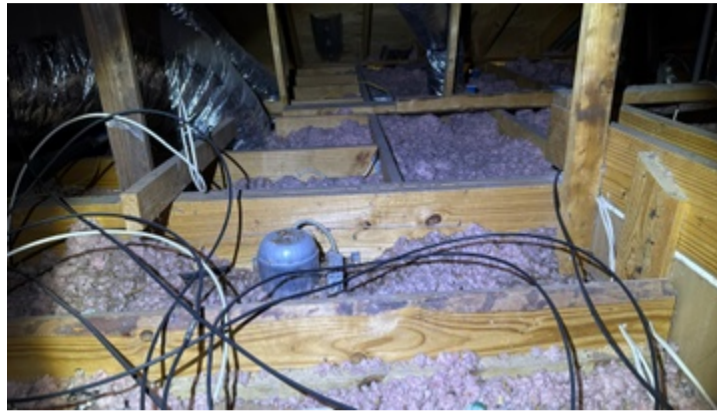
Attic photos / videos

**Monitor deficiency**

Missing / Insufficient Attic Insulation

The attic insulation is missing / insufficient.

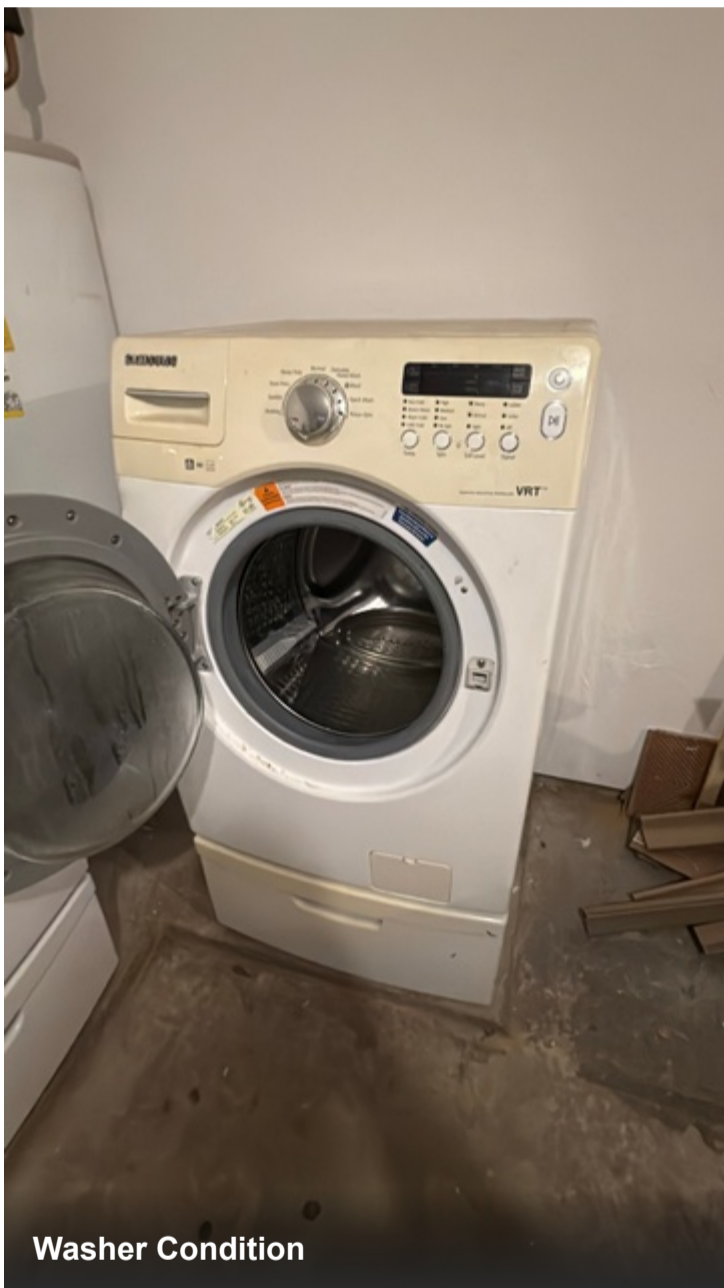
Functional With Cosmetic Defects

Washer Condition

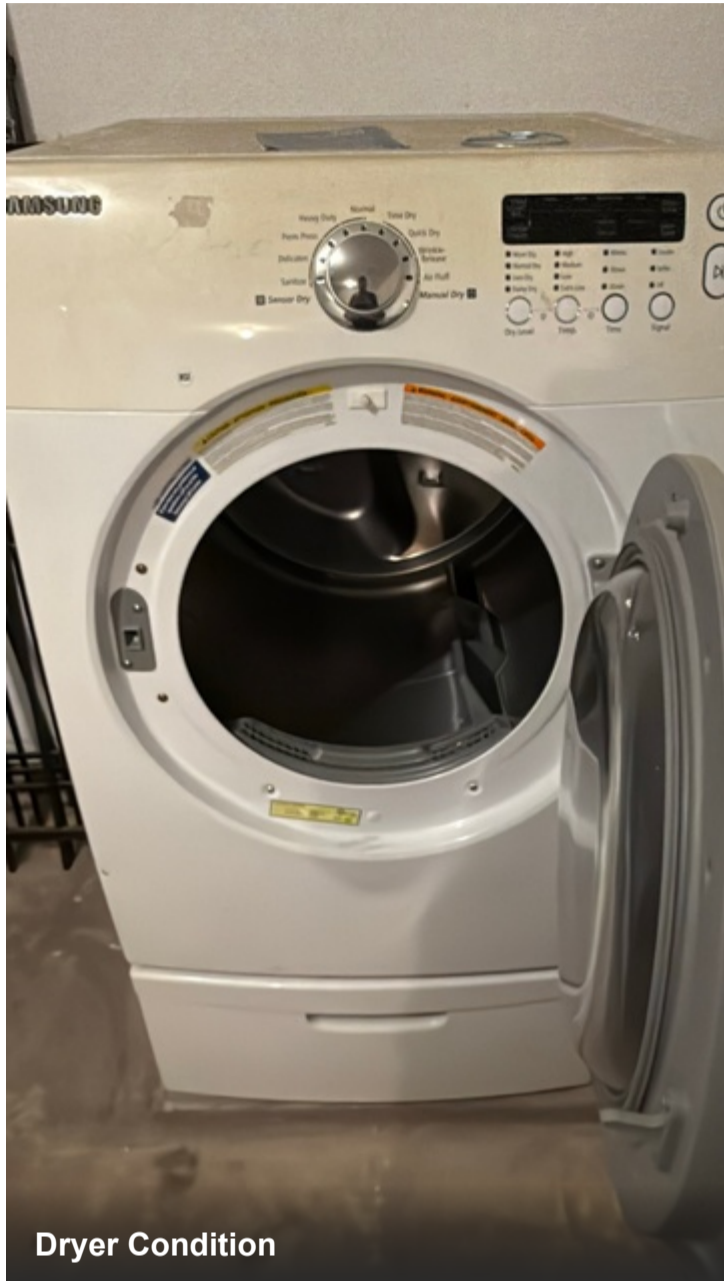
Functional With Cosmetic Defects

Dryer Condition

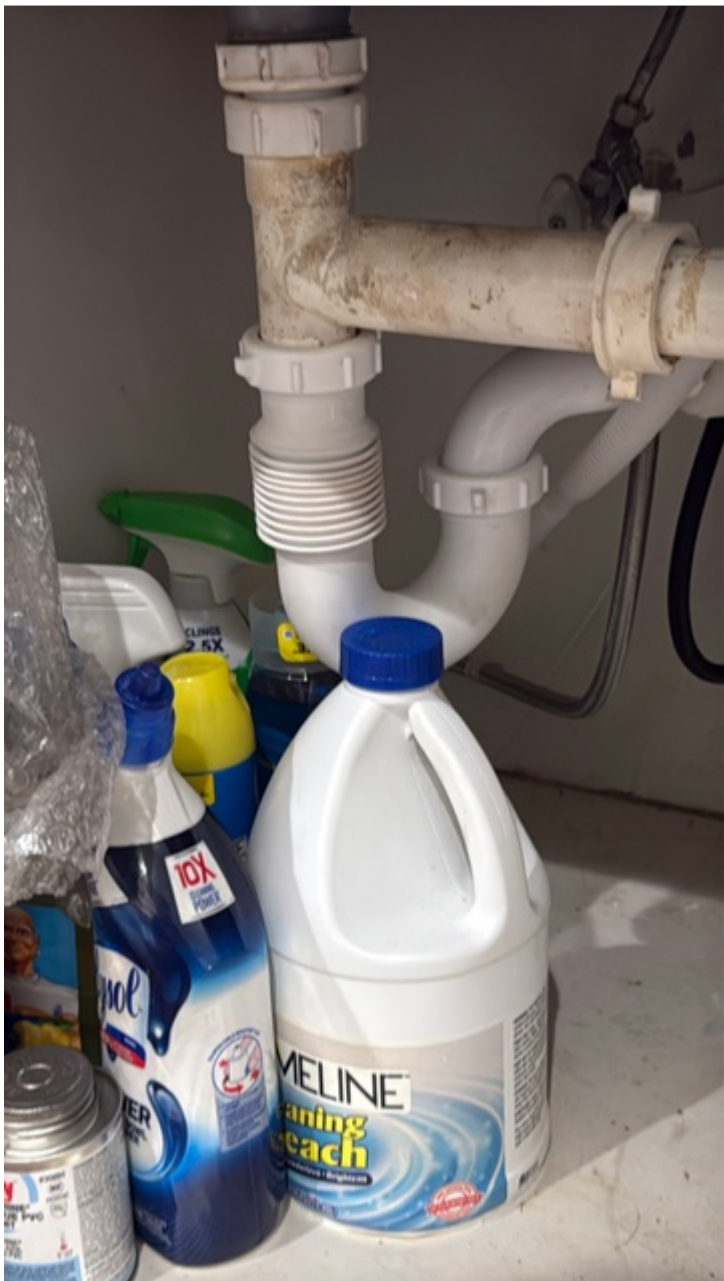
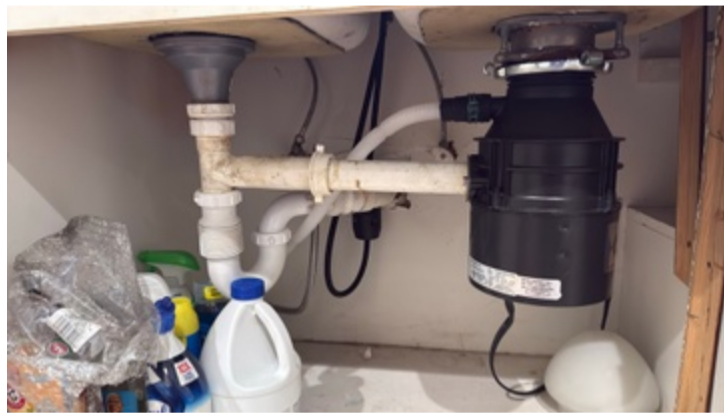
**Repair deficiency**

There is accordion drain material present.

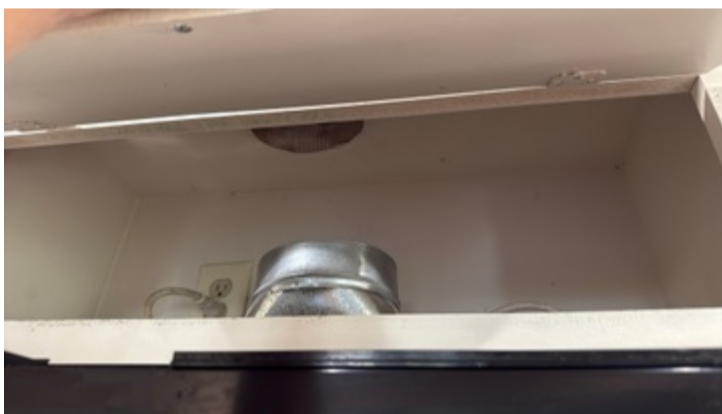
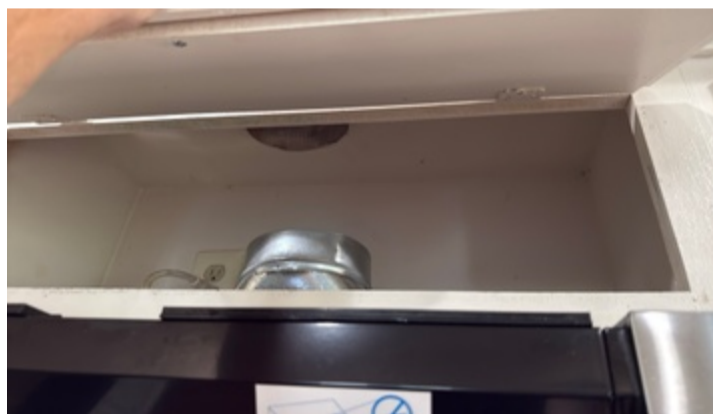
The exhaust fan does not vent to the exterior.

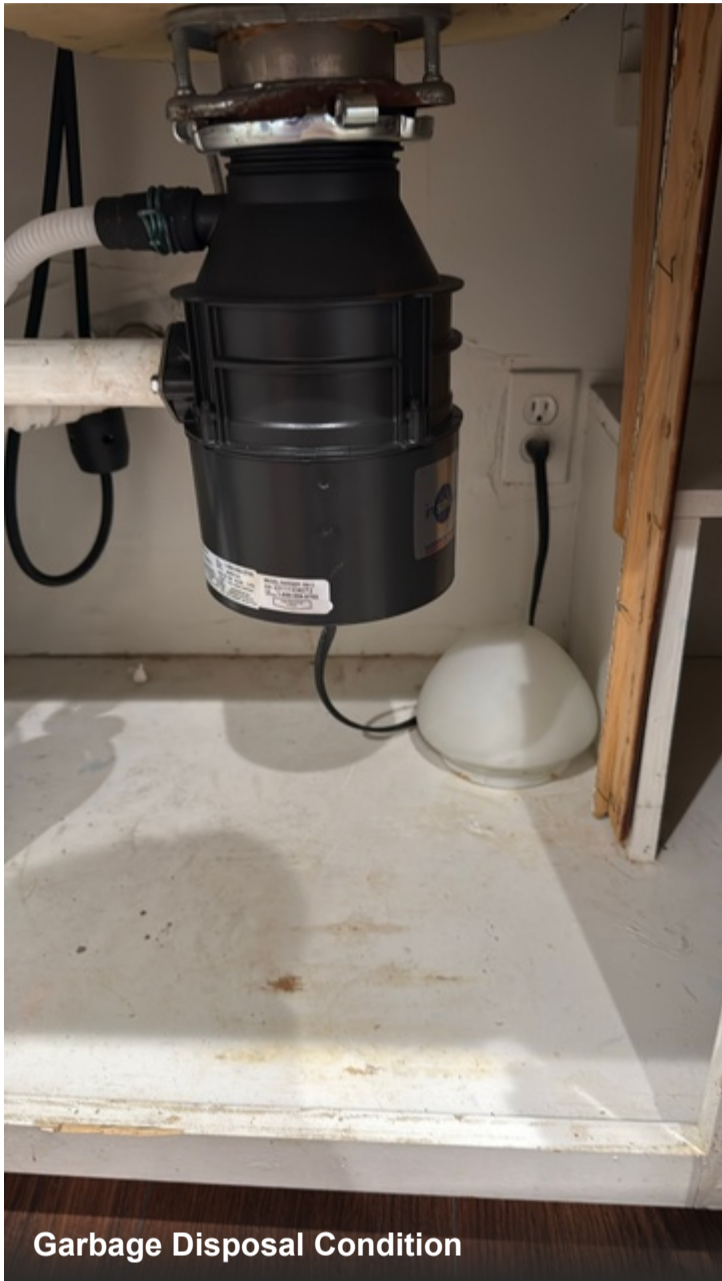
Non-Functional

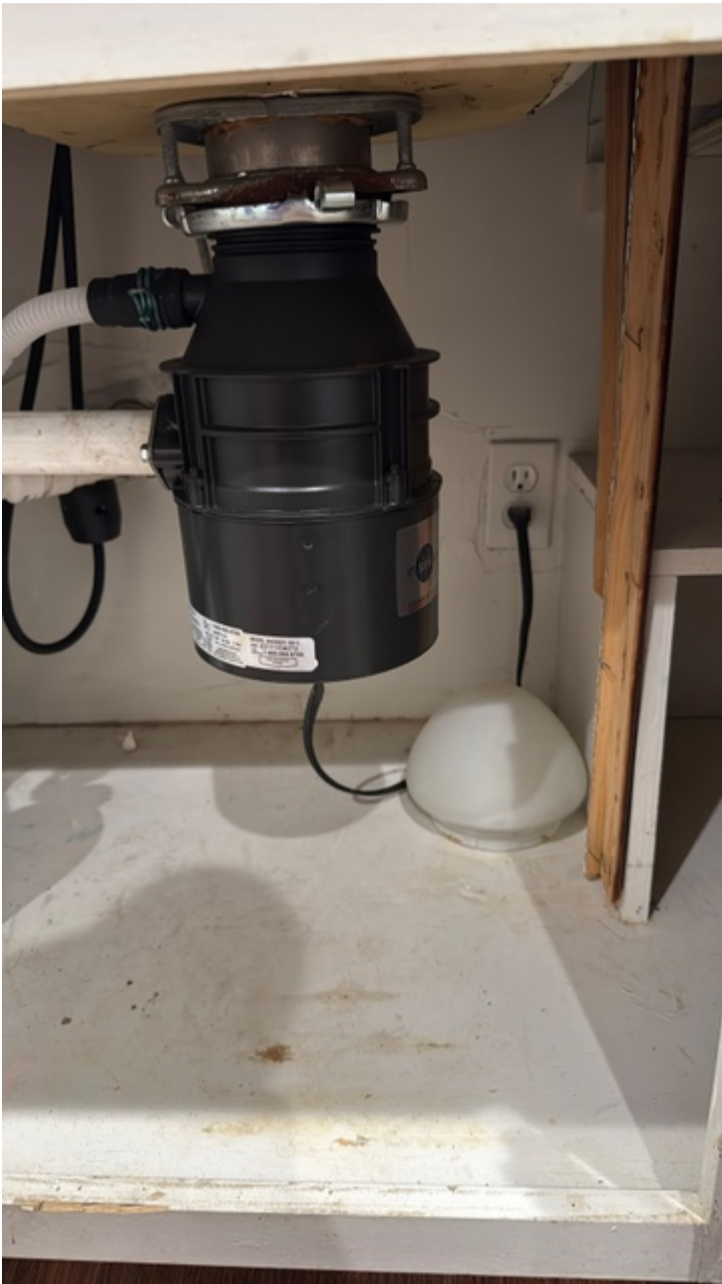
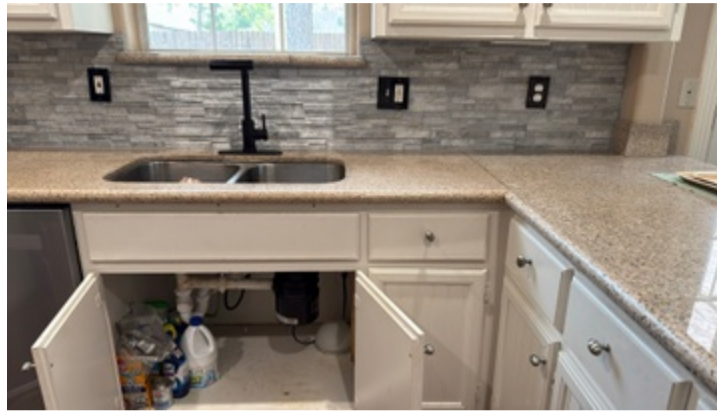
The garbage disposal is inoperable.

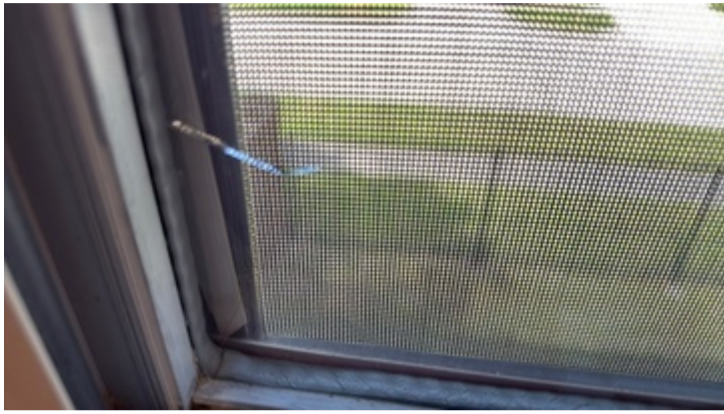
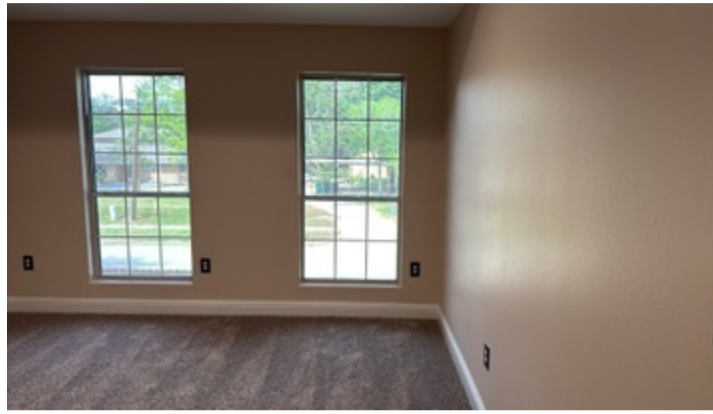
Broken Window Pane

One or more windows have broken glass pane(s).

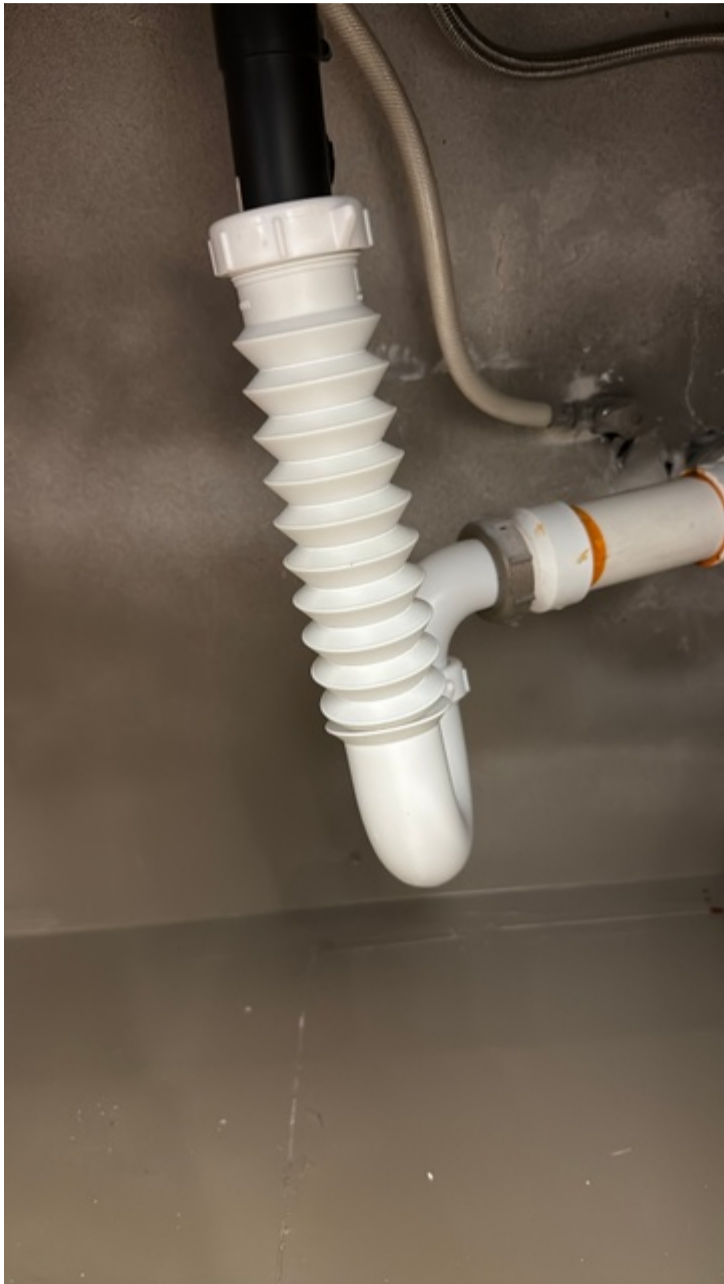
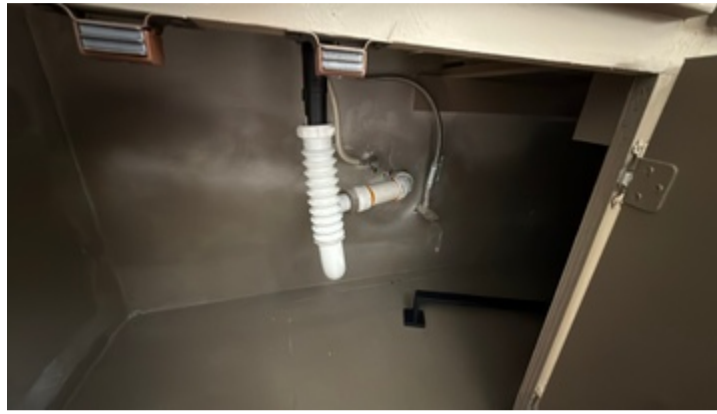
<u>Flex Drain Present</u>

The flex draining is prone to clogging.

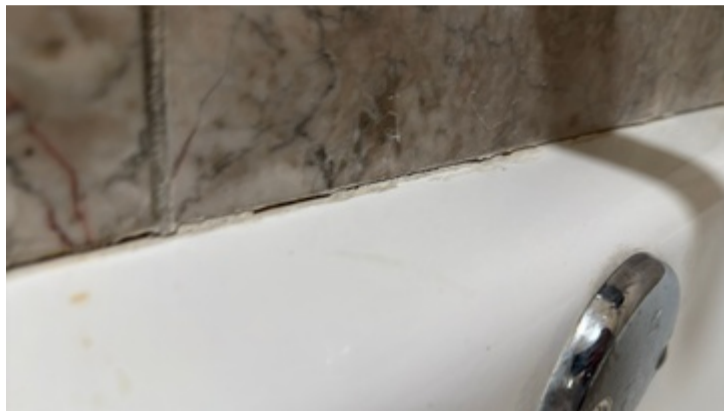
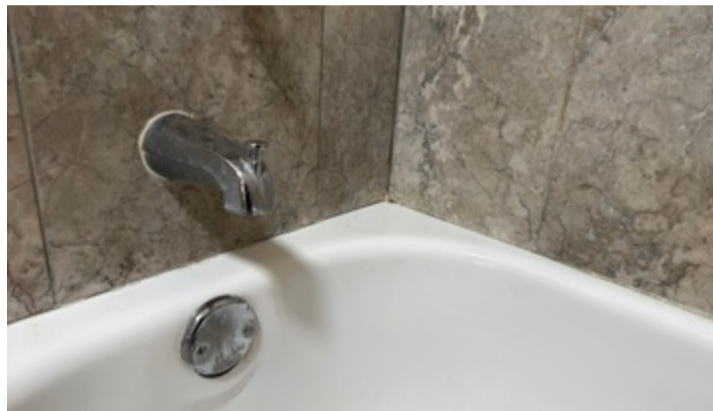
Deteriorated Caulking Around Tub / Surround

The caulking around the tub / surround has deteriorated.

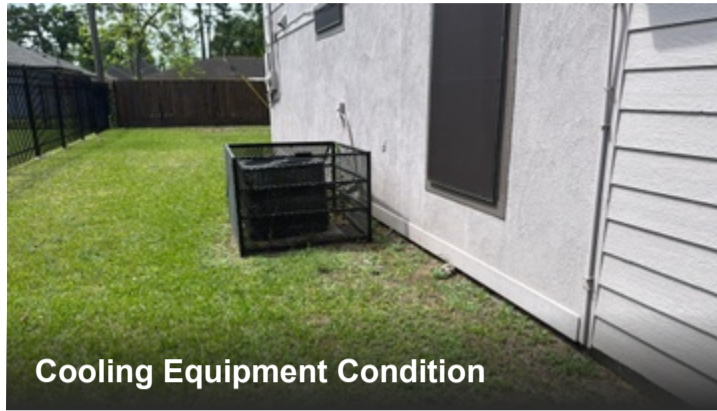
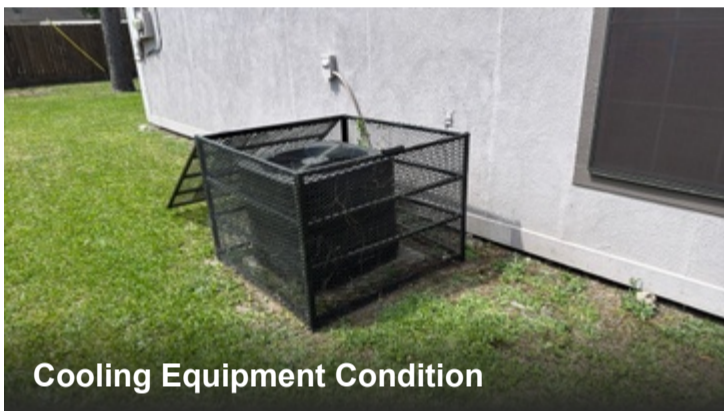
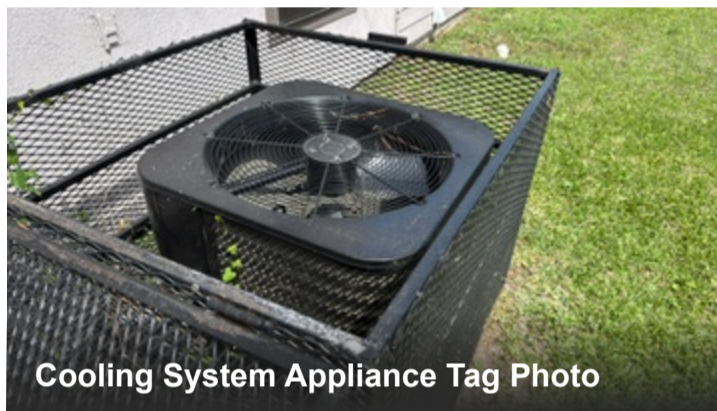
**Repair deficiency**

Rusting or Damaged HVAC Drip Pan

The drip pan below the air conditioning unit is rusting or damaged.

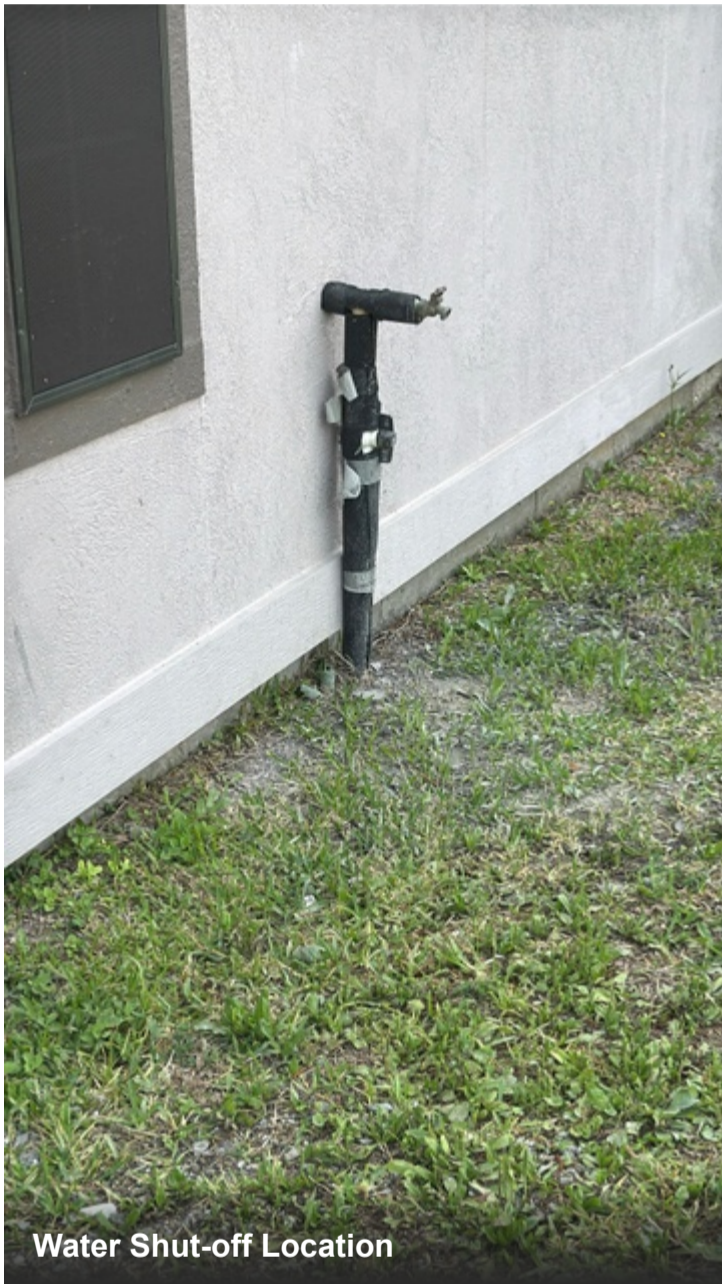
**Repair deficiency**

Missing Anti-Siphon Valve

There is no anti-siphon device present.

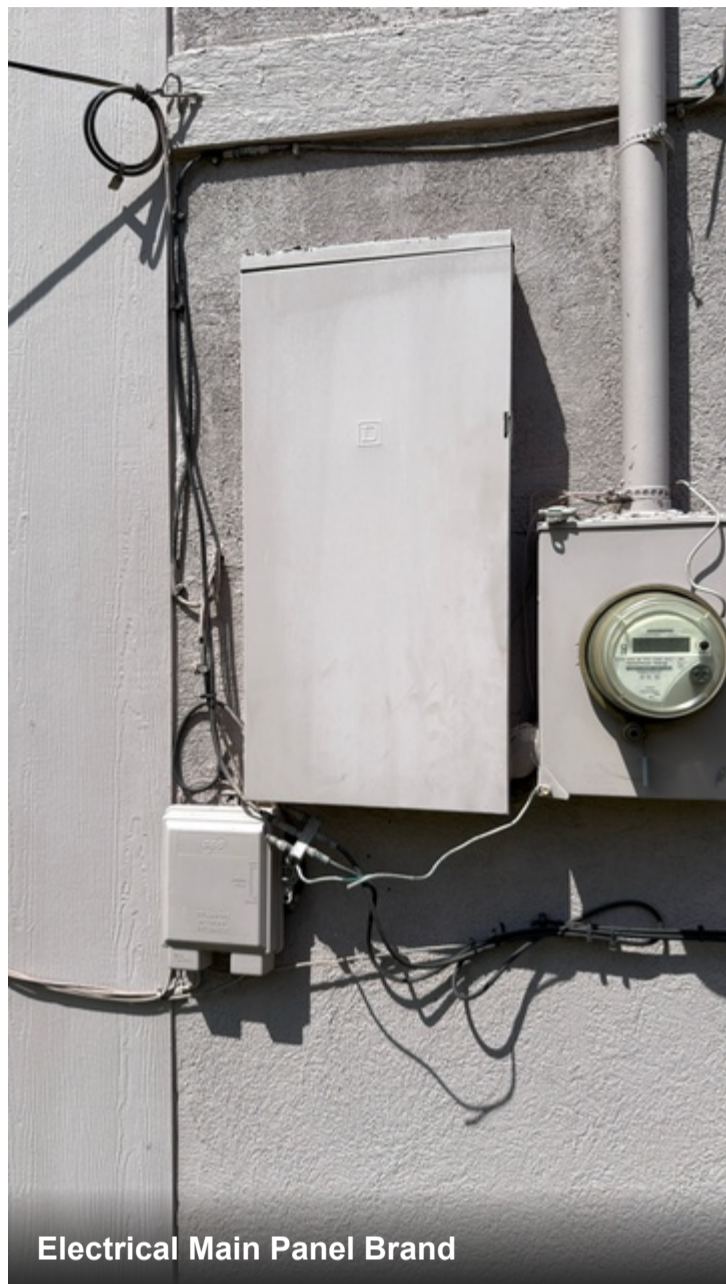
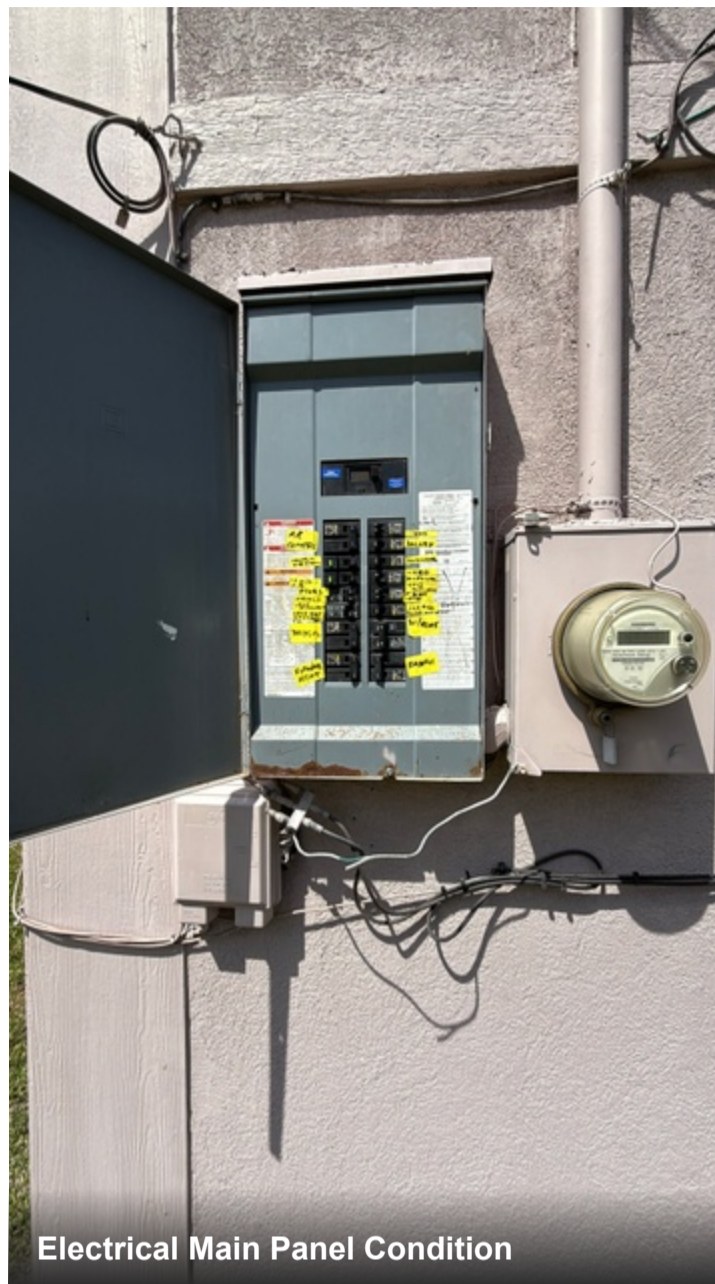
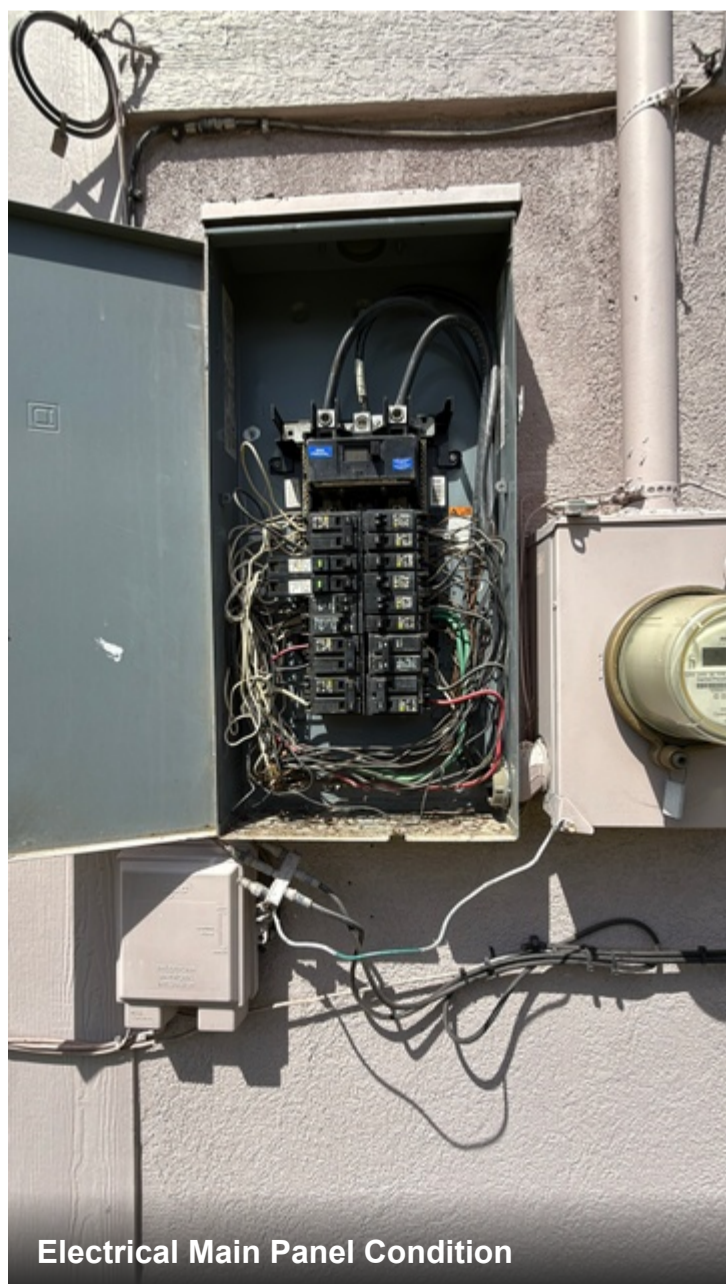
**Repair deficiency**

Missing Surge Protection

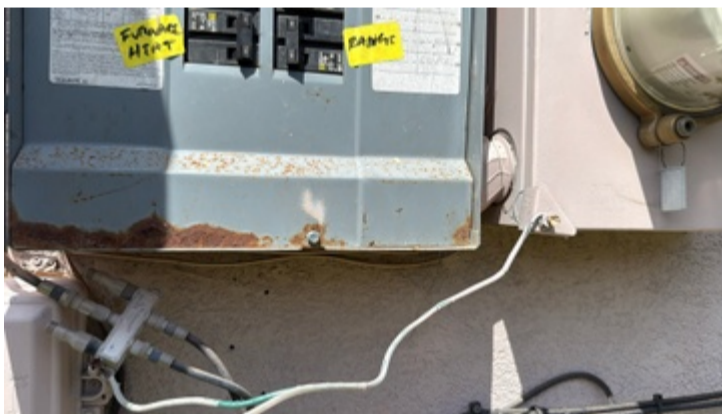
**Repair deficiency**

Rusted Main Breaker Panel

The main breaker panel is rusted.

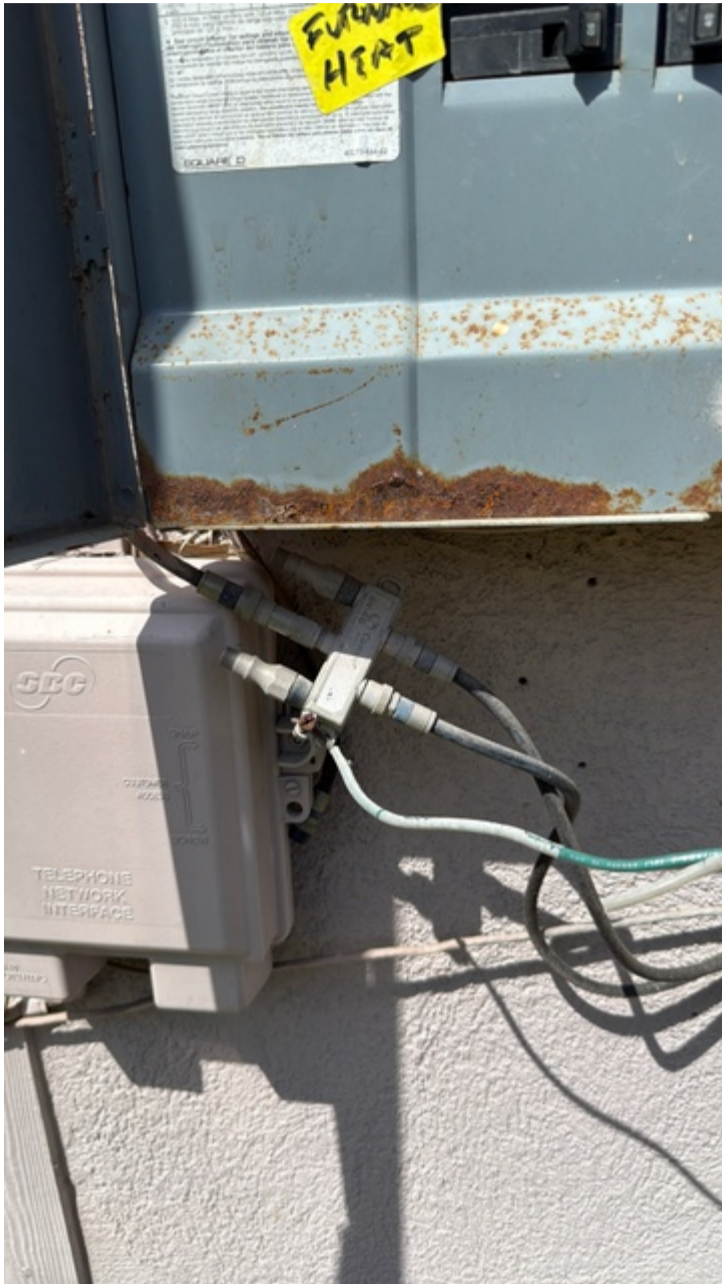
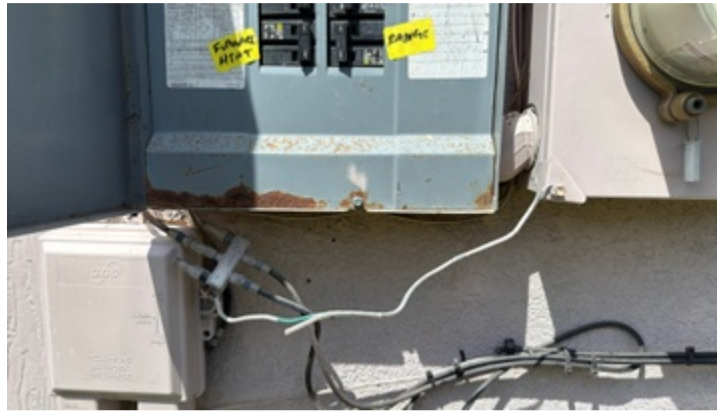
Missing / Incorrect Screws for Electrical Panel

There are missing / incorrect screws.

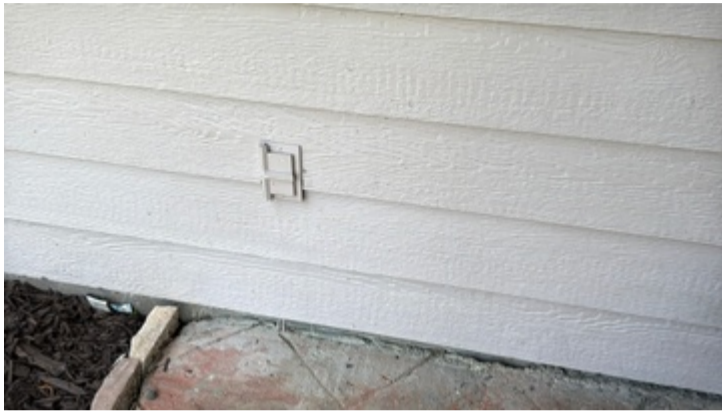
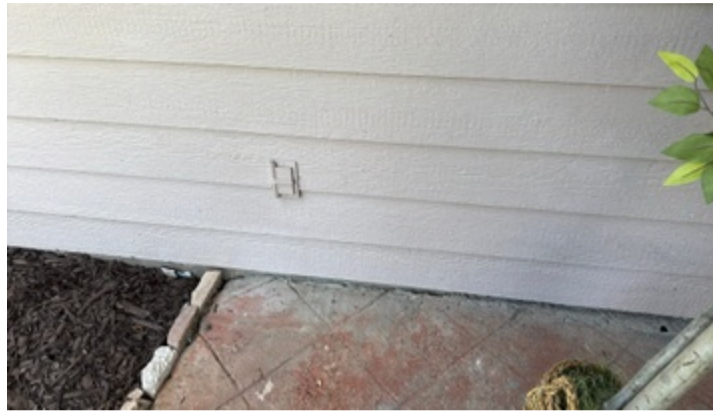
Missing Weather-Resistant Cover

There should be a water-resistant cover installed.
