FOUNDATION CONSULTATION

2718 Lazy Spring Dr
Houston, TX 77080

Ariana White
08/31/2025

Project Information: GreenWorks	Project Information: Inspection	Project Information: Report Issue
Project Number	Date	Date
202103	08/31/2025	09/02/2025

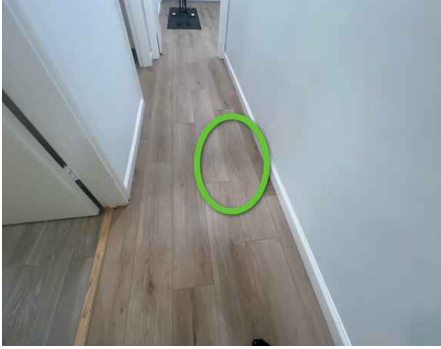
Floor Distress: Floors Out-of-Level / Spongy

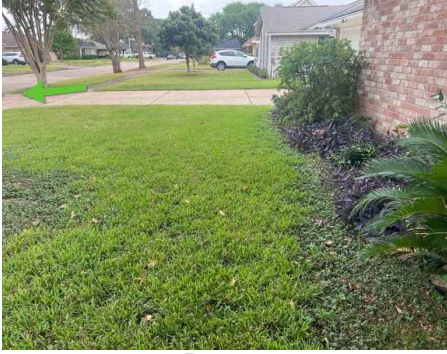
Front

Slope of Grade

Positive, Flat

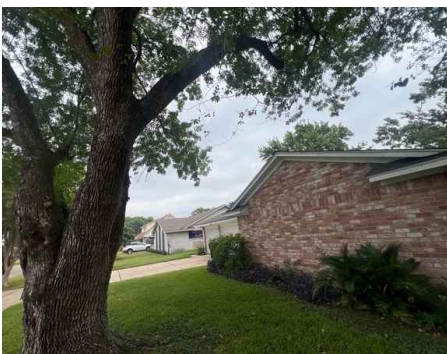
Front Right

Trees Within 10ft

Yes

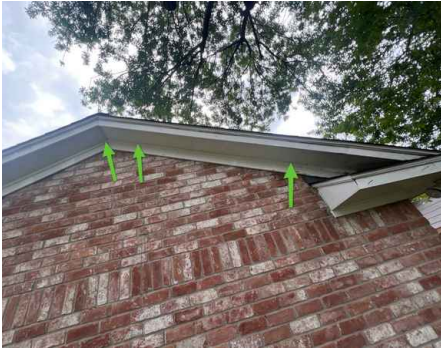
Front Right

Frieze Board Joint Separation

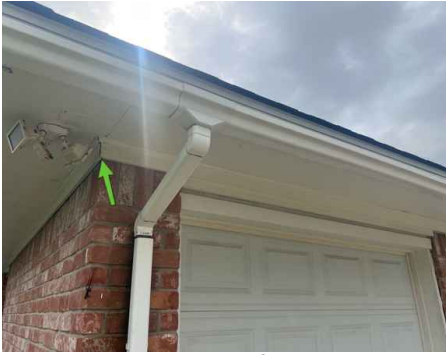
Front Left

Trim Separation

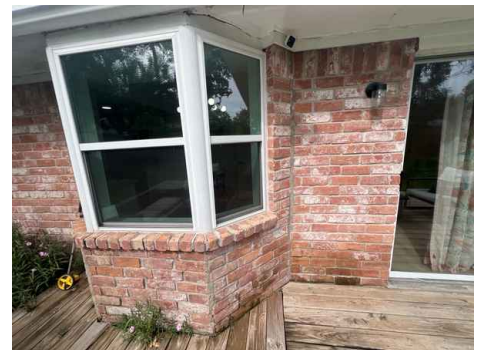
Rear

Previous Repair
