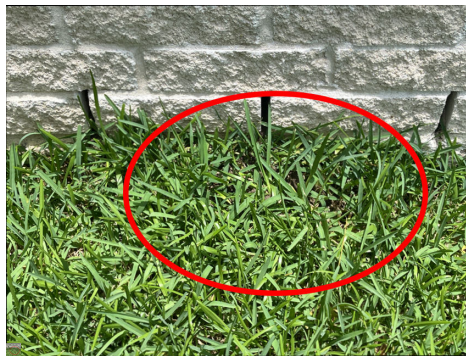
Right: Ant nest

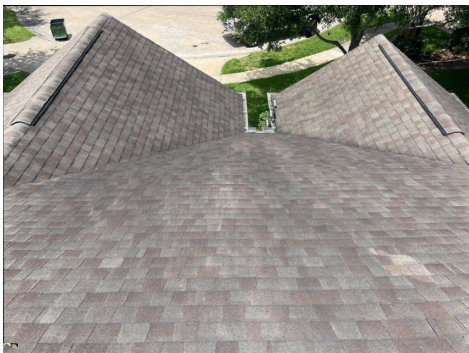
Front

The degree of granule loss/deterioration on the shingles indicated the roofing material was nearing the end of its life cycle. Replacement will become necessary in the near future. It would be wise to budget for the replacement.

**Damaged, torn and/or missing shingles were observed on the roof. We recommend having all damaged shingles replaced to prevent further damage and water intrusion.**

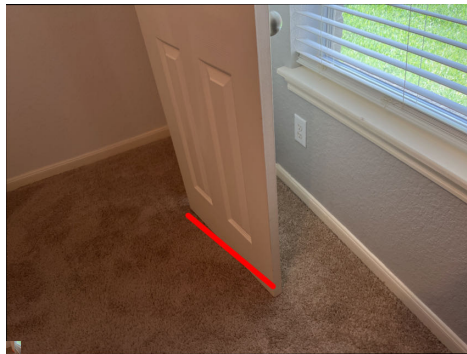
Bedroom 3 closet, rubbed on carpet

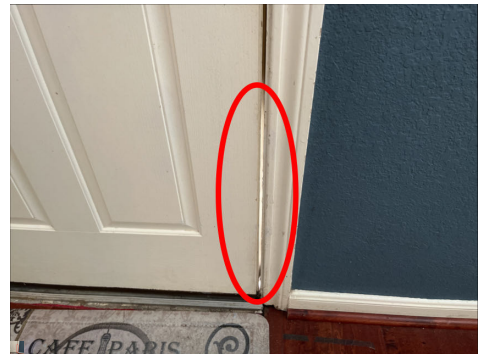
Back door: Daylight

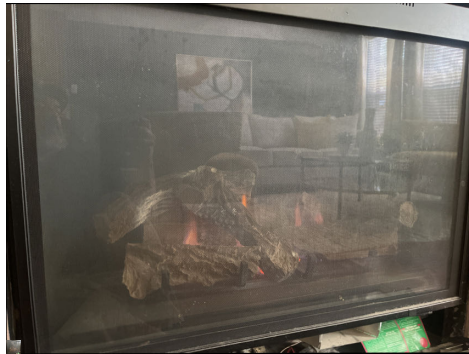
The fireplace had some fog on its inside glass panel, which I recommend cleaning. It is necessary to clean the glass periodically. During initial start-up, condensation, which is normal, forms on the inside of the glass and causes lint, dust and other airborne particles to cling to the glass surface. Also, initial paint curing may deposit a slight film on the glass. All glass should be cleaned after the first 4 to 6 hours of initial burning to remove deposits before they become baked on through further use. After the initial cleaning, glass should be cleaned two or three times during the heating season. For more information, you can go to <http://www.americanheritagefireplace.com/faqs.html>

Fireplace fired up

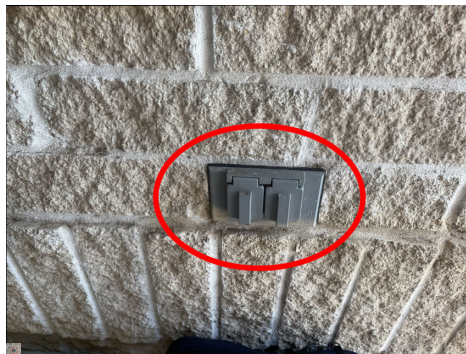
Exterior: Bubble cover recommended

Today's standards require having a bubble cover on all exterior receptacle outlets exposed to the elements. We recommend making the upgrade.

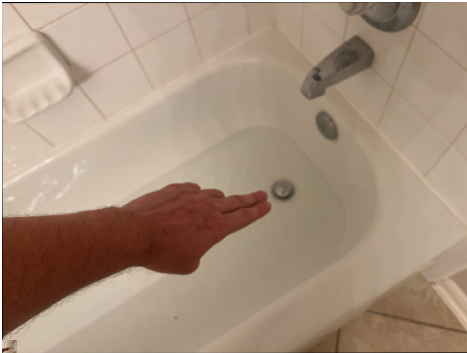
Bathroom 1: Slow drain

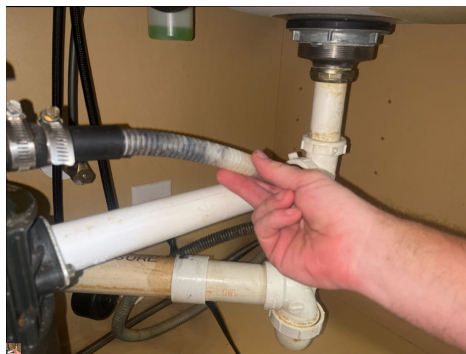
No high-loop or air gap

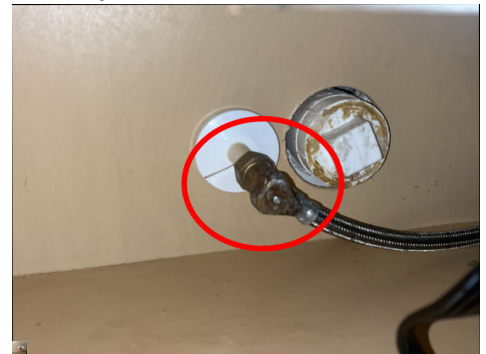
The dishwasher responded to controls but did not receive water supply despite the corresponding valve being on. We recommend having the appliance and connections serviced and repaired.

Supply valve on but no water at dishwasher

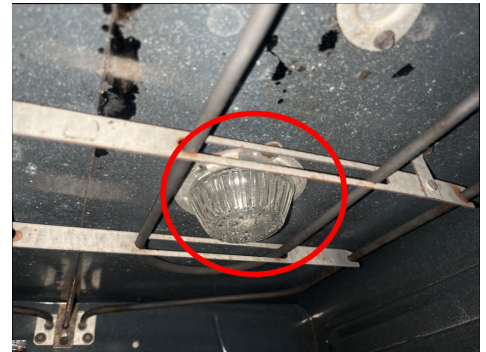
The light for the oven was not operating at the time of inspection. We recommend replacing the bulb. Should this not resolve the issue, we recommend having the unit serviced.

Light inoperable

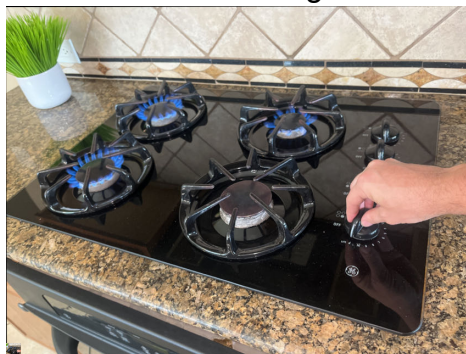
The automatic igniter at one of the gas-fired cooktop burners did not operate at the time of inspection. We recommend repair.

Faulty auto-igniter

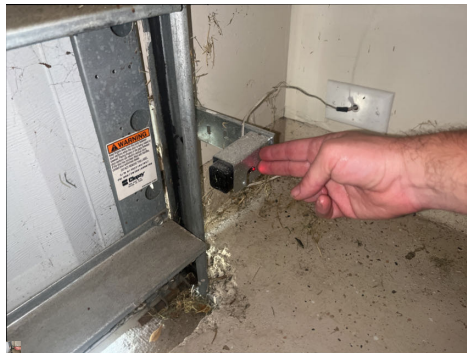
The photo sensor was installed at a height greater than 6 inches. Safety standards designed to protect small children limit the maximum mounting height for garage door photo sensors at 6 inches. We recommend correction by a qualified contractor.

Photo eye sensor more than 6" off ground

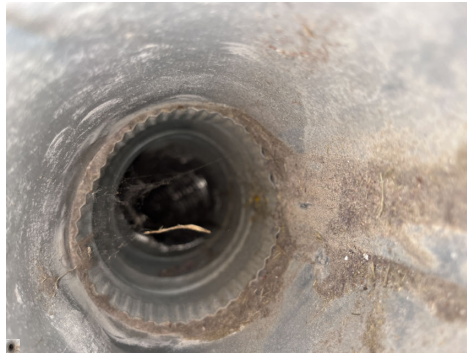
The dryer vent had lint or debris build up on the interior of the exhaust duct. This in turn could lead to clogging of the dryer vent, preventing proper drying of the clothes and overheating of the dryer, which are potential fire hazards. We recommend having the dry vent cleaned.

Dryer vent: Dirty

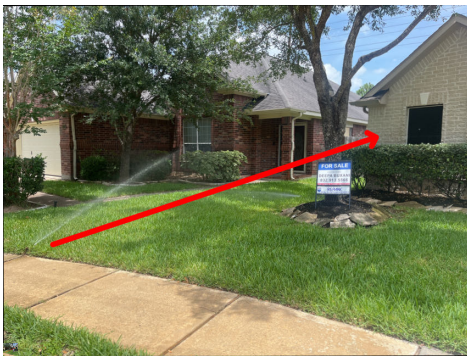
A sprinkler head was spraying the structure. We recommend adjusting the head so as to not add excessive water on the structure. This was observed in zone 1, 2, 3, 4.

Zone 1: Sprayed structure

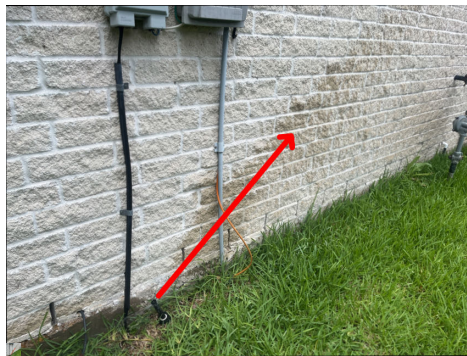
Zone 4: Sprayed structure
