## TREC REI 7-6 SUPER INSPECTOR RESIDENTIAL INSPECTION

11027 Hilltop Park Ln  
Cypress, TX 77433

# PROPERTY INSPECTION REPORT FORM

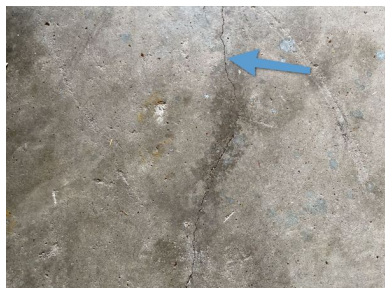
**3: Flooring Creak/Pops**

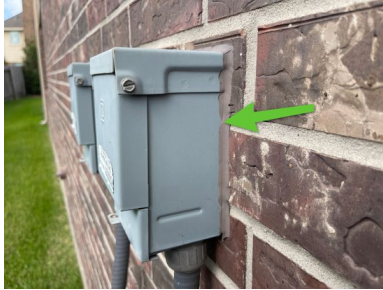
**1: Partial arc-fault protection installed**

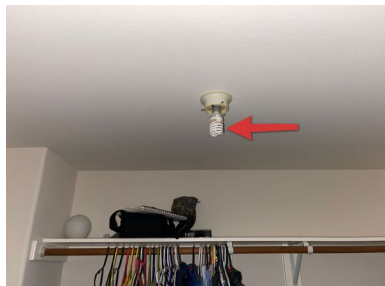
**4: Missing CO alarms**

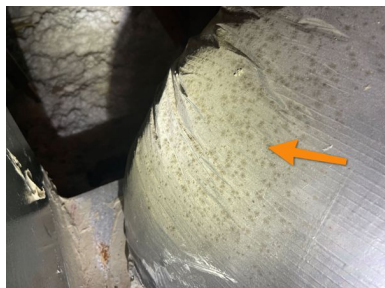
**3: Condenser suction line insulation deteriorated**

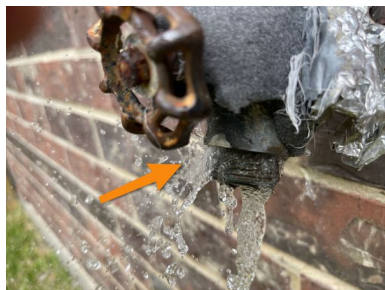
One or more exterior faucets leaked from the anti-siphon device when the valve was opened. Repair or replacement is recommended.

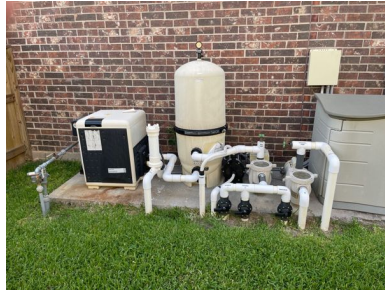
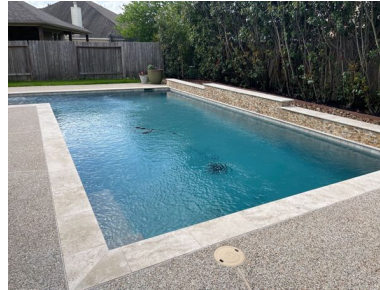
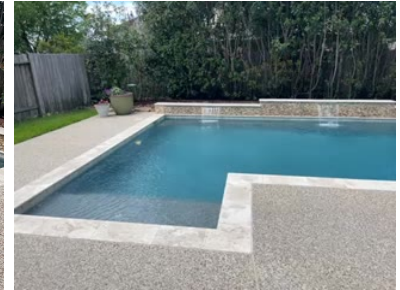
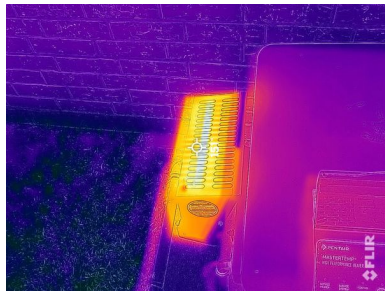
Pool heater displayed service light on the controller when activated. Further evaluation by a qualified irrigation specialist is recommended.
