# 20119 Forest Dr

# Spring, Texas 77388

| Type | <b>Home Inspection and Floor Plan Report - 20119 Forest Dr</b> |
| Inspected by | <b>HomeTeam Inspection Service - North Houston</b> |

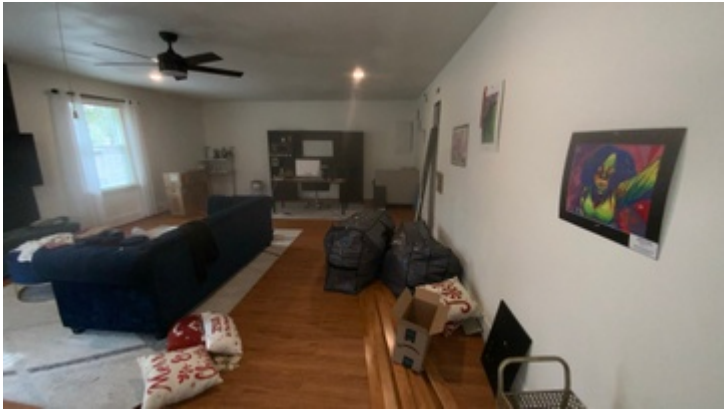
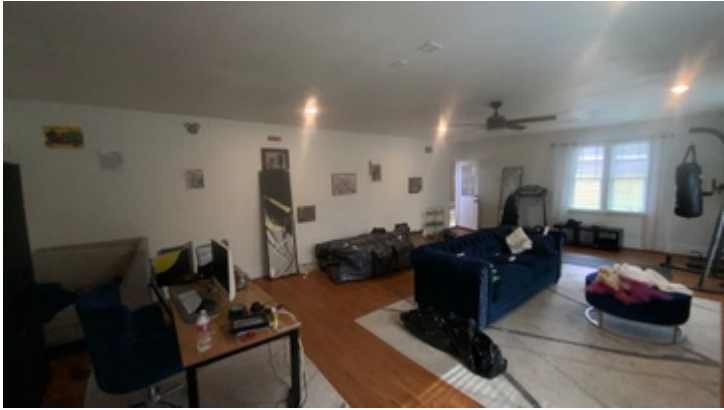
**Additions / Conversions Observed**

Yes

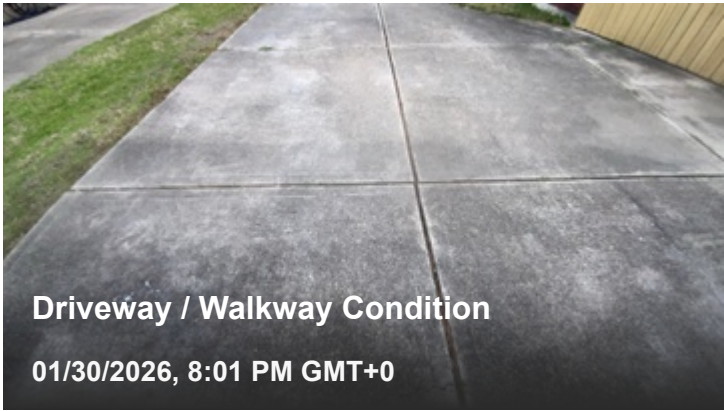
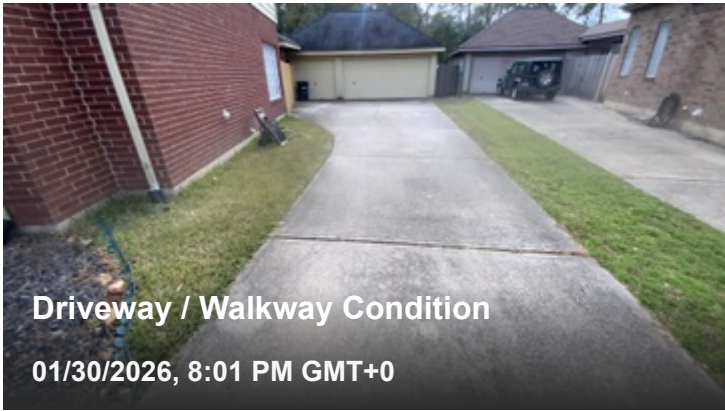
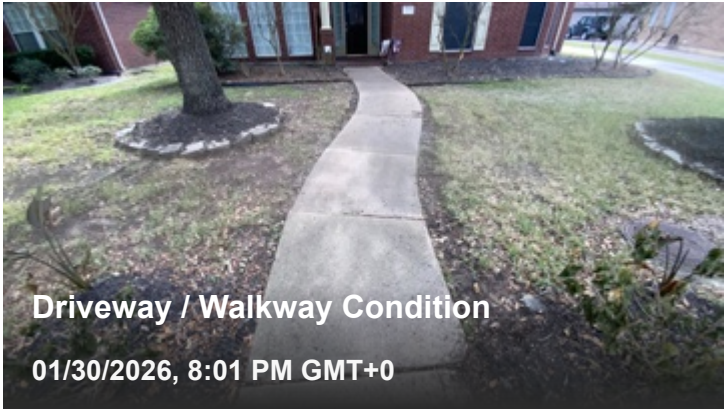
Driveway / Walkway Condition

Fair (Some Repairs)

Repair deficiency

Trip Hazard

Monitor deficiency

Minor Cracks in the Driveway

The driveway has minor cosmetic cracks.

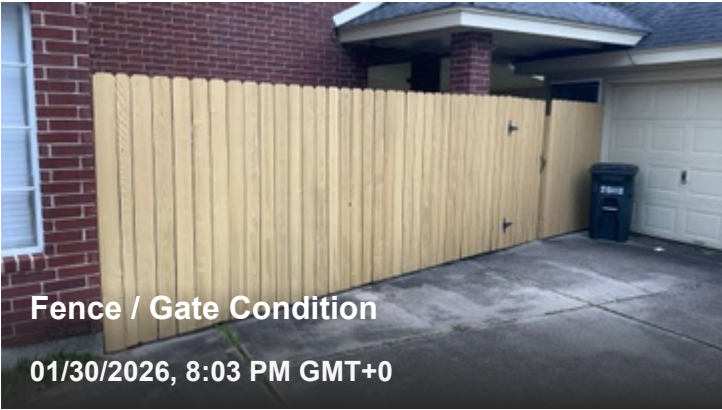
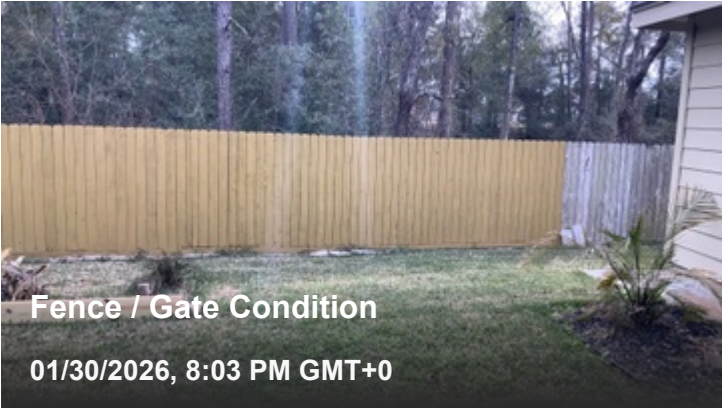
Fence / Gate Condition

Good (Cosmetic Issues Only)

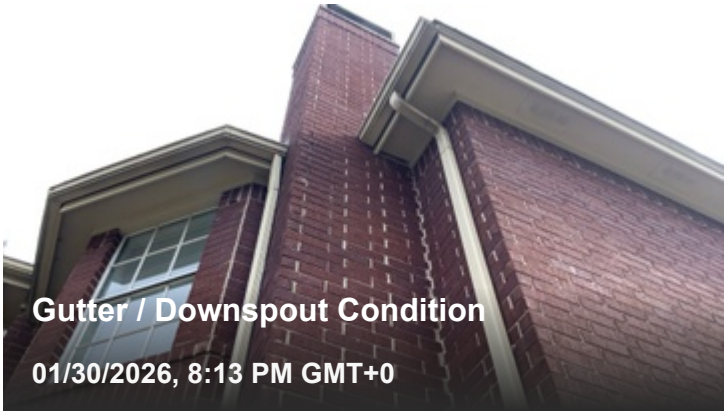
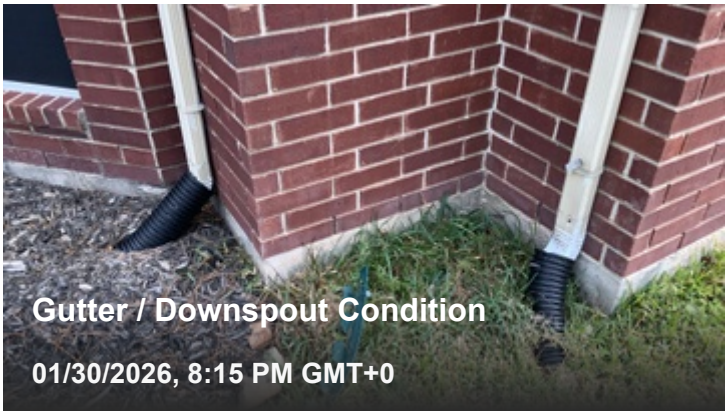
**Damaged Gutter / Downspout**

The gutter / downspout is damaged.

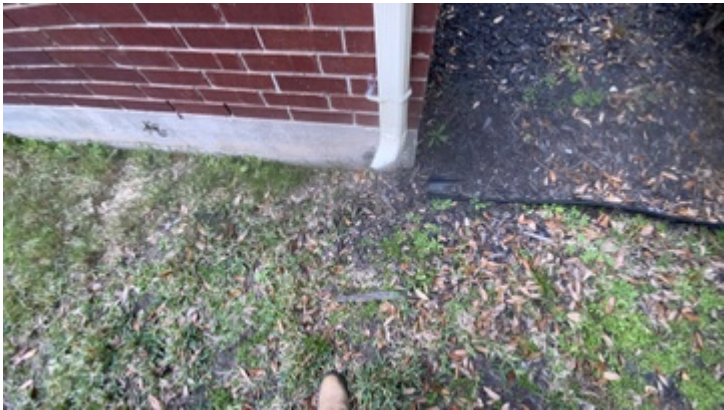
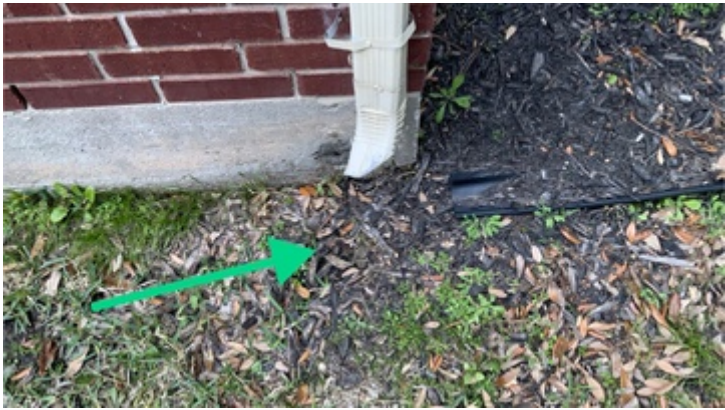
Missing Downspout Splash Blocks

There are no splash blocks for the downspouts.

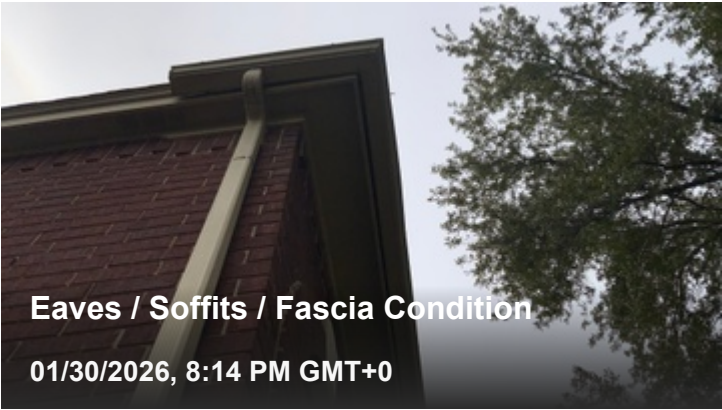
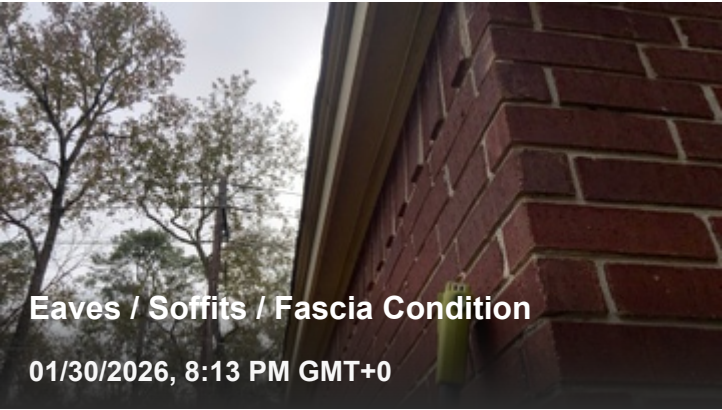
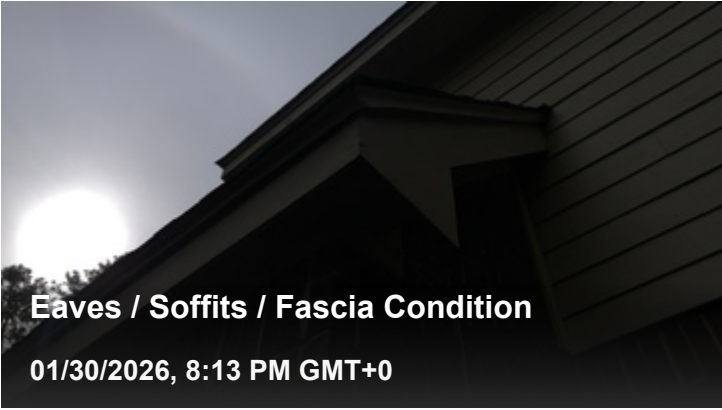
Damaged Soffit Paint

The paint is damaged on the soffits / eaves.

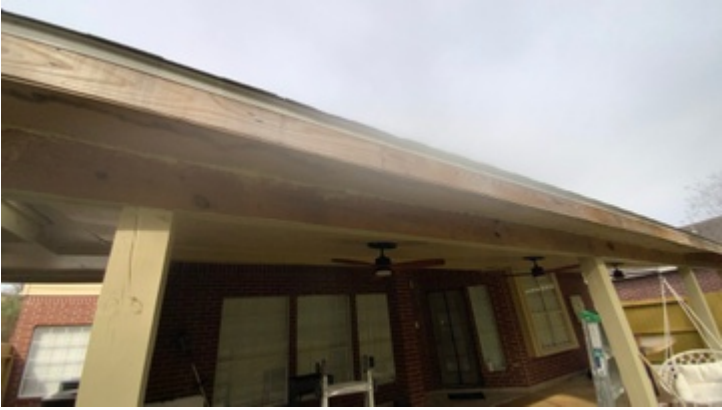
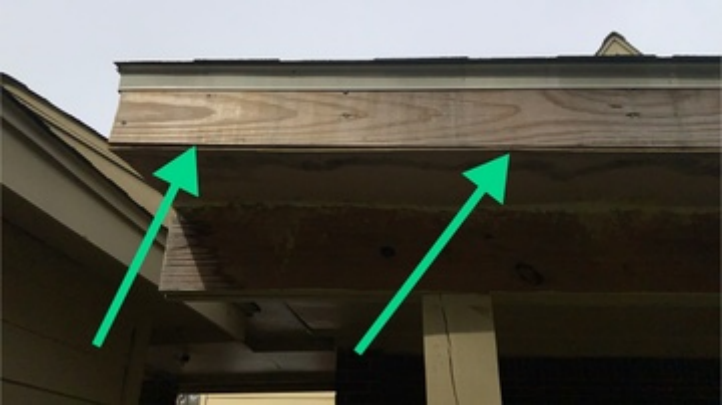
Monitor deficiency

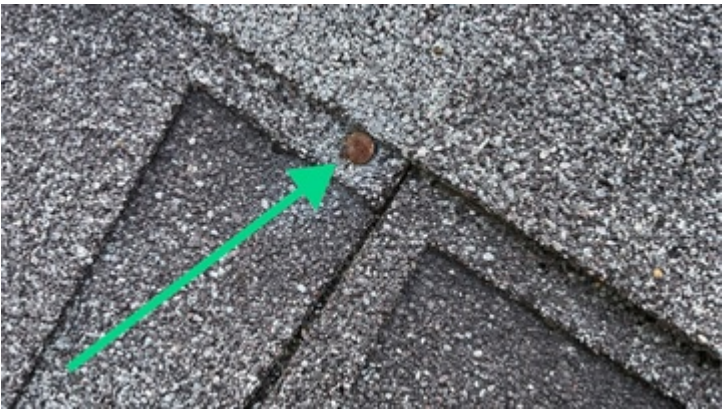
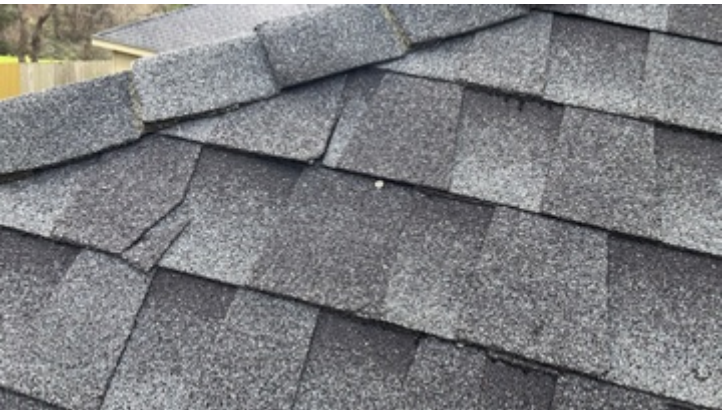
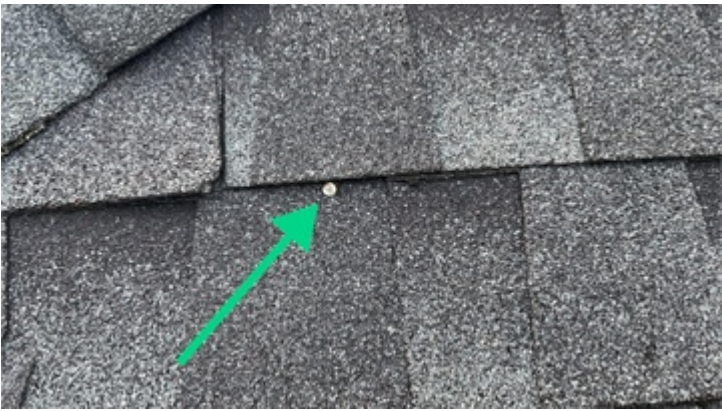
**Repair deficiency**

**Exposed Roof Nails**

There is one or more exposed nail(s) on the roof.

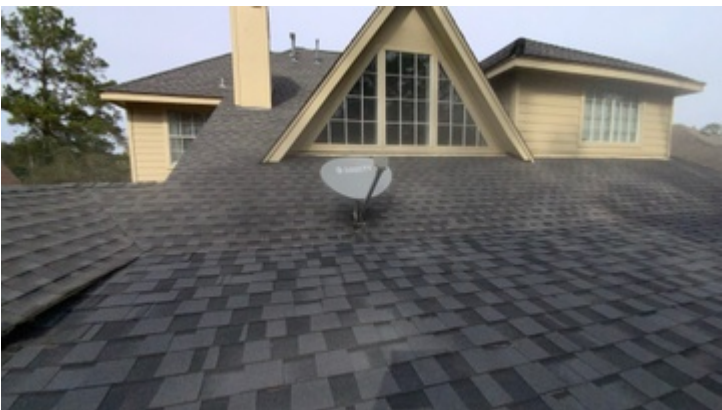
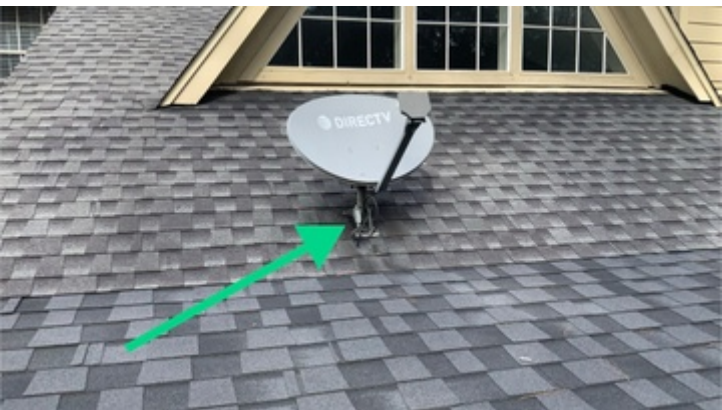
**Repair deficiency**

**Satellite Dish Bracket(s)**

Satellite dish brackets installed over roof covering materials.

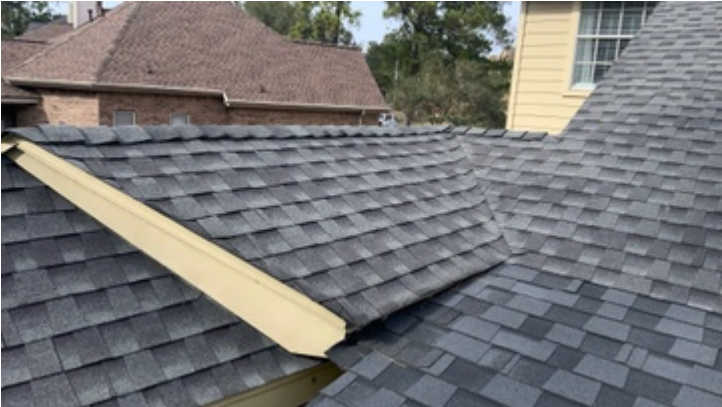
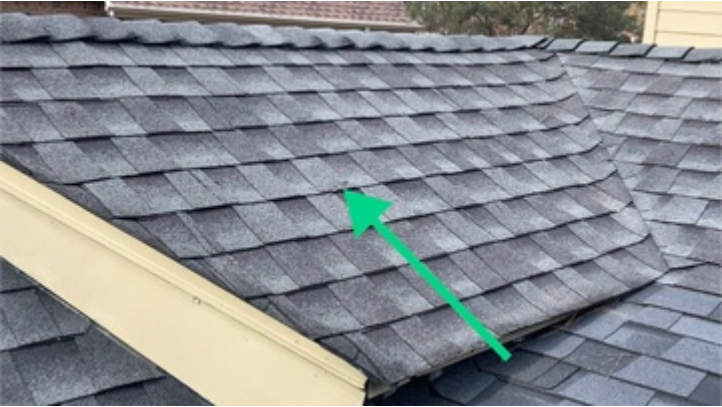
**Repair deficiency**

**Damaged Shingles**

One or more shingles are cracked or torn.

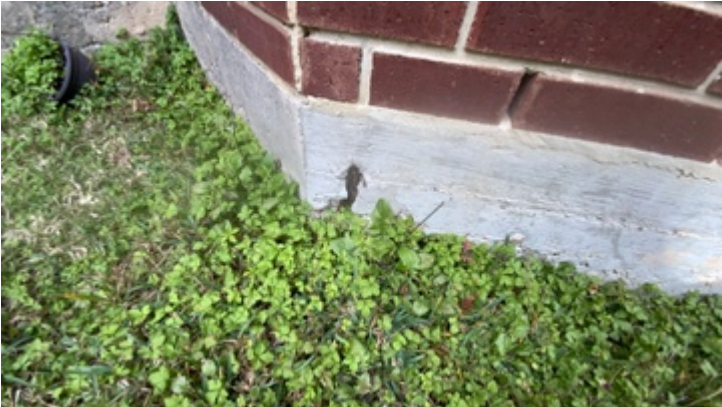
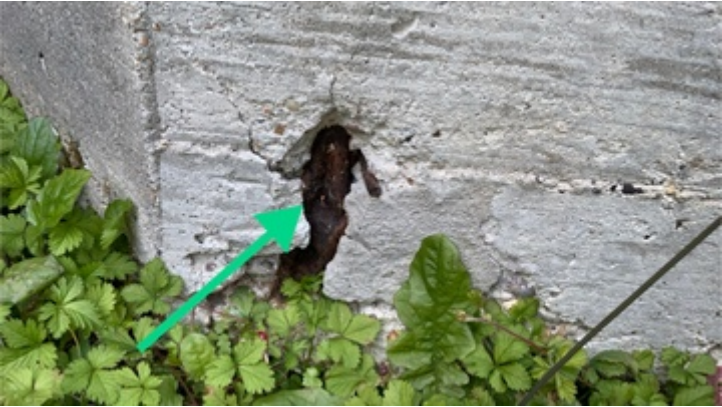
Safety deficiency

Exposed Rebar from Concrete

Exposed rebar protruding from concrete.

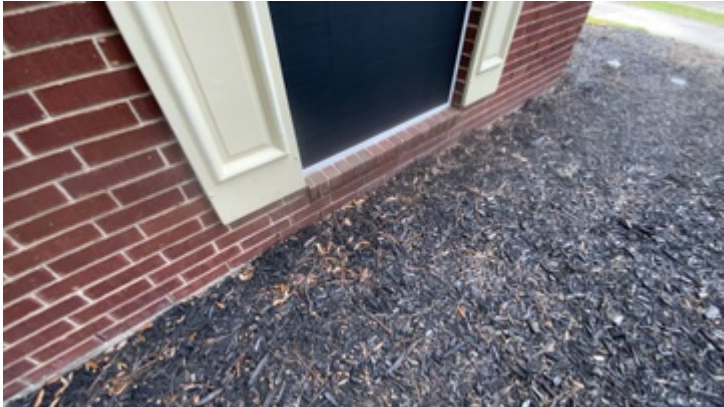
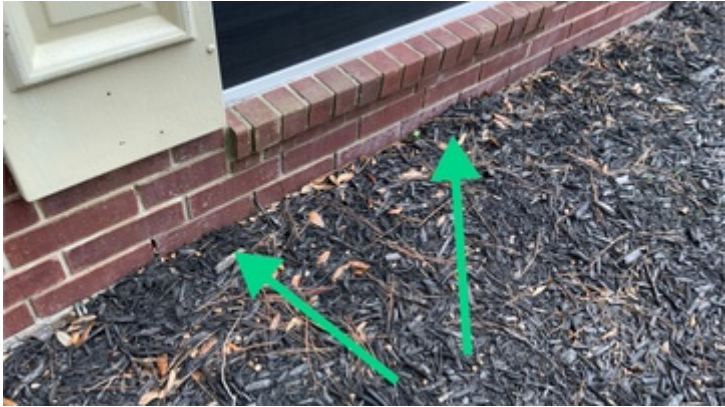
**Repair deficiency**

**High Soil Grade**

There are areas of high soil around the foundation.

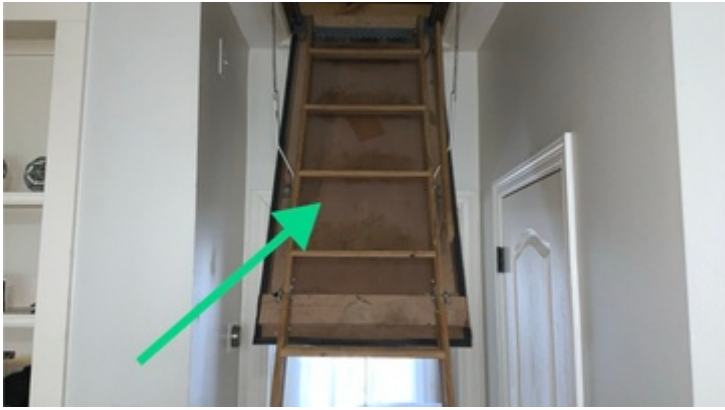
Repair deficiency

Missing Attic Hatch Insulation

There is no insulation for the attic access hatches.

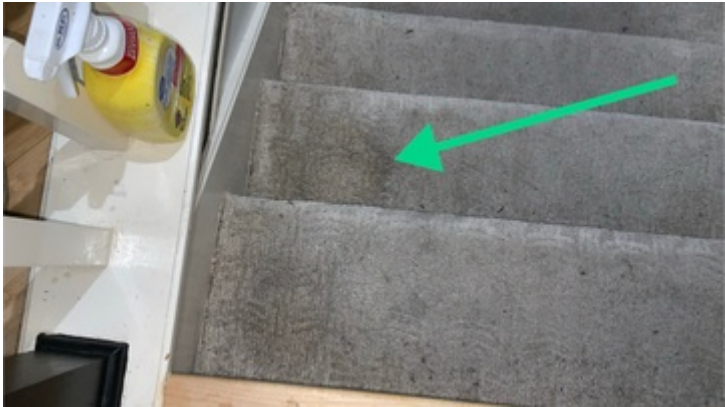
Monitor deficiency

Stained Carpet

The carpet has areas of staining or discoloration.

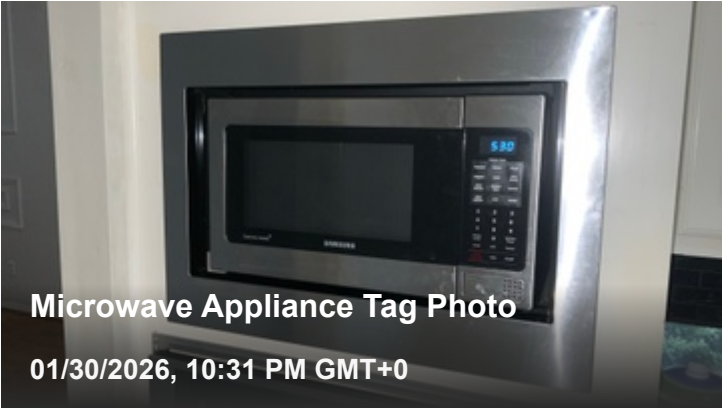
Microwave Condition

Functional With Cosmetic Defects

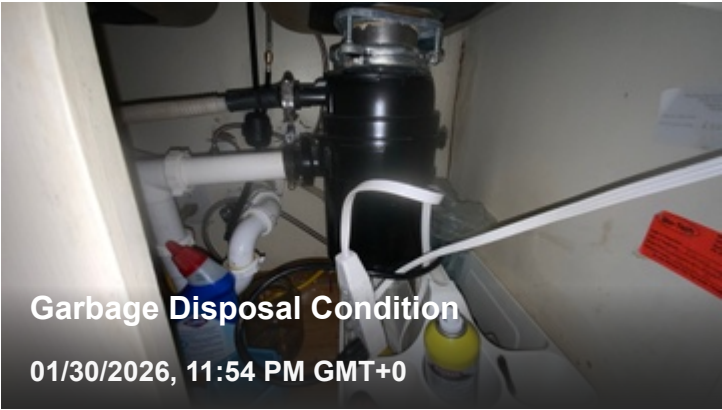
Garbage Disposal Condition

Functional With Cosmetic Defects

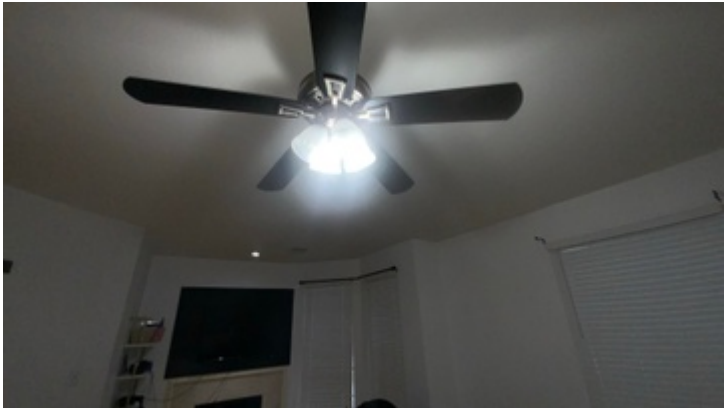
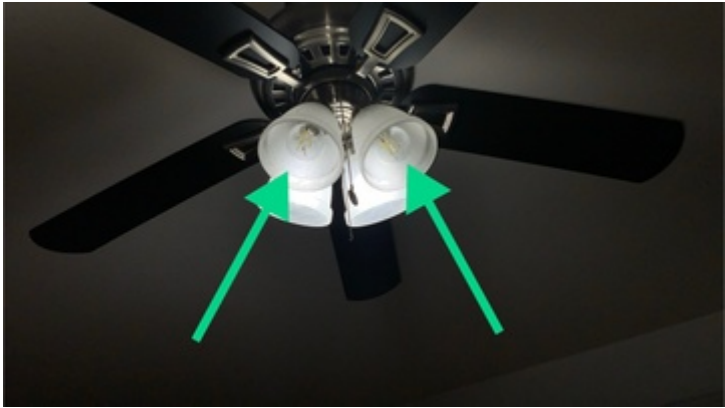
Monitor deficiency

Inoperable or Missing Light Bulb

One or more light bulbs have burnt out or are missing.

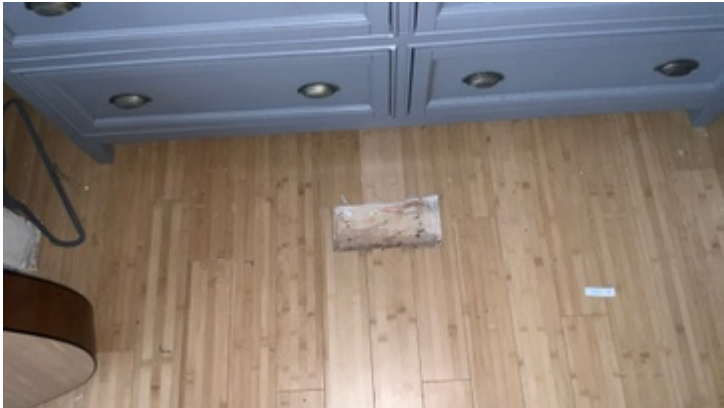
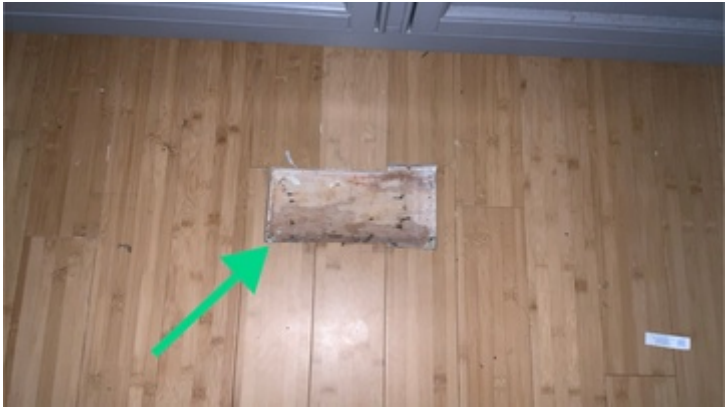
**Repair deficiency**

**Damaged Flooring**

The floors are damaged.

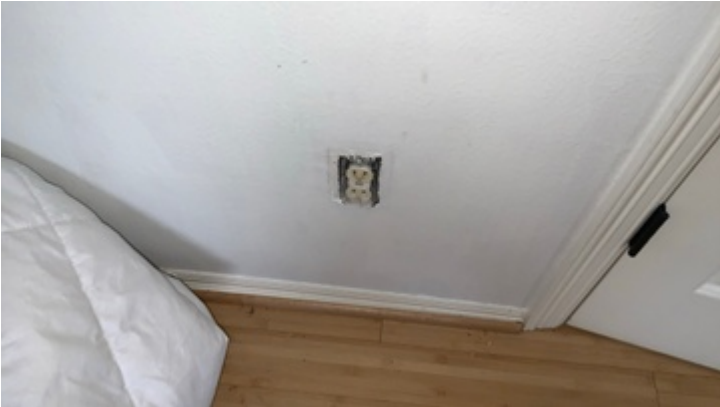
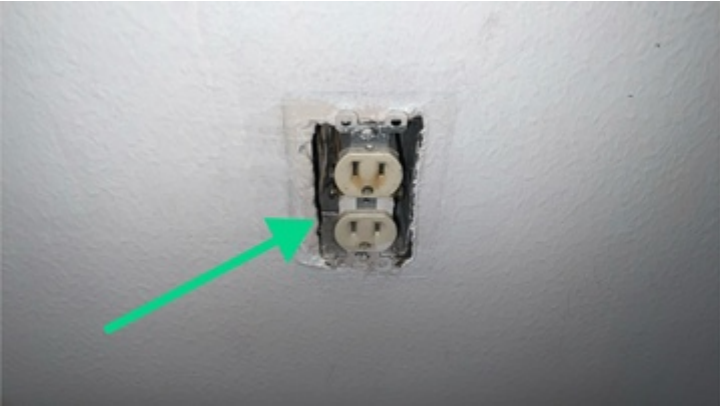
**Missing Cover Plate**

One or more switches / outlets / receptacles are missing a cover plate.

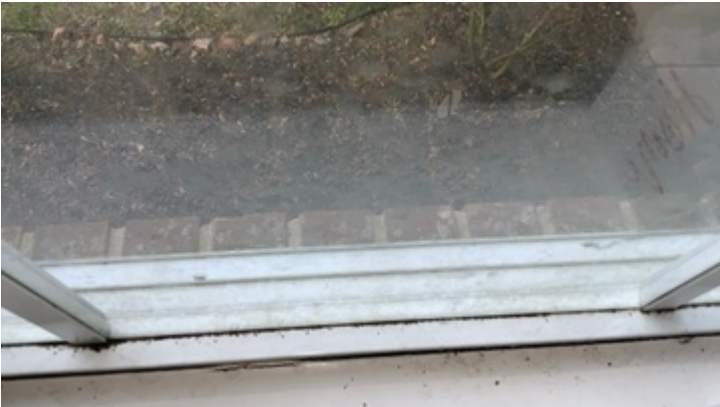
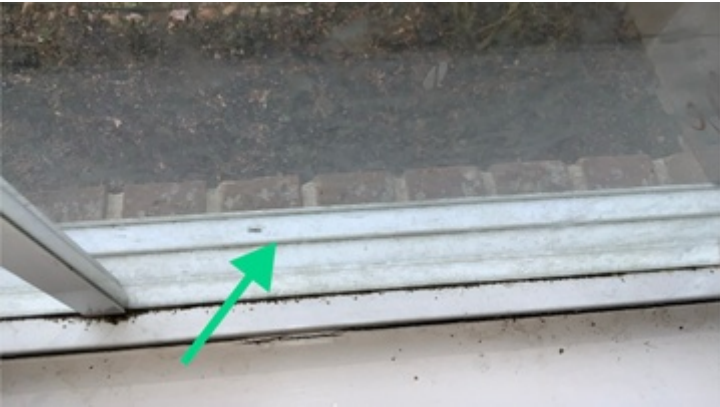
**Missing Window Screen**

One or more windows are missing a screen.

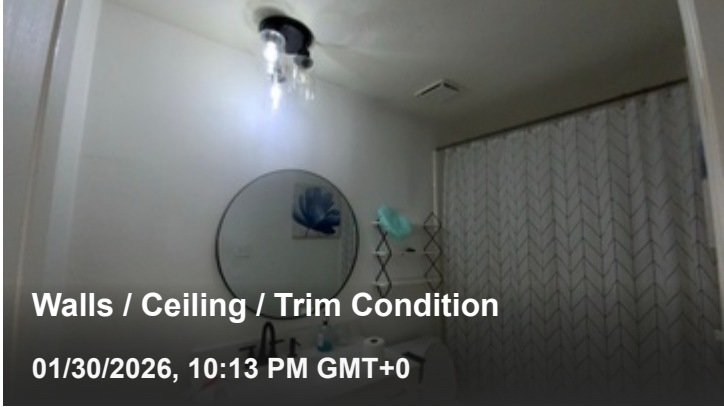
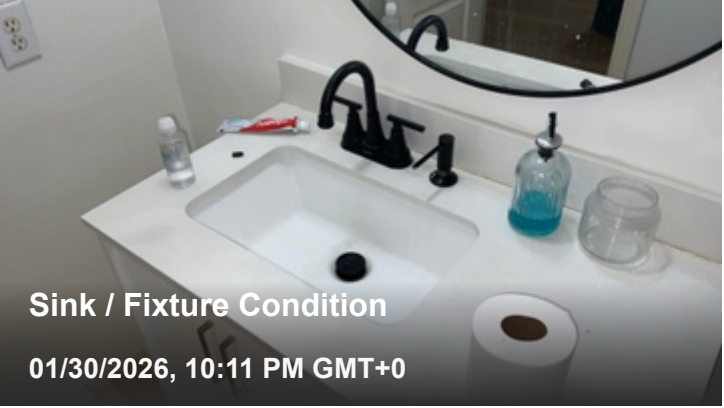
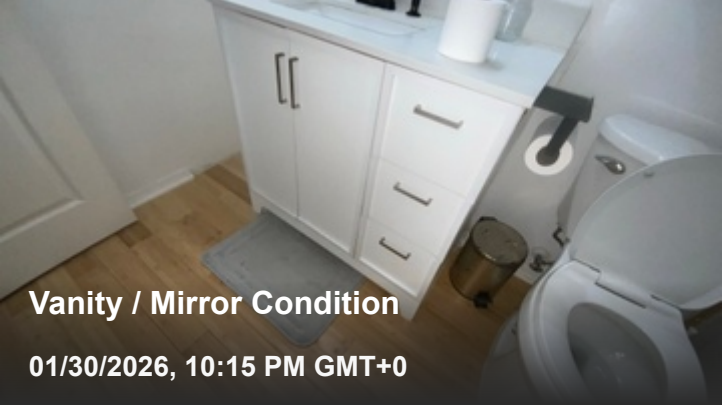
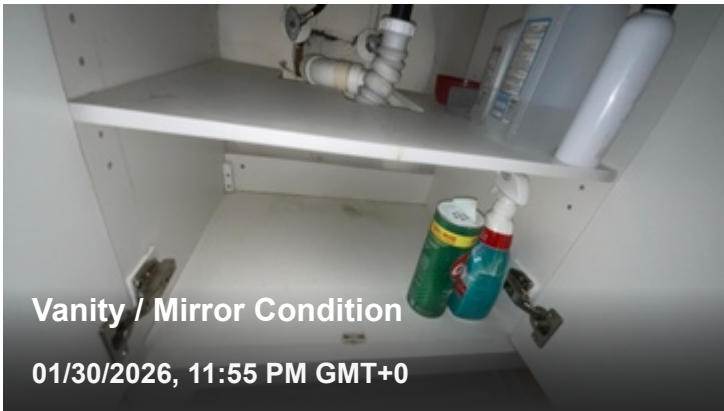
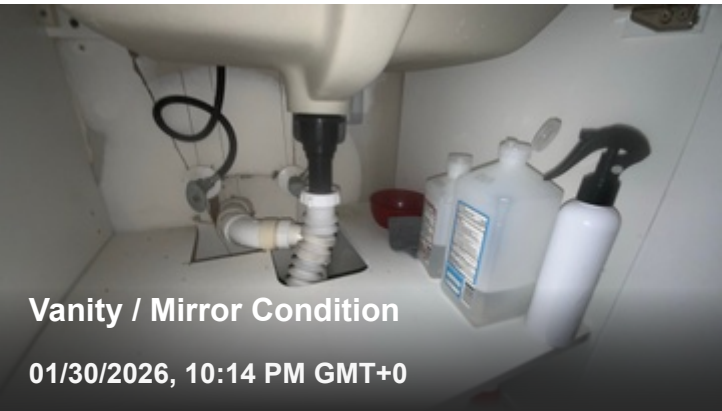
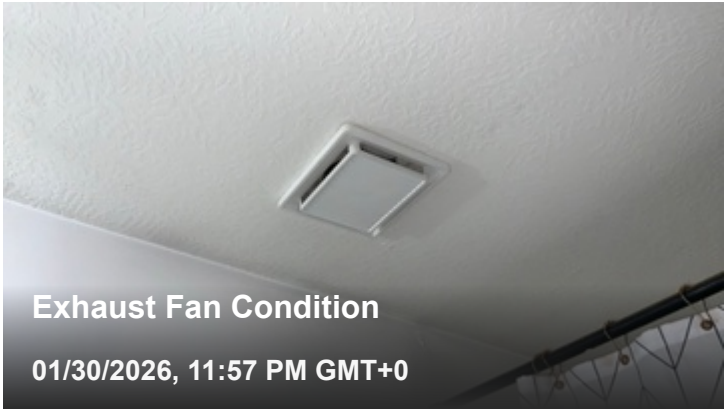
Bathroom 2 photos / videos

**Repair deficiency**

**Damaged Shower Tile**

The shower tile surface in the bathroom is cracked, damaged, or missing.

Minor Wall Cracks

There is minor cracking on the wall / ceiling.

Inoperable or Missing Light Bulb

One or more light bulbs have burnt out or are missing.

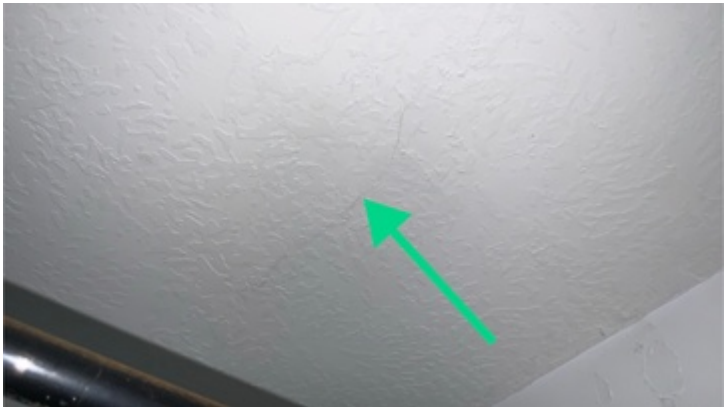
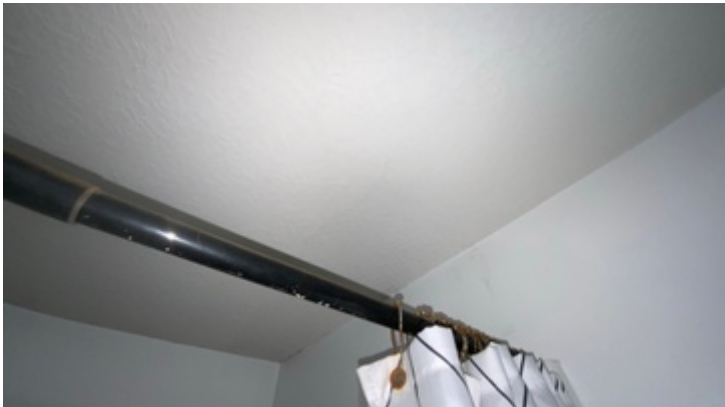
Bathroom 2 photos / videos

Monitor deficiency

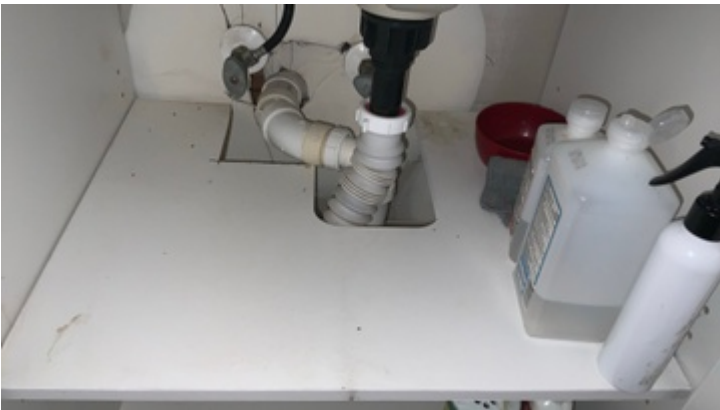
Bathroom 2 photos / videos

Monitor deficiency

The flex draining is prone to clogging.

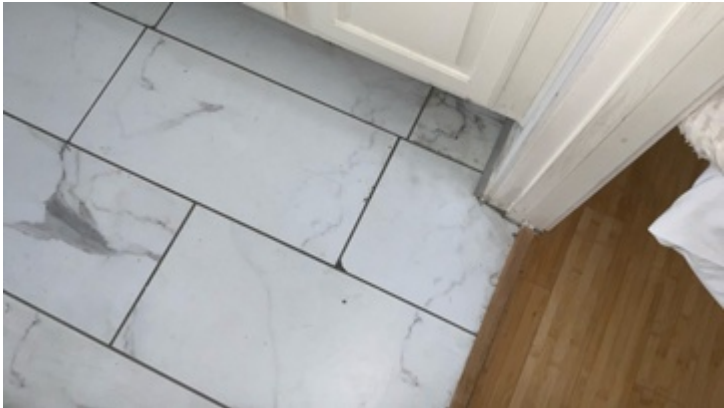
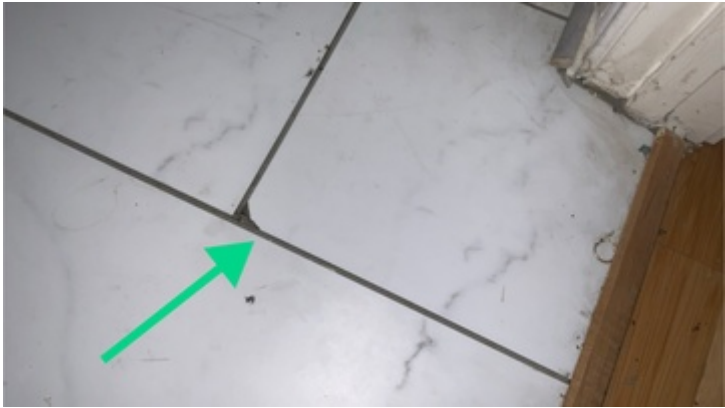
Bathroom 3 photos / videos

**Repair deficiency**

**Loose Tiles**

Loose tiles are present.

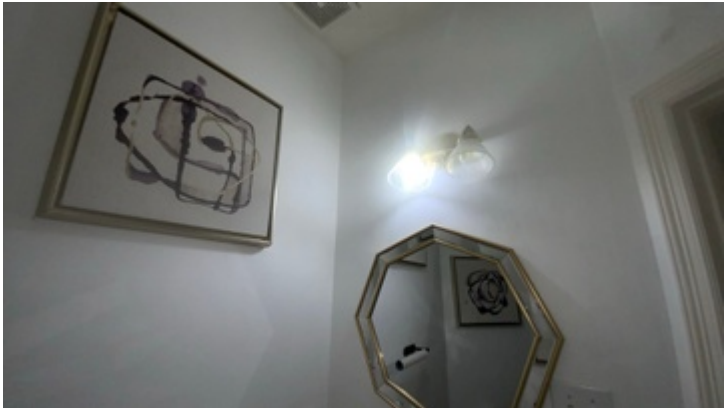
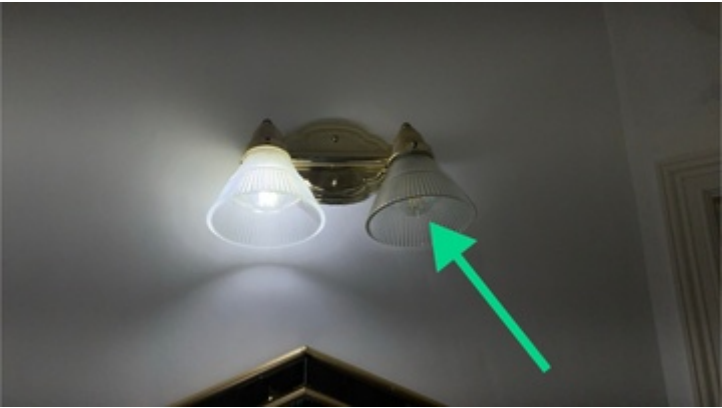
Bathroom 4 photos / videos

Inoperable or Missing Light Bulb

One or more light bulbs have burnt out or are missing.

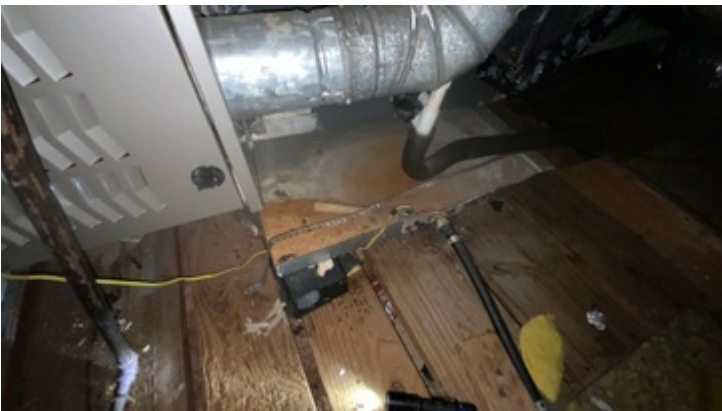
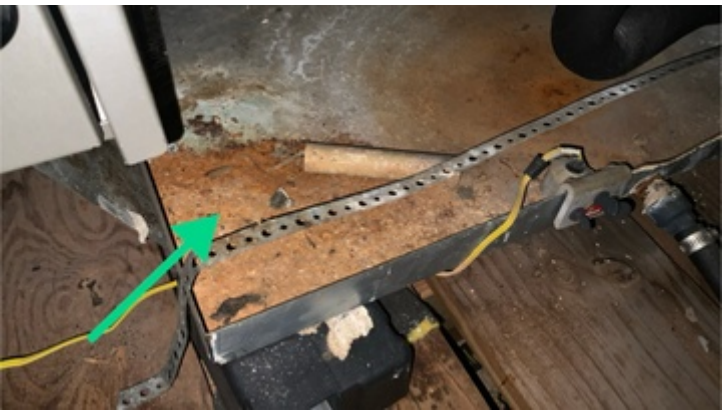
Cooling 2 photos / videos

Rusting or Damaged HVAC Drip Pan

The drip pan below the air conditioning unit is rusting or damaged.

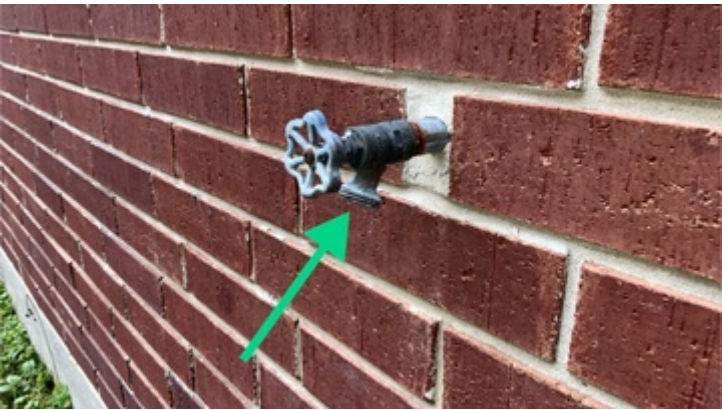
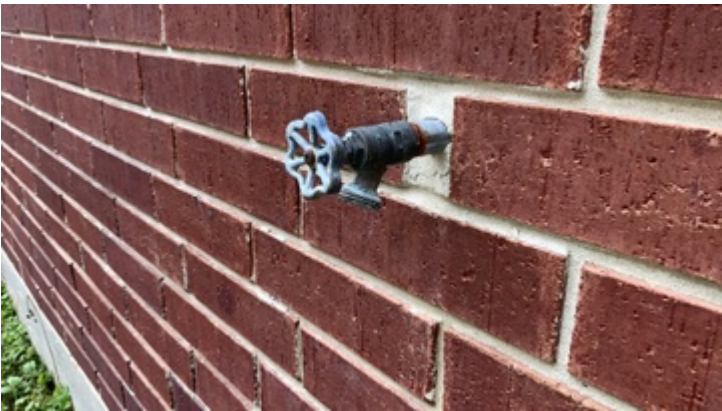
Main Water Supply photos / videos

**Missing Anti-Siphon Valve**

There is no anti-siphon device present.

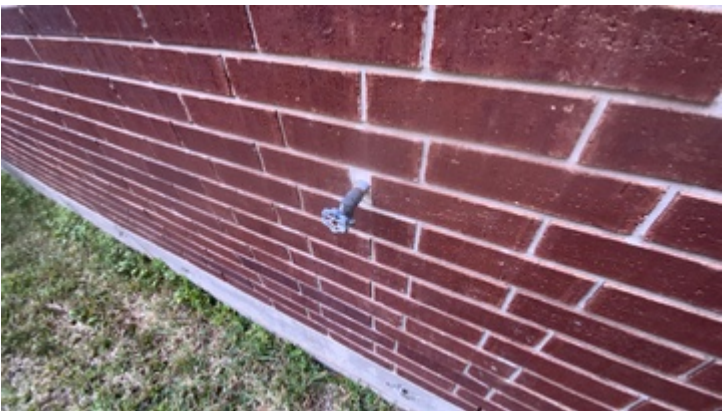
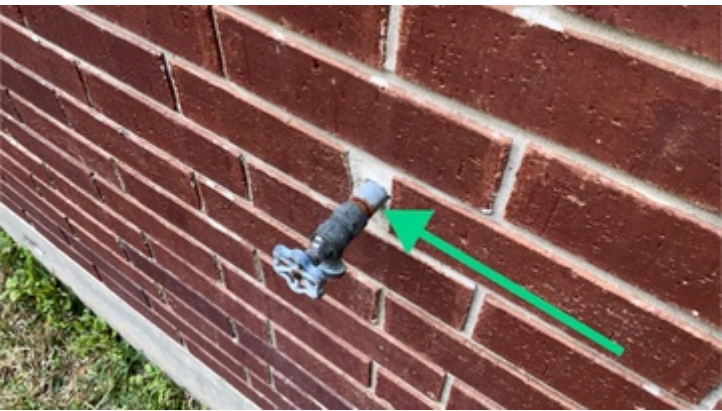
Main Water Supply photos / videos

**Uninsulated Water Lines**

The water lines are uninsulated.

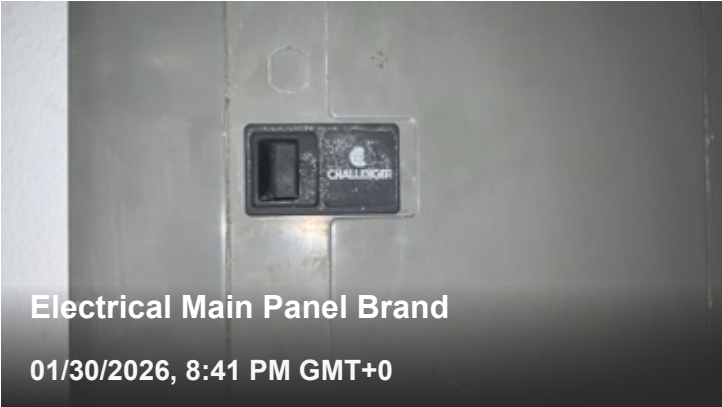
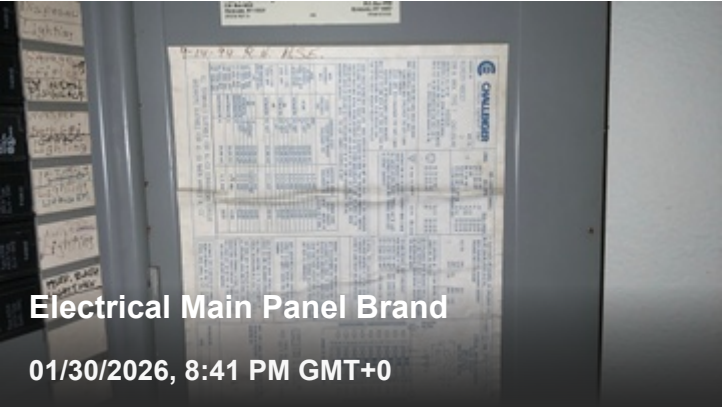
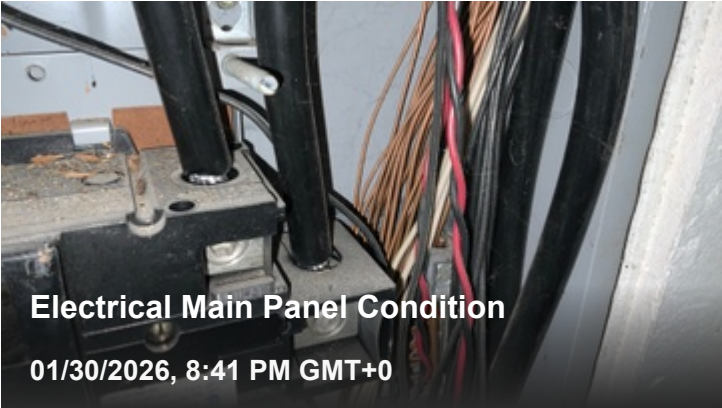
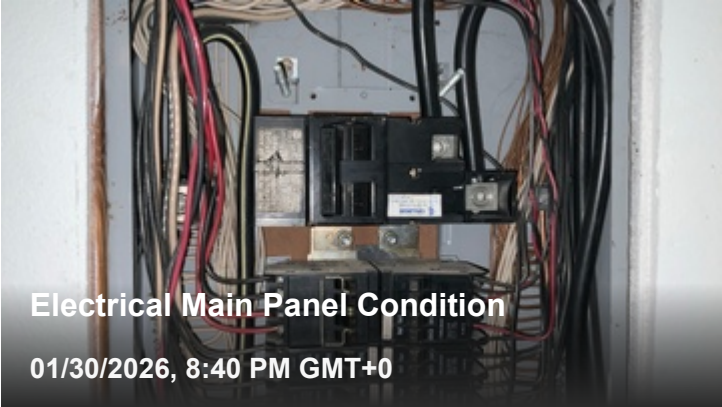
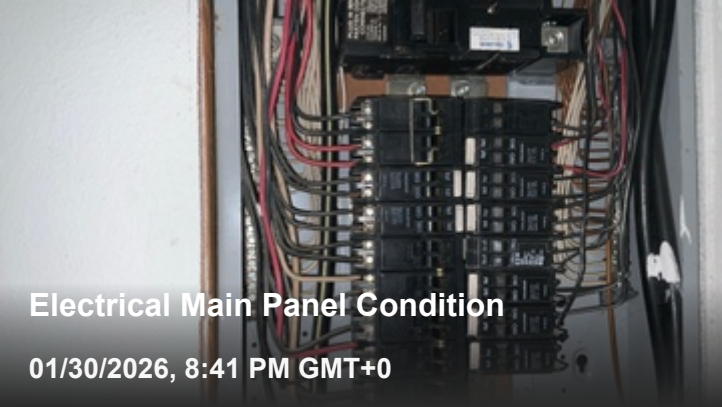
Electrical Main Panel Condition

**Fair (Some Repairs)**

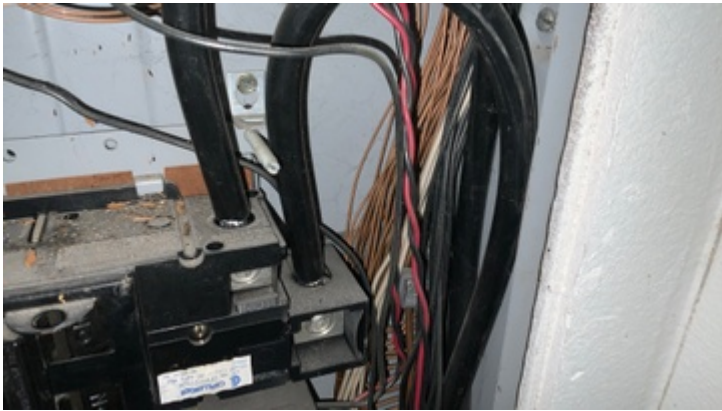
Aluminum wiring in electrical panels is missing an antioxidant application.

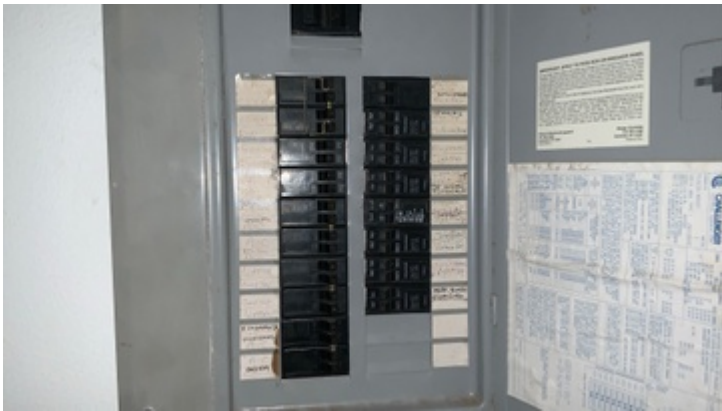
Missing AFCI Breaker

A required Arc-Fault Circuit Interrupter is missing.

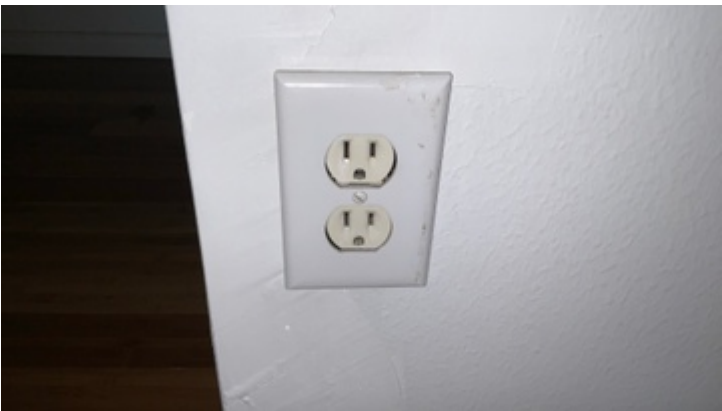
Unsafe Outlets

One or more receptacles / outlets are not tamper resistant.

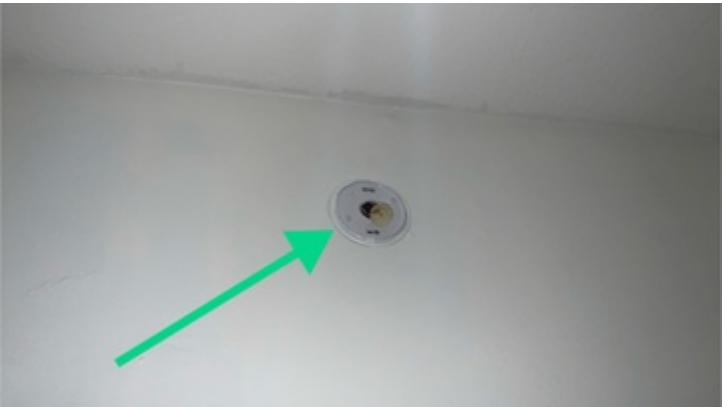
1st Floor

Missing Smoke Detector(s)

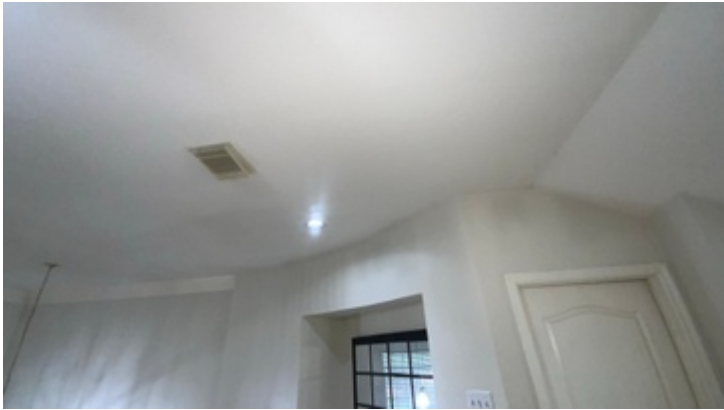
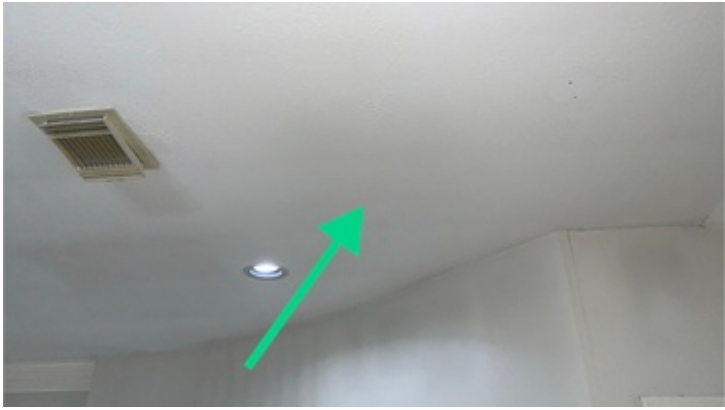
2nd Floor

Missing Carbon Monoxide Detector(s)

One or more carbon monoxide detector(s) is missing or not installed.
