# BIANCHI HOME INSPECTIONS

## PROPERTY INSPECTION REPORT

**Property Address: 1519 Brook Grove Dr.**

**Date of Inspection: 07/18/2024**

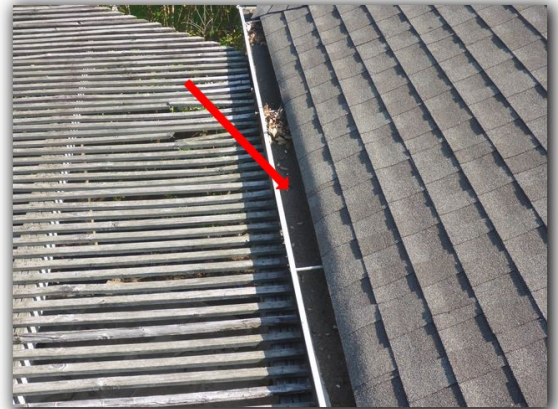
Full of debris and/or holds standing water.

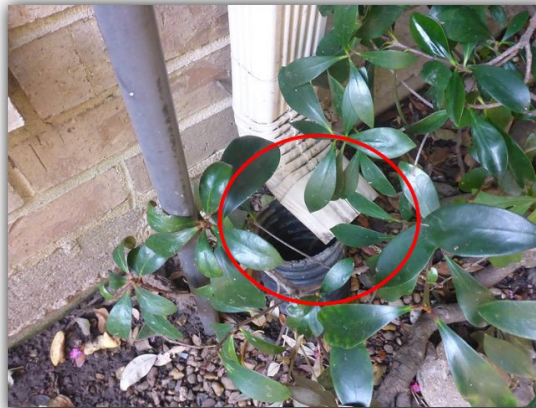
End of downspout(s) needs to be better connected to the drain system at one or more locations.

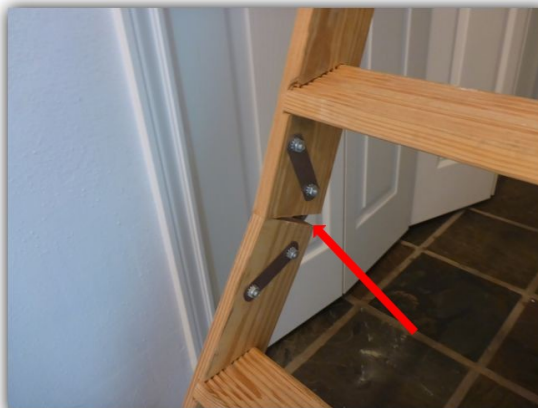
Attic ladder not cut to fit properly, which puts undue stress on the ladder; there should be no gaps at section ends.

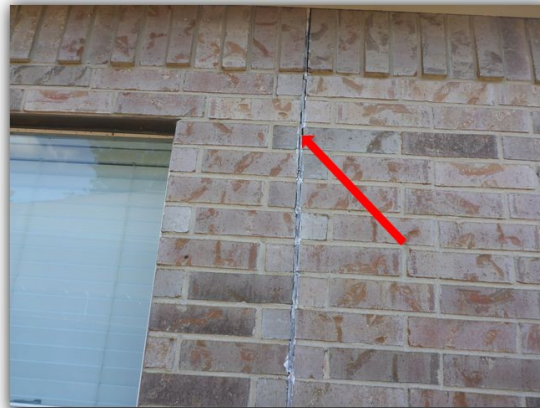
Expansion joint(s) and / or inside corners in brick veneer need caulking. Ensure any mortar present in the expansion joint is first removed before sealing.

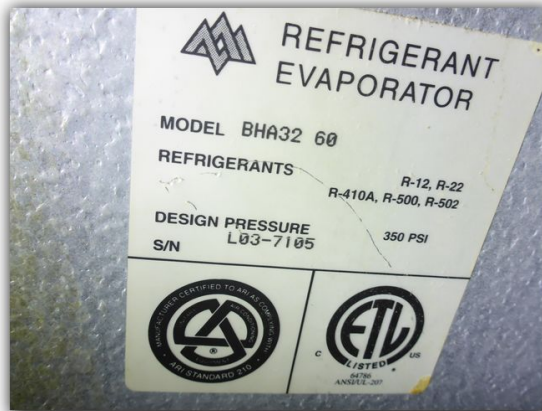
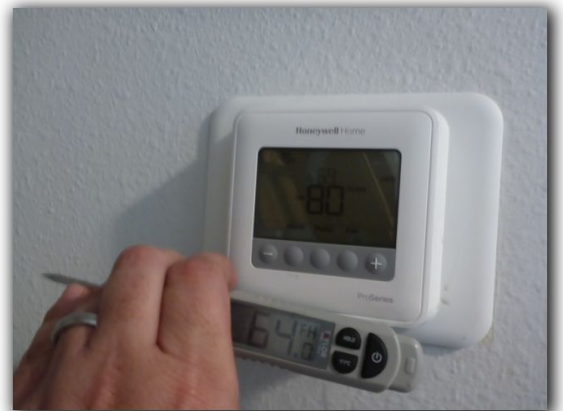
**EVAPORATOR COIL:**

Make: ASPEN AIR (2003)

Capacity: 5 TON

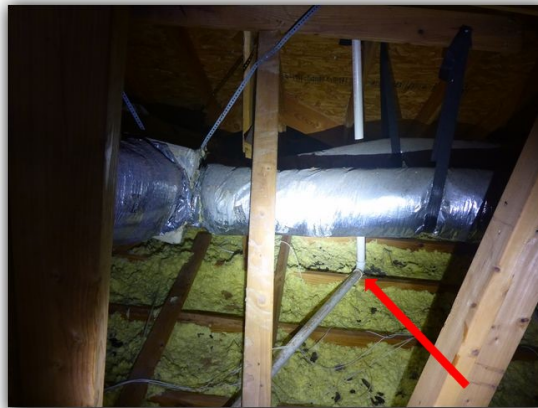
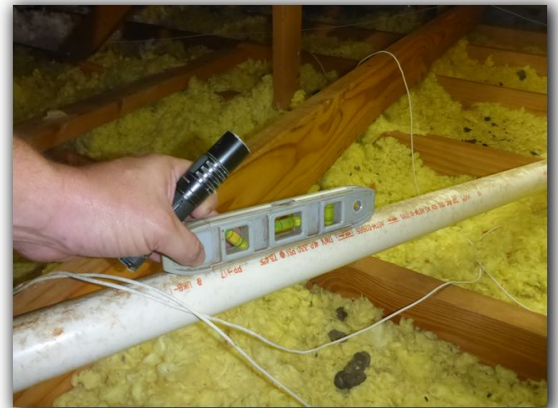
Reverse slope of drain waste vent line, does not tilt towards downhill for drainage of condensate, possibly blocking proper venting of sewer gas.
