HOME INSPECTION 7-6

12818 Ribbon Meadow Ct  
Humble, TX 77346

# PROPERTY INSPECTION REPORT FORM

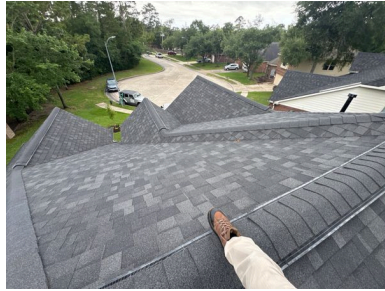
The asphalt shingle roof coverings are in satisfactory condition with normal wear commensurate with the age of the roof.

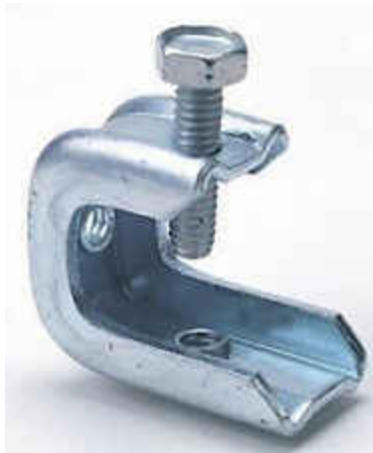
The gas log fireplace does not have a damper clamp. A damper clamp is a required safety device designed to keep the damper partially open at all times. This ensures proper venting of combustion gases, including carbon monoxide, out of the home. Without a damper clamp, the damper could be fully closed while the gas logs are in use, which could lead to dangerous gas buildup inside the home.

Damper clamp example

Recommendation: Contact a qualified professional.

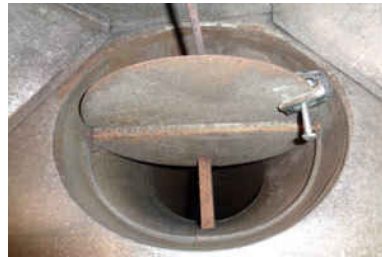
Example of a damper with clamp.

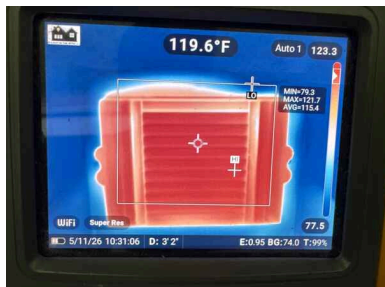
The heating system appeared to be operating at the time of inspection. Supply air temperatures measured at the registers indicated heated air was being delivered to the living space. The photo(s) below show thermal images of representative supply air temperatures at the registers at the time of inspection.

119° supply air

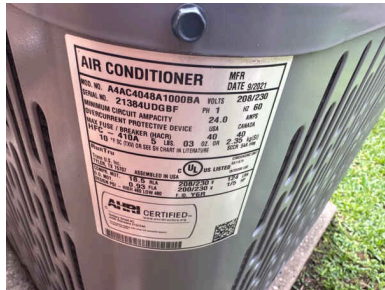
2021 4 ton condenser

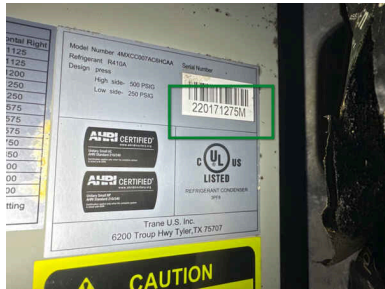
2022 evaporator

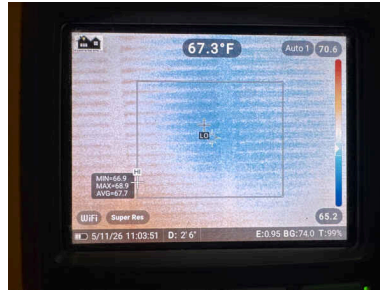
Today's temperature differential (Delta-T): 20 degrees. This component appears to be performing adequately at the time of this inspection. It achieves an operation, function, or configuration consistent with accepted industry practices for its age.

67° return air

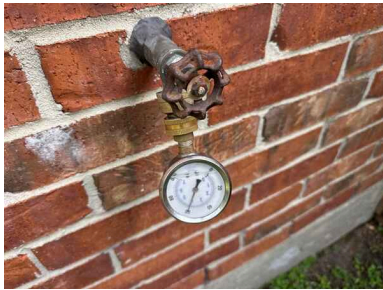
*Static water pressure reading:* 60 psi

60 psi

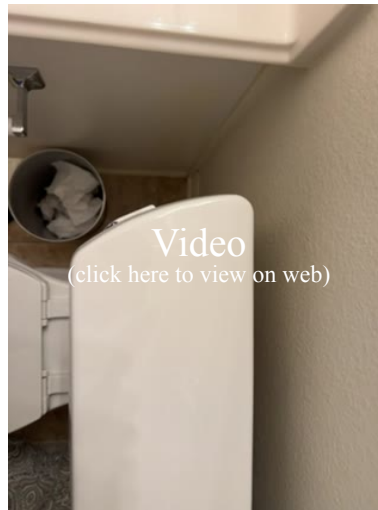
Loose water tank

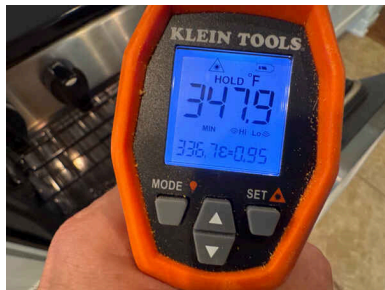
The oven(s) were operated and maintained a temperature within the acceptable range of +/-25 at 350 degrees.

347° oven

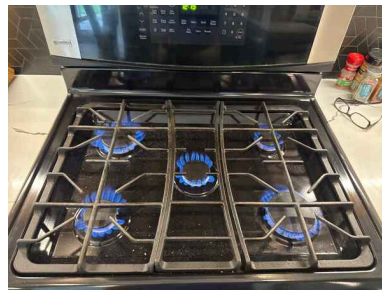
Operational burners

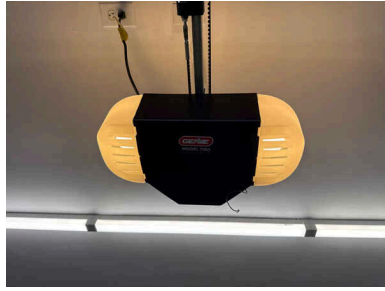
*Auto-opener Manufacturer: GENIE*

The garage door operator(s) were tested by operating the wall-mounted transmitter and checking for proper operation. The door(s) were examined for significant damage or installation-related deficiencies. No reportable conditions were present at the time of inspection unless otherwise noted in this report.

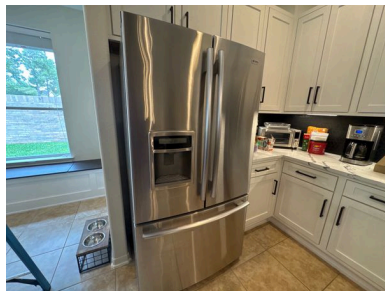
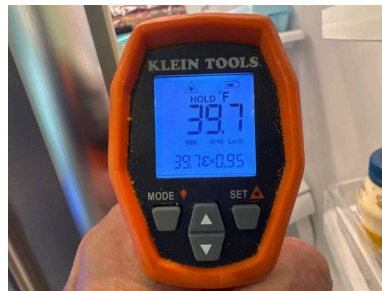
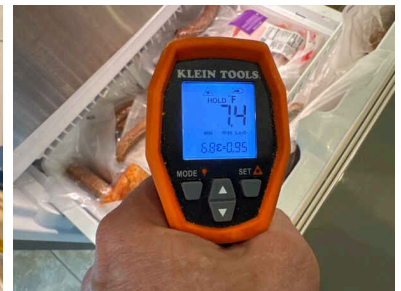
*Refrigerator Manufacturer: KENMORE -*

*The refrigerator and freezer were operating at appropriate temperatures at the time of inspection. The ice maker was also operational. No deficiencies were noted with the visible operation at the time of inspection.*

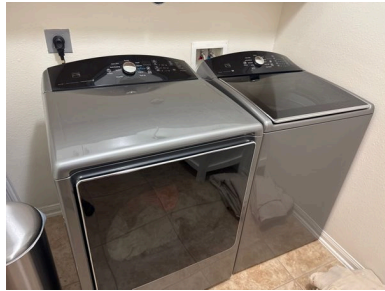
Washer/Dryer Manufacturer: Kenmore -

The washer and dryer were operated through a normal cycle at the time of inspection. Both appeared to be functioning as intended, and no deficiencies were noted with their visible operation.

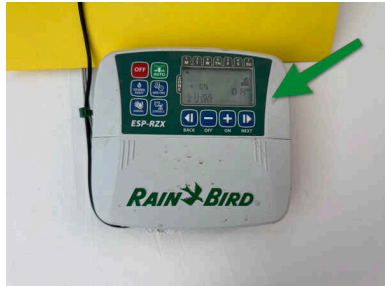
Control panel

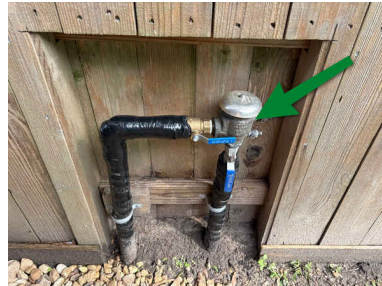
Backflow preventer

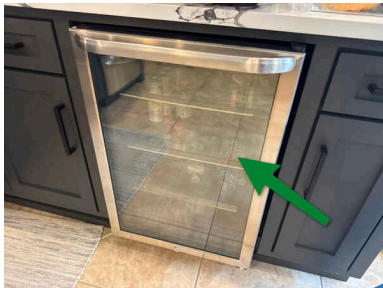
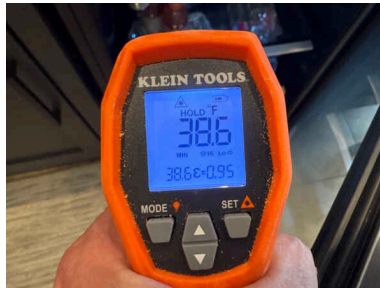
*Beverage refrigerator :*

The beverage refrigerator was operating at an appropriate temperature at the time of inspection. No deficiencies were noted with the visible operation.
