BUILDING ENVELOPE MOISTURE INSPECTION

2135 Quenby St
Houston, TX 77005

Maja Djukic
04/03/2025

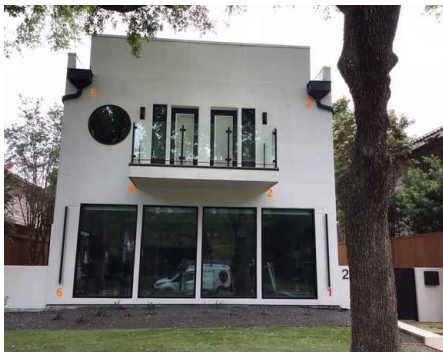
Photo of elevation with test sites:
Photo of Elevation

DETERIORATED SITES

Test Sites	%	Substrate Condition
1	None Taken	Soft

Test Site	%	Substrate Condition
2	31% (Saturated)	Firm
3	54% (Saturated)	Firm
4	21% (Saturated)	Firm
5	24% (Saturated)	Firm
6	55% (Saturated)	Firm

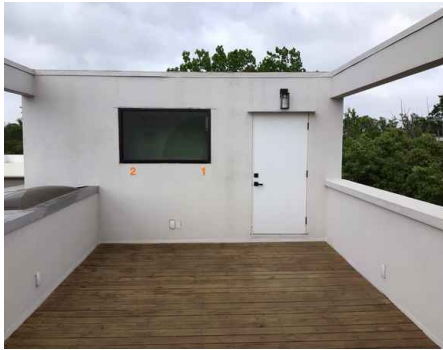
6.1.1 Photo of elevation with test sites

Photo of elevation with test sites:
