Moisture Inspection Report

Inspected for
Adam Garst
2135 Quenby St
Houston, TX 77005
1/2/2026

Property Address: 2135 Quenby St , Houston TX 77005			
Property Information		Inspection Information	
Client's Name	Adam Garst	Inspection Type	Invasive Moisture Inspection
Client's Phone	281-610-1296	Date of Inspection	1/2/2026
Client's Email	garstadam@gmail.com	Inspector	Tony Trinidad EDI #TX-192
Type of Exterior	Hard Coat Stucco	Present at Inspection	Buyer(s), Buyer's realtor(s), Home Inspector
Substrate (if known)	Wood	Temperature	70-80 degrees
Property Age	46	Weather Conditions	Clear, Dry
Square Footage	4079	Last Known Rainfall	2-5 days
Stories	3		
Type of Windows	Metal

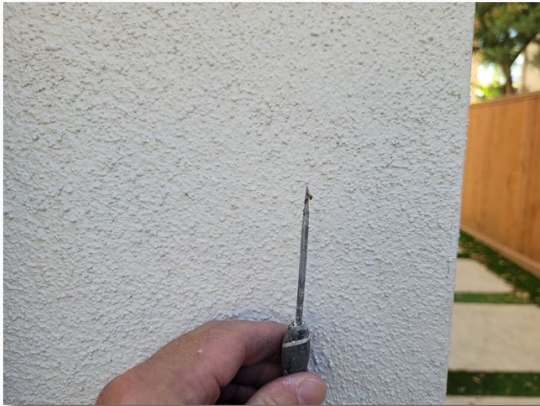
1 - 1: Moisture Intrusion: Areas of elevated moisture and / or possible substrate / framing damage was found at the following locations as reported on the "Moisture Testing" page:

Soft or Missing Substrate - Refer to the *Moisture Testing page for the condition of the substrate at each test location*. If the substrate is not firm when inserting the moisture meter probes, this can indicate possible wood rot / damage due to previous or active water penetrations in the area near the probed location.

1- 1.1 Example of dark / discolored wood on probe, indication of wood rot

Repair Process: It is recommended that these areas be further assessed and repaired by a qualified stucco contractor, as needed. Core sampling or inspection holes should be performed by your contractor to confirm any suspected substrate and / or framing damage found by the inspector. Test locations are not representative of the total area of suspected damage, but provide information on general areas where repairs may be needed. Typical repairs to remedy soft or missing substrate include doing a partial tear-off of the stucco around the location until clean dry substrate is found and repairing as needed. During repairs, the total area any underlying damage should be determined by your contractor. It is important to thoroughly review and understand the scope of work in the repair proposal provided by your contractor. In addition, it is recommended to discuss the potential for "Change Orders" that may occur once work begins.

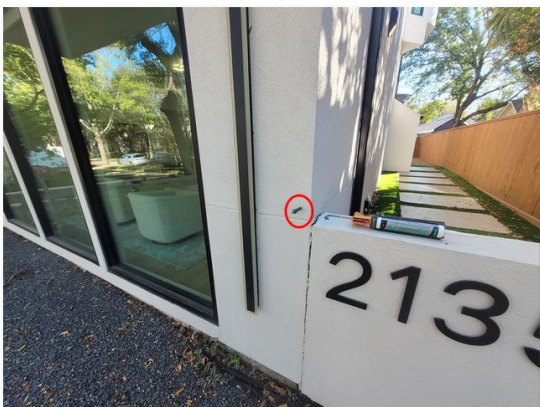
1- 1.3 Test Location K - Soft substrate encountered

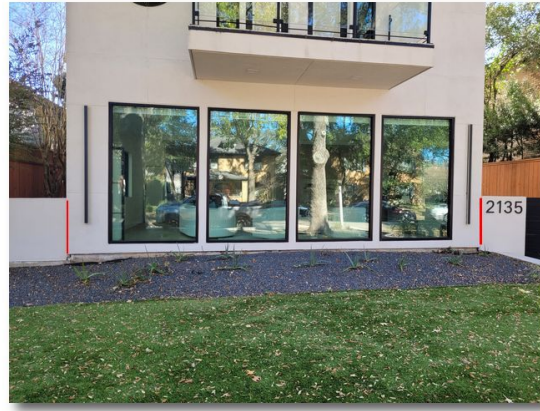
1- 2.2

1 - 2: Damaged / Aged / Missing Sealant: Damaged, aged, and / or missing sealant was found at wall penetrations, joints, windows, and / or other voids on the exterior. Properly installed sealant provides a barrier against moisture intrusion. Recommend repairs using a top quality, low modulus, polyurethane sealant or sealant recommended by the manufacturer of your system.

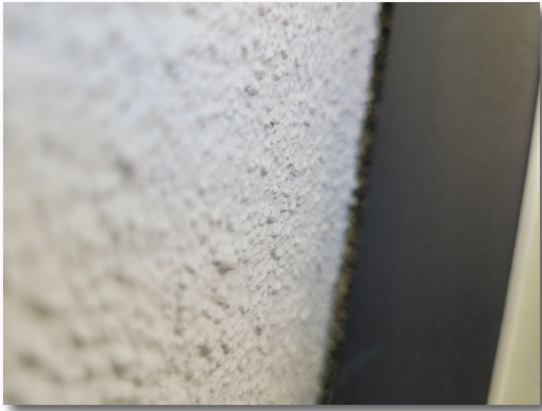
1- 2.3 Seal all lights

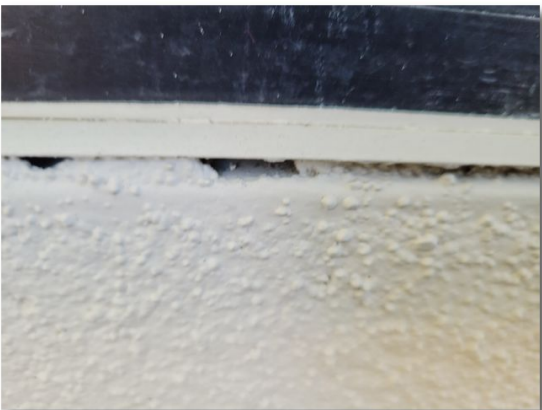
1- 2.5 Seal windows

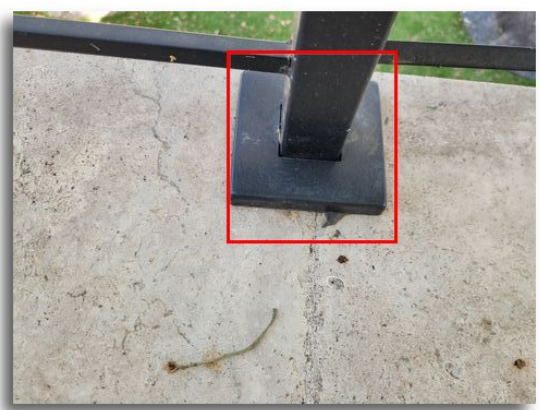
1- 2.6 Seal top mount fasteners on balcony

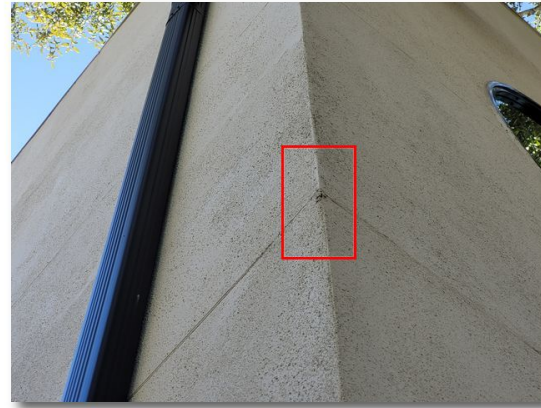
1- 3.2

1 - 3: **Cracks Present:** Cracks were found at the stucco cladding. Hairline cracks (generally 1/16 of an inch) are commonly found with stucco systems. These cracks should be monitored and repaired as needed. It is recommend that cracks larger than hairline are repaired by a qualified stucco contractor.

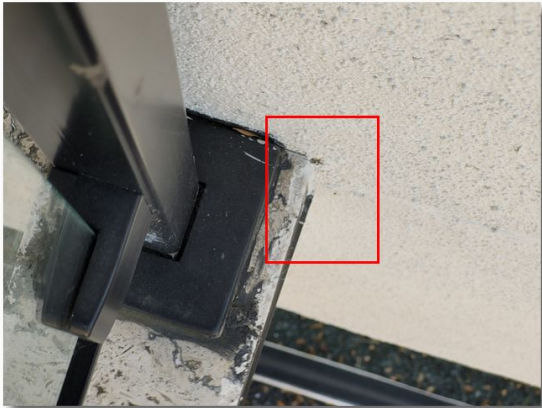
1- 5.1

1 - 5: Balcony Diverter Flashing Missing: Diverter flashing has not been installed at the wall and balcony intersections. Diverter flashing helps to prevent moisture intrusion and allow water to properly drain away from the wall. It is recommended to install diverter flashing when elevated moisture or damage is discovered as a result of the missing flashing. Installation typically requires removal of all waterproofing/tiles so the flashing can be installed over the wood or appropriate membrane. **Retrofitting flashing is not a recommended repair.**

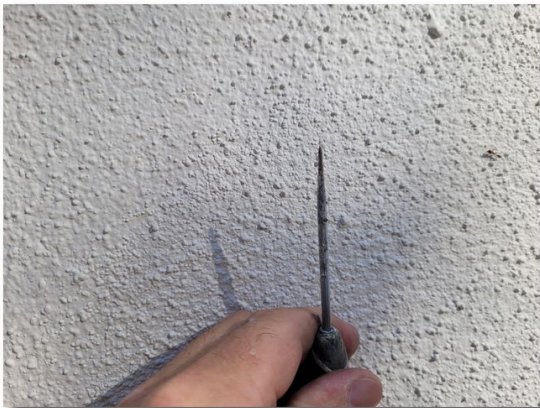
2- 1.1 Example of dark / discolored wood on probe, indication of wood rot

Repair Process: It is recommended that these areas be further assessed and repaired by a qualified stucco contractor, as needed. Core sampling or inspection holes should be performed by your contractor to confirm any suspected substrate and / or framing damage found by the inspector. Test locations are not representative of the total area of suspected damage, but provide information on general areas where repairs may be needed. Typical repairs to remedy soft or missing substrate include doing a partial tear-off of the stucco around the location until clean dry substrate is found and repairing as needed. During repairs, the total area any underlying damage should be determined by your contractor. It is important to thoroughly review and understand the scope of work in the repair proposal provided by your contractor. In addition, it is recommended to discuss the potential for "Change Orders" that may occur once work begins.

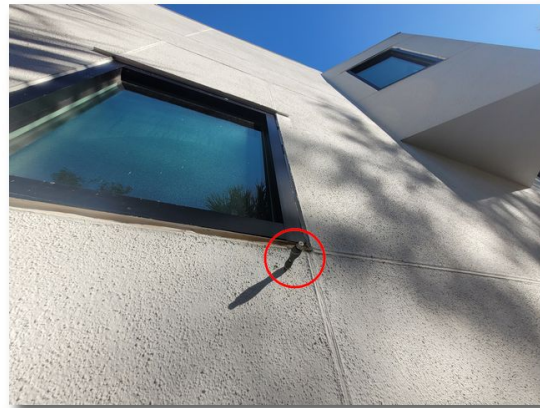
Test Location	Moisture Content	Substrate Condition	Additional comments
A	<15%	Firm	Reading taken below window.
B	N/A	Soft	Soft substrate was observed when drilling/probing. This is an indication of moisture damage / wood rot. Reading taken below window.
C	N/A	Soft	Soft substrate was observed when drilling/probing. This is an indication of moisture damage / wood rot. Reading taken at roof / wall intersection.
D	N/A	Soft	Soft substrate was observed when drilling/probing. This is an indication of moisture damage / wood rot. Reading taken mid wall.
E	<15%	Firm	
F	N/A	Soft	Soft substrate was observed when drilling/probing. This is an indication of moisture damage / wood rot. Reading taken below window.
G	N/A	Soft	Soft substrate was observed when drilling/probing. This is an indication of moisture damage / wood rot. Drainage relief not present.
H	N/A	Soft	Soft substrate was observed when drilling/probing. This is an indication of moisture damage / wood rot. Drainage relief not present.

2- 1.2 Test Location B - Soft substrate encountered

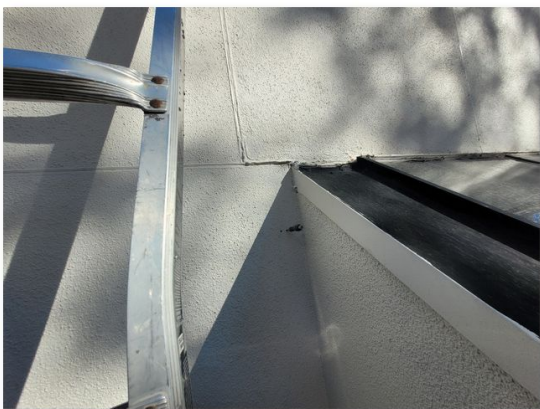
2- 1.3 Test Location C - Soft substrate encountered

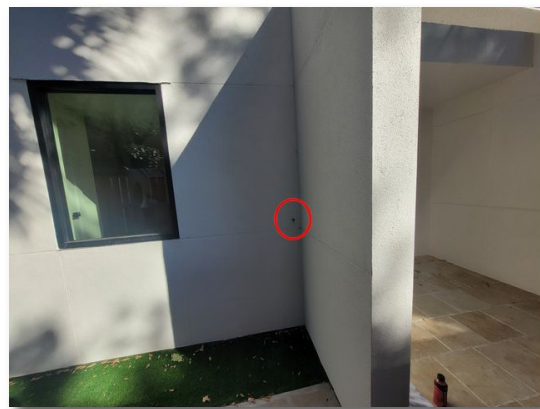
2- 1.4 Test Location D - Soft substrate encountered

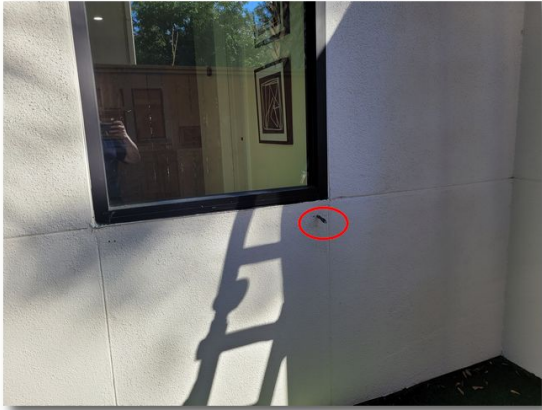
2- 1.5 Test Location F - Soft substrate encountered

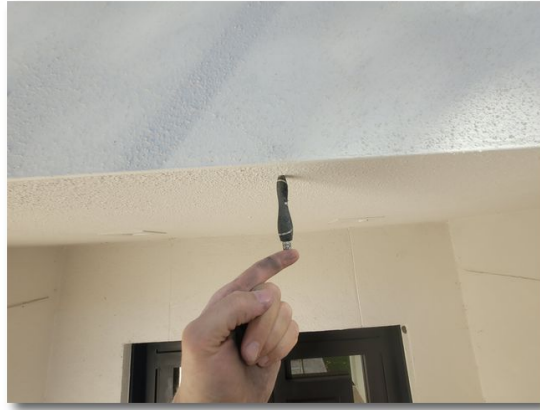
2- 1.6 Test Location G - Soft substrate encountered

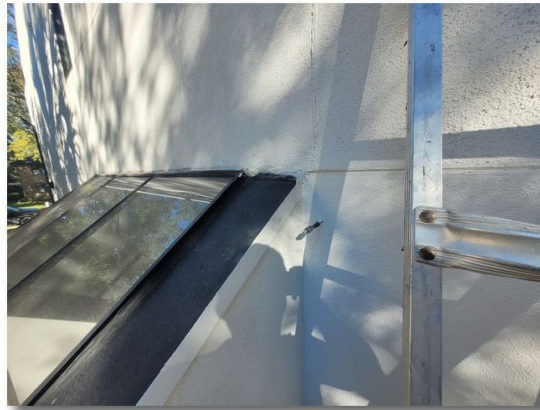
2- 1.8 Test Location I - Soft substrate encountered

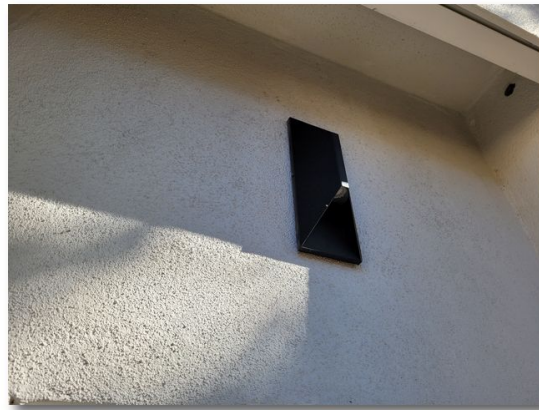
2 - 2: Damaged / Aged / Missing Sealant: Damaged, aged, and / or missing sealant was found at wall penetrations, joints, windows, and / or other voids on the exterior. Properly installed sealant provides a barrier against moisture intrusion. Recommend repairs using a top quality, low modulus, polyurethane sealant or sealant recommended by the manufacturer of your system.

2- 2.2 Seal lights

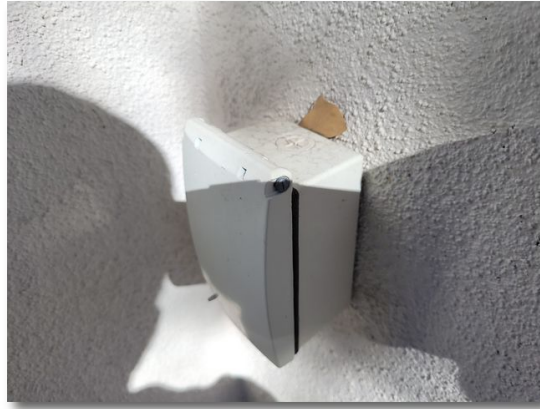
2- 2.6 Seal outlet

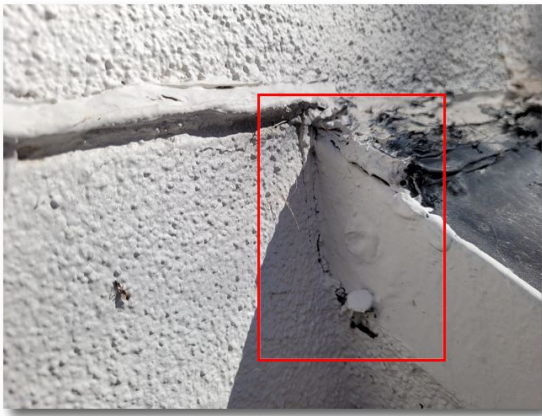
2- 2.7 Seal roof / wall intersections

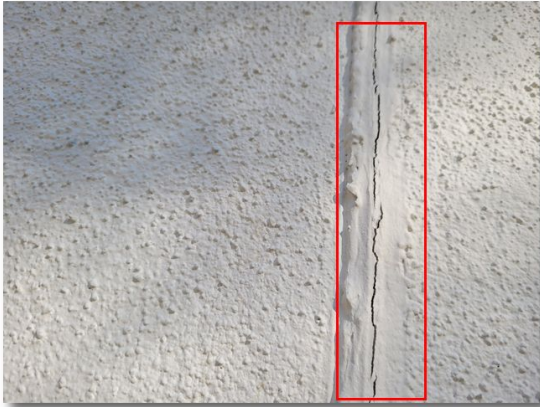
2- 3.3 Control joint crack

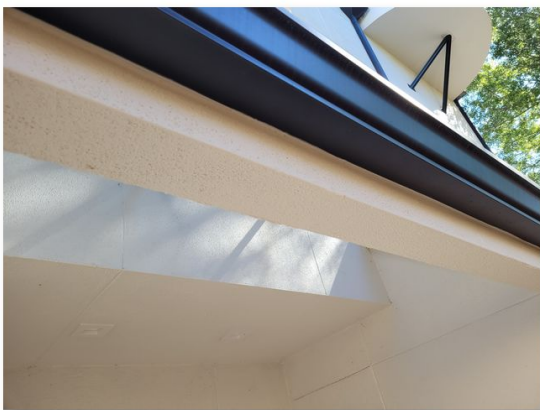
2- 4.1

2 - 4: Missing Drainage Openings: Drainage openings are not installed at the stucco walls / soffit. Drainage openings assist with allowing incidental moisture to escape. Incidental moisture can become trapped in these enclosed areas, sometimes referred to as a "stucco bucket". This trapped moisture can lead to wood rot at the substrate and framing. **If** elevated moisture or possible substrate / framing damage was found, a drainage opening should be installed during repairs.

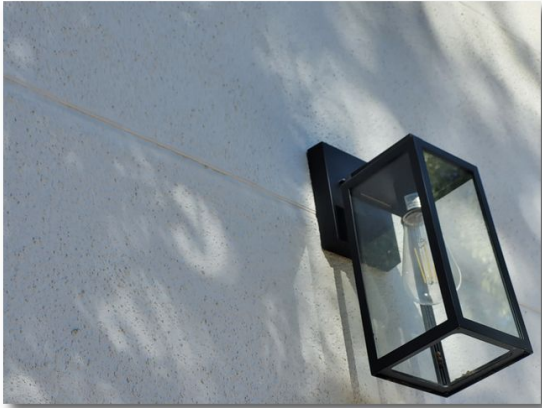
3 - 1: Damaged / Aged / Missing Sealant: Damaged, aged, and / or missing sealant was found at wall penetrations, joints, windows, and / or other voids on the exterior. Properly installed sealant provides a barrier against moisture intrusion. Recommend repairs using a top quality, low modulus, polyurethane sealant or sealant recommended by the manufacturer of your system.

3- 1.1 Seal light

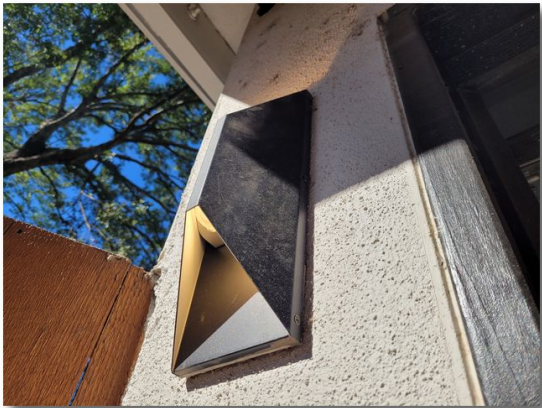
3- 1.3 Seal lights

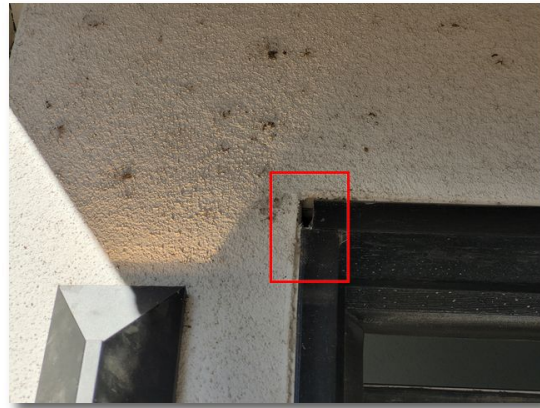
3- 1.4 Seal void at top left corner of garage

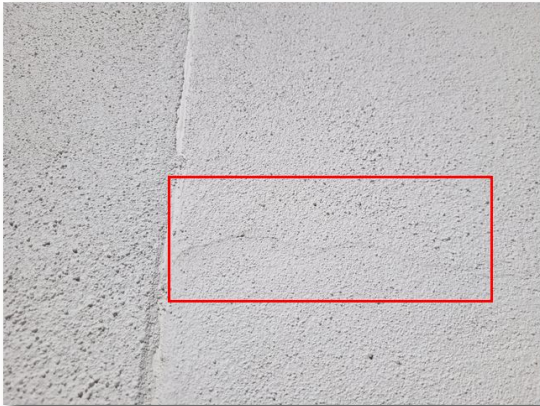
3- 2.1

3 - 2: Cracks Present: Cracks were found at the stucco cladding. Hairline cracks (generally 1/16 of an inch) are commonly found with stucco systems. These cracks should be monitored and repaired as needed. It is recommend that cracks larger than hairline are repaired by a qualified stucco contractor.

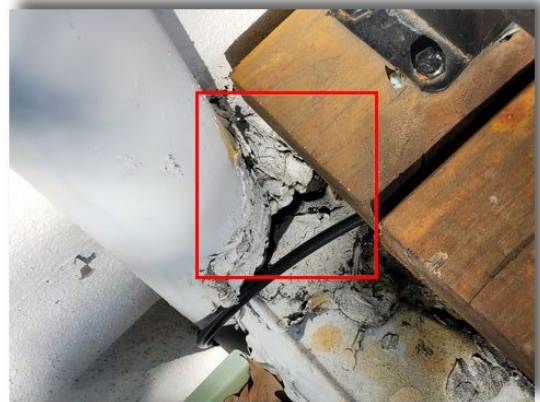
3- 3.1

3 - 3: Balcony Diverter Flashing Missing: Diverter flashing has not been installed at the wall and balcony intersections. Diverter flashing helps to prevent moisture intrusion and allow water to properly drain away from the wall. It is recommended to install diverter flashing when elevated moisture or damage is discovered as a result of the missing flashing. Installation typically requires removal of all waterproofing/tiles so the flashing can be installed over the wood or appropriate membrane. *Retrofitting flashing is not a recommended repair.*

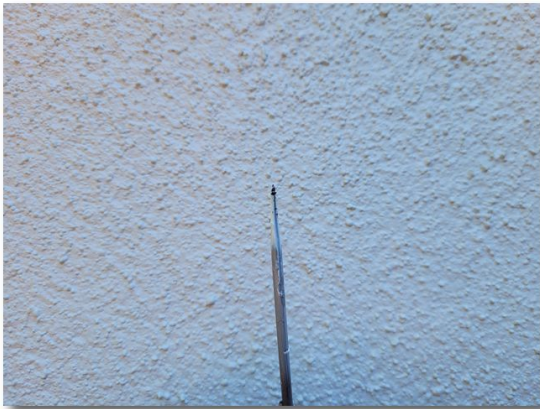
4 - 1: Moisture Intrusion: Areas of elevated moisture and / or possible substrate / framing damage was found at the following locations as reported on the "Moisture Testing" page:

4- 1.1 Example of dark / discolored wood on probe, indication of wood rot

Repair Process: It is recommended that these areas be further assessed and repaired by a qualified stucco contractor, as needed. Core sampling or inspection holes should be performed by your contractor to confirm any suspected substrate and / or framing damage found by the inspector. Test locations are not representative of the total area of suspected damage, but provide information on general areas where repairs may be needed. Typical repairs to remedy soft or missing substrate include doing a partial tear-off of the stucco around the location until clean dry substrate is found and repairing as needed. During repairs, the total area any underlying damage should be determined by your contractor. It is important to thoroughly review and understand the scope of work in the repair proposal provided by your contractor. In addition, it is recommended to discuss the potential for "Change Orders" that may occur once work begins.

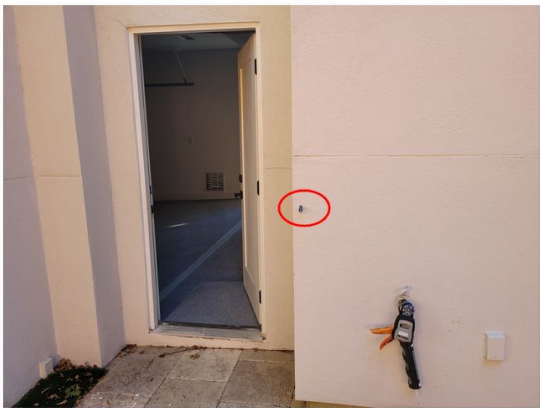
Test Location	Moisture Content	Substrate Condition	Additional comments
A	<15%	Firm	
B	N/A	Soft	Soft substrate was observed when drilling/probing. This is an indication of moisture damage / wood rot. Corner cracks needing repair present.
C	N/A	Soft	Soft substrate was observed when drilling/probing. This is an indication of moisture damage / wood rot. Corner cracks needing repair present.
D	N/A	Soft	Soft substrate was observed when drilling/probing. This is an indication of moisture damage / wood rot. Diverter flashing not installed at balcony intersection.
E	<15%	Firm	
F	<15%	Firm	
G	N/A	Soft	Soft substrate was observed when drilling/probing. This is an indication of moisture damage / wood rot.
H	<15%	Firm

4- 1.3 Test Location C - Soft substrate encountered

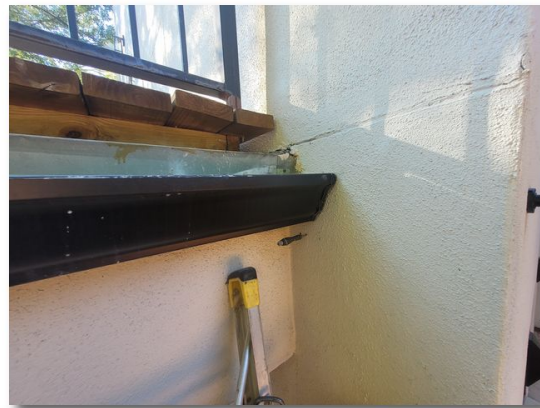
4- 1.4 Test Location D - Soft substrate encountered

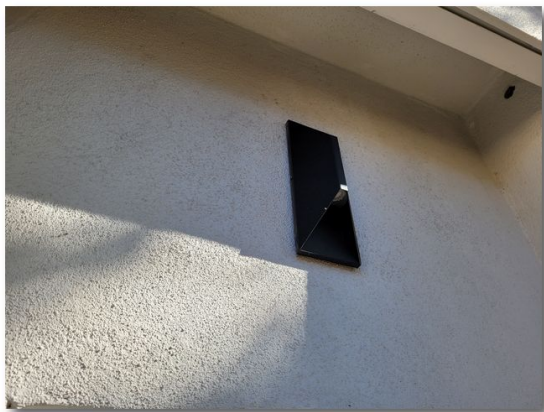
4 - 2: Damaged / Aged / Missing Sealant: Damaged, aged, and / or missing sealant was found at wall penetrations, joints, windows, and / or other voids on the exterior. Properly installed sealant provides a barrier against moisture intrusion. Recommend repairs using a top quality, low modulus, polyurethane sealant or sealant recommended by the manufacturer of your system.

4- 2.3 Seal lights

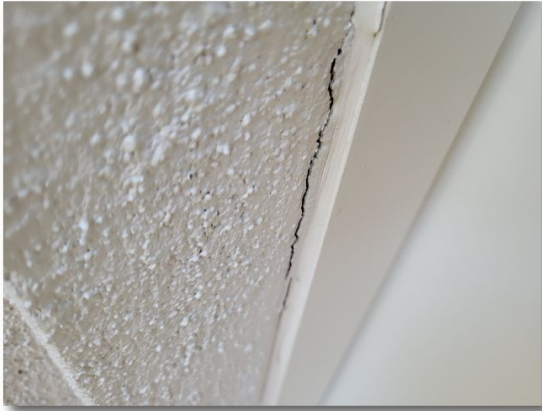
4- 2.5 Seal door frame

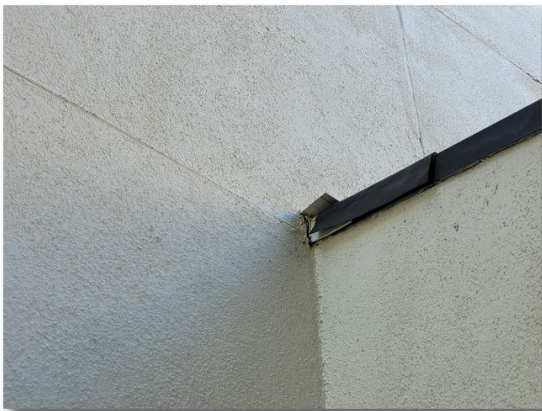
4- 2.7 Seal roof / wall intersection

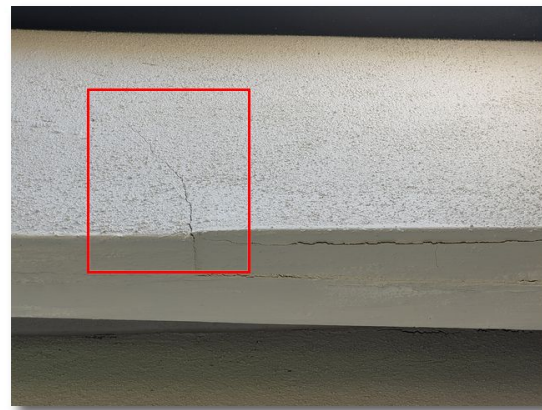
4- 3.2

4 - 3: Cracks Present: Cracks were found at the stucco cladding. Hairline cracks (generally 1/16 of an inch) are commonly found with stucco systems. These cracks should be monitored and repaired as needed. It is recommend that cracks larger than hairline are repaired by a qualified stucco contractor.

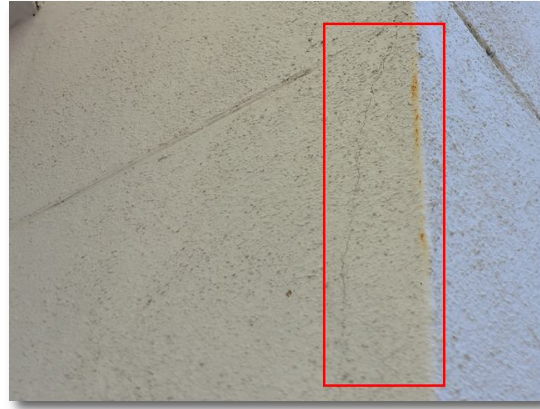
4- 3.4 Corner crack

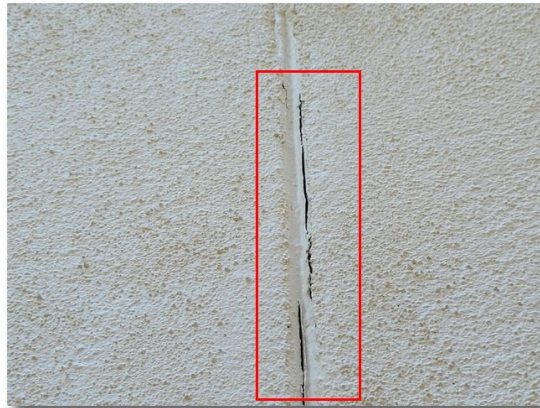
4- 3.8 Control joint crack

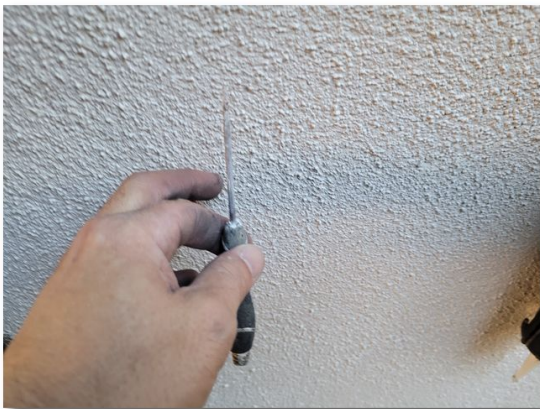
5 - 1: Moisture Intrusion: Areas of elevated moisture and / or possible substrate / framing damage was found at the following locations as reported on the "Moisture Testing" page:

5- 1.1 Example of dark / discolored wood on probe, indication of wood rot

Repair Process: It is recommended that these areas be further assessed and repaired by a qualified stucco contractor, as needed. Core sampling or inspection holes should be performed by your contractor to confirm any suspected substrate and / or framing damage found by the inspector. Test locations are not representative of the total area of suspected damage, but provide information on general areas where repairs may be needed. Typical repairs to remedy soft or missing substrate include doing a partial tear-off of the stucco around the location until clean dry substrate is found and repairing as needed. During repairs, the total area any underlying damage should be determined by your contractor. It is important to thoroughly review and understand the scope of work in the repair proposal provided by your contractor. In addition, it is recommended to discuss the potential for "Change Orders" that may occur once work begins.

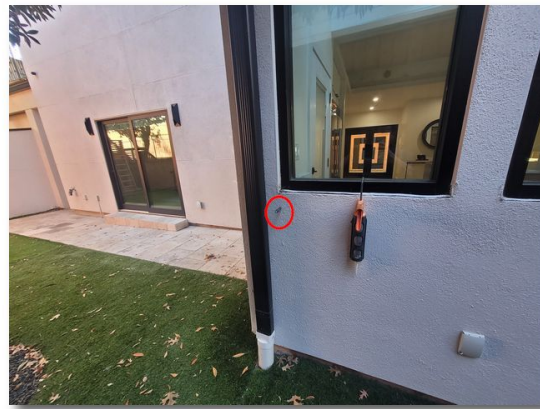
Test Location	Moisture Content	Substrate Condition	Additional comments
A	N/A	Soft	Soft substrate was observed when drilling/probing. This is an indication of moisture damage / wood rot.
B	<15%	Firm	
C	<15%	Firm	
D	<15%	Firm	
E	<15%	Firm	
F	N/A	Soft	Soft substrate was observed when drilling/probing. This is an indication of moisture damage / wood rot.
G	<15%	Firm	
H	<15%	Firm	
I	N/A	Soft	Soft substrate was observed when drilling/probing. This is an indication of moisture damage / wood rot.
J	<15%	Firm	
K	<15%	Firm	
L	<15%	Firm	
M	N/A	Soft	Soft substrate was observed when drilling/probing. This is an indication of moisture damage / wood rot.
N	<15%	Firm	
O	N/A	Soft	Soft substrate was observed when drilling/probing. This is an indication of moisture damage / wood rot.
P	<15%	Firm	
Q	<15%	Firm	
R	<15%	Firm	
S	<15%	Firm	
T	<15%	Firm

5- 1.2 Test Location A - Soft substrate encountered

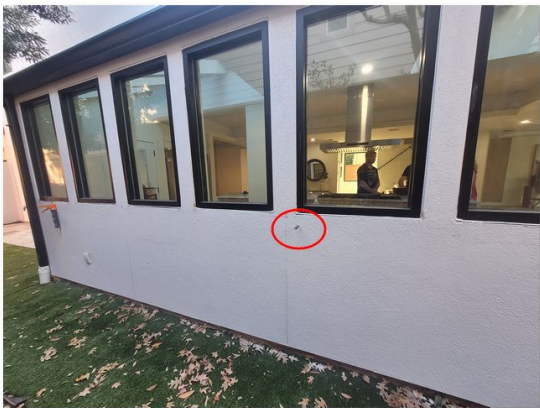
5- 1.3 Test Location F - Soft substrate encountered

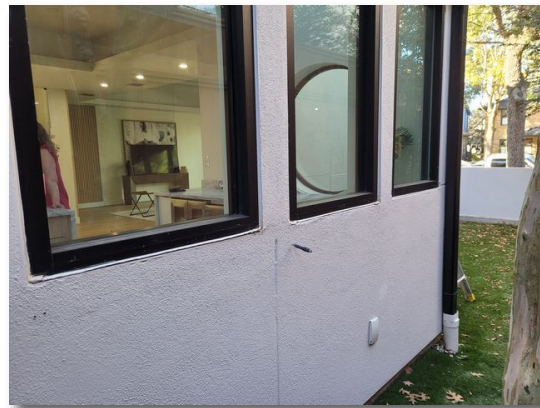
5- 1.4 Test Location I - Soft substrate encountered

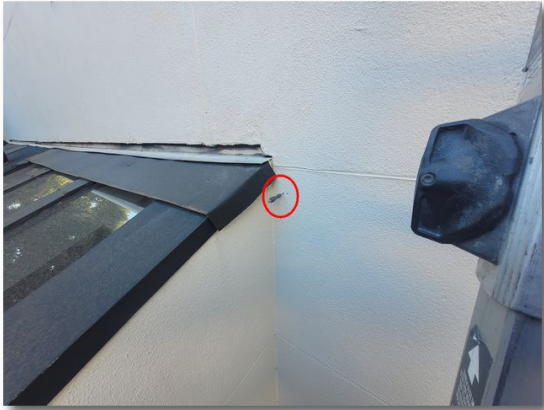
5- 1.5 Test Location M - Soft substrate encountered

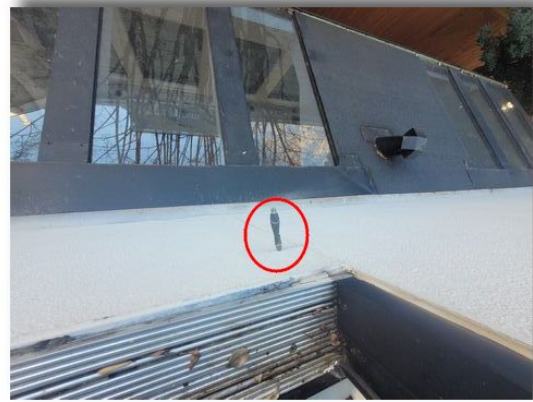
5- 1.6 Test Location O - Soft substrate encountered

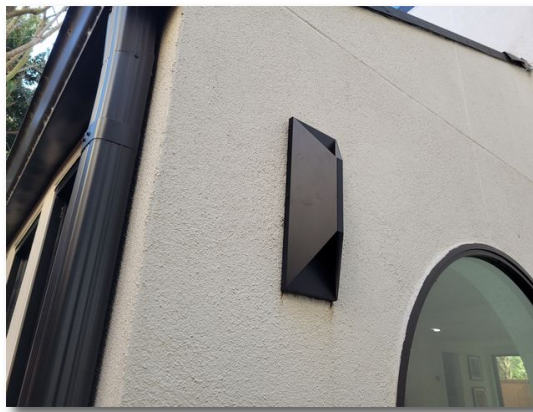
5 - 2: Damaged / Aged / Missing Sealant: Damaged, aged, and / or missing sealant was found at wall penetrations, joints, windows, and / or other voids on the exterior. Properly installed sealant provides a barrier against moisture intrusion. Recommend repairs using a top quality, low modulus, polyurethane sealant or sealant recommended by the manufacturer of your system.

5- 2.2 Seal lights

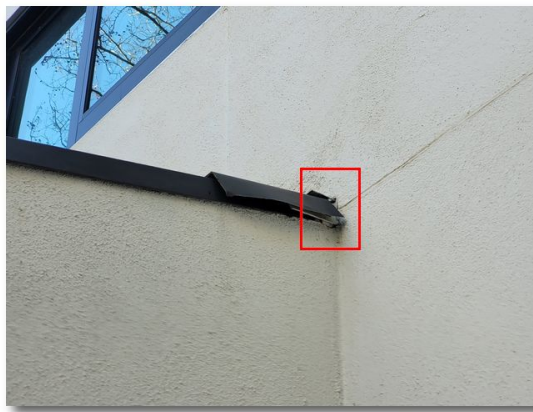
5- 2.4 Seal roof / wall intersection

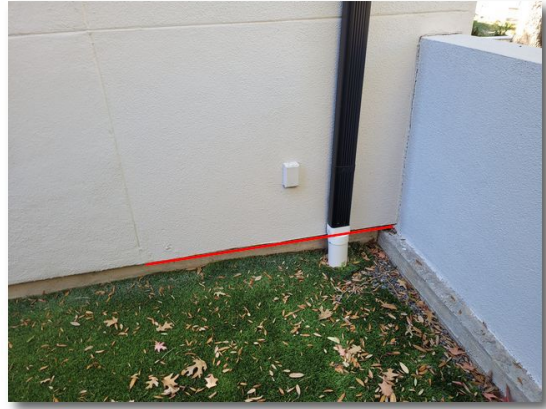
5- 4.2

5 - 4: Damaged Substrate at Bottom of Wall: Damaged substrate was observed at the bottom of the wall by physically touching the substrate from behind the weep screed. It is recommended that these areas be further assessed and repaired by a qualified stucco contractor, as needed.

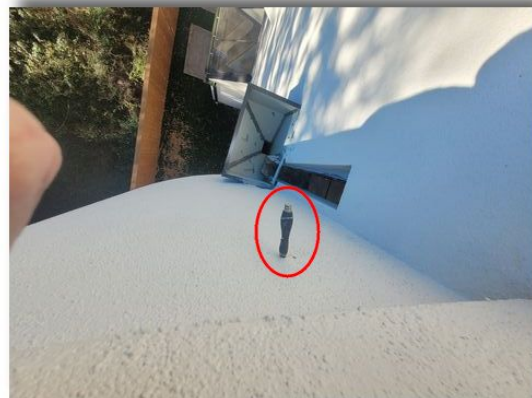
6 - 1: Moisture Intrusion: Areas of elevated moisture and / or possible substrate / framing damage was found at the following locations as reported on the "Moisture Testing" page:

Soft or Missing Substrate - Refer to the *Moisture Testing* page for the condition of the substrate at each test location. If the substrate is not firm when inserting the moisture meter probes, this can indicate possible wood rot / damage due to previous or active water penetrations in the area near the probed location.

6- 1.3 Test Location L - Soft substrate encountered

Repair Process: It is recommended that these areas be further assessed and repaired by a qualified stucco contractor, as needed. Core sampling or inspection holes should be performed by your contractor to confirm any suspected substrate and / or framing damage found by the inspector. Test locations are not representative of the total area of suspected damage, but provide information on general areas where repairs may be needed. Typical repairs to remedy soft or missing substrate include doing a partial tear-off of the stucco around the location until clean dry substrate is found and repairing as needed. During repairs, the total area any underlying damage should be determined by your contractor. It is important to thoroughly review and understand the scope of work in the repair proposal provided by your contractor. In addition, it is recommended to discuss the potential for "Change Orders" that may occur once work begins.

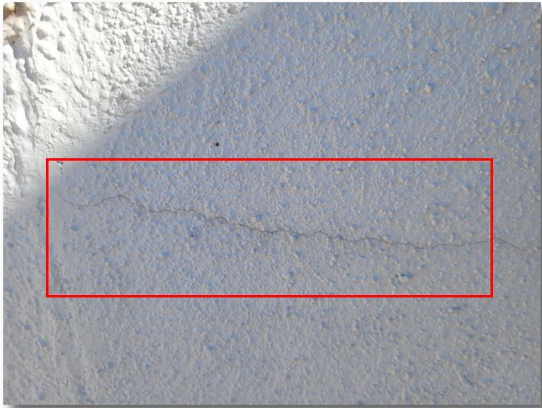
6- 3.1

6 - 3: Cracks Present: Cracks were found at the stucco cladding. Hairline cracks (generally 1/16 of an inch) are commonly found with stucco systems. These cracks should be monitored and repaired as needed. It is recommend that cracks larger than hairline are repaired by a qualified stucco contractor.

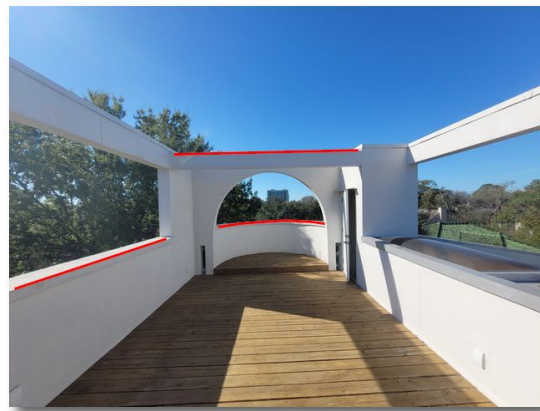
6- 4.2

6 - 4: Flat Surfaces Without Cap Flashing: Flat / low slope surfaces were observed at the stucco walls. Flat / low slope surfaces are more prone to cracking, standing water, and moisture intrusion, leading to wood rot of the sheathing and framing within the wall cavity. Recommend installing cap flashing or other waterproofing methods to prevent damages from occurring. *Cap flashing should be installed with fasteners on the sides, not through the top surface.*

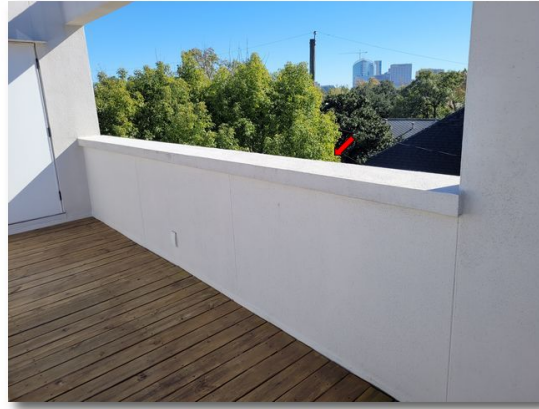
6- 5.2

6 - 5: Rust: Rust was observed at this location. It is recommended this area is repaired to prevent further rust / damage from occurring.

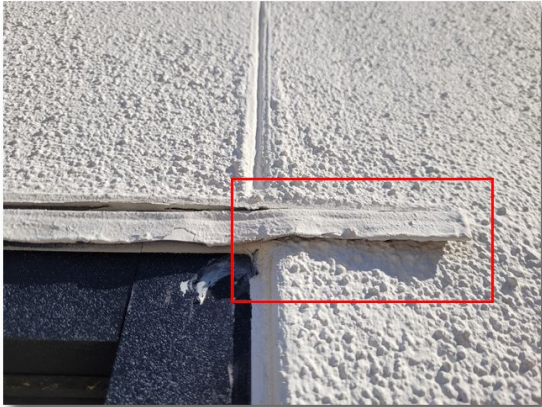
G- 3.1

G - 3: Improper Head Flashing: The head flashing on most windows do not flap down on the sides. This is an improper installation of head flashing and can create voids at the top corners. Ideally, the flashing should lap down on the sides to direct moisture away from the window corners. Recommend having the head flashing installed properly on the affected windows during repairs.
