# ***Fox Inspection Group***

## **Frame Inspection Report**

13802 Arroyo Grande, Cypress, TX 77433  
Inspection prepared for: Jorge Galeano  
Real Estate Agent: Aaron Greeley - CB&A, Realtors

Date of Inspection: 9/21/2023 Time: 9:00 AM  
Age of Home: 2023 Size: 3001  
Order ID: 108701

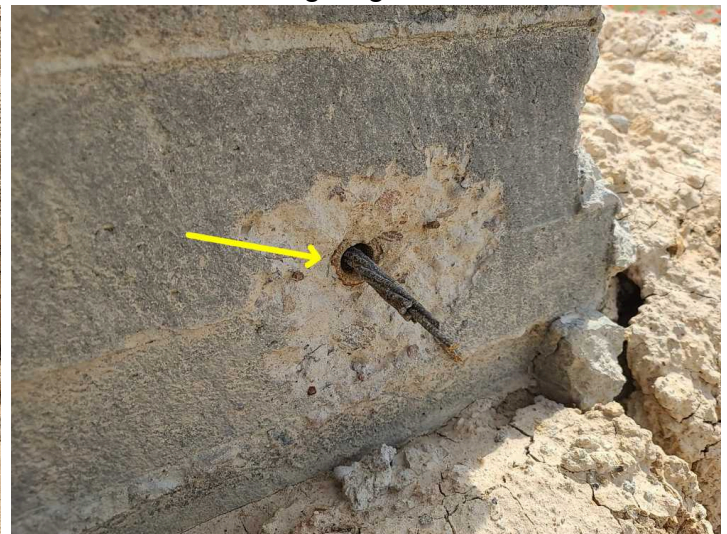
Post tension cable live ends are exposed/ not cut back at all four corners

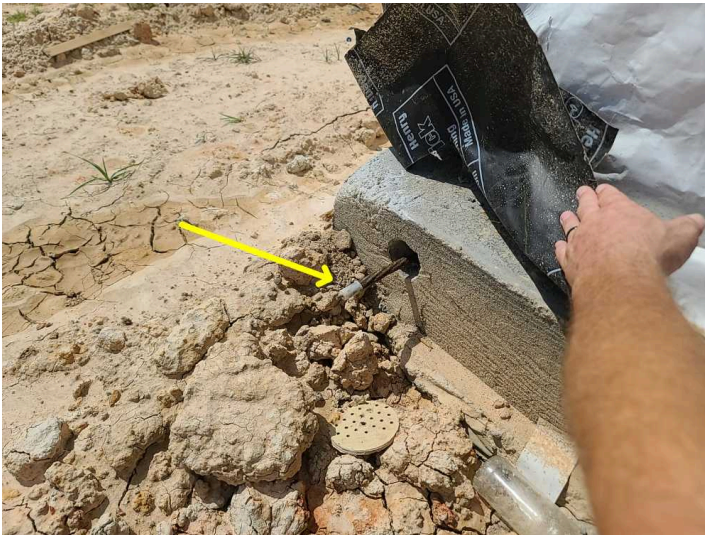
Post tension cable live ends are exposed/ not cut back at all four corners

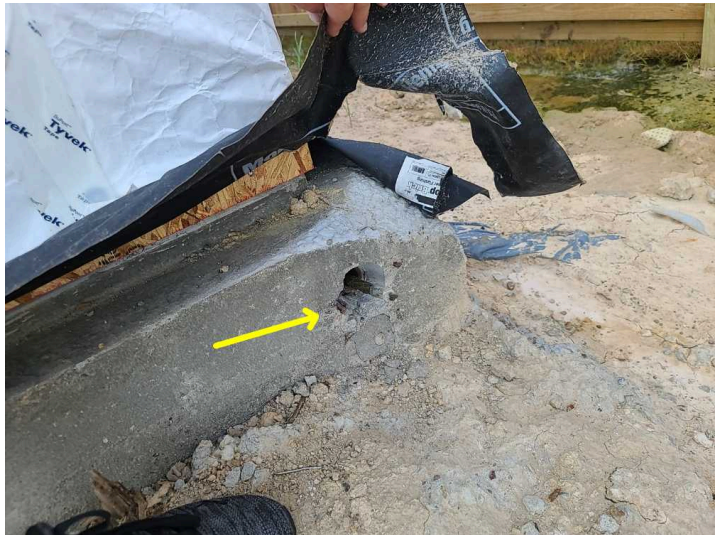
Post tension cable live ends are exposed/ not cut back at all four corners

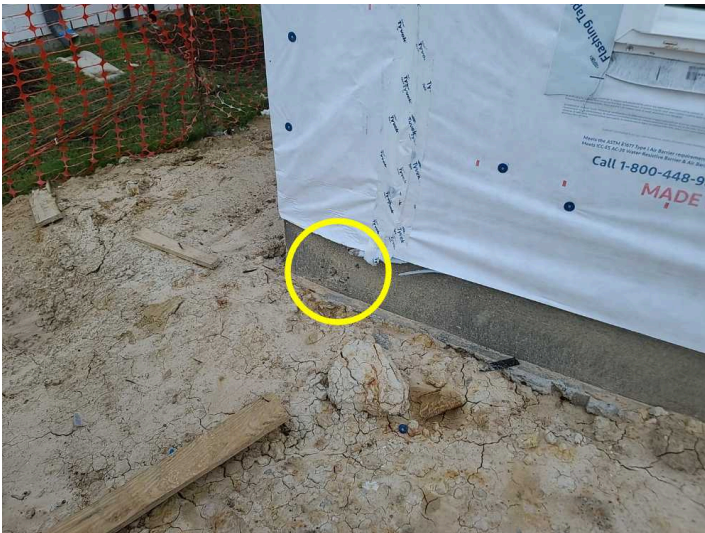
Post tension cable live ends are exposed/ not cut back at all four corners

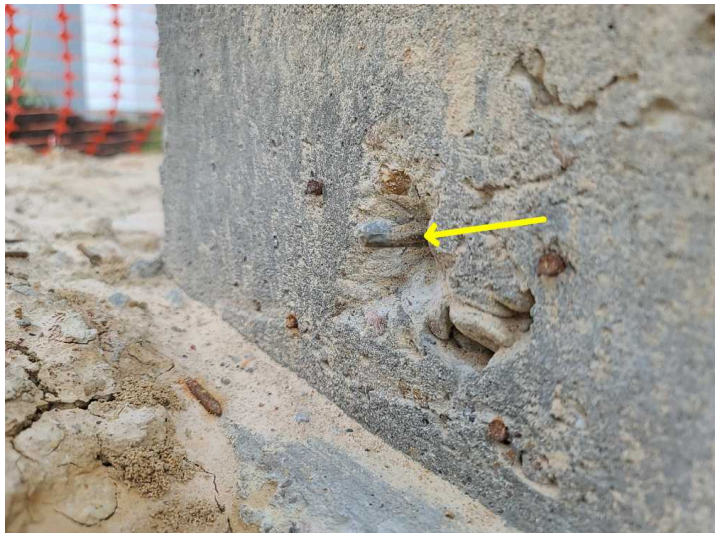
Post tension cable live ends are exposed/ not cut back at all four corners

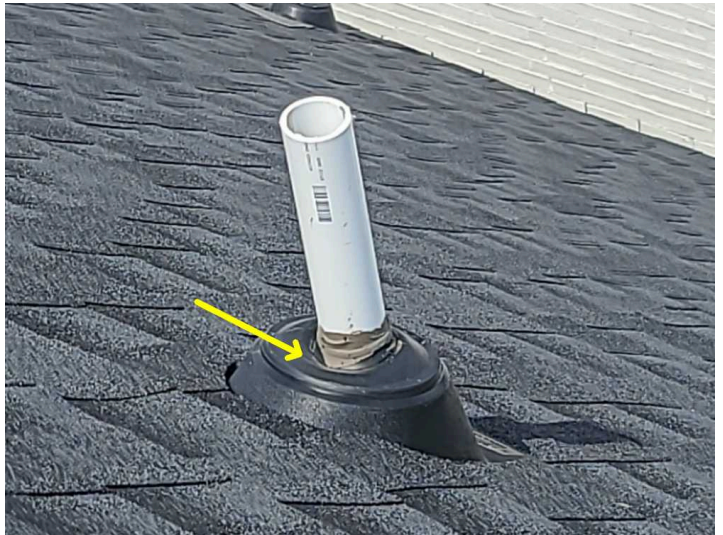
Rubber gasket of one or more drain waste vents was observed to have an inverted rubber gasket. This condition can allow rainwater to accumulate and penetrate.

Rubber gasket of drain waste vents have an inverted rubber gasket

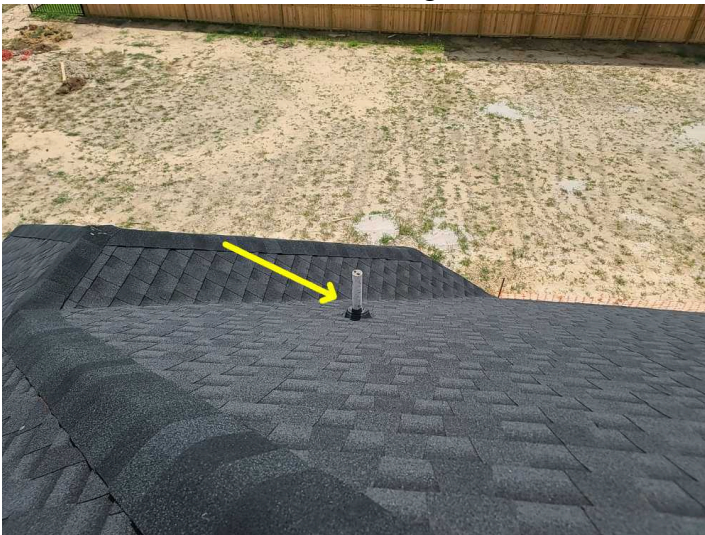
Rubber gasket of drain waste vents have an inverted rubber gasket

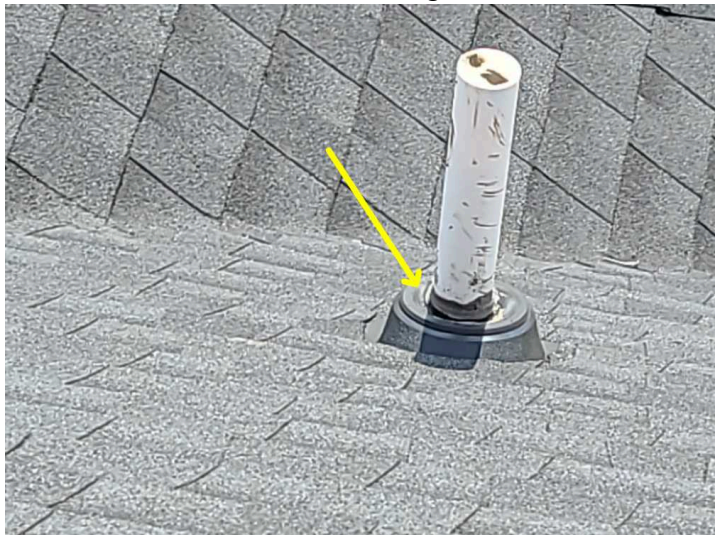
Rubber gasket of drain waste vents have an inverted rubber gasket

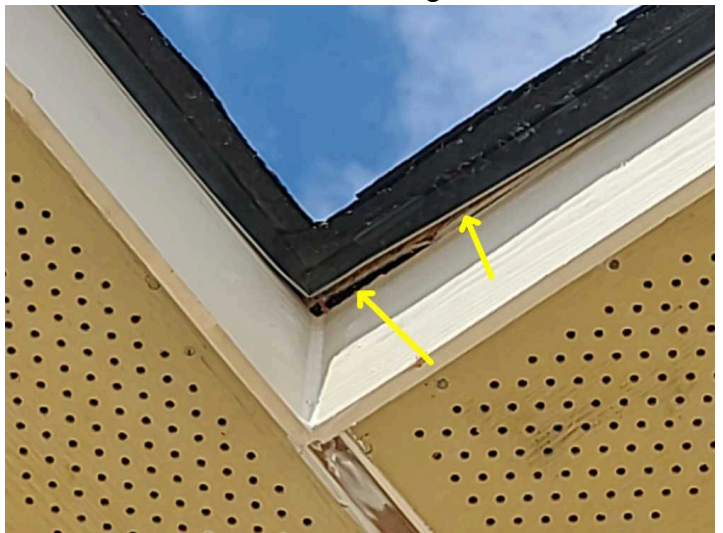
Metal drip edge is lifted/ bent at the East roof edge above back patio.

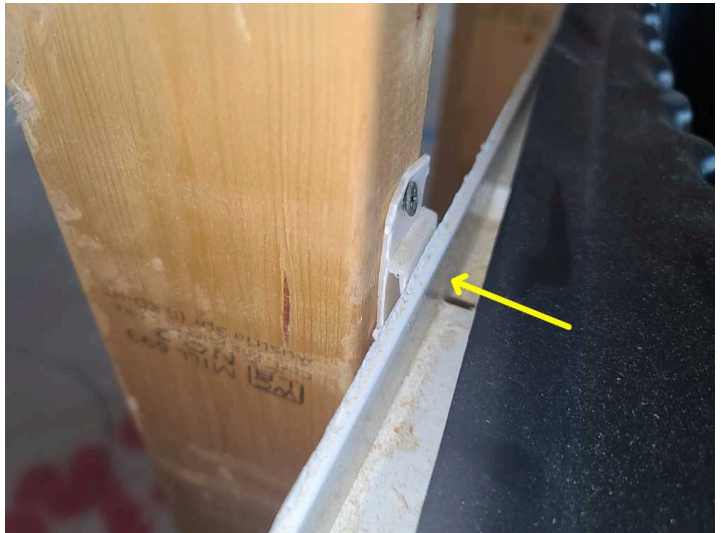
Fiberglass tub securing clips are not properly seated at tub lip; Northwest guest bedroom.

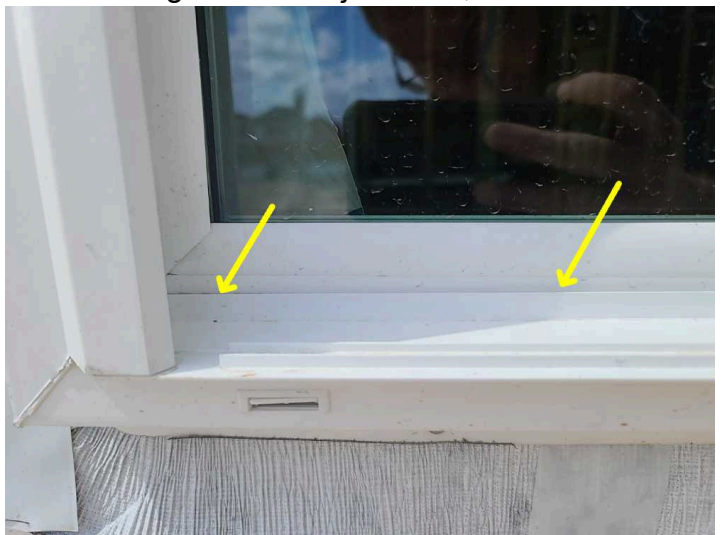
Lower window frames/ sills are not square/ not level. Flanges need adjustment; bonus/ flex room
